**Oregon State Office  
Bureau of Land Management  
Annual Facility Safety Inspection – FY 2004**

**OR WA BLM Facility Safety Inspection Report – Oregon State Office**

**Facility** Oregon State Office **Date** Tues/Wed – April 6&7 2004

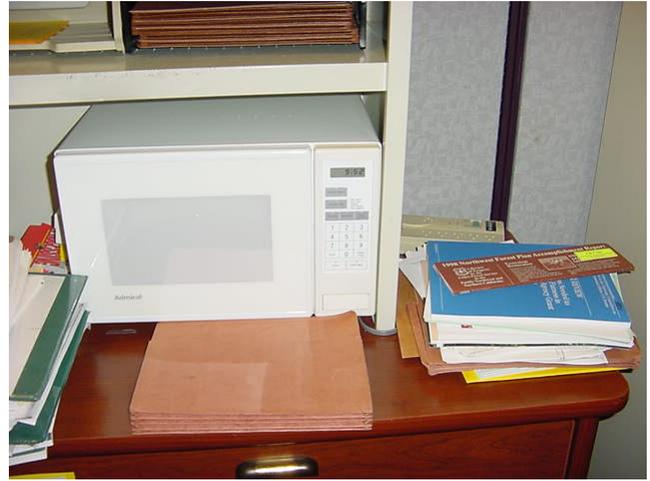
inappropriate placement of microwave  
Ventilation poor/electrical concern

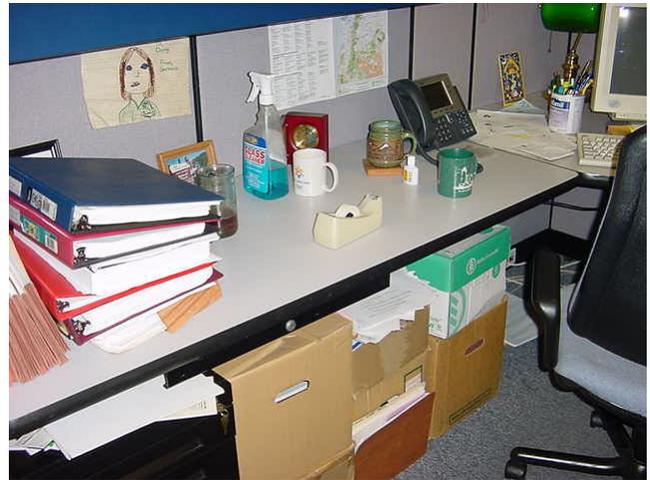
under desk storage presents  
tripping hazards/materials atop cords

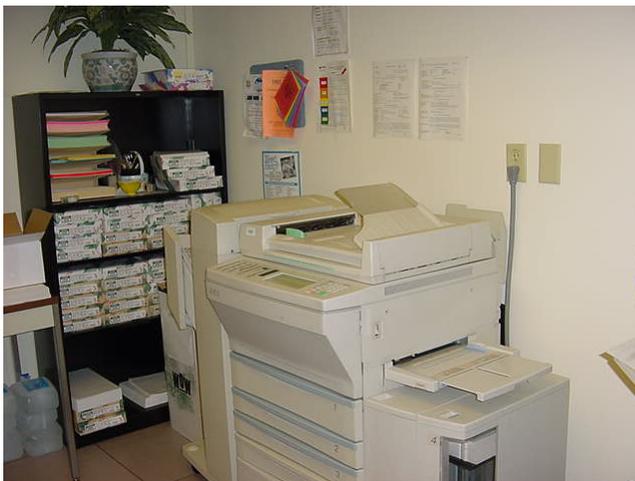
A well-kept common area/MSDS forms available and displayed

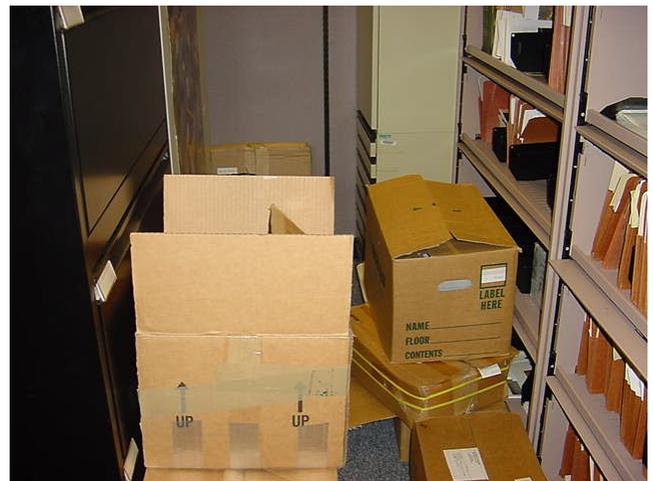
Storage area aisles blocked

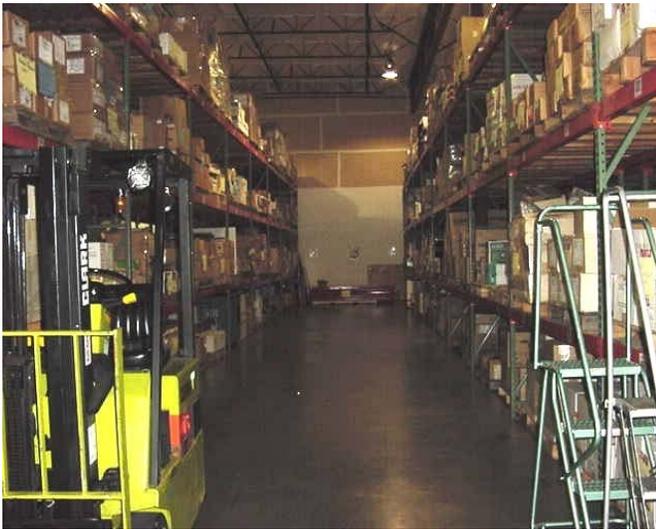
Aisle well kept and organized

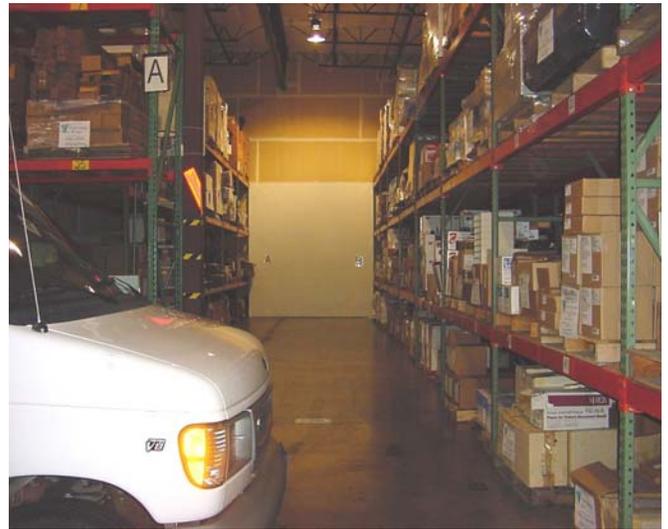
Aisle clear of materials

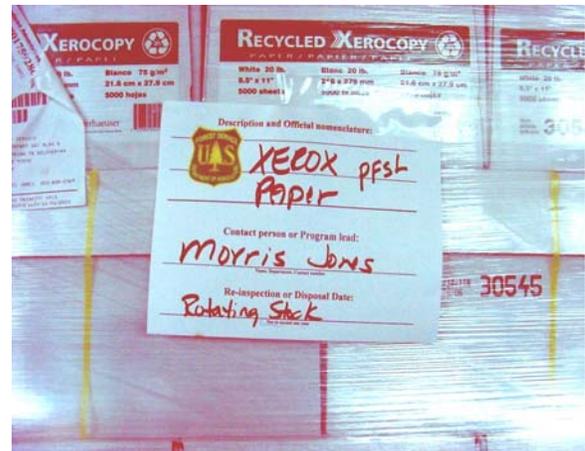
interagency identification system  
for supplies and materials
