# Telegraph Fire

## Recreation and Wilderness Resource Assessment

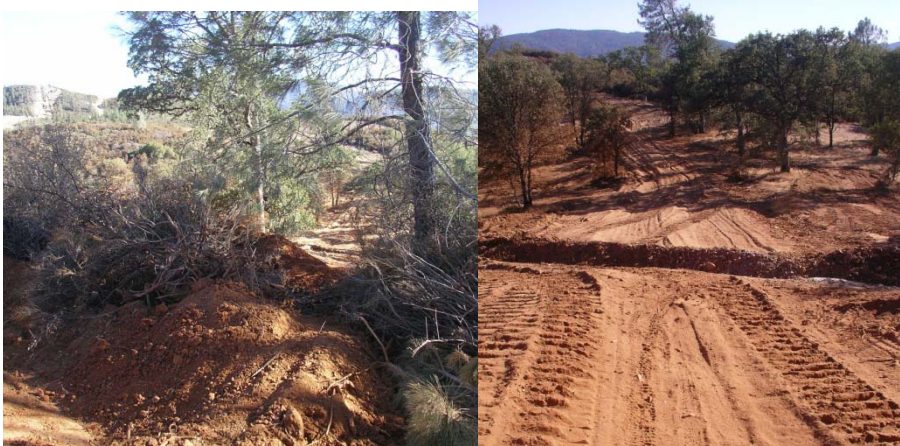
6 foot berm with brush (looking south)

The other side of same berm.

Notice the motorcycle track already in each photo.
