Fire: Red Bridge #: DM93

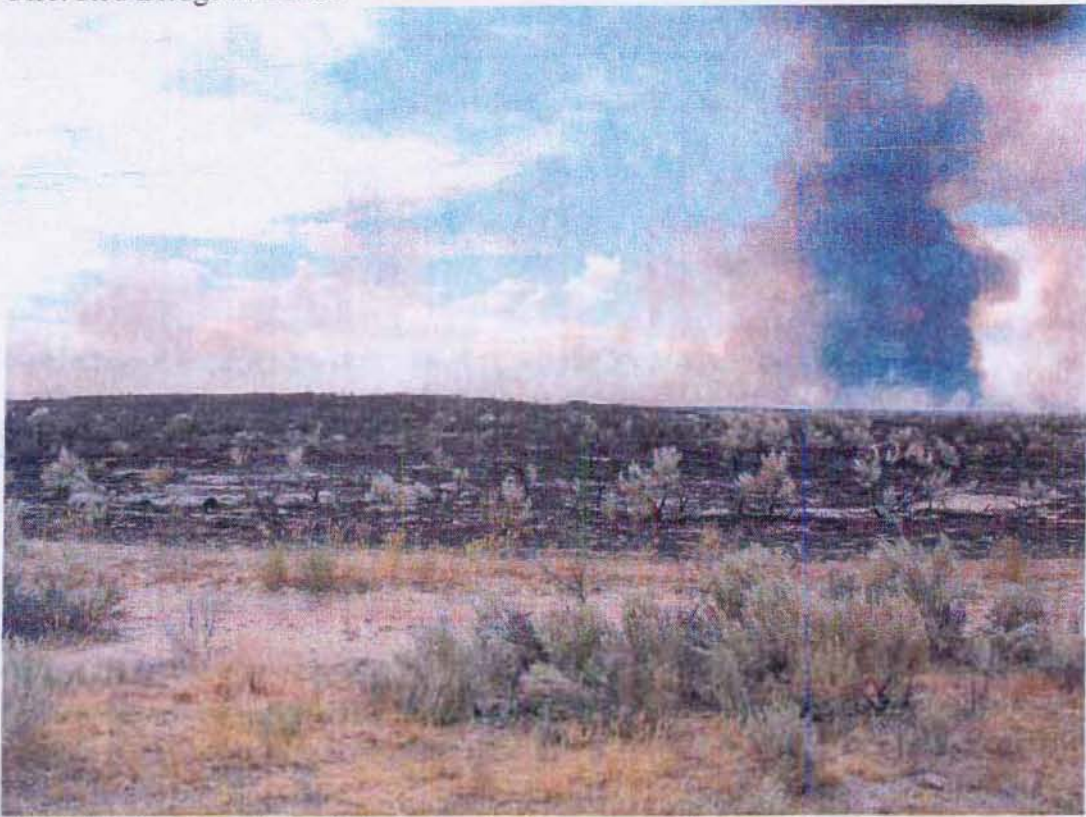
Photo # 1 Over all view of fire/general origin area, facing North.

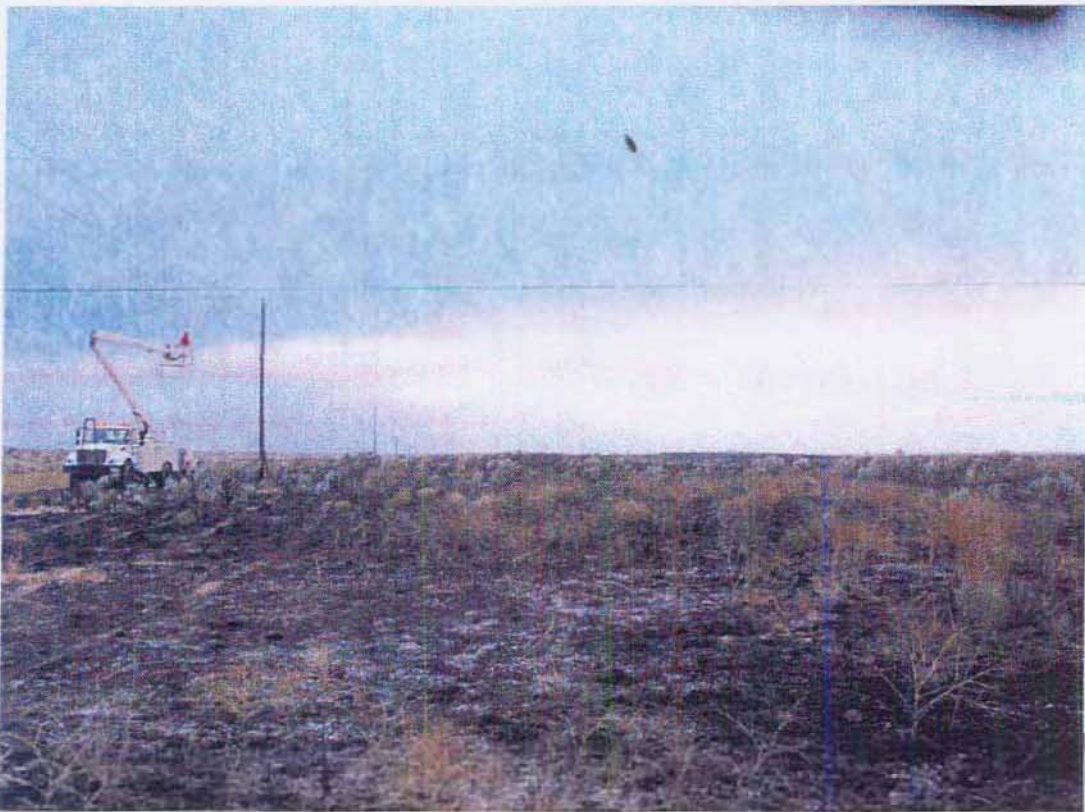
Photo # 2 Over all view of fire/general origin area, facing West.

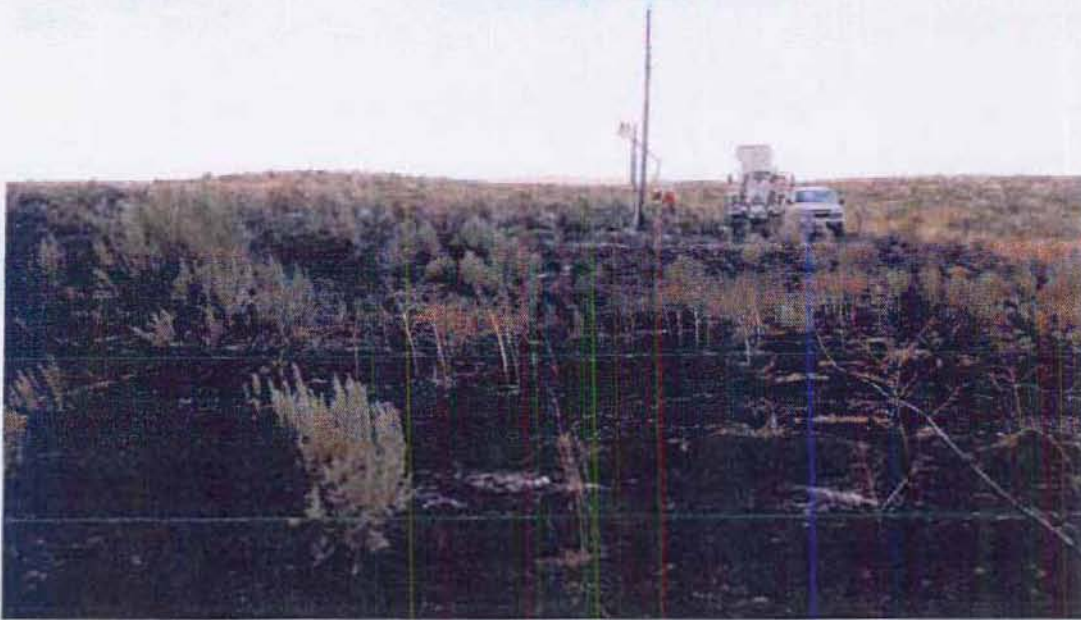
Photo # 4 Over all view of fire/general origin area, facing East.

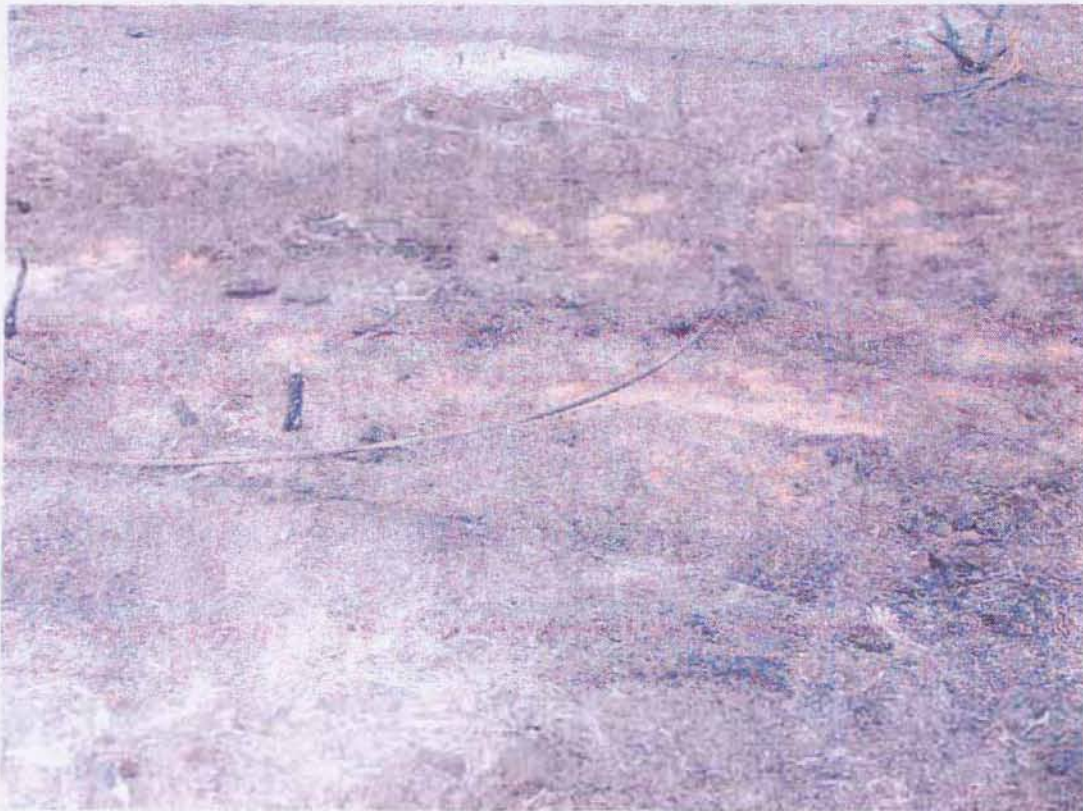
Photo # 6 End of power line in general origin area. (End on the East side – facing North)

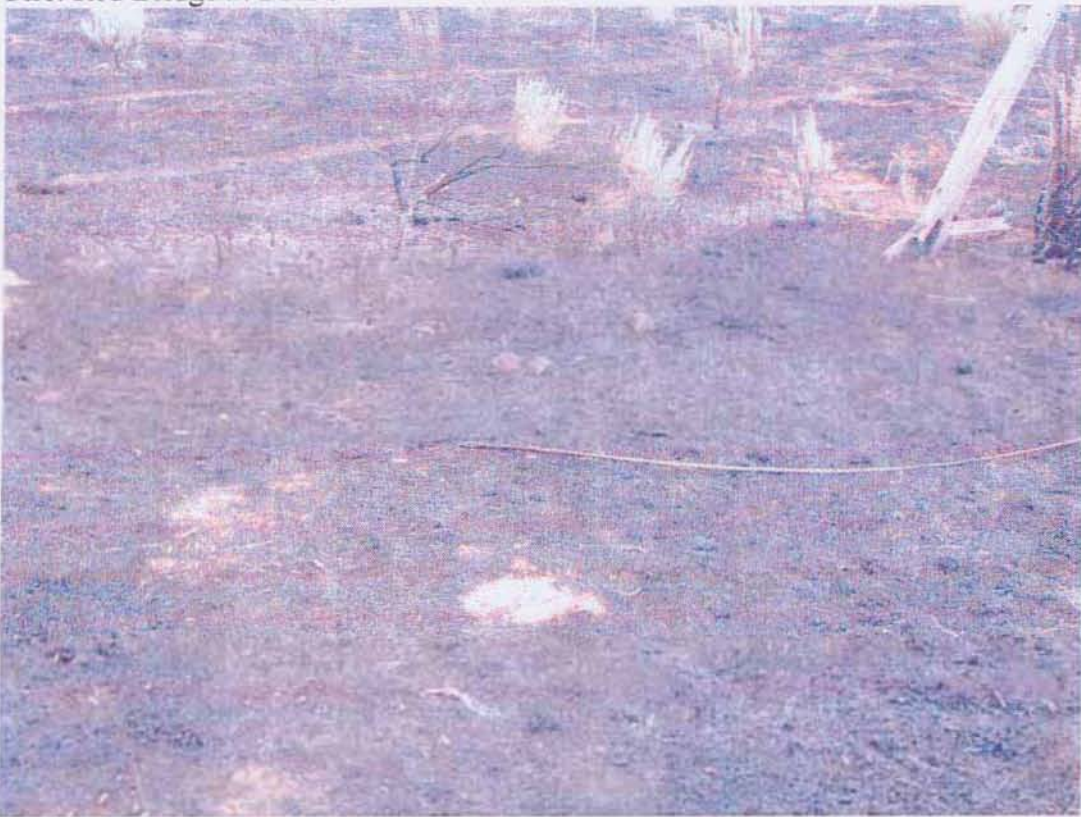
Photo # 7 End of power line in general origin area. (End on West side – facing North)

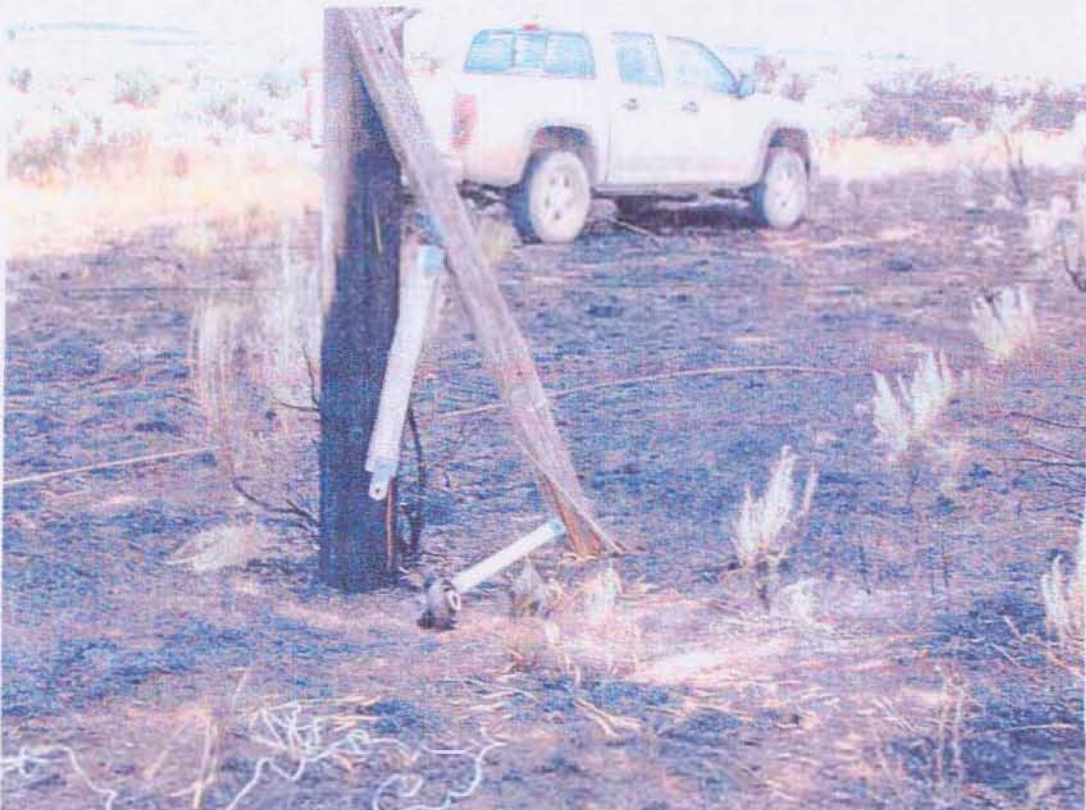
Photo # 8 Closest power pole where line went down. Note: broken power line on the ground to the right of pole. Facing South West.

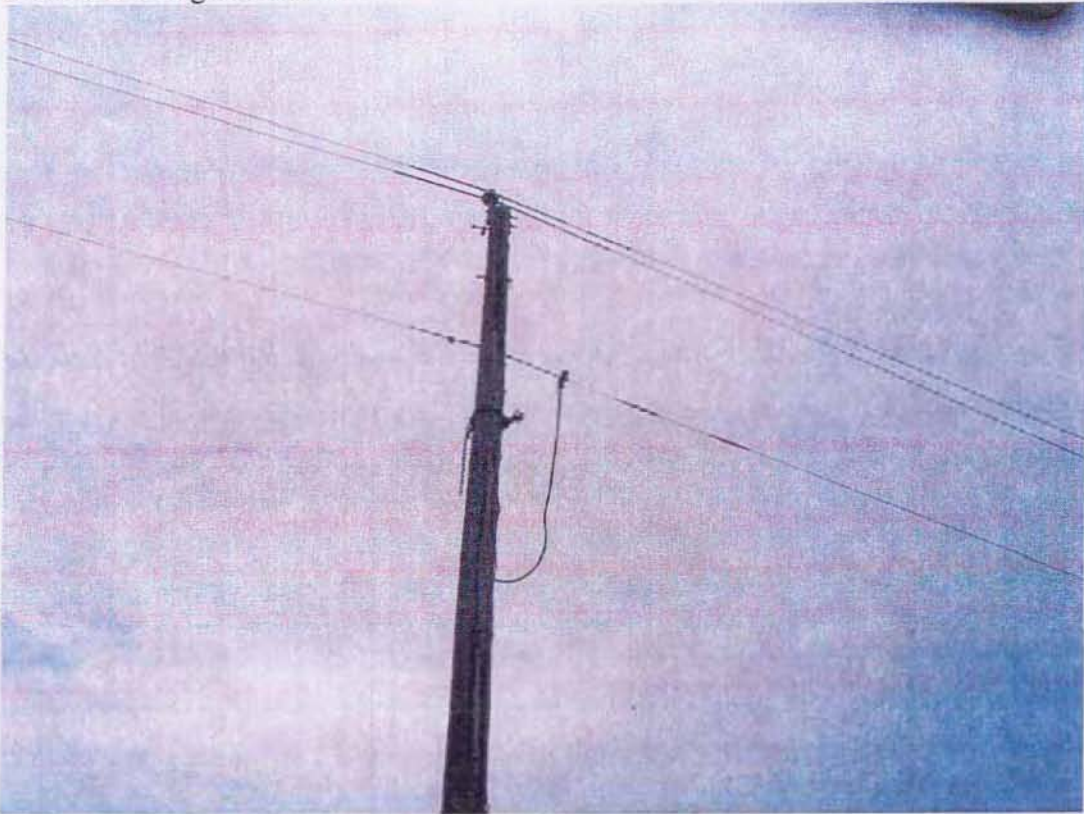
Photo # 9 Top of same power pole shown in photo #8.

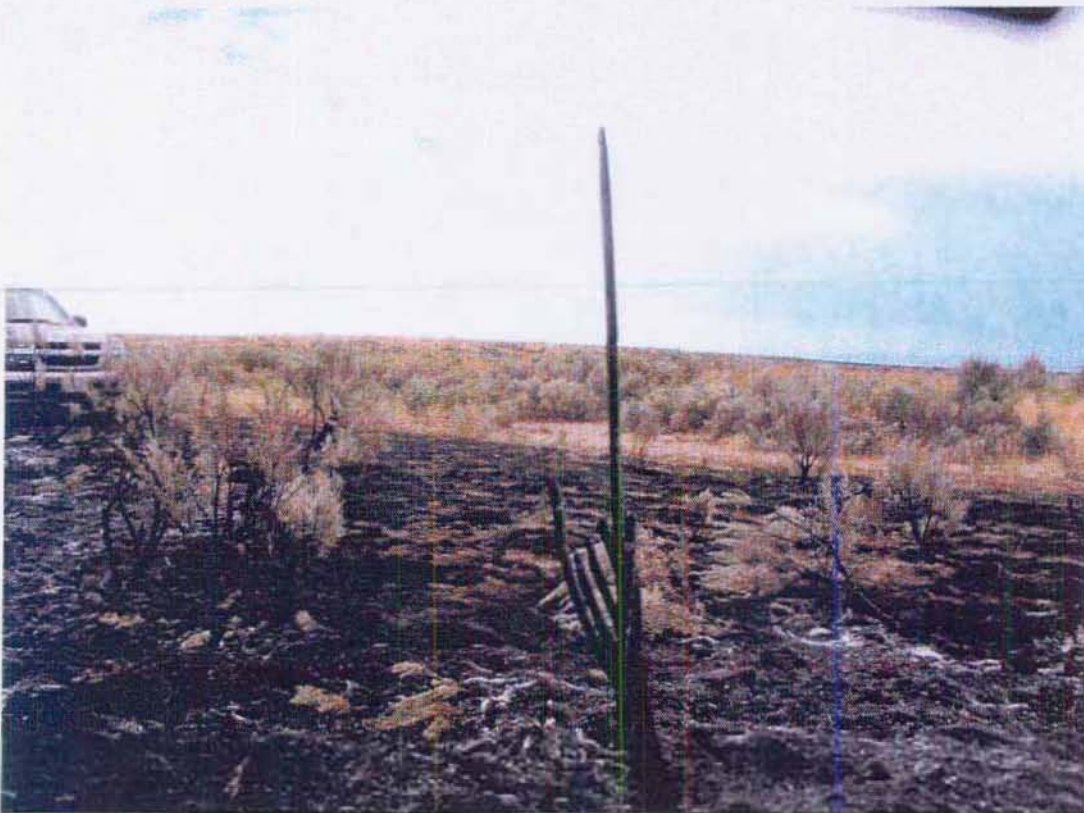
Photo # 10 End of power line (I am holding it up) facing South.

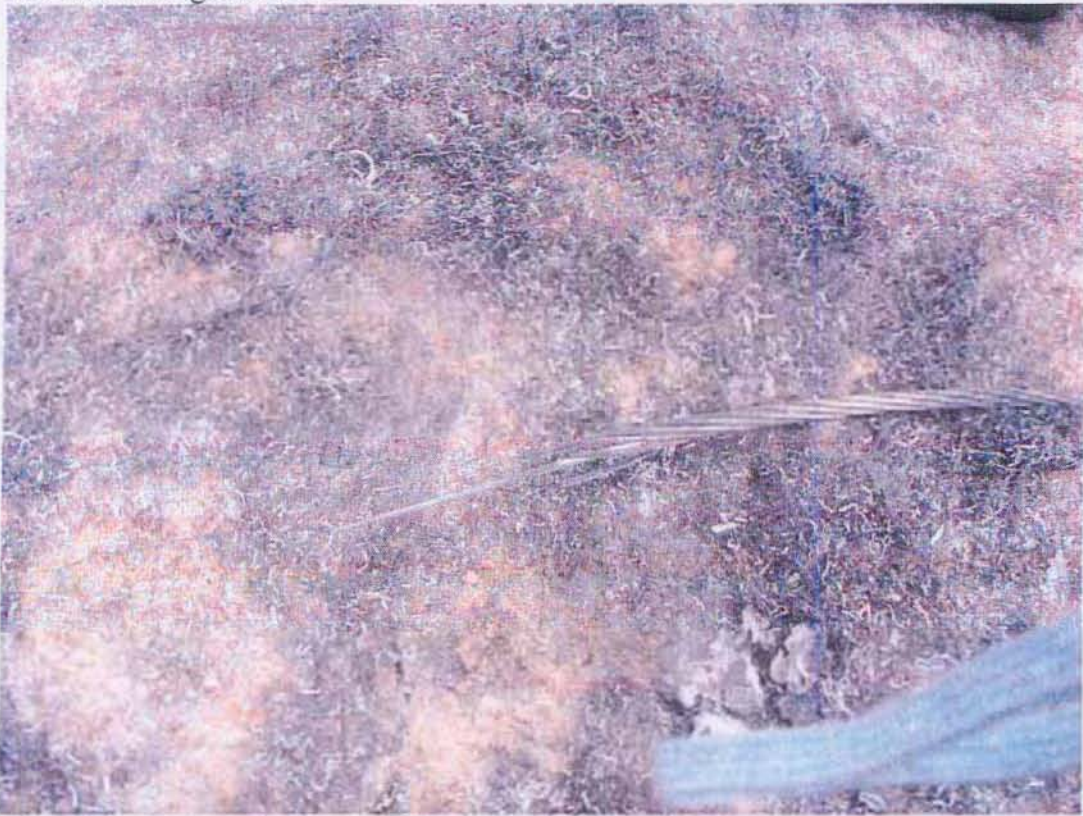
Photo # 11 Same end of power line shown in photo #10, laying on the ground.

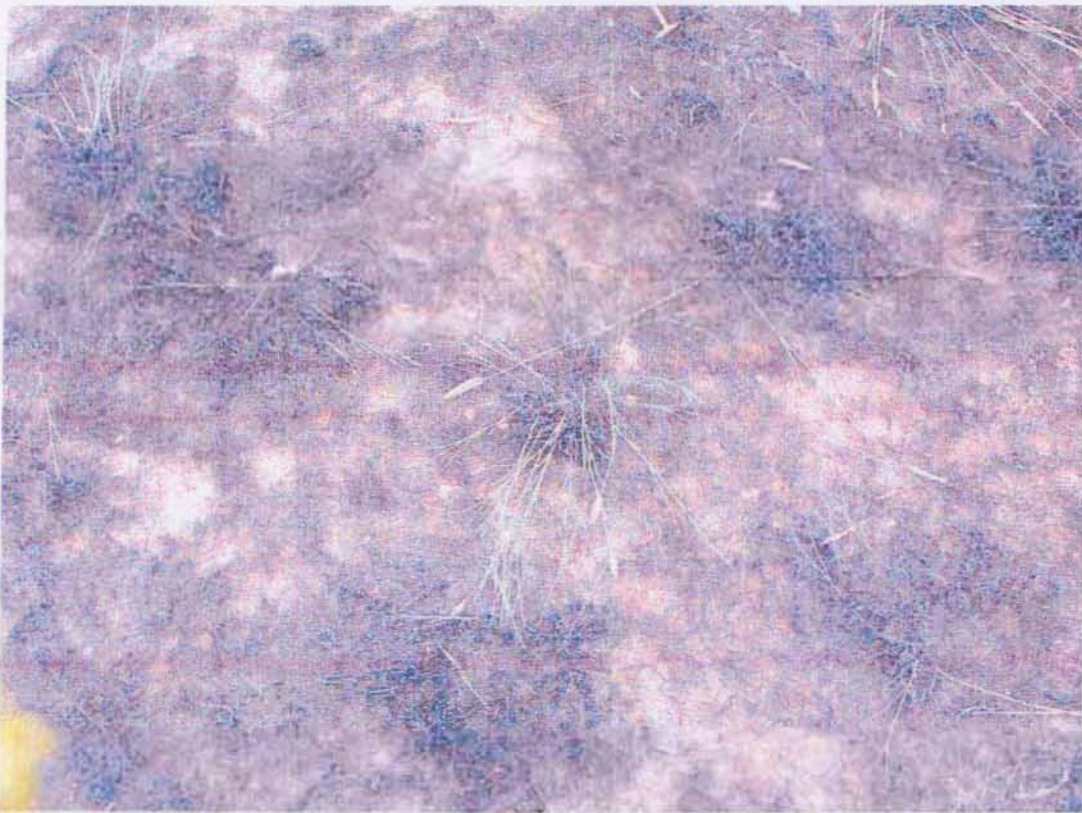
Photo # 12 Backing indicator, facing South. Fire backing bottom to top of photo.

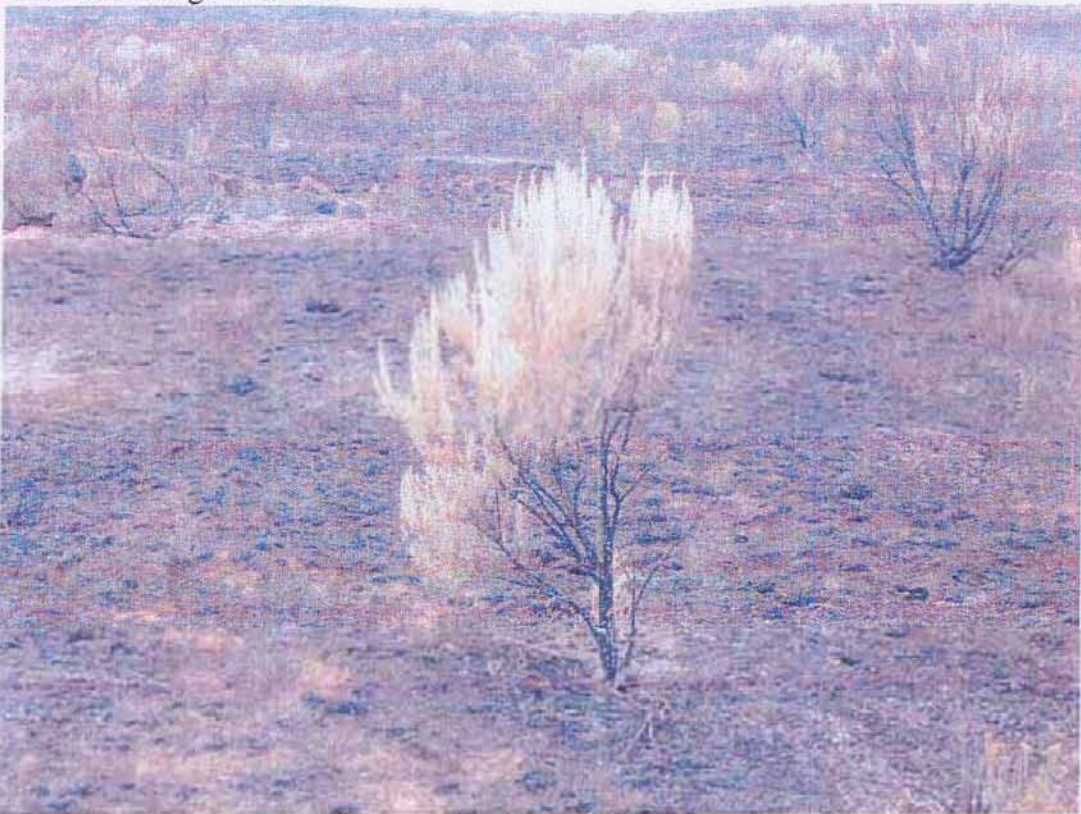
Photo # 13 Advancing indicator, facing North West. Fire advancing left to right in photo.

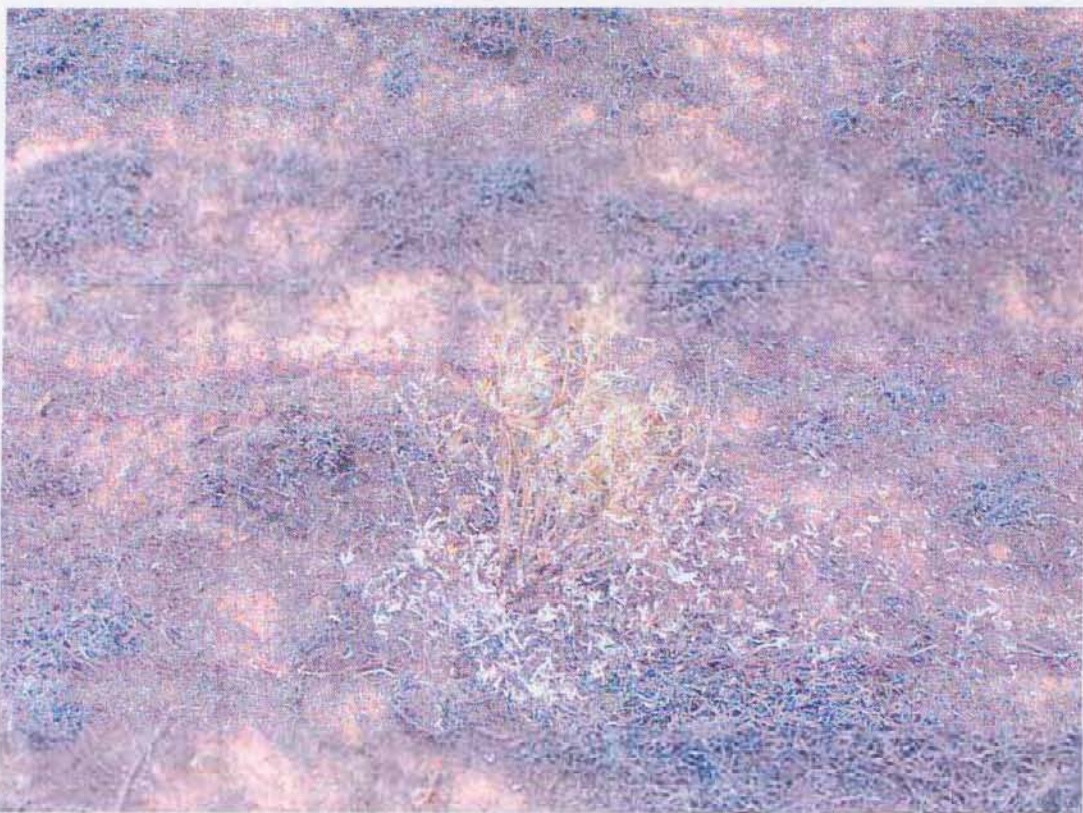
Photo # 14 Lateral indicator, facing North. Note: unburned fuel and foliage freeze indicating that the wind was coming from the South West.

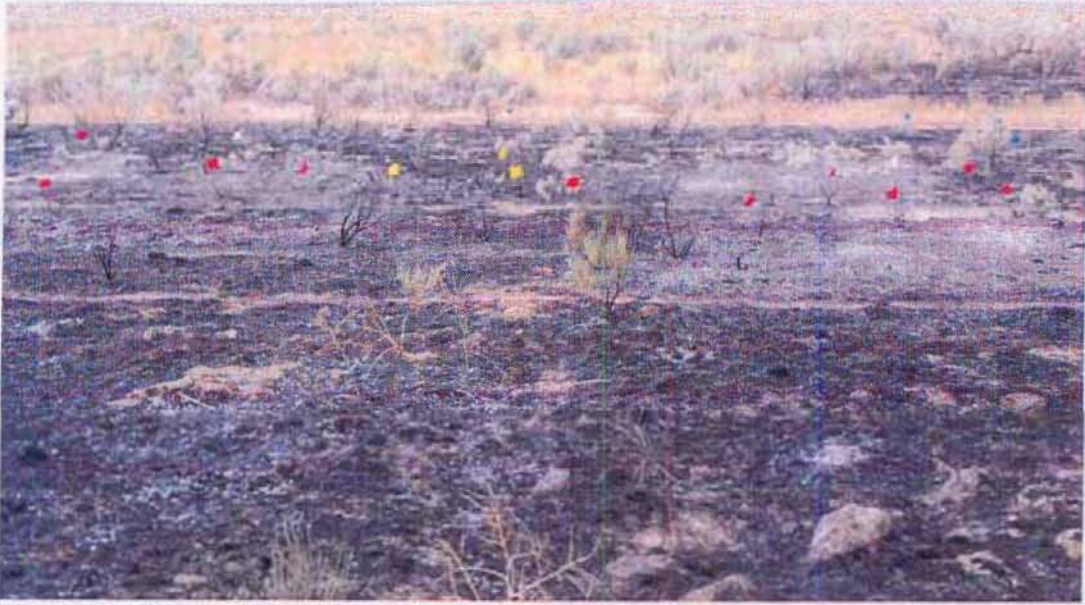
Photo # 15 View of specific origin areas, facing South.

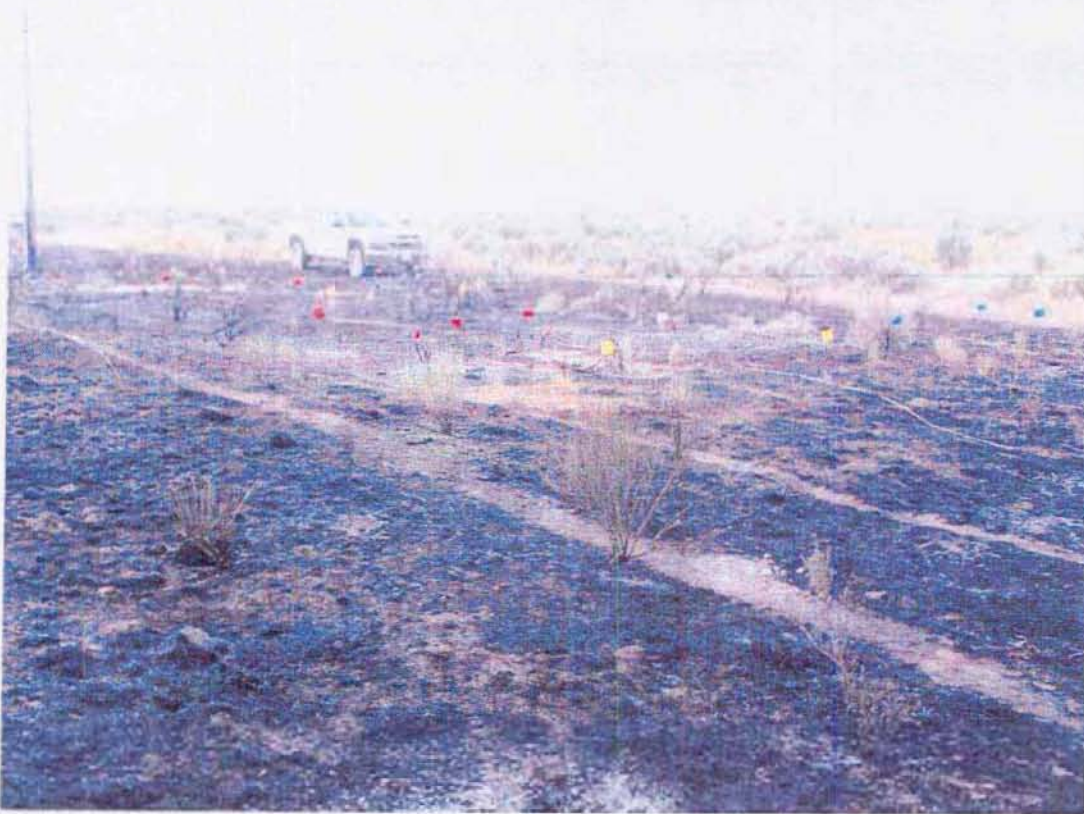
Photo # 16 View of specific origin areas, facing South East.

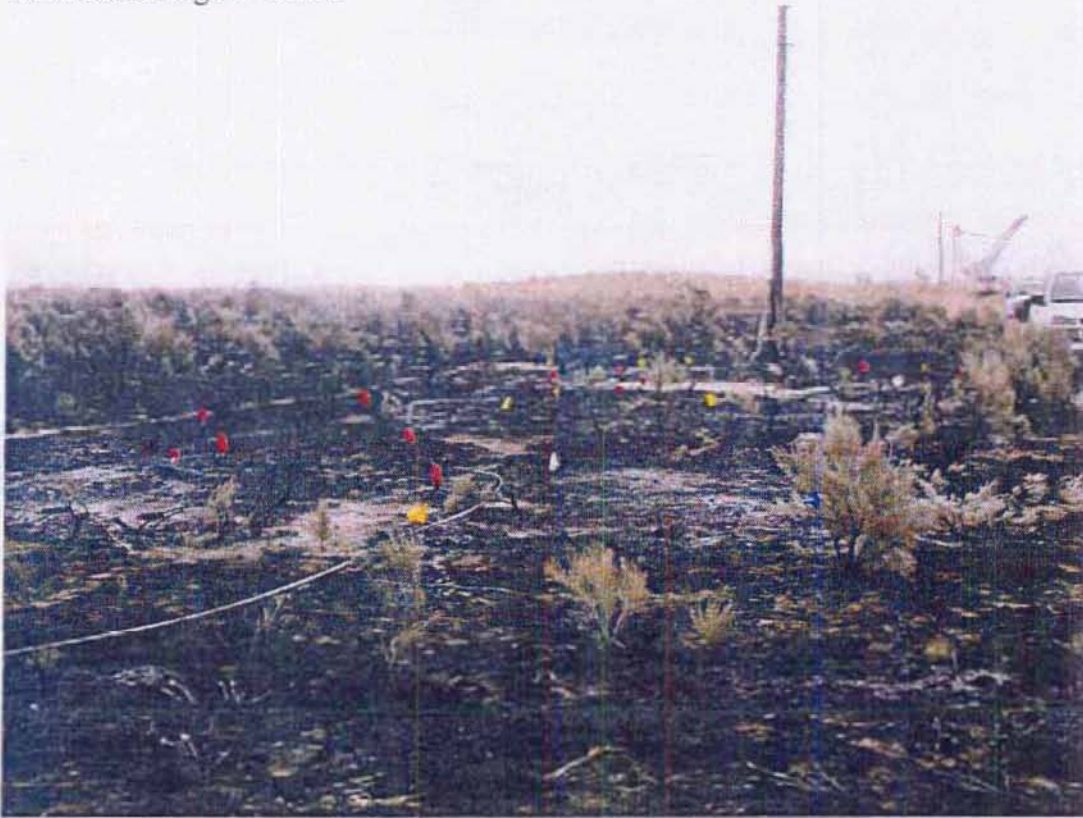
Photo # 17 View of specific origin area, facing North East.

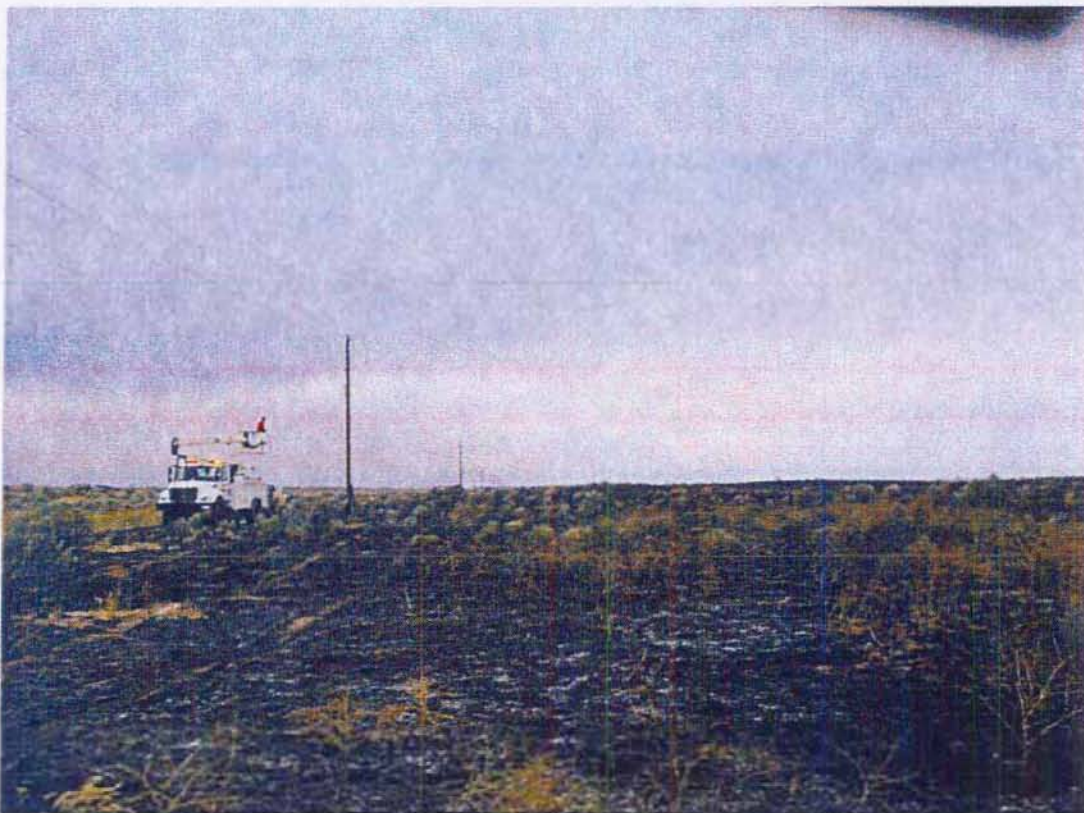
Photo # 3 Overall view of fire/general origin area, facing West – compare to photo # 2

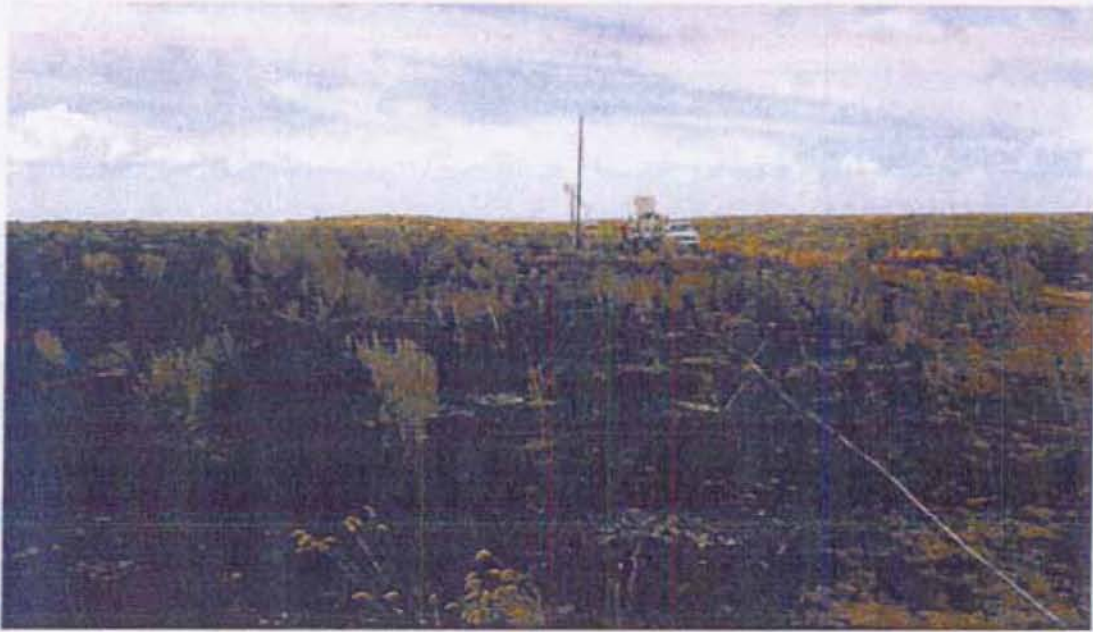
Photo # 5 Overall view of fire/general origin area, facing East – compare to photo # 4
