# U.S. DEPARTMENT OF THE INTERIOR BUREAU OF LAND MANAGEMENT

## Aviation Operations Alert

No. 11-01

Subject: Lessons Re-learned

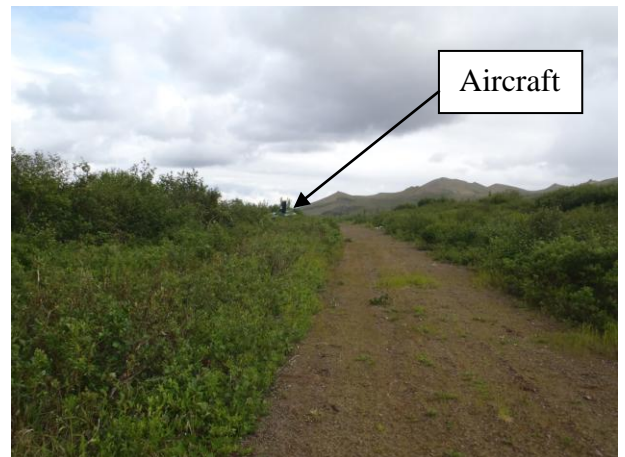
1. July 26, Airplane Incident with Potential (IWP) during takeoff from a landing strip with marginal parameters for error. Cessna 207 Skywagon landing gear width 10' - width of clearing on landing strip 12-20'. On takeoff roll, the aircraft drifted left causing the left main gear to come in contact with the brush lining the edge of the landing strip. No injuries.

Lessons Re-learned: Use the correct aircraft for the mission and category of flight. Reference: [BLM National Aviation Plan, 5.7 Categories of flight](#) and [Safecom 11-0744](#)

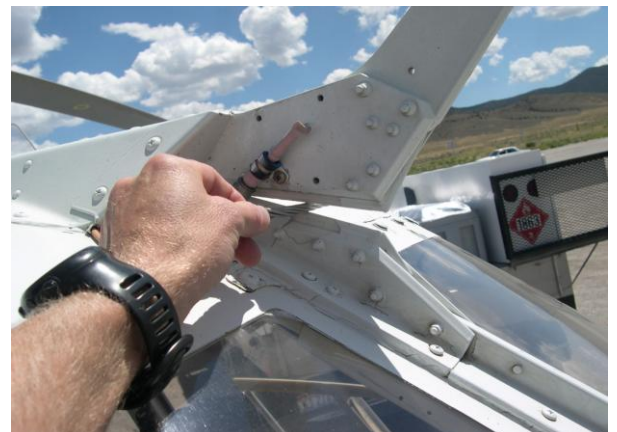
2. Aug 13, Helicopter Wire Strike upon landing for refueling. AS350 B2 with bucket on descended through power lines. Contract mandated wire cutter kit severed both wires. No damage to aircraft or injuries.

Lessons Re-learned: Always conduct a high and low level recon prior to attempting to land. All eyes and a sterile cockpit must be engaged during all landings and takeoffs. Unfortunately after completing a 360 degree recon the Pilot did not see the power pole or power lines running through the L.Z. Reference: [IHOG Chpt 3: Operational Planning Pg. 3-24](#), [Interagency Standards for Fire and Fire Aviation Operations, Pg. 16-8](#) and [Safecom 11-0779](#)

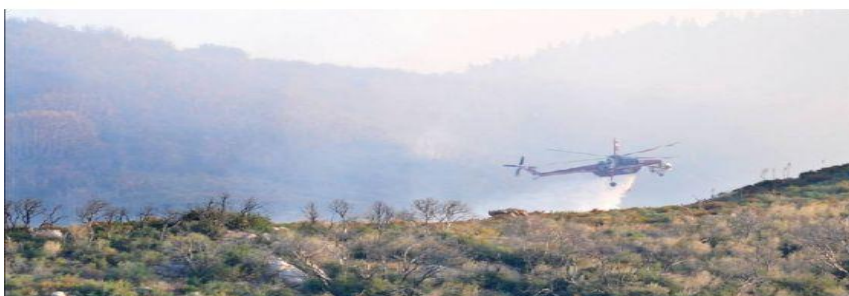
3. Aug 16, Helitanker water drop impacted firefighters during line construction. Radio communications between ground personnel and aircraft confirmed the line as being clear to drop. Medevac required, transporting two firefighters with unknown injuries.

**Lessons Re-learned:** Ensure communications are heard and understood to include: knowing the pilot's intentions, providing concise and accurate target description, confirming target area is clear of all personnel and crew location is secure if rolling or falling debris is dislodged, provide honest and constructive feedback on drops. If drops are unsafe – immediately stop the drops and communicate concerns to the appropriate person.

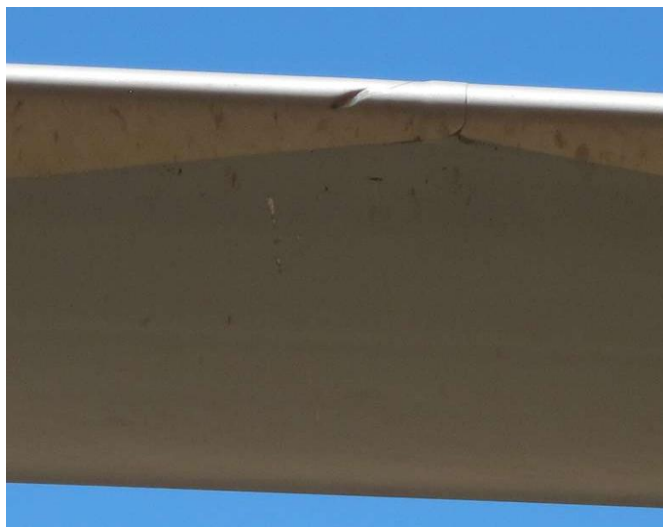
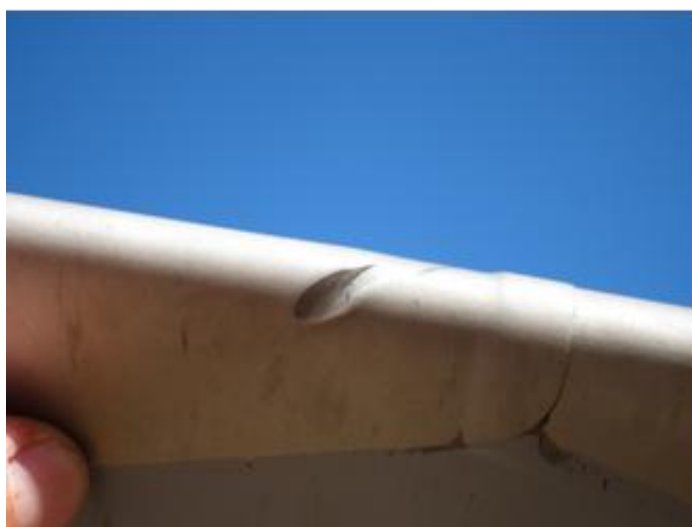
4. Aug 26, Helicopter Rotor Strike during loading/unloading of passenger gear in an external basket on an AS350B2. The HECM noticed a loose saw file in the expanded metal bottom of the external basket; the loose file was tossed away from the aircraft while the blades were turning impacting the leading edge of one main rotor blade. No injuries.

**Lessons Re-learned:** Secure light/loose items awaiting transportation and never toss, throw, fling, pitch, chuck or hurl items around aircraft. Reference: [Incident Response Pocket Guide pg. 54, Tools and equipment.](#) and [Safecom 11-0847](#)
