SUMMARY OF
BILL BARRETT CORPORATION'S
WEST TAVAPUTS PLATEAU
CULTURAL RESOURCE MONITORING PLAN
BASELINE DATA COLLECTION, FALL 2010

Bureau of Land Management,
Price Field Office,
Price, Utah

MOAC Report No. 09-156b

December 26, 2010

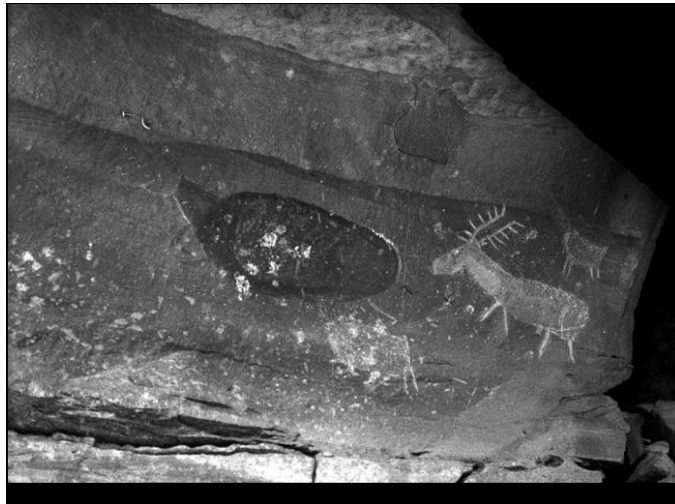
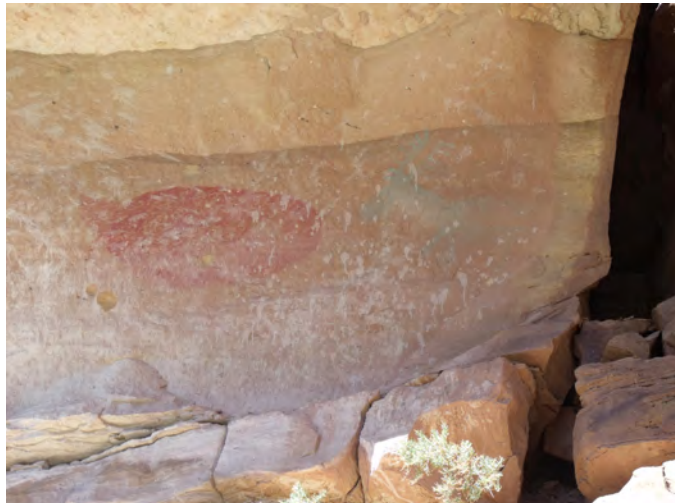
(Comparison of Rock art at Daddy Canyon (42Cb9829) between ca. 1931 and 2011.

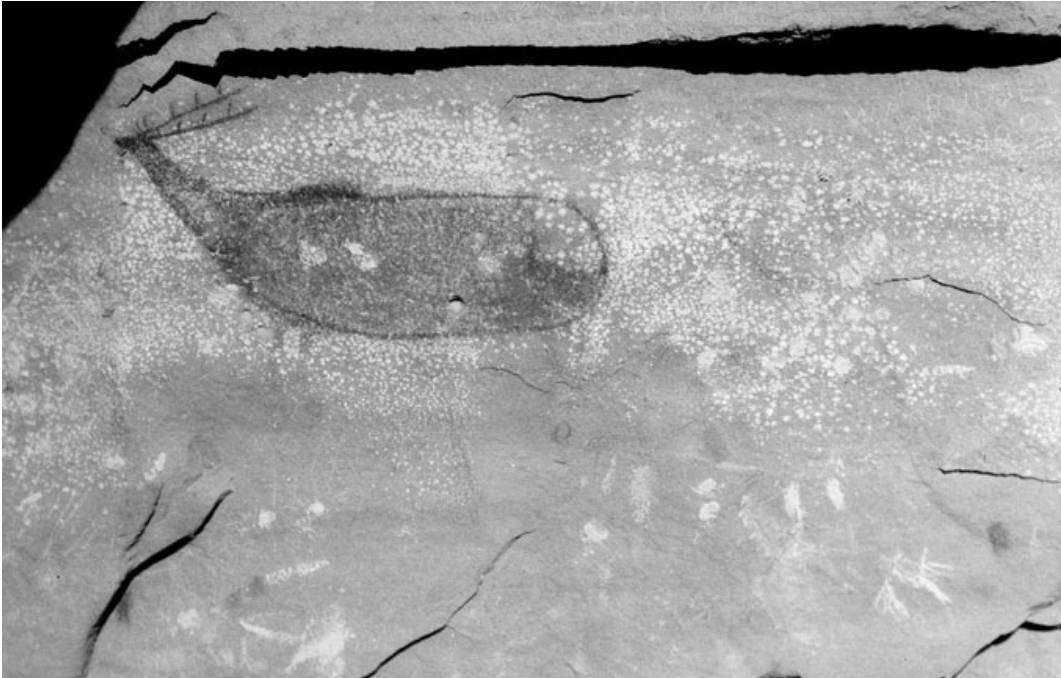
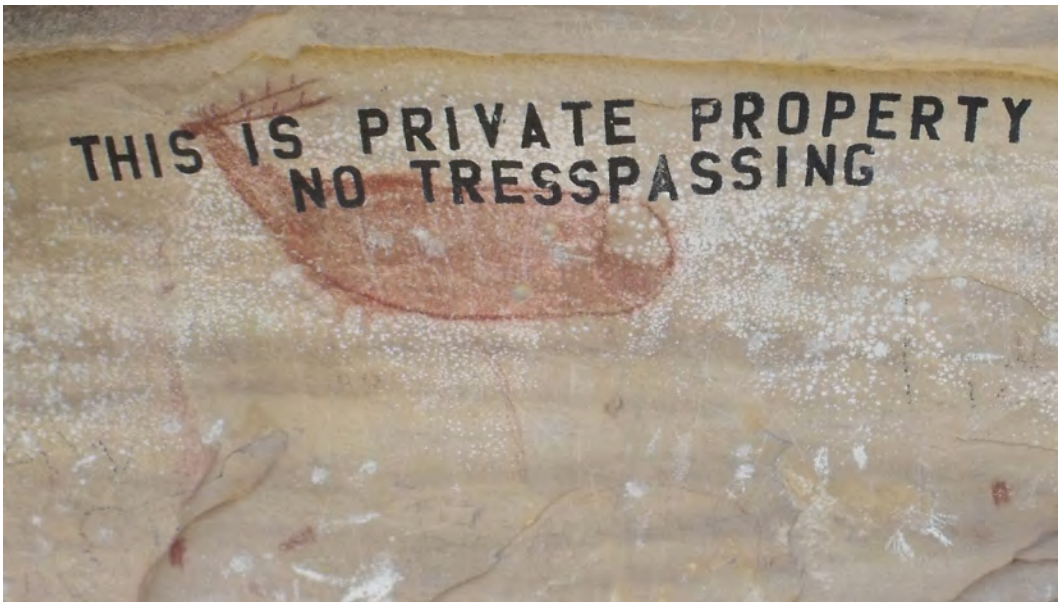
In addition to overall site condition, these criteria were also applied to subsurface disturbance and rock art condition. For example, if a rock art site contained graffiti or some other impact on every nearly every panel (e.g., Figure 2), the criteria could be applied specifically to the rock art.

Figure 2. Comparison of Elk in Rasmussen Cave ca 1931 and 2010.

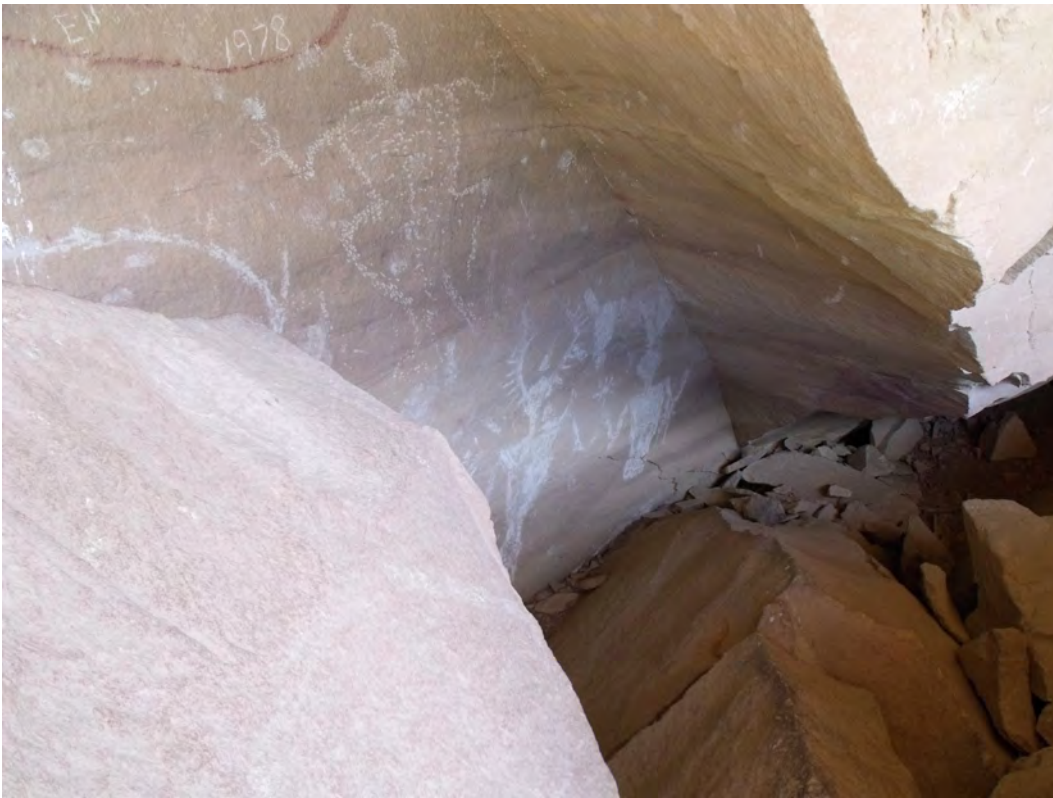
Figure 3. Graffiti (ca. 1978) and Chalking (ca. 1931) at Rasmussen Cave (42Cb0016)

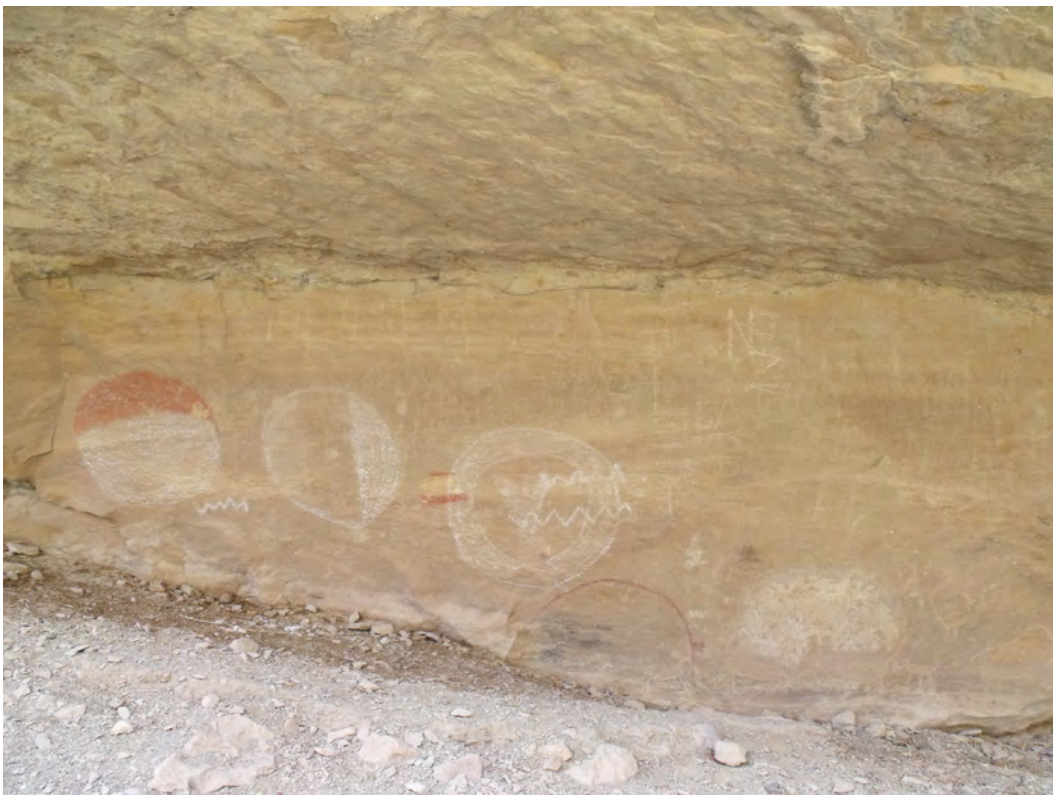
Figure 4. Graffiti associated with shields at the Hunt Panel (42Cb0239)

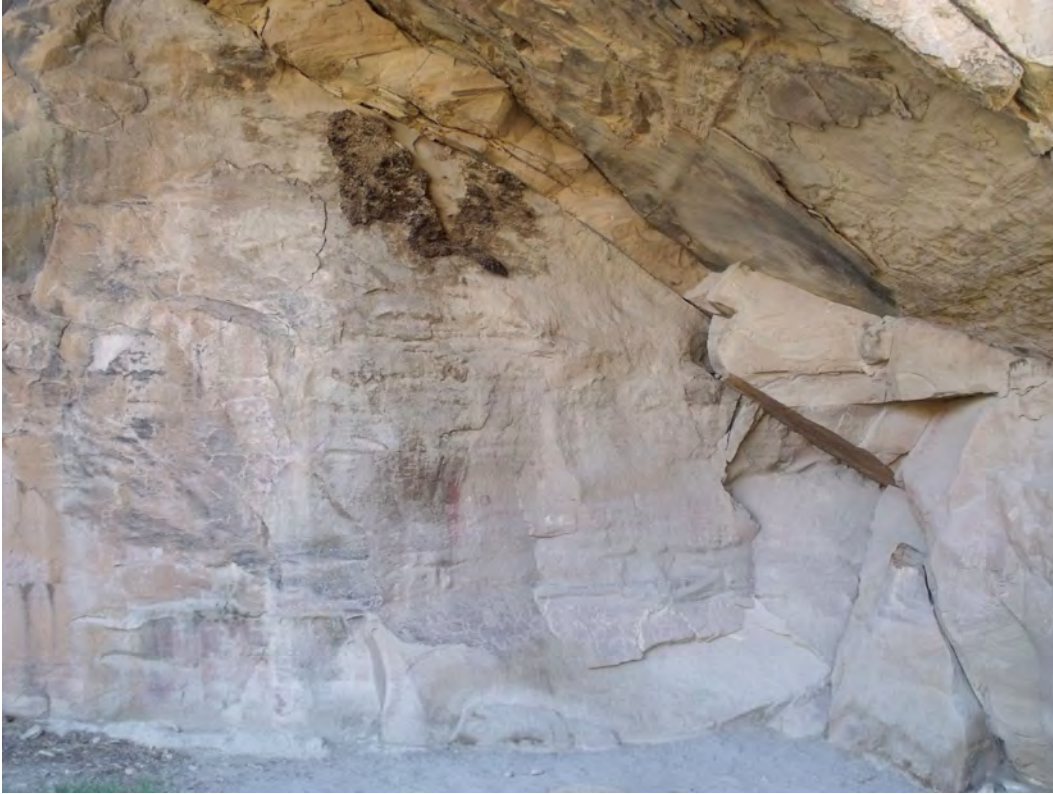
Impacts to rock art mostly include dust accumulation and graffiti (scratches, initials, inscriptions, art images). In some cases, dust accumulation could be tied to runoff from above or from road dust, but in many instances both processes of accumulation appear to be happening. Dated initials and inscriptions were uncommon, but most of the observed recent dates are from the 1990s. Evidence of chalking and latex peels were noted only at major rock art sites such as Rasmussen Cave (42Cb0016) and the Hunt Panel (42Cb0239). Attempted removal of rock art elements were noted at 42Cb1279 (First Site)

Figure 5. Pack rat urine, dust, graffiti and attempted removal of element at First Site (42Cb1279).
