Information Bulletin No. OR-2004-125

Subject: Annual Facility Safety Inspection Results

**Oregon State Office
Bureau of Land Management
Annual Facility Safety Inspection – FY 2004**

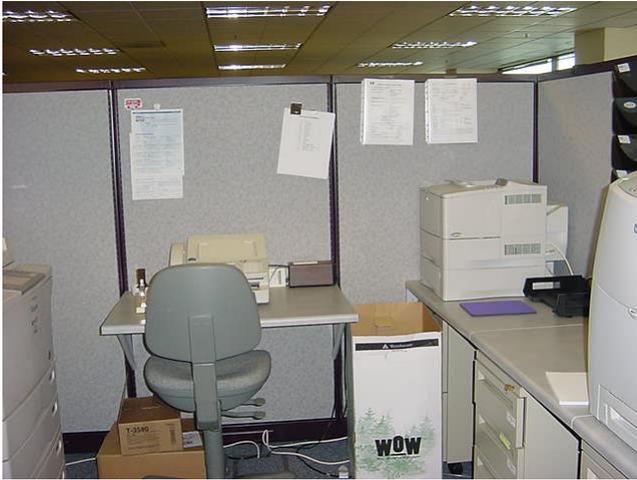
Common Area – Well organized
MSDS forms posted

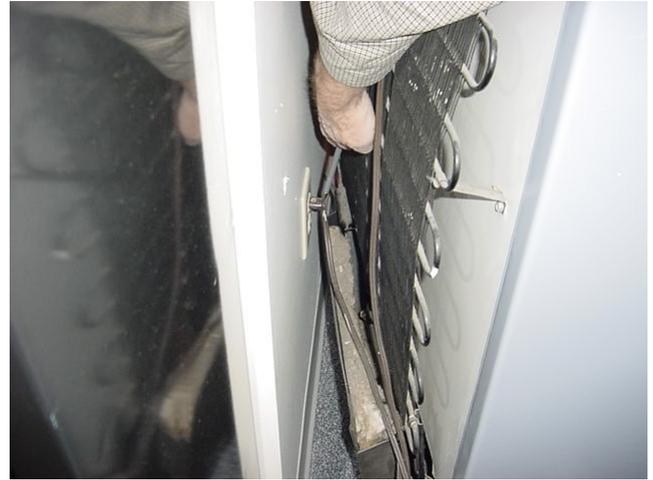
8	2 nd Floor REO/ISMS	NEC 250.114 29 CFR 1910.304 29 CFR 1910.334	3	Refrigerator (old model) in break area has damaged plug – not grounded: significant ice buildup within freezer	Remove refrigerator; replace with updated model; consider different placement within area	
9	2 nd Floor REO/ISMS	NFPA 70E NEC 29 CFR 1910.22 29 CFR 1960.1 PL 91-156 (GDC)	4	Microwave placed on desk under cabinet	Remove microwave to alternate location

Refrigerator cord frayed and broken
Significant electrical hazard

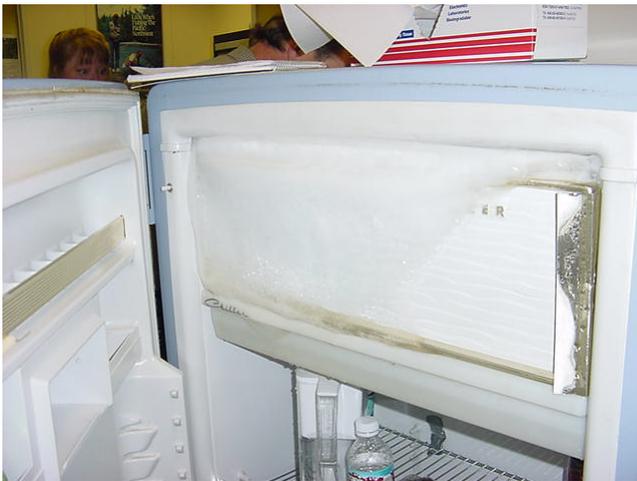
Freezer defrost required
Poses property damage issue
should refrigerator fail

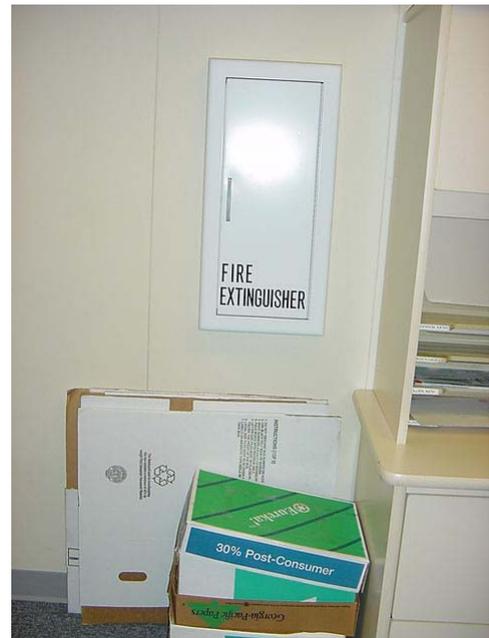
Item #	Location	OSHA Reference	RAC* Code	Discrepancy	Recommendation	Safety Use Only Follow/Up
10	2 nd Floor REO/ISMS	29 CFR 1910.157 29 CFR 1960.1 PL 91-156 (GDC)	4	Materials stacked under fire extinguisher wall access	Remove all materials	
11	2 nd Floor REO/ISMS	29 CFR 1910.303 NFPA 70E (NEC)	4	2 power strips “daisy-chained” (multi-plug adapters – not surge protectors)	Remove adapters; secure one surge protector; reorganize power tap needs Rearrange equipment within conference area to resolve	
12	2 nd Floor SE	29 CFR 1910.22 29 CFR 1960.1 PL 91-156 (GDC)	4	Minor housekeeping needed; stacking of materials on floor under shelves within cubicles	Perform housekeeping needs on regular basis; remove items to appropriate storage areas	
13	2 nd Floor NW	29 CFR 1910.22 29 CFR 1960.1 PL 91-156 (GDC)	4	Minor housekeeping needed; heavy items stacked on desk shelving within cubicles – bracing not adapted for heavy items	Continue housekeeping efforts; remove heavy items on desks; place in alternate areas

Access blocked to fire extinguisher

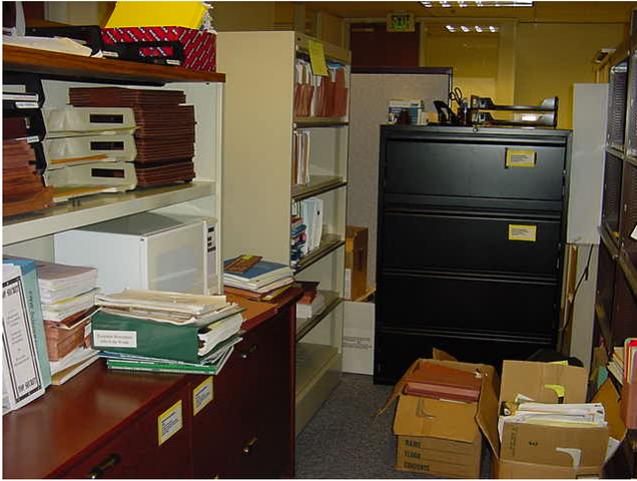
Housekeeping required
Tripping hazards in aisle way

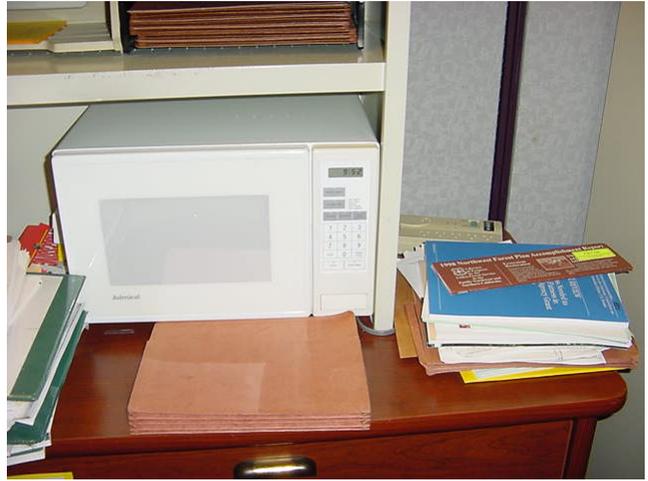
inappropriate placement of microwave
Ventilation poor/electrical concern

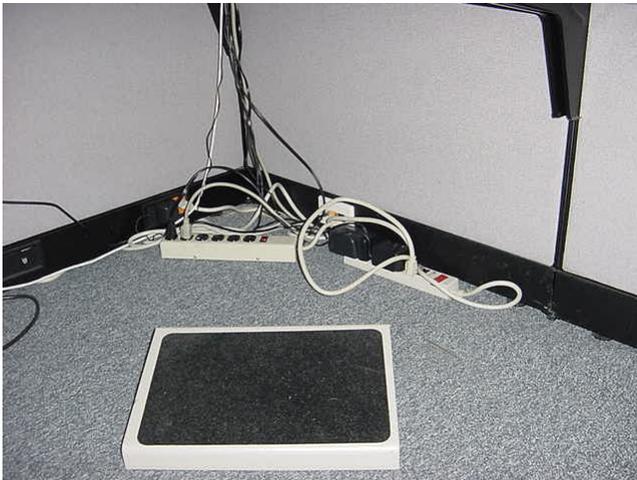
Example of "daisy-chaining" of
power strip and surge protector

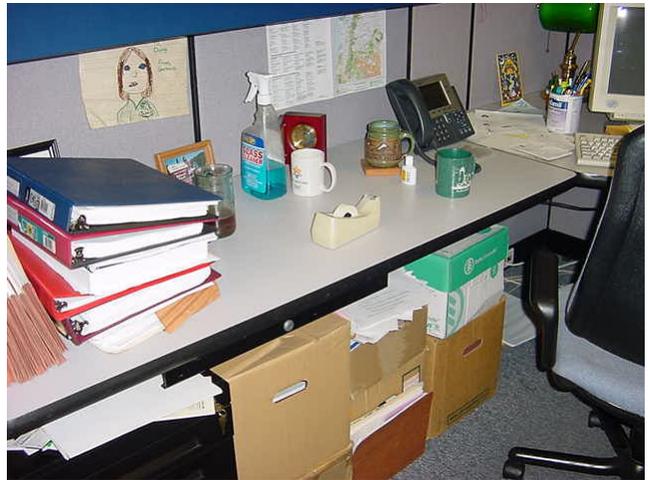
under desk storage presents
tripping hazards/materials atop cords

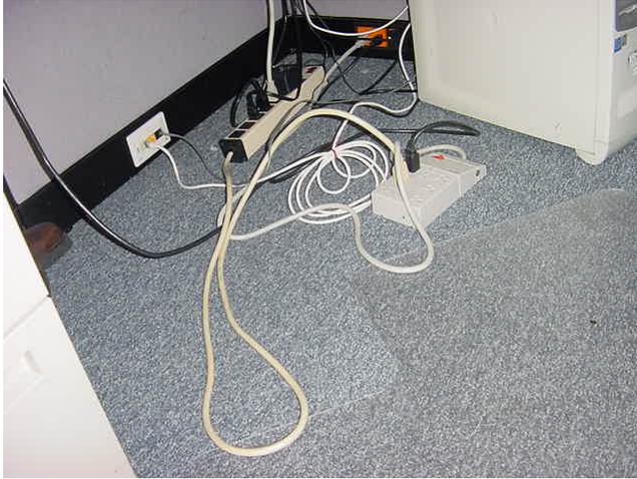
Electrical cords pose tripping hazards
“Daisy –chaining” example

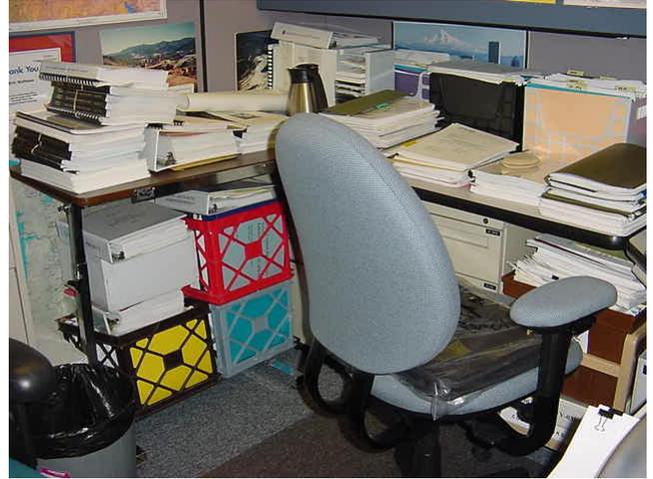
Cubicle used as storage/work area

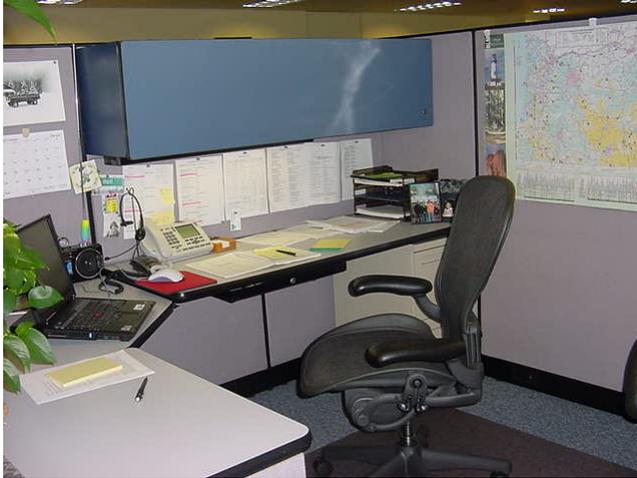
A well-kept, organized work space

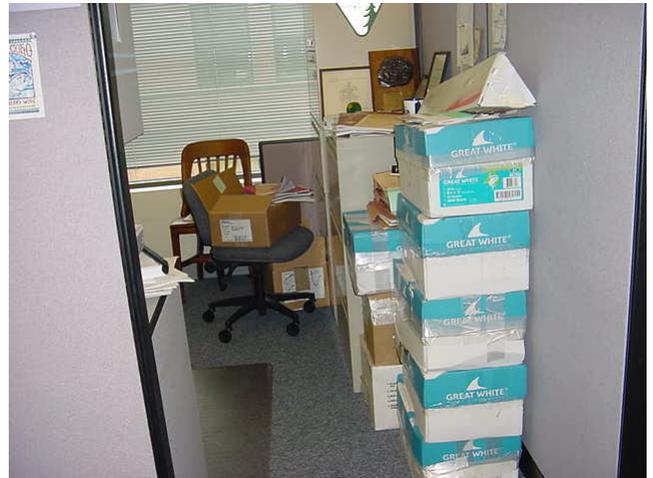
Aisle/passageway blocked

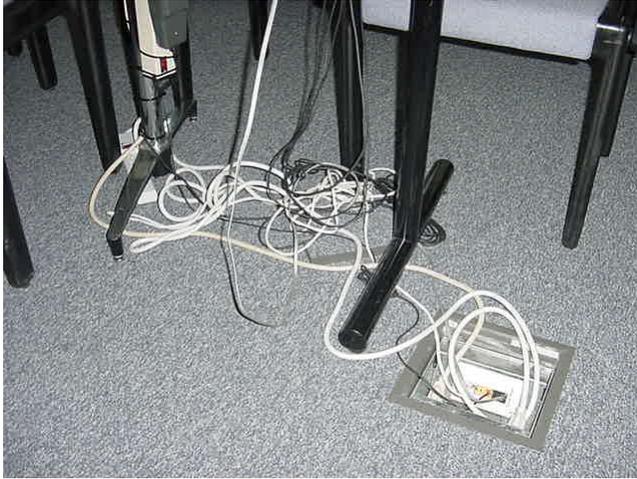
Phone/electrical wires pose tripping hazards

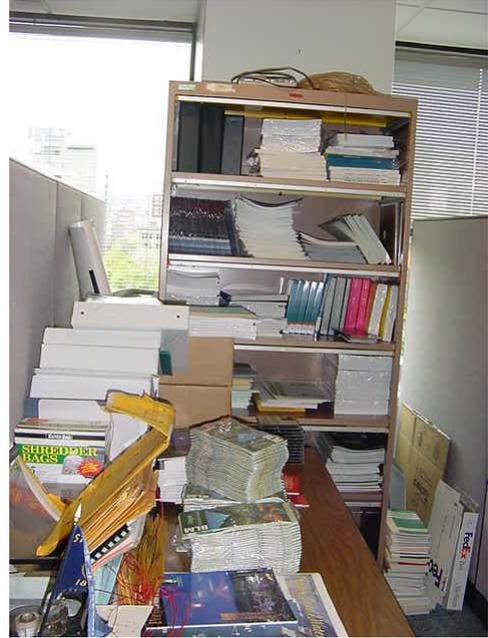
Space between cubicles used as storage

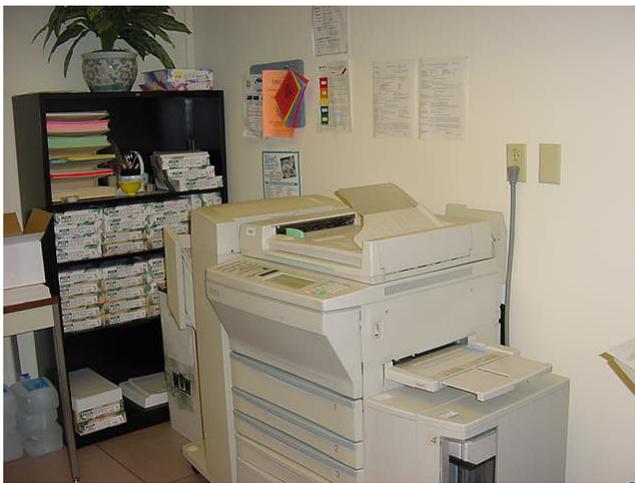
A well-kept common area/MSDS forms available and displayed

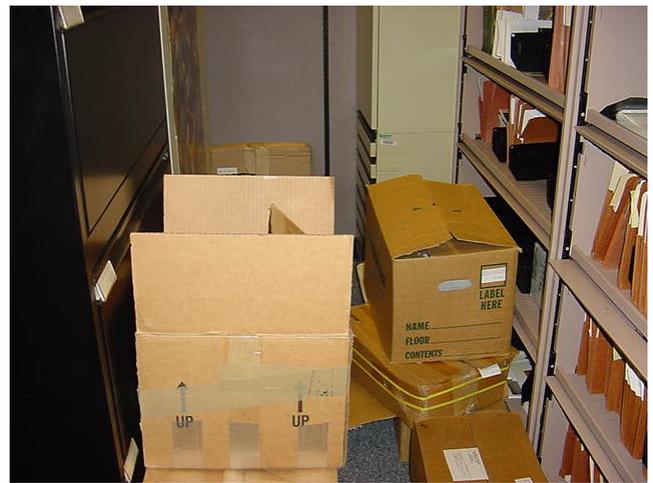
Storage area aisles blocked

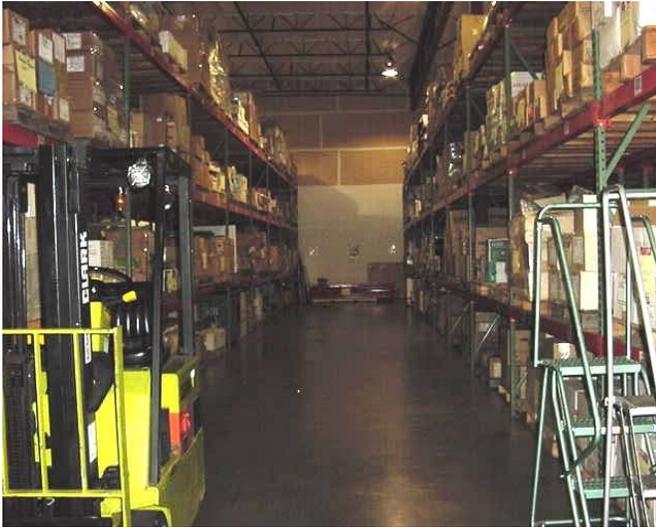
Aisle well kept and organized

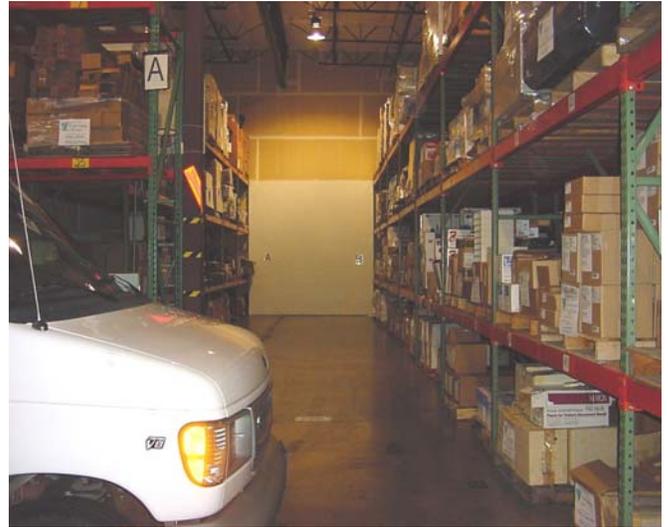
Aisle clear of materials

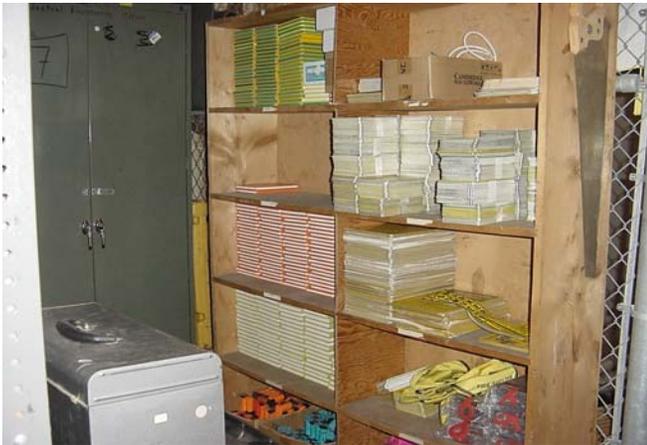
Cadastral storage organized

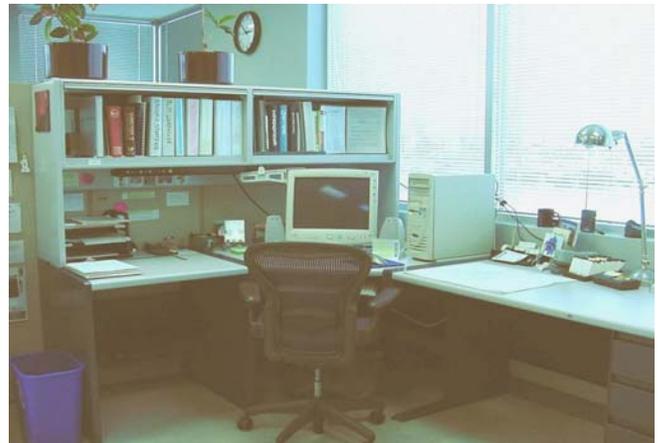
Office area well kept

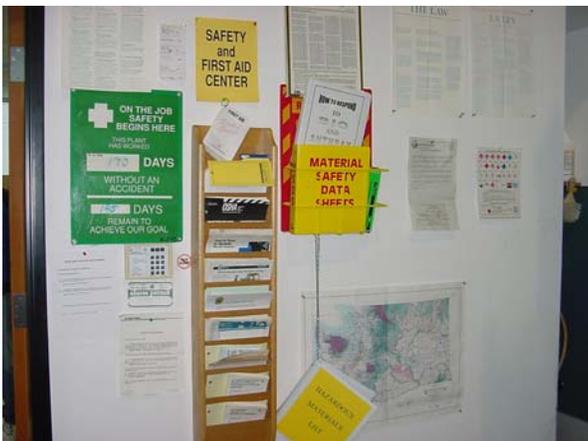
Display board for MSDS info

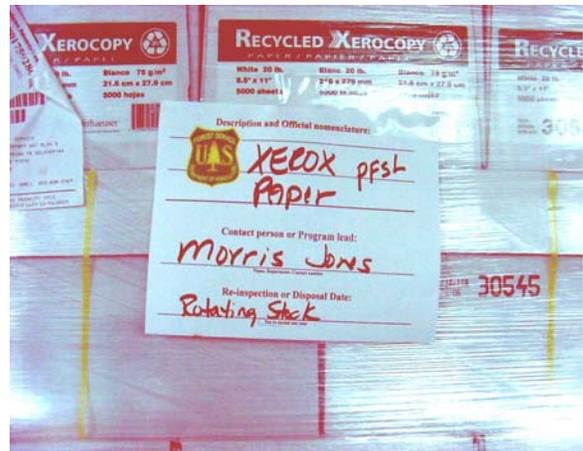
interagency identification system
for supplies and materials
