U.S. Department of the Interior
Bureau of Land Management

Projects FY 21-22

Federal Helium Operations

KDOT 50-35 KA-2383-01

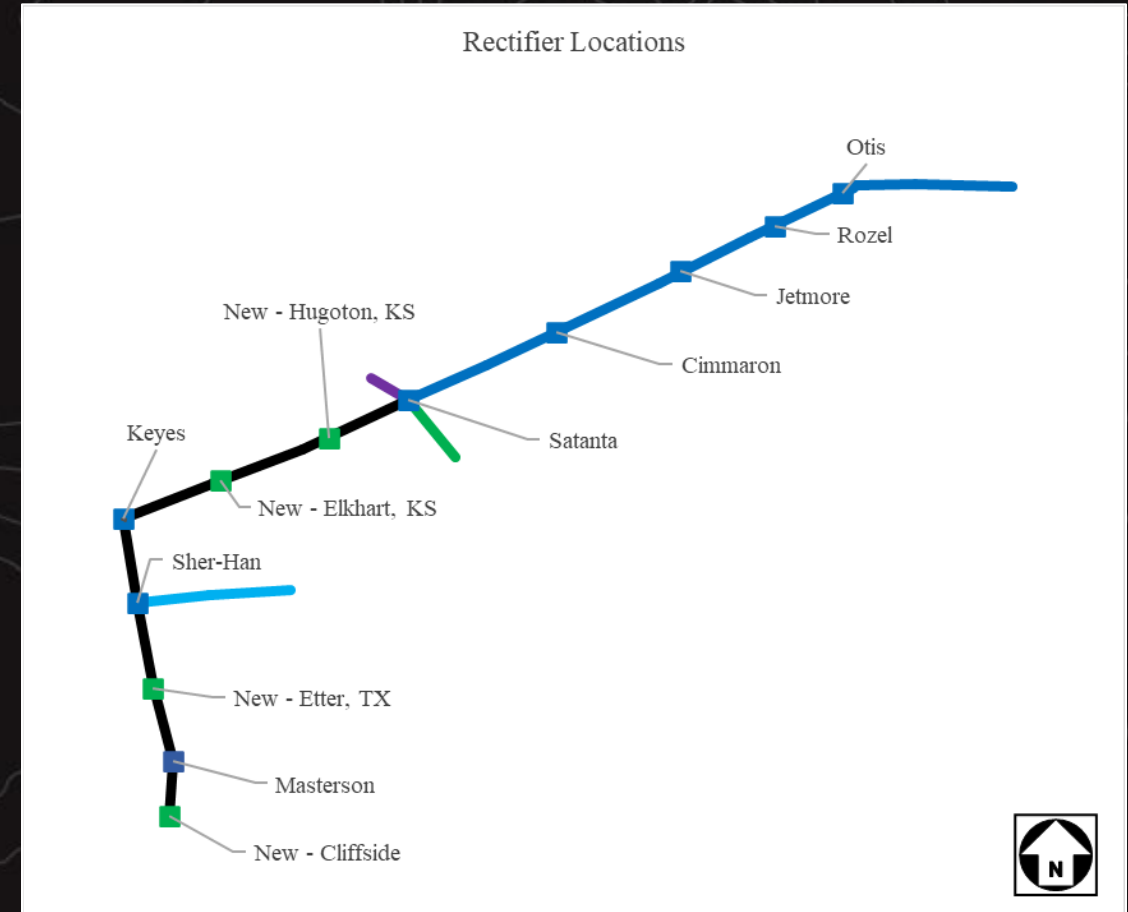
CP – Rectifier Locations

- 8 existing rectifiers
 - Cliffside and privately owned Otis rectifiers providing current as well (not shown)
- 4 Rectifiers added in 2021
 - Weak points from 2012 CIS
 - Working to establish account with energy supplier

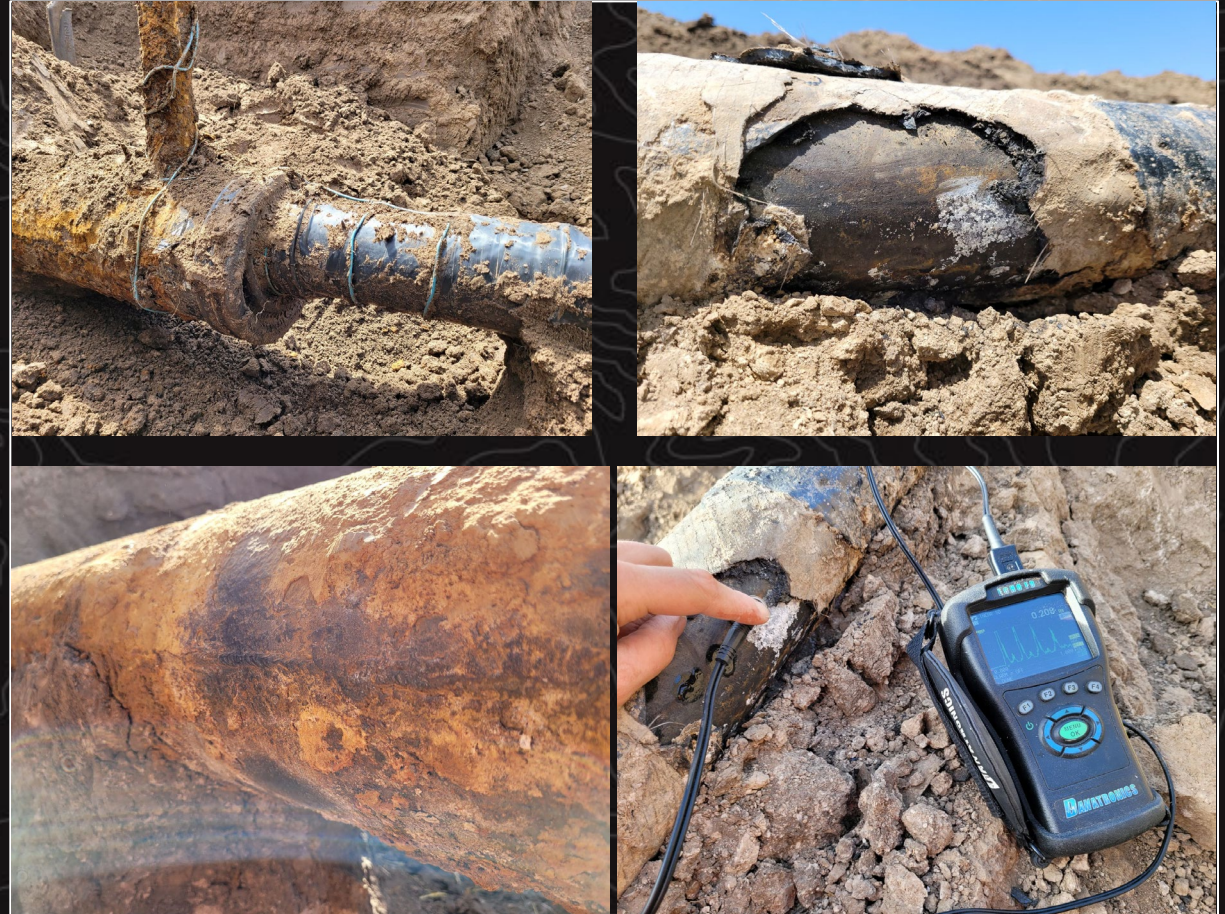
1. Bare casing; good seal
2. Calcareous deposit
3. Corrosion on casing
4. WT carrier pipe (0.208")

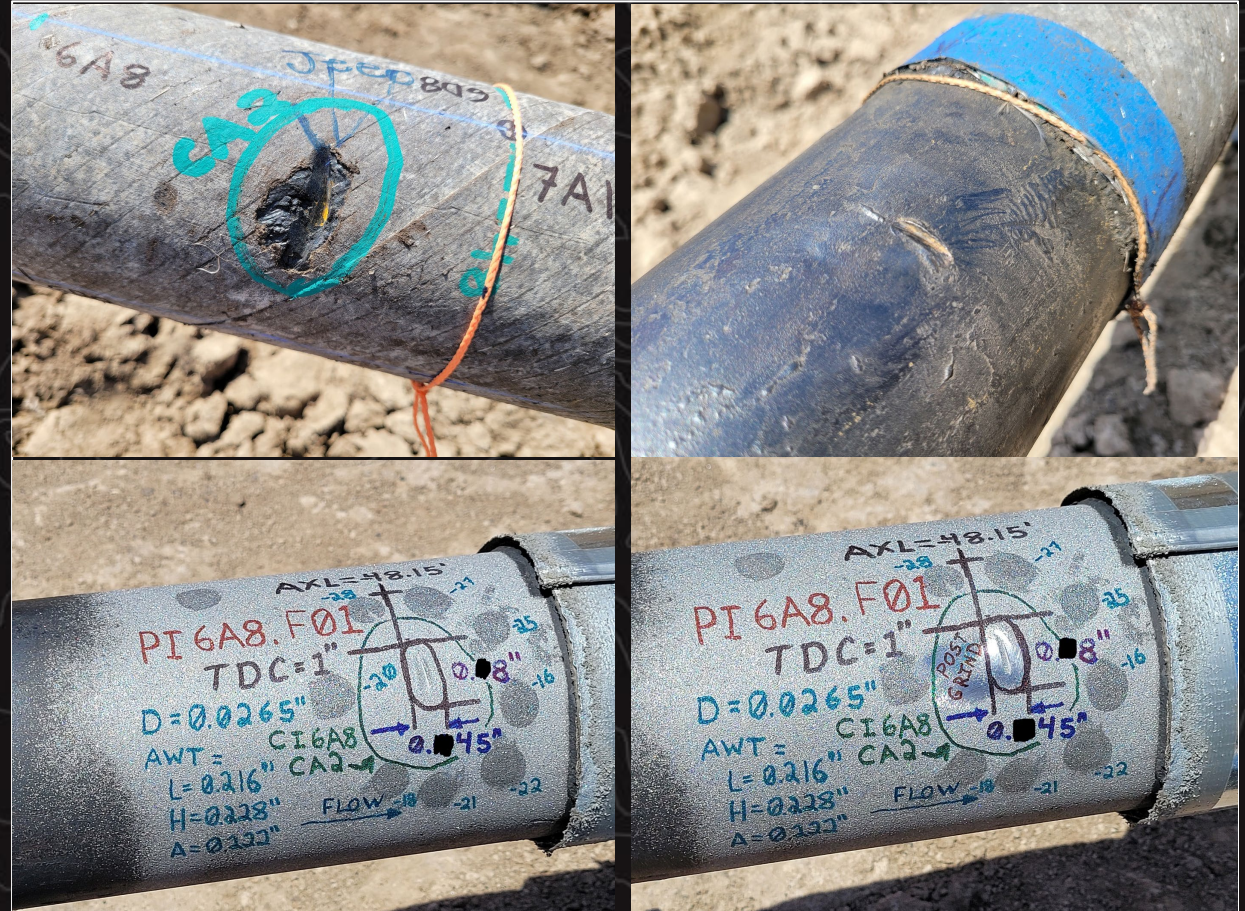
1. Pipe damage
2. After coating removal
3. After sandblasting
4. Grind repair

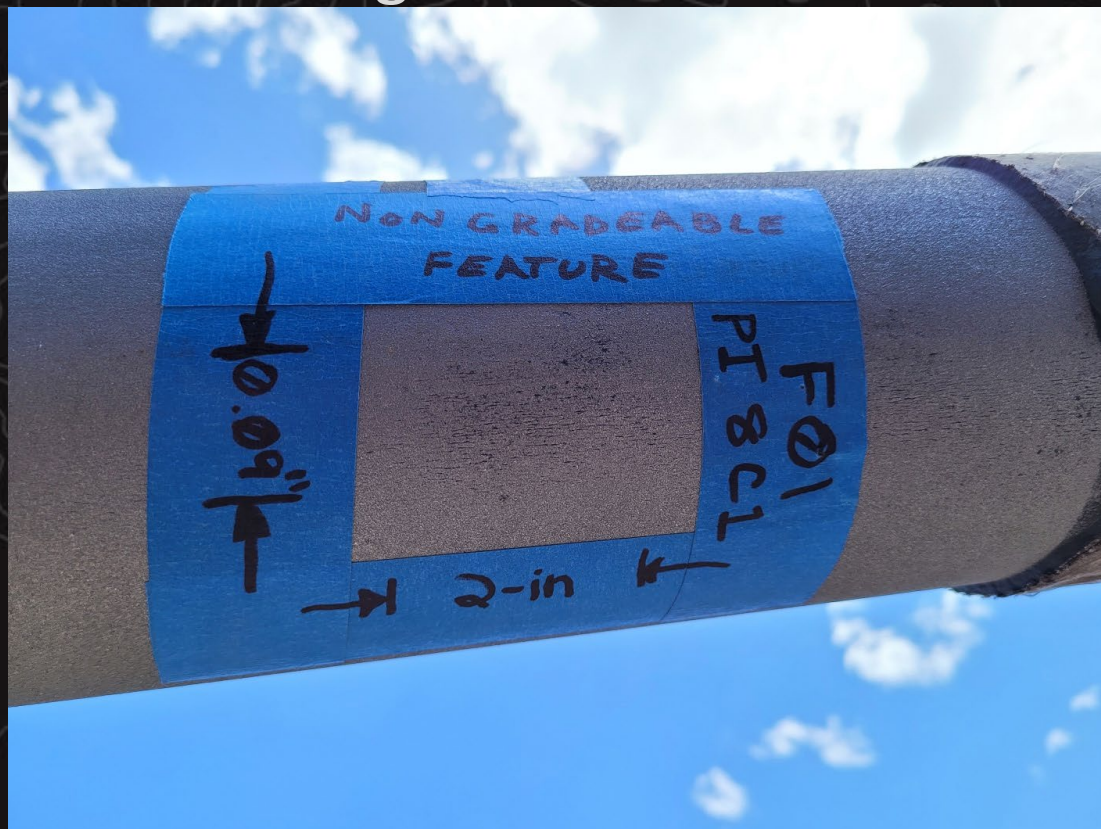
Surface irregularities

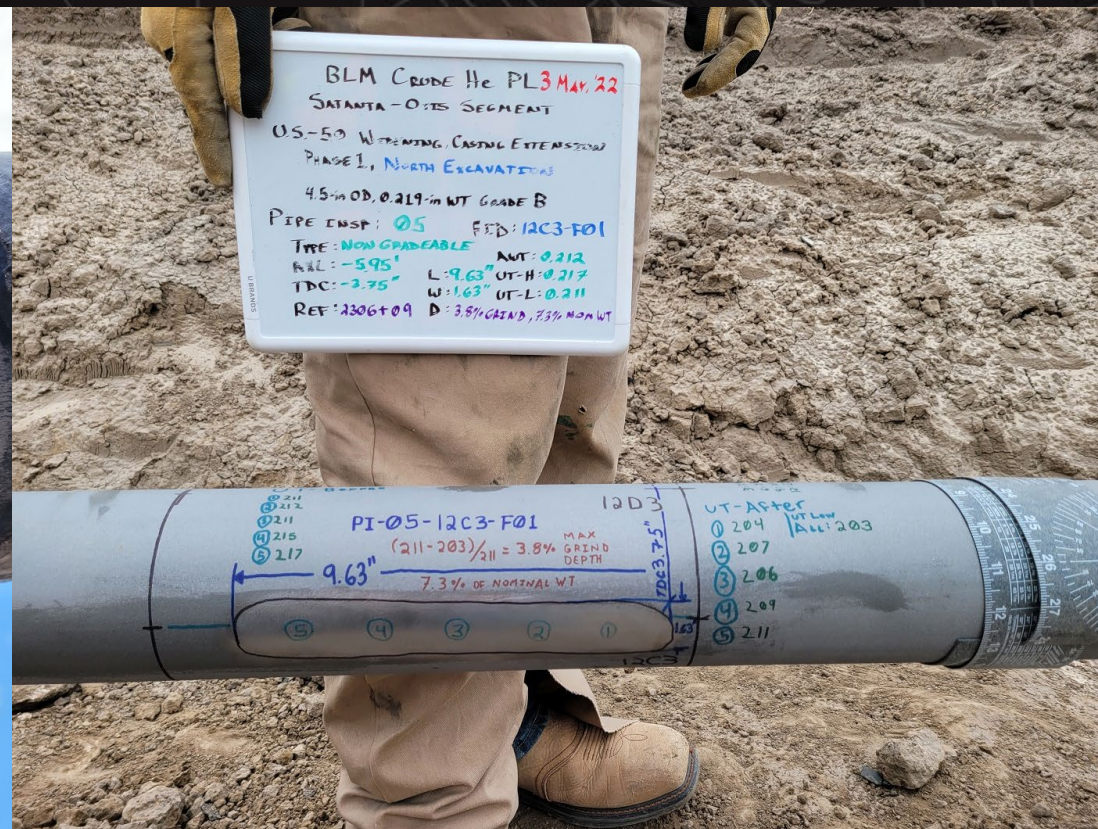
Grind test

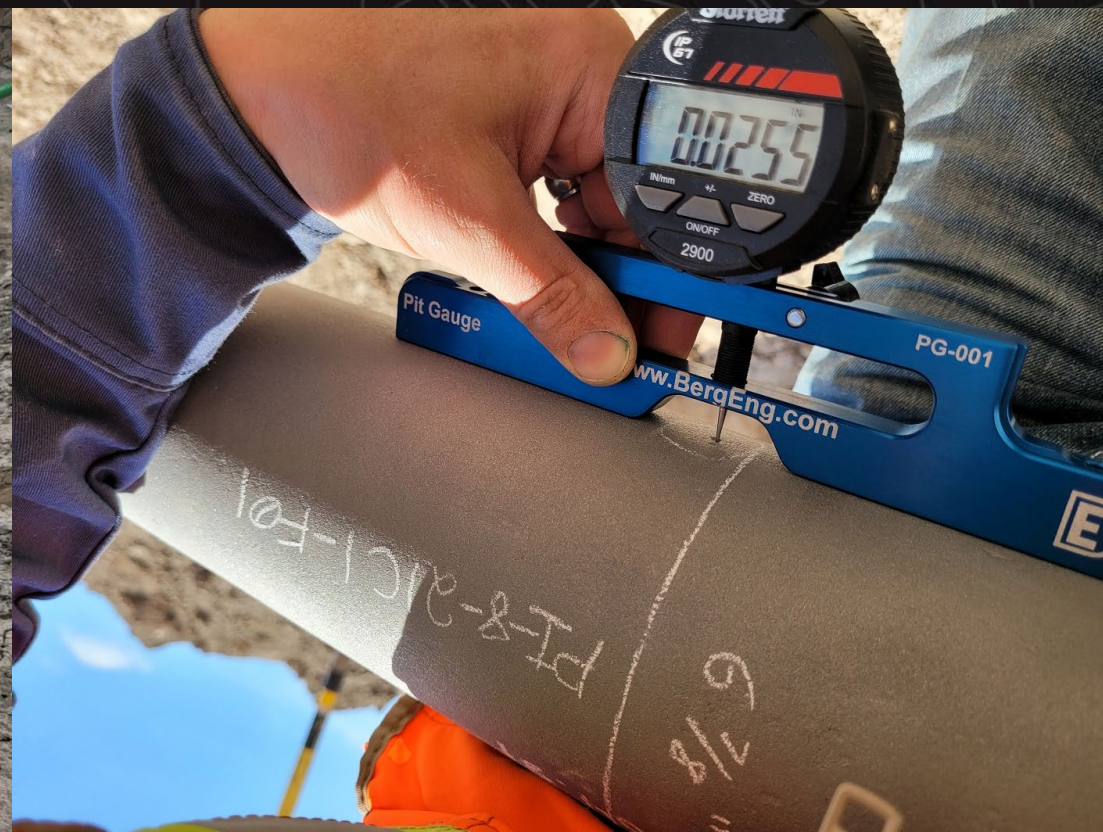
Worst case pit (carrier pipe)

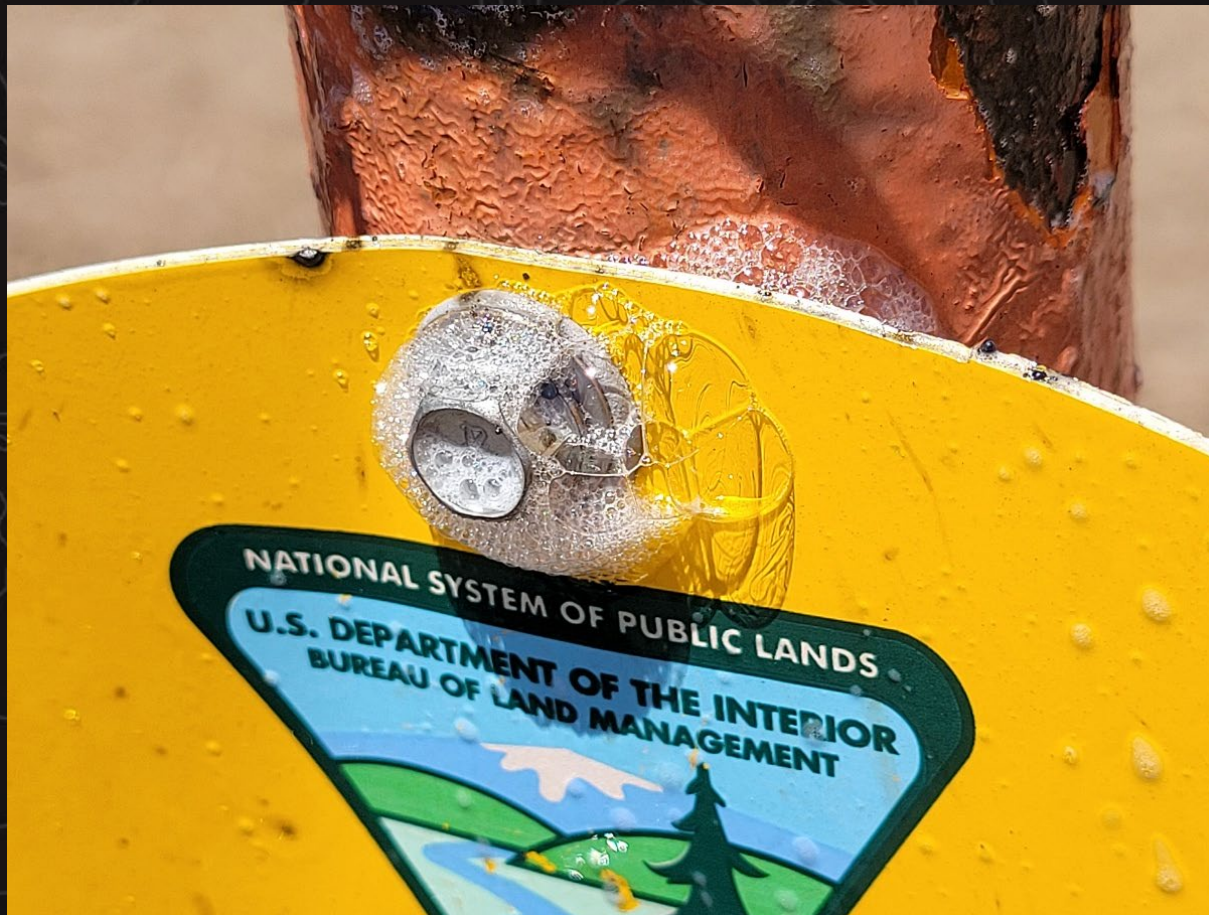
- Casing pressure test
 - 1 psi/20 min (good results)
 - Leak on casing vent (shown)
