United States Department of the Interior

December 30, 2025

Subject: Stream focused data collection in and around the Salmon River watershed in 2025 to guide fish passage issue resolution and support future stream reclamation planning at the Platinum mine site.

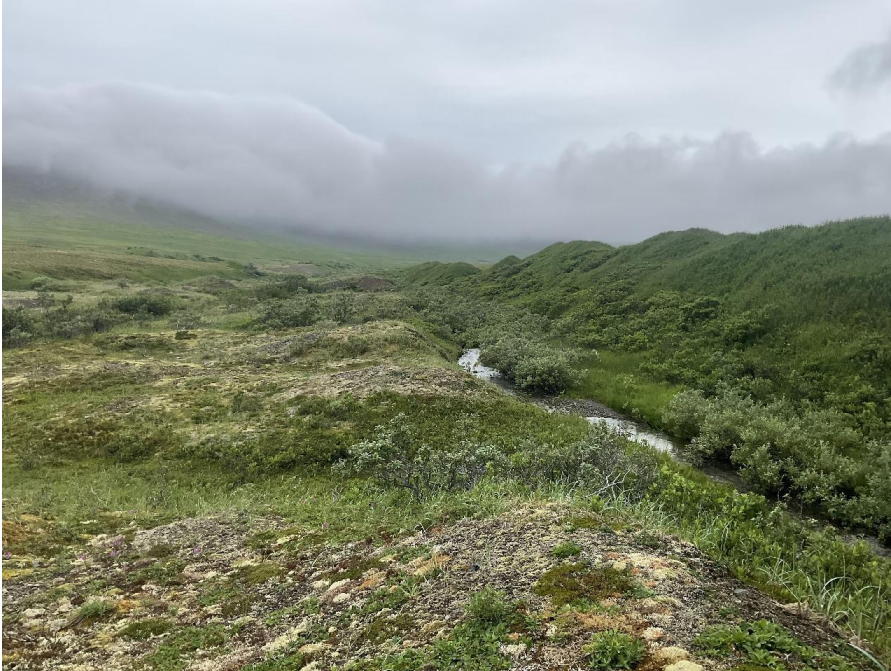
Photograph 2. Clara Creek (upstream view). The creek is confined by overburden (right side of photo) and tailings (left side).

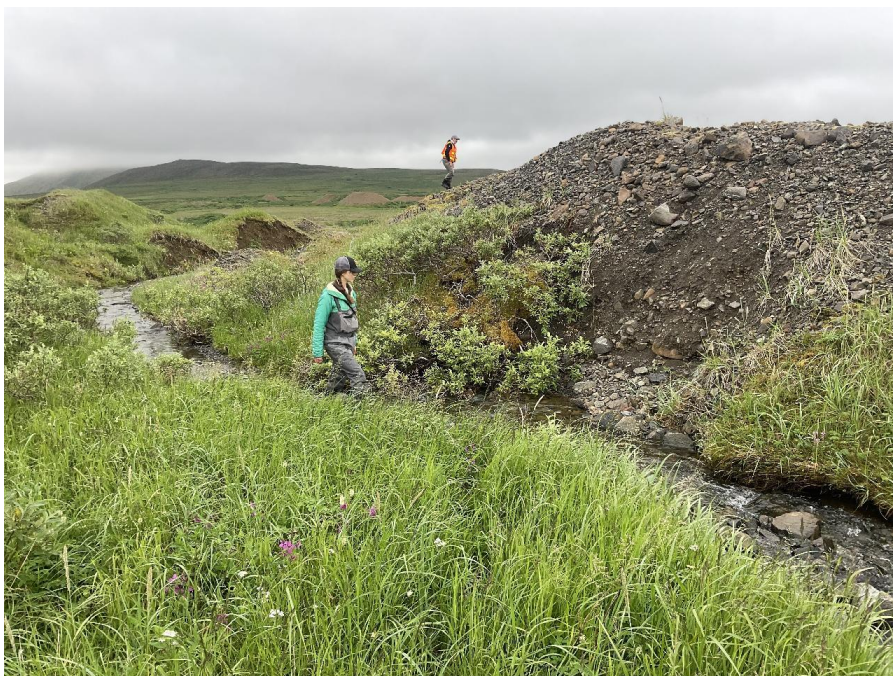
Photograph 3. Dowry Creek (downstream view) where the stream is actively eroding overburden piled next to the creek.

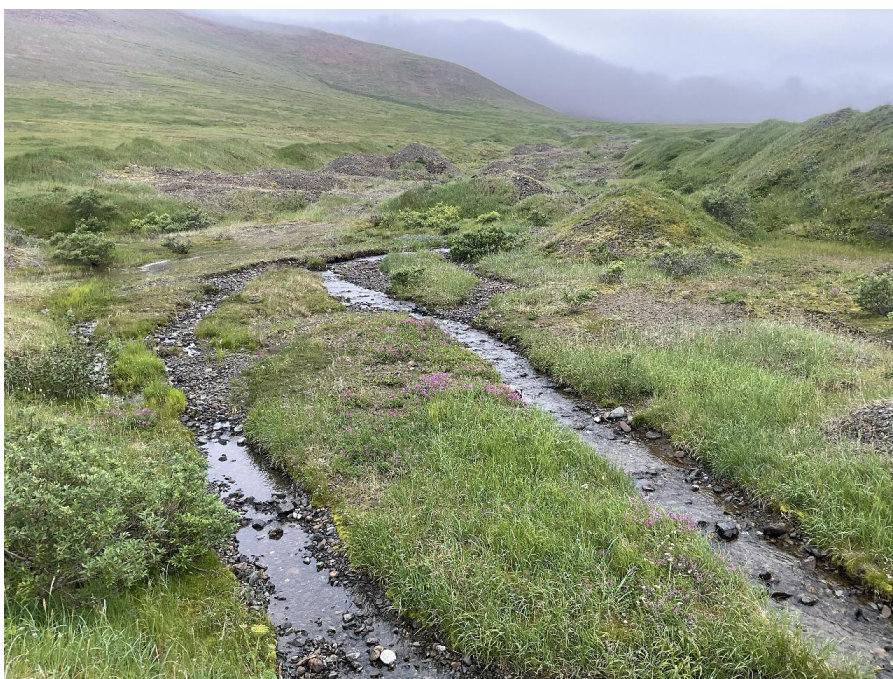
Photograph 4. Dowry Creek (upstream view) where the channel is braided, a planform typical of placer mined streams that have not been reclaimed or recovered from disturbance

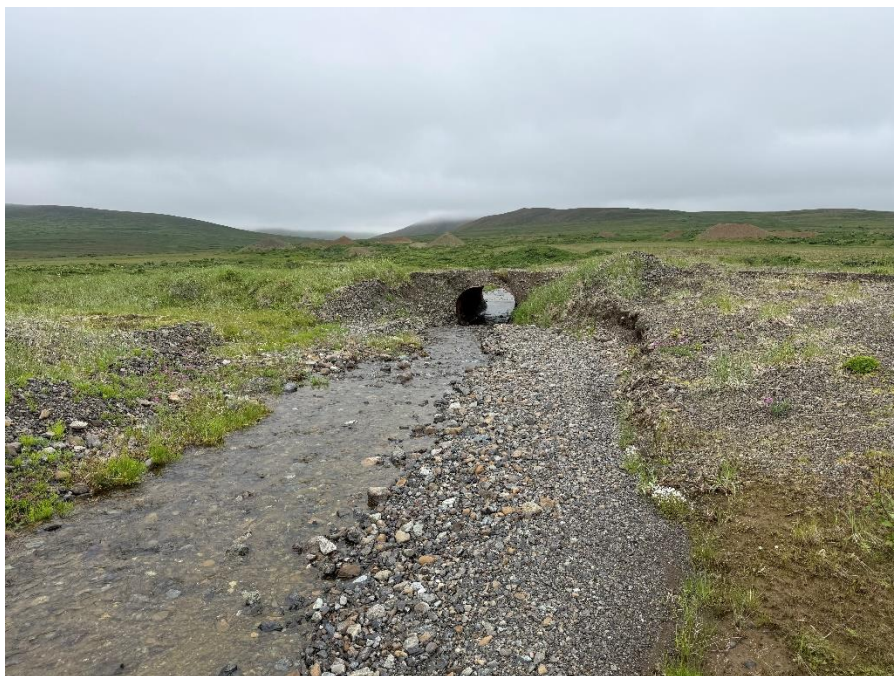
This creek is located in the adjacent watershed to Clara Creek and is similarly sized. It also originates on Red Mountain and has an obvious history of mining. Like Clara Creek, Dowry Creek has also recovered well since mining ceased in the area; however, there are areas of major erosion, incision, and braiding. Dowry Creek could benefit from the removal of encroaching overburden and mined material, as well as some streambank stabilization measures. The road stream crossing, a corrugated metal pipe set just below stream grade, is undersized and susceptible to washing out.

Photograph 5. Undersized culvert on Dowry Creek (downstream view). Note enlarged channel and sediment deposition upstream of culvert.

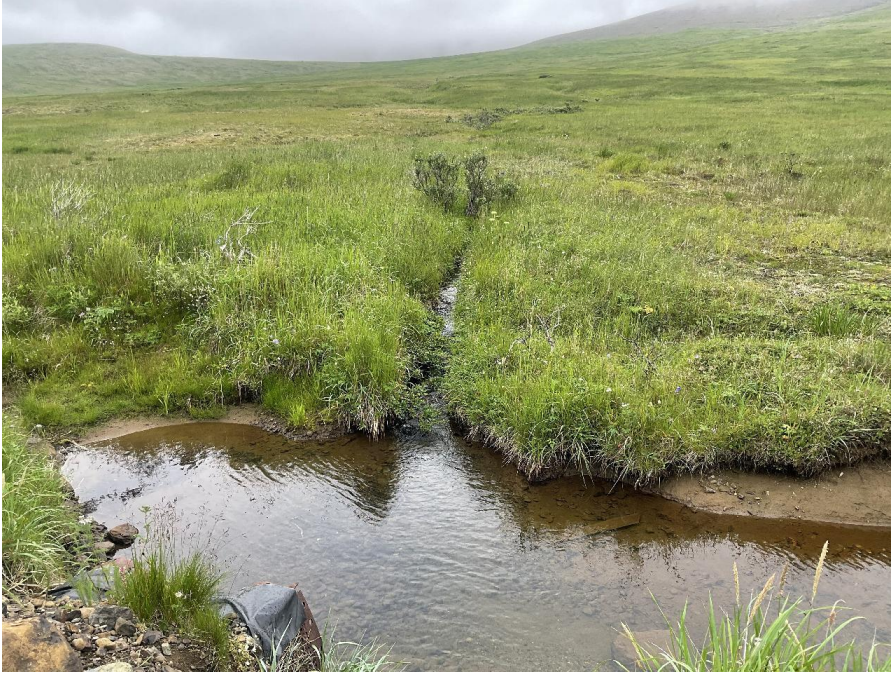
Like Clara and Dowry creeks, Boulder Creek originates on the east slope of Red Mountain. This small stream had no apparent evidence of past mining such as tailing or overburden, however we only explored a short stretch of this creek near the road. The access road and associated culvert were creating backwater conditions and pooling upslope of the culvert.

Photograph 6. Boulder Creek where the channel is ponded upstream of the road crossing, likely indicating it may be undersized.

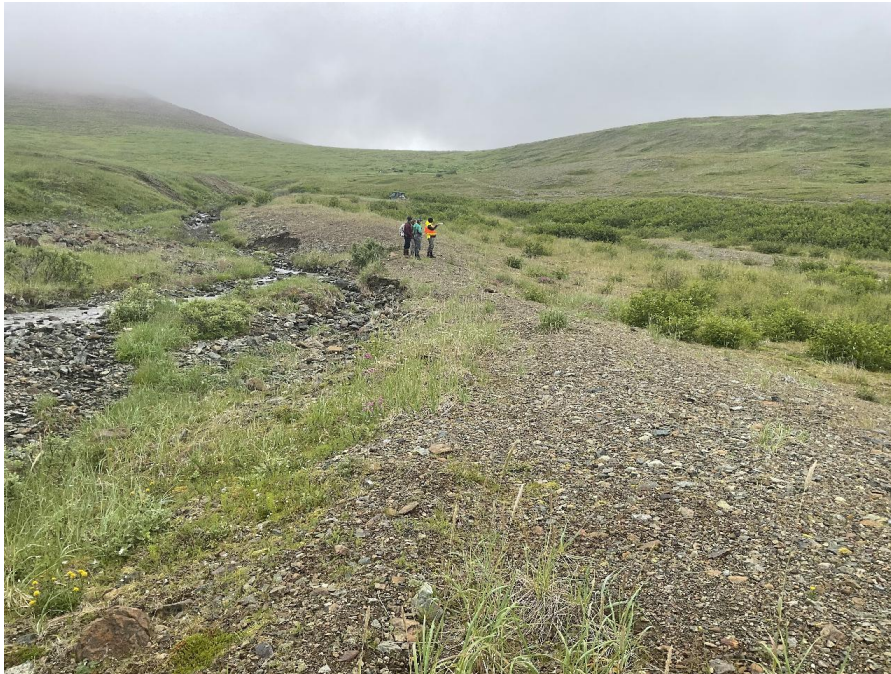
The middle and lower sections of Squirrel Creek showed signs of mining including past and more recent activity by XS Platinum prior to their operation shutting down in the early 2010s. The creek alignment is currently perched above the valley floor in one section (see Photographs 9 and 10) with a berm of material temporarily preventing the creek from shifting to the east along the access trail. We did not survey the valley to quantify the elevation of the creek in relation to the valley bottom but those data should be available from LiDAR information anticipated for delivery to BLM in early 2026. The lower most section of Squirrel Creek is significantly confined by overburden that has revegetated but areas of erosion are evident. Squirrel Creek joins Platinum Creek at the mine camp and is inaccessible by fish due to large berms of mine tailings along the Salmon River.

Photograph 8. Upstream view of Squirrel Creek illustrating the creek's perched position in the valley. The area on the right side of the image is several feet lower than the creek elevation. The berm between the creek and the valley bottom is showing signs of erosion and may eventually allow the creek to shift to the east.

- 1) filling low areas with excess tailings from along the Salmon River to create a more natural valley shape (e.g., Squirrel Creek needs to be in the valley bottom with accessible and properly sloped floodplains), and
- 2) spreading the piles of overburden to enhance the growth medium of rocky areas.
- 3) Replacing the culvert on a mine camp road with one that is designed to allow fish passage.

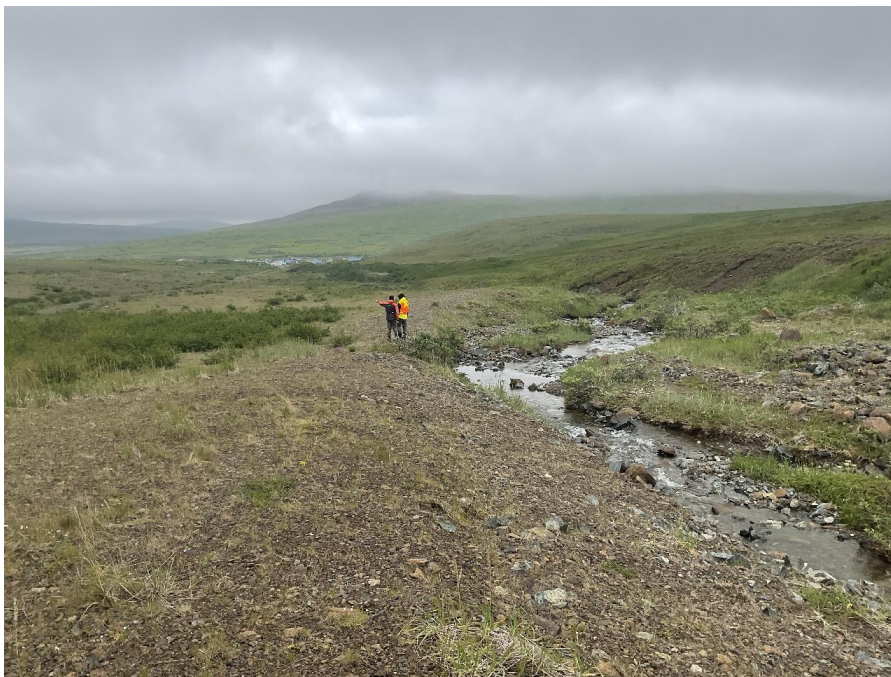
Photograph 9. Downstream view of Squirrel Creek with staff standing on the berm of material currently maintaining the perched stream position.

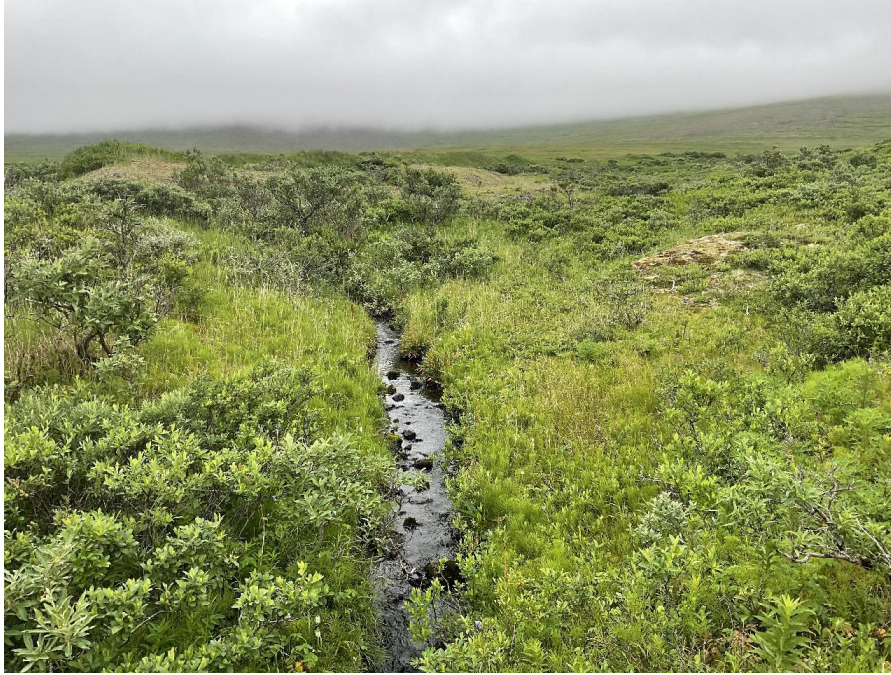
Photograph 10. Upstream view of Dry Gulch

This small stream drains off the southeast side of Red Mountain and is a tributary of Platinum Creek. It has signs of past disturbance with large piles of overburden along the creek. This stream is currently inaccessible by fish due to tailing barriers along the Salmon River that block the entire Platinum Creek drainage to fish.

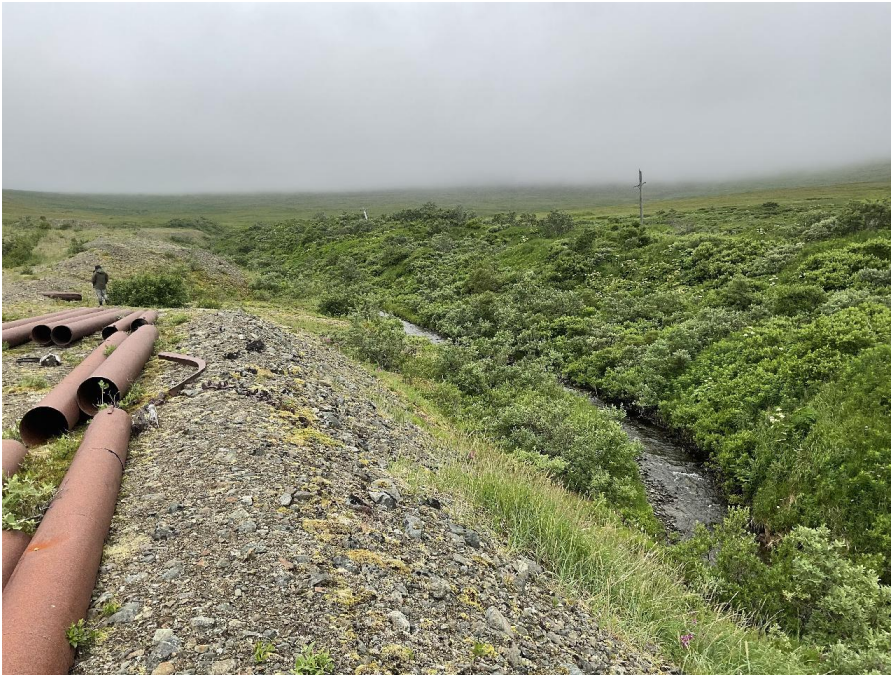
Photograph 11. Upstream view of Platinum Creek valley where tailing piles confine the stream and limit floodplain development.

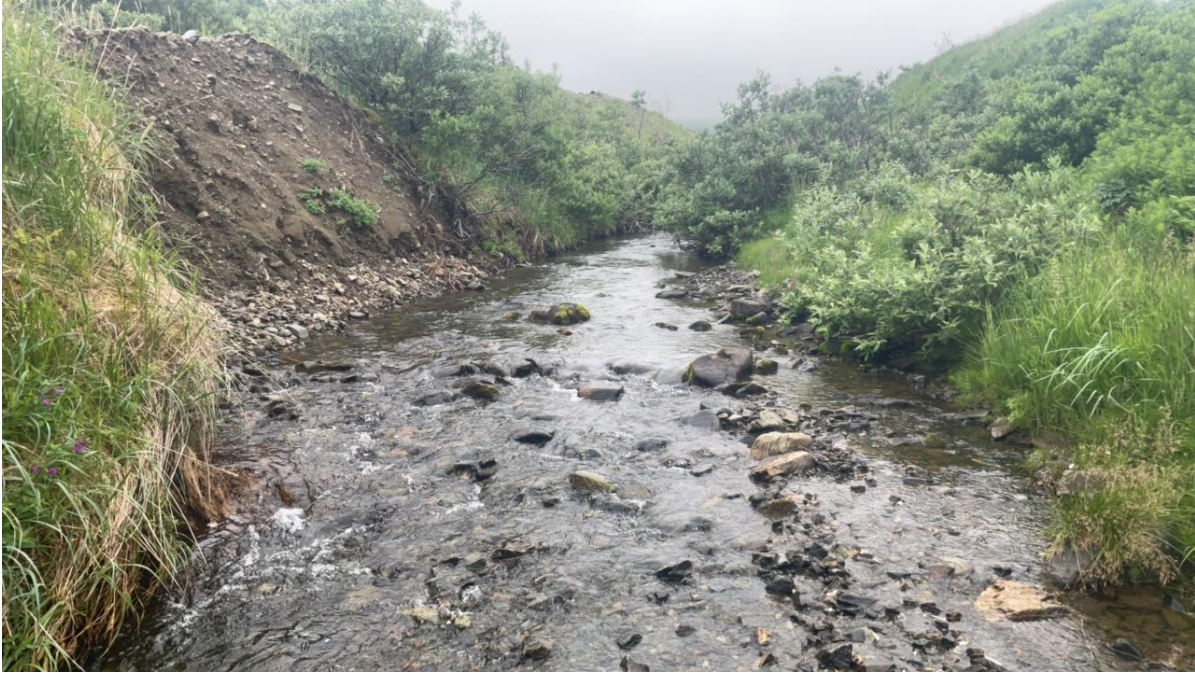
Photograph 13. Downstream view of Platinum Creek showing a confined section with no floodplain and bank erosion.

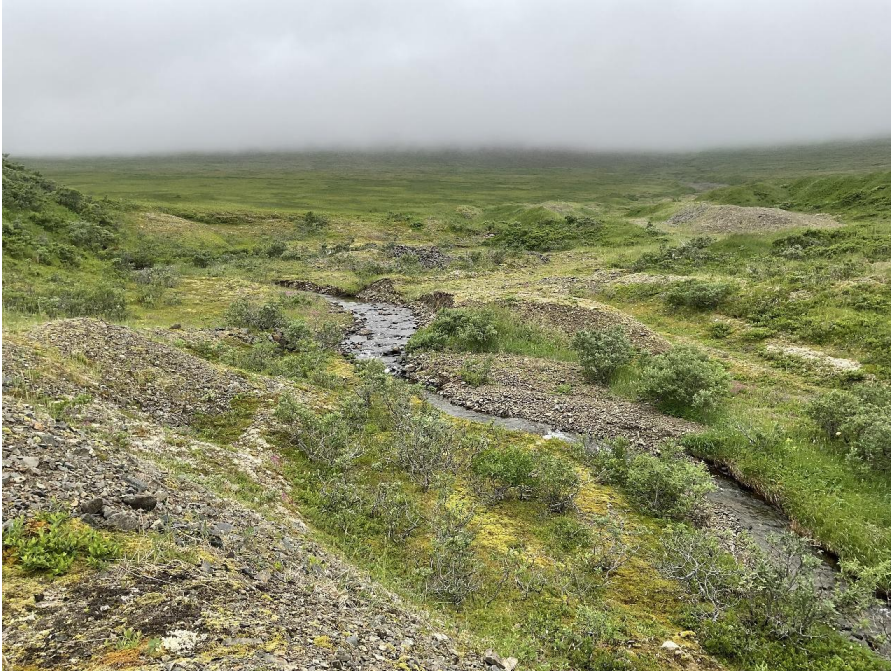
Photograph 15. Area of Platinum Creek immediately downstream of the confluence with Fox Gulch. Fox Gulch shows significant residual impacts from past mining.

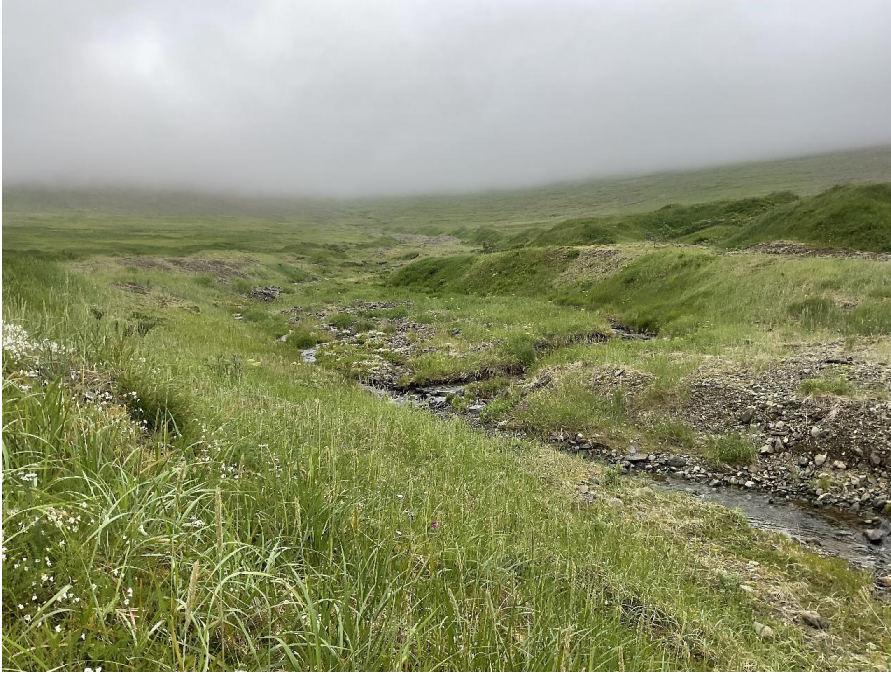
This stream drains off of the southeast side of Red Mountain and is the uppermost tributary to Platinum Creek. Extensive residual mining impacts are evident throughout its length with limited floodplain development, braided channel conditions and very little woody riparian vegetation in contrast to upper Platinum Creek. This headwater stream likely contributes excessive sediment delivery to Platinum Creek and should be considered for more in-depth assessments in the future.

Photograph 19. Upstream view of Fox Gulch from near its confluence with Platinum Creek.

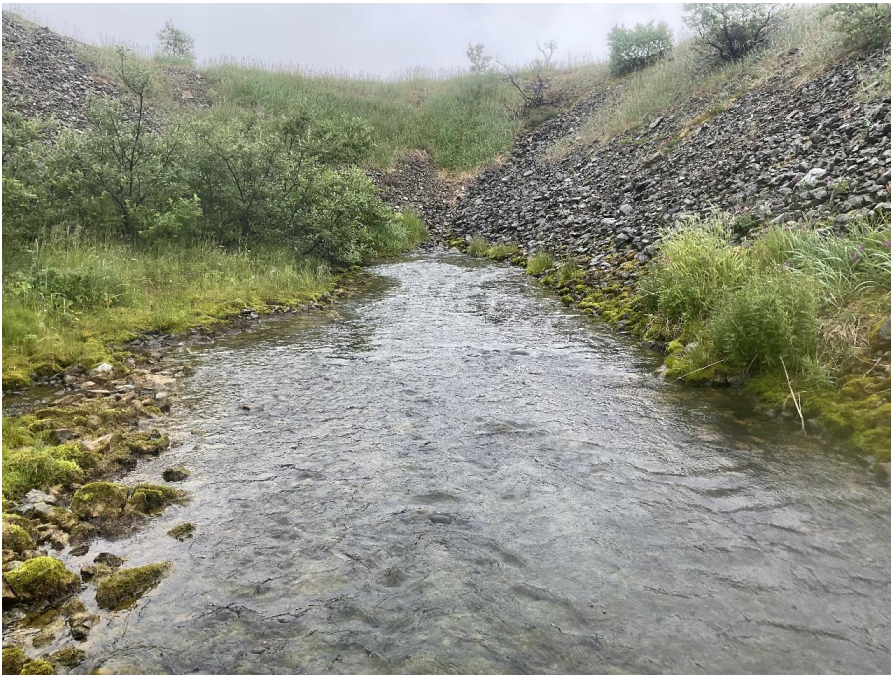
Streams like Platinum Creek that are isolated from Salmon River by large berms of mine tailings and overburden should be further assessed to determine potential areas for surface reconnection. Basic reconnaissance during this site visit noted a couple areas that appeared to be major Platinum Creek/Salmon River connections as evidenced by surface flow expressions near the base of tailings.

Photograph 20. Significant expression of surface water emerging from the tailings that is likely from Platinum Creek.

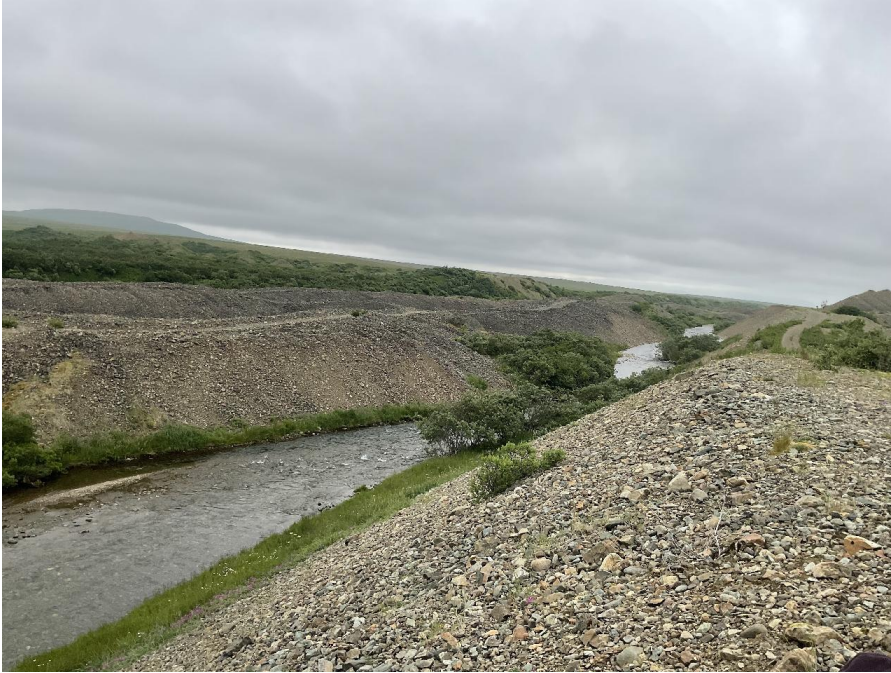
Photograph 21. Typical conditions along the Salmon River showing the confinement created by the tailings and limited development of small, vegetated benches along the stream.

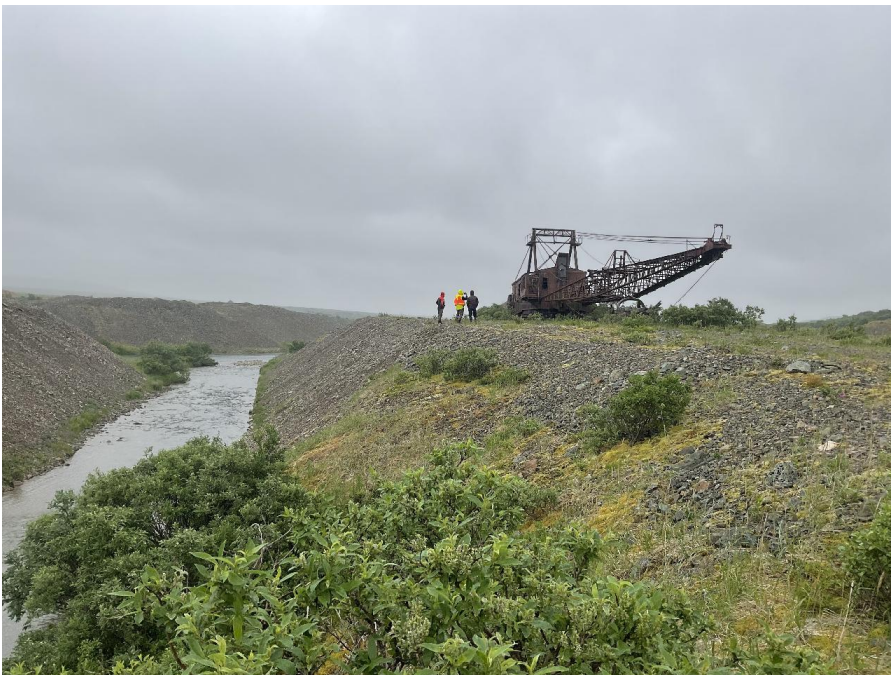
Photograph 22. Downstream view of Salmon River near the remains of an old dragline. This image shows the magnitude of mine tailings in contrast to the staff members standing in the distance.

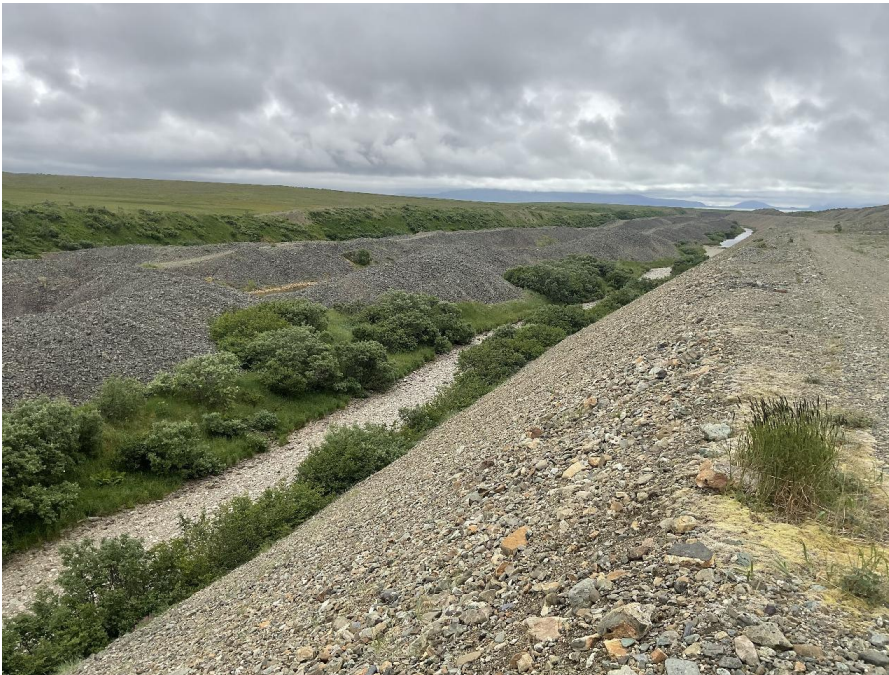
Two dry sections of the Salmon River appeared to indicate the loss of surface flow laterally beneath/through the tailings. Ponded areas in the adjacent tailing areas along the dry reaches showed signs of stream flow that connected the upstream termination of stream flow and the downstream initiation of surface water in the main stream channel. These observations suggest that surface flow in the stream channel may be lost into the porous tailings and re-entering downstream. LiDAR data will allow staff to compare surface water elevations in the stream channel and adjacent ponded areas nested in the tailings. Potential tracer studies should also be considered to not only improve our understanding of tributary connectivity with the Salmon River, but also the dynamics of intermittent stream sections. These types of studies could greatly improve our understanding of flow dynamics through the tailings and help shape strategies for improving fish passage in the future.

Photograph 23. Dry section of Salmon River. Ponded areas in the tailings on the left side of the image were observed to have stream current that coincides with the loss and regain of surface flow in the mainstem of the Salmon River.

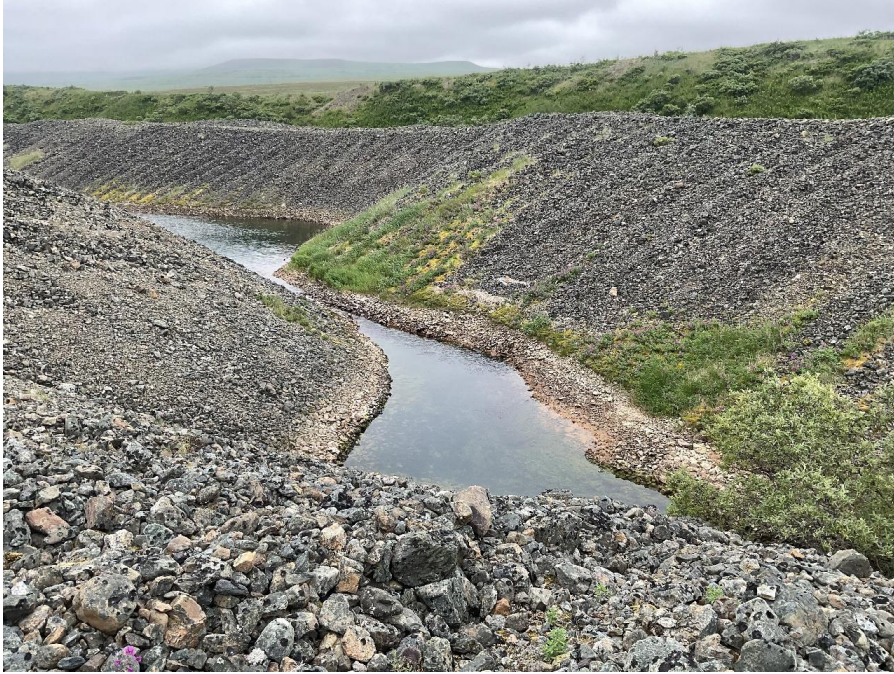
Photograph 24. Example of a ponded section in the tailings that is adjacent to a dry stream section and shows clear signs of stream flow emerging from the upstream end of the ponded area and exiting at the downstream end near where the mainstem Salmon River begins surface flows again.
