A Field Investigation of Glacial Lake Outburst Potential in the Taiya River Watershed, Skagway, Alaska

Chuck Denton, Larry Standley, and Brent Lewis

BLM-Alaska Open File Report 99
June 2005

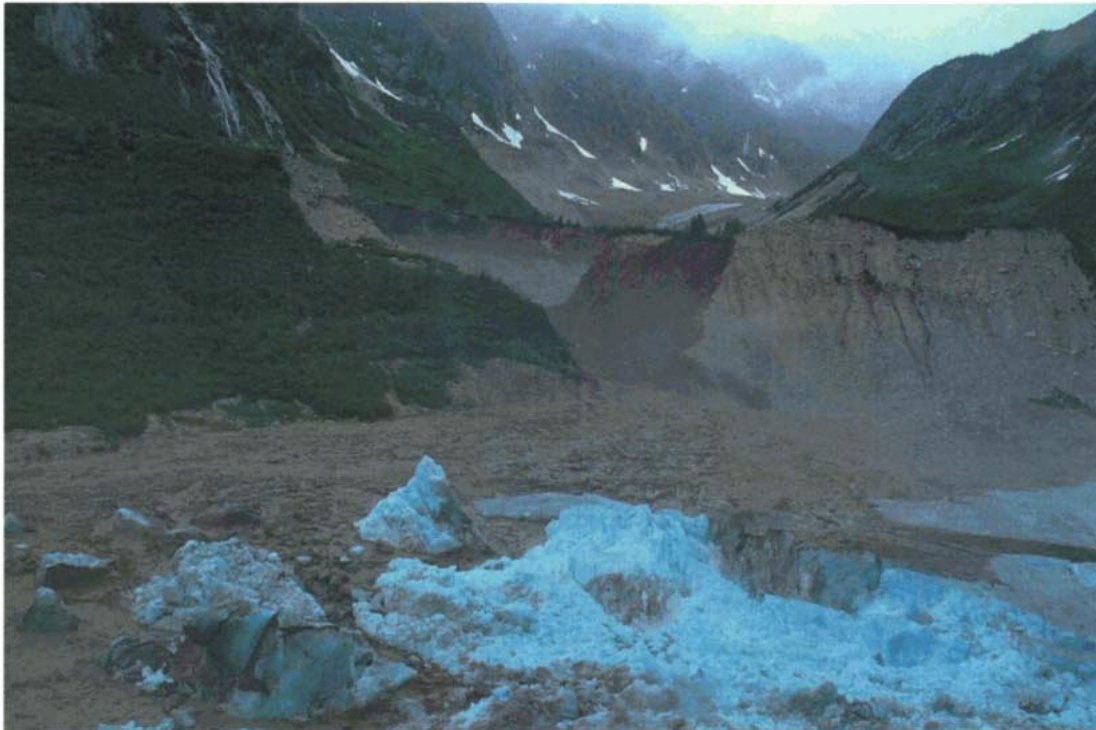
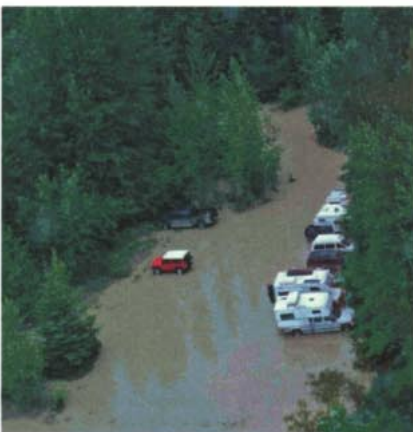
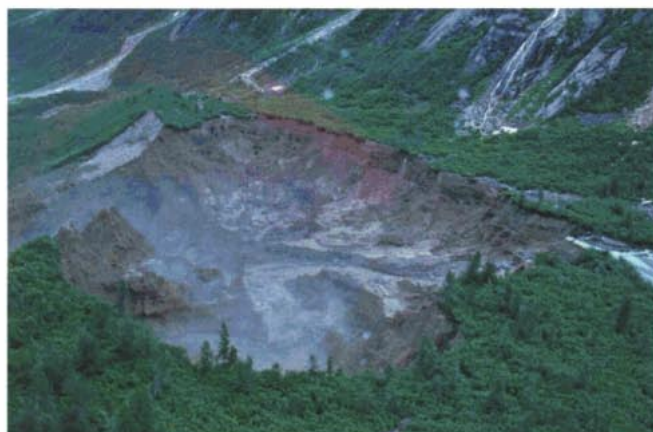
A lateral moraine of West Creek Glacier in the Taiya River watershed near Skagway, Alaska, liquefied in July 2002, causing debris to slide into a glacial lake in front of the glacier's terminus. This event triggered a tremendous flood at Klondike Gold Rush National Historic Park and the community of Dyea, causing extensive damage to bridges, roads and private property. Photos courtesy TEMSCO Helicopters.

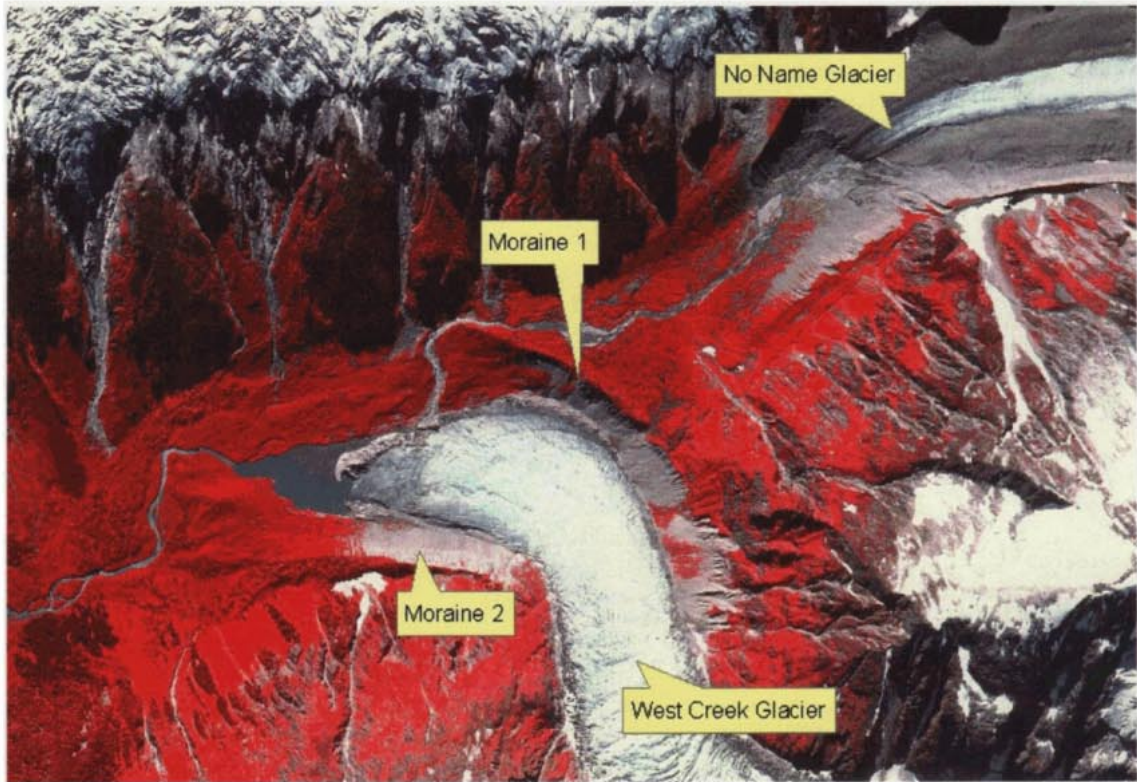
Figure 2. Infrared aerial photo of the West Creek Glacier area, August 1979.

The 2002 glacial lake outwash event was created by the collapse of Moraine 1 (Figure 2). Moraine 1 is a lateral moraine to the West Creek Glacier that formed perpendicular to the No Name glacier river valley (Figure 2). This configuration created a structure composed of glaciated (fine) material with steep side slopes that were disproportional to its relative height. As the No Name Glacier receded, the area behind the moraine filled in with very fine sediment. This soil class characteristically has a considerable pore space volume, which results in its ability to retain large volumes of water as compared to coarse-textured soils (Miller, 1990). It is also more susceptible to erosional forces due to its small particle size (Miller, 1990). The relatively fine sediment of this moraine was subject to saturation from drainage coming from the No Name valley. Steep, wet and fine sediments created a high potential for slope stability failure.

Dave Herbig of TEMSCO Helicopters reported observing water and debris spewing from the base of the moraine the day prior to its collapse. There is no available information concerning the structural integrity of the moraine before the 2002 event. Considering the characteristics of the fine material that composed the moraine, the annual precipitation of the area, and the witnessed account of the events prior to the collapse, we hypothesized that water drained through the moraine creating a preferential flow path. This path may have resulted in seepage of water at the base of the moraine. As the flow of water through the moraine increased incrementally, this may have resulted in the increased removal of erosive moraine material. This process resulted in the extreme preferential flow path of water and debris that discharged at the base of the moraine.

The removal of material created a sinkhole which resulted in further instability and the catastrophic release of debris into the West Creek glacial lake displacing water into West Creek. This caused a majority of the lake to fill in with debris, which rapidly displaced water into West Creek, and greatly diminished the lake's current holding capacity.

An inspection of lateral Moraine 2 (Figure 2) adjacent to the West Creek Glacial Lakes identifies a different situation compared to that of Moraine 1. Moraine 2 is approximately 520 ft (158 m) high, 150 ft (46 m) thick at the base and 50 ft (15 m) thick at the top. The majority of the moraine has a slope of 35 percent with the top 50 ft (15 m) having 60 percent slope. Moraine 2 is composed of multiple size class sediments which have been pushed against the rocky slope of a mountain side. This rocky slope provides structural support to the underside of the moraine which may prevent a catastrophic collapse similar to that which occurred at Moraine 1. In addition, the location of Moraine 2 makes it much less subject to constant saturation as was the case for Moraine 1. It was evident from the size and composition of the toe of the slope that material from the steeper sections has been sloughing off over time. This is likely to continue until a stable angle of repose is reached.

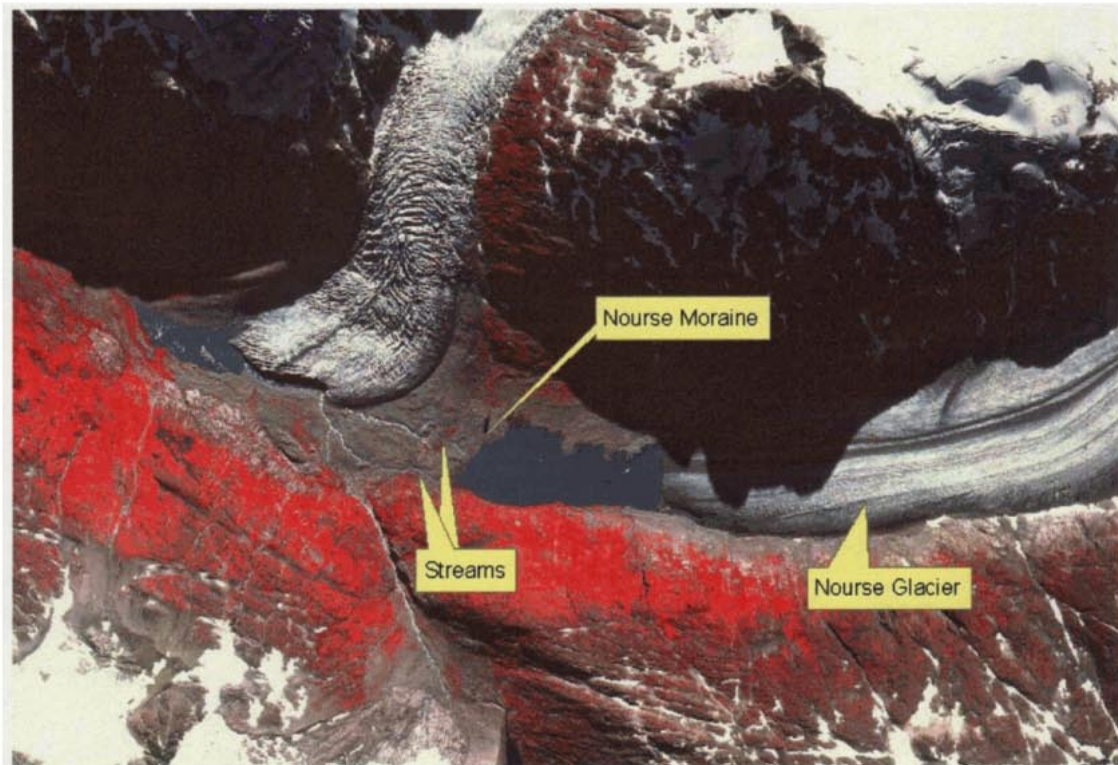
Figure 3. Infrared aerial photo of the Nourse Glacier area, August 1979.

The surface of the Nourse moraine is composed of multiple size class sediments including large boulders, cobble and sand. The Nourse moraine has a measured length of 2,640 ft (804 m), an average slope of 15 percent, and a calculated height of 396 ft (120 m), confirming Capps (2004) measurements. Two streams have formed that allow water to flow over the moraine (Figure 3). These streams appear to be well armored by small boulders and cobble. Observations revealed no areas of excessive sagging or sloughing.

Typically, moraines such as that found at the Nourse Glacier are held together by the presence of an ice core (Souchez, R.A., 1971, Reynolds, 1998, Moorman, et al.2000). As average annual temperatures increase, these ice cores become susceptible to degradation. A failure may occur when the moraine structure becomes too weak to hold back the force created by the large volume of water trapped behind the moraine.

The malfunction of the EM equipment prevented a subsurface inspection of the Nourse moraine. The composition and surface slope (15 percent) of this moraine does not indicate a high potential for instability or failure. However, the large volume of water trapped behind this moraine has the potential to cause significant downstream damage if catastrophically released. According to Hal Pranger (geomorphologist, National Park Service), seven different dam failure equations were used to estimate peak discharge in the event of a catastrophic moraine failure. All seven equations estimate an at-the-moraine discharge in the 250,000 (cfs) range. Five equations estimate the peak discharge at Dyea to be in excess of five times the estimated 500-year flood event on the Taiya River.

The overall integrity of the Nourse moraine should be determined in order to provide improved information concerning geohazards on public lands. It remains extremely important to fully understand the subsurface structural integrity of this moraine, and specifically the presence or absence of an ice core, in order to more accurately predict hazard potential.

This information may assist downstream land managers in deciding the best course of action to mitigate damages caused by flooding. These inspections should include a surface inspection to identify any seepage locations and rates and an evaluation of the internal composition and integrity of the moraine through the use of geophysical instrumentation.
