Location: Kolmakof Cinnabar Mine (Site), Sect. 6, T17N, R53W, SM
Date: 18 Aug 2006
Subject: HazMat Inspection
Inspector: Larry Beck, Environmental Protection Specialist

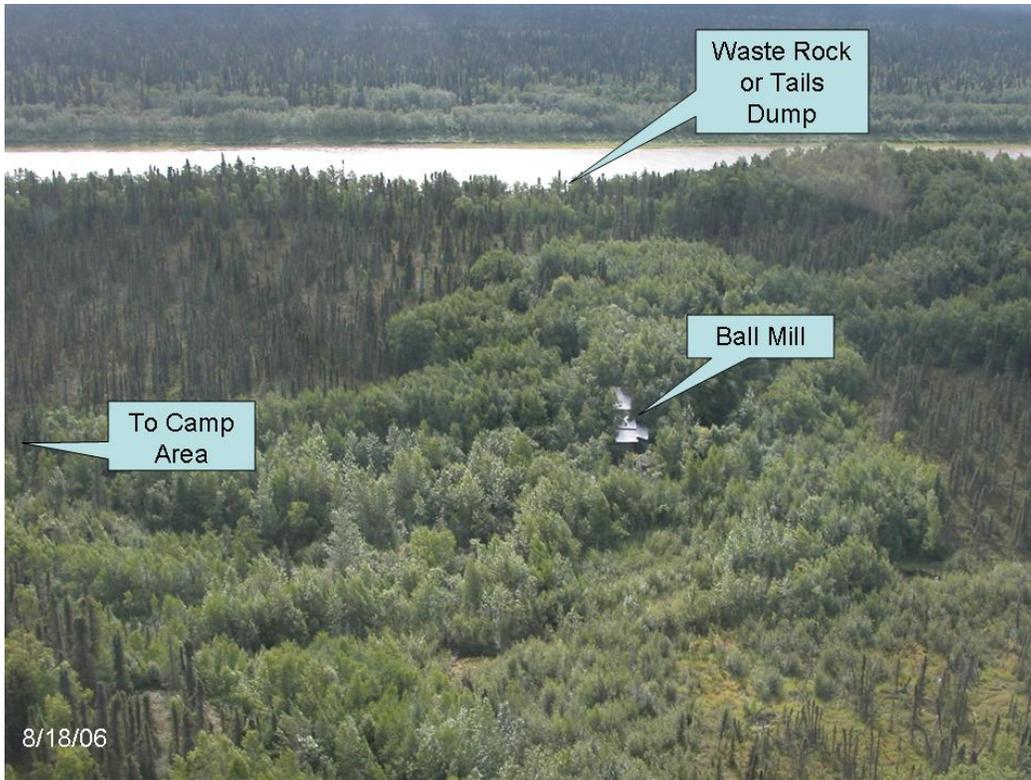
Mill Area looking South toward the river

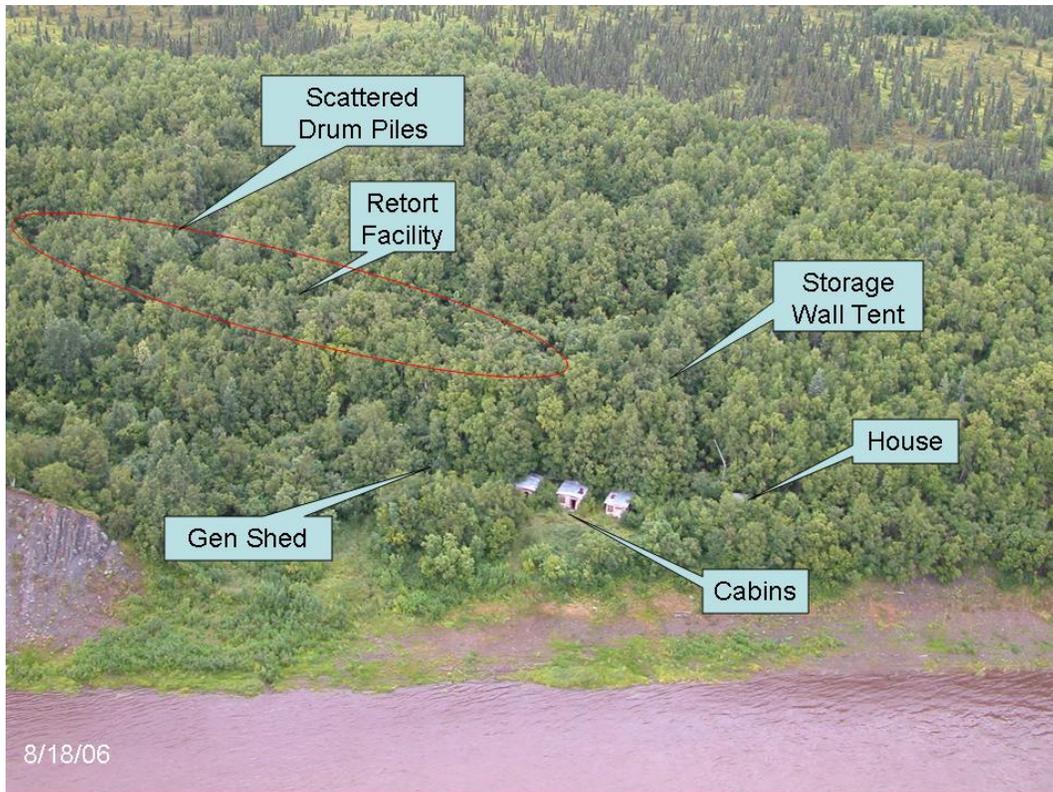
Camp Area looking North. Location of key features are noted though not all are visible in the photo.

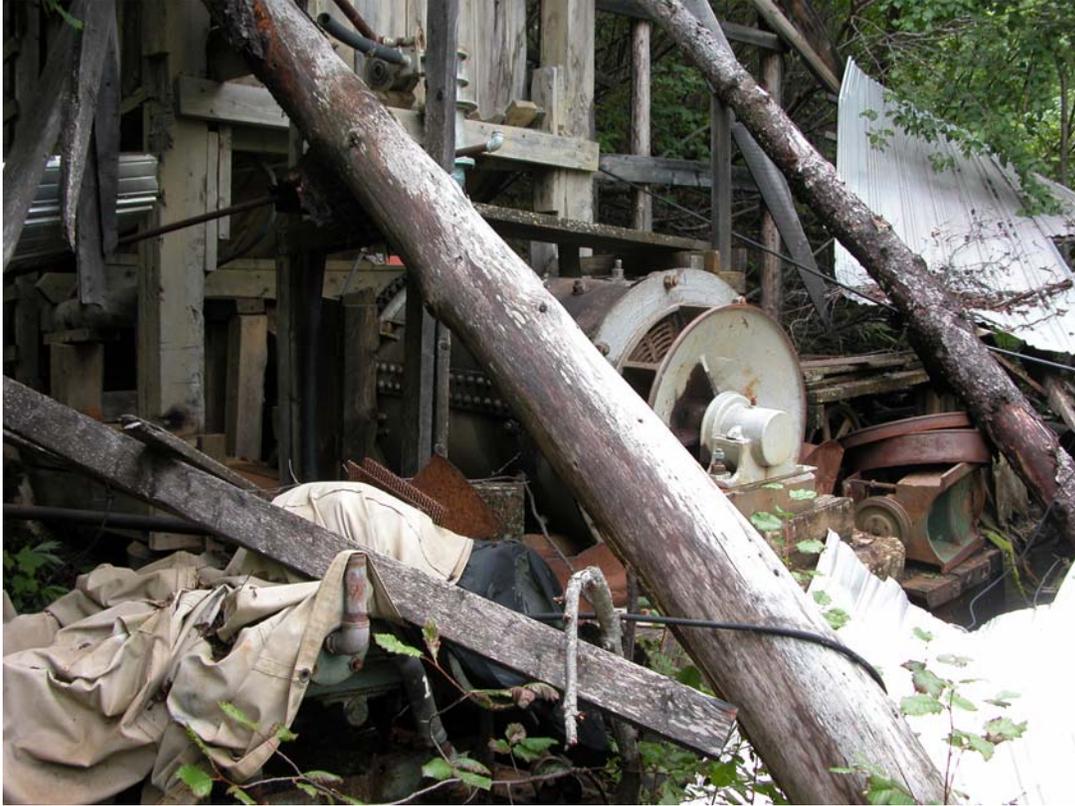
Collapsing Ball Mill. Surface water is passing under the debris.

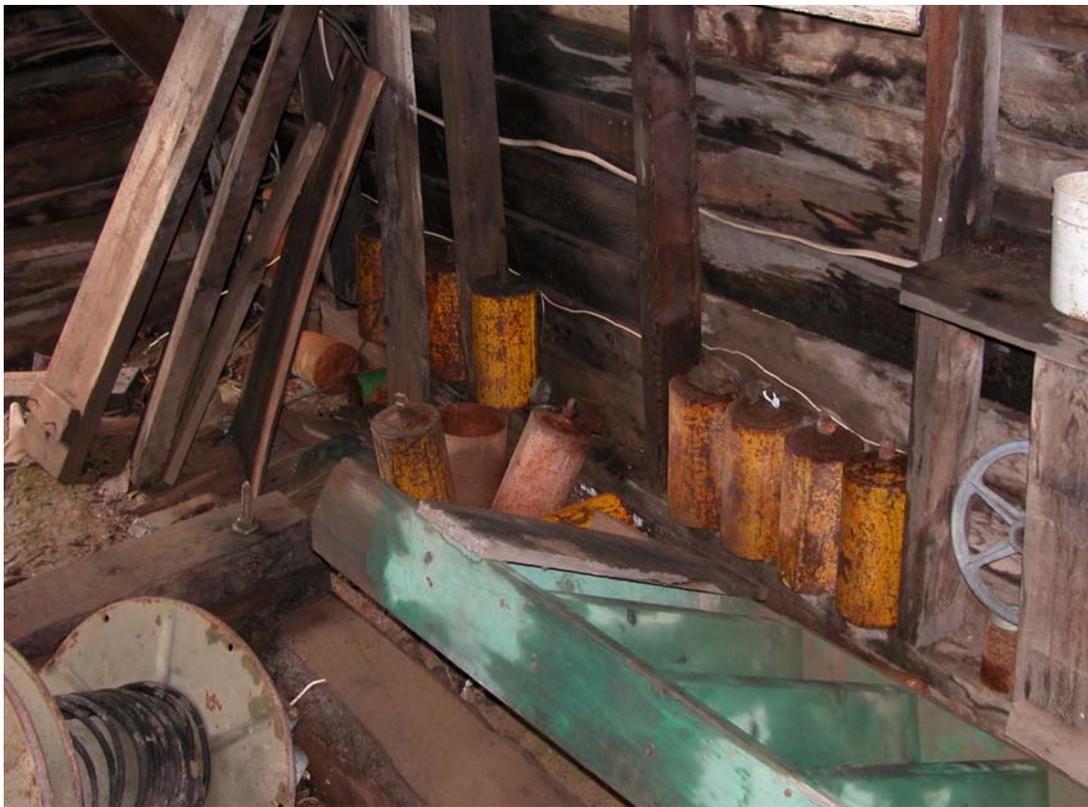
Mercury flasks in shed next to Ball Mill

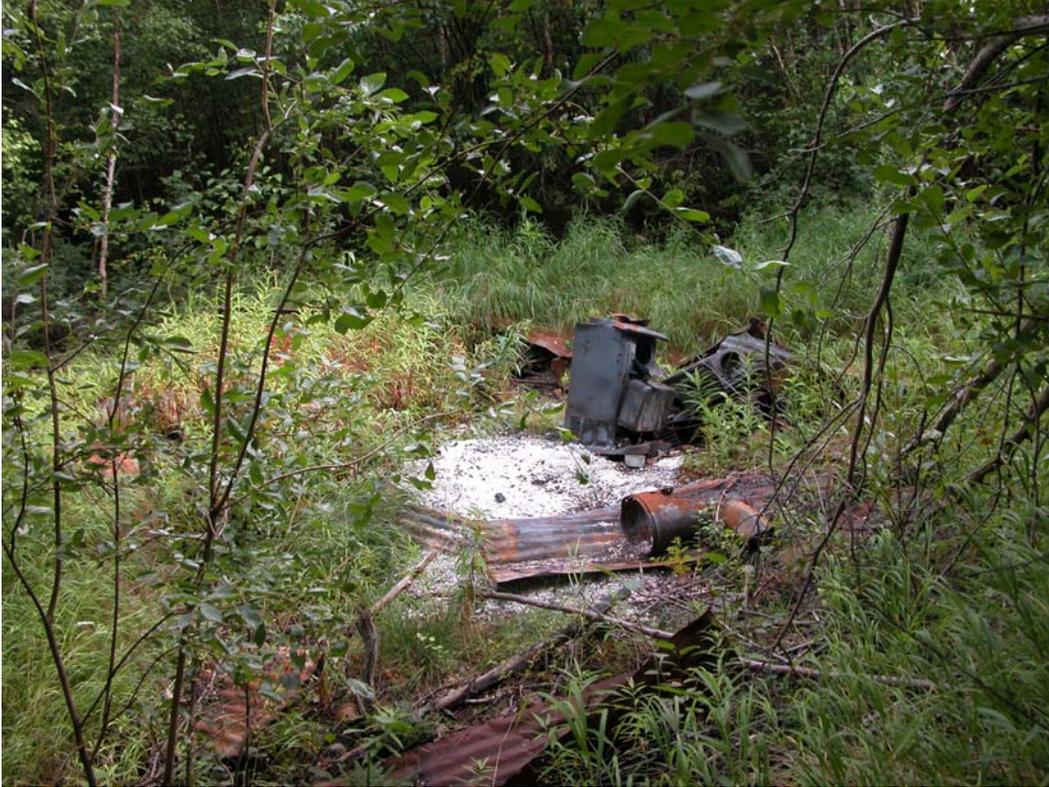
- There is no documentation in the case file to describe what type of explosive the "dynamite" was, except some photos which show labeling that it was manufactured by the Atlas Chemical Company, and that it was in an advanced stage of deterioration from exposure to the elements. "Dynamite" is a often used generic term for many varieties of stick type explosives – the original dynamite was nitro-glycerin in compressed sawdust in a wax-paper wrapped stick. The case file photos appear to show the explosives were probably TNT or similar chemical. Many chemicals used in explosives are CERCLA Hazardous Substances and some are Listed or Characteristic Hazardous Wastes. Since no pre-fire analysis of the "dynamite" was conducted, there may be leached chemicals in the soil, from either pre-burn or as a result of the fire.

Remains of the burned-down “dynamite” shed. Residual toxic chemicals may be present in the soil.

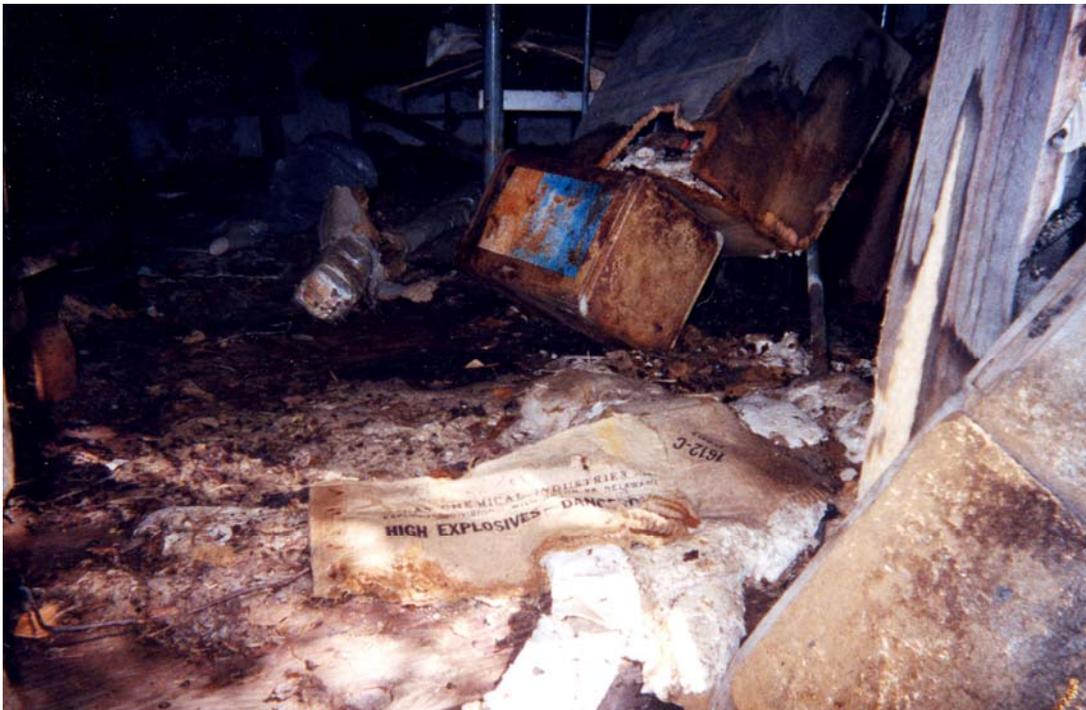
Scanned photo of the “dynamite”, from the case file circa June 2000. Deteriorated explosives are on the ground, with a wood case seen in the background resting on an empty Blazo can. The pasty, white appearance suggests the explosive is TNT, which does contain hazardous chemicals.

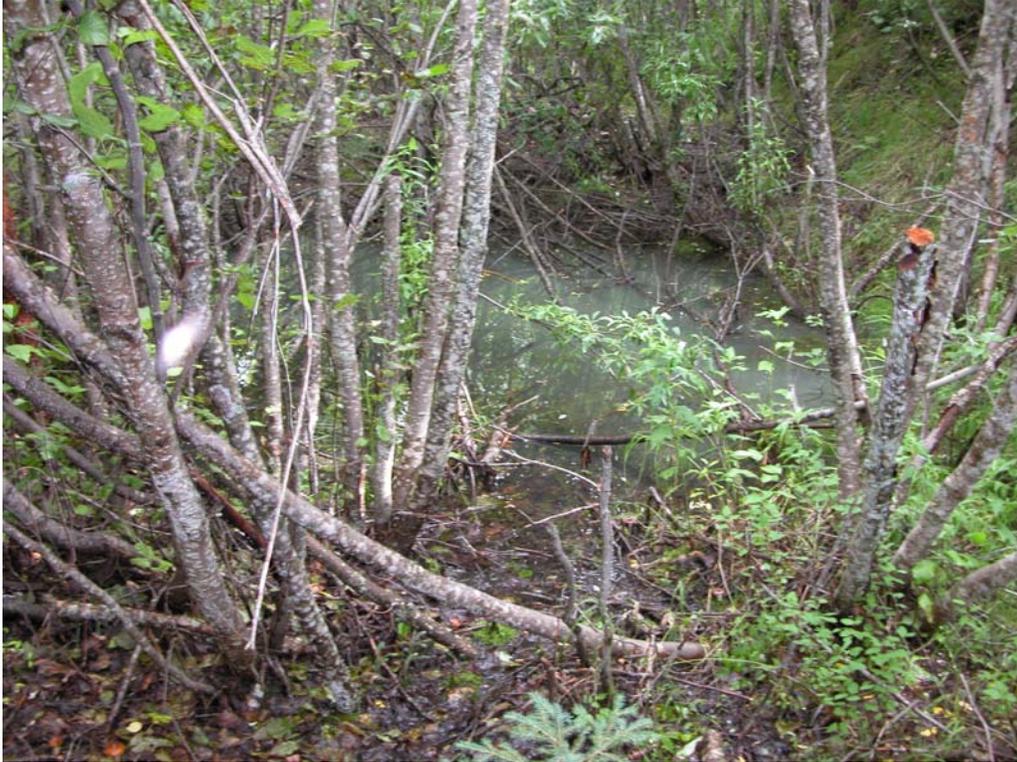
- The water filling the pond is coming from or flowing through probable tails. Being spring fed it is probably relatively warm so does not freeze immediately when winter arrives. Given where the water is coming from, there is a possibility that it may be contaminated with toxic metals.

Pond near the Ball Mill. Cloudy water is probably due to heavy rains on the day of and prior to the inspection. This pond is located about 10-15 feet from the Ball Mill. The hillside in the background is likely man-made – tails or waste rock.

Recommendation: BLM should conduct a formal Removal Site Evaluation (RSE) per the BLM CERCLA Response Actions Handbook. Areas investigated should include the retort area(s), tails/waste rock dump, and the spring fed creek to determine if they are spreading mercury or other toxic metal contamination and if removal action is warranted. The burned “dynamite” shed soils should also be investigated to determine if the deteriorating explosives leached chemicals into the soil before the shed was burned, or if residues left by the fire are present. Should no evidence of contamination be detected, having a properly conducted RSE will facilitate conveyance of the land to TKC (F-14900-A2). I estimate that the RSE will cost \$100K-\$150K. The Central Hazmat Fund will be the most viable source for cleanup funds after the RSE is completed, if further work is warranted.

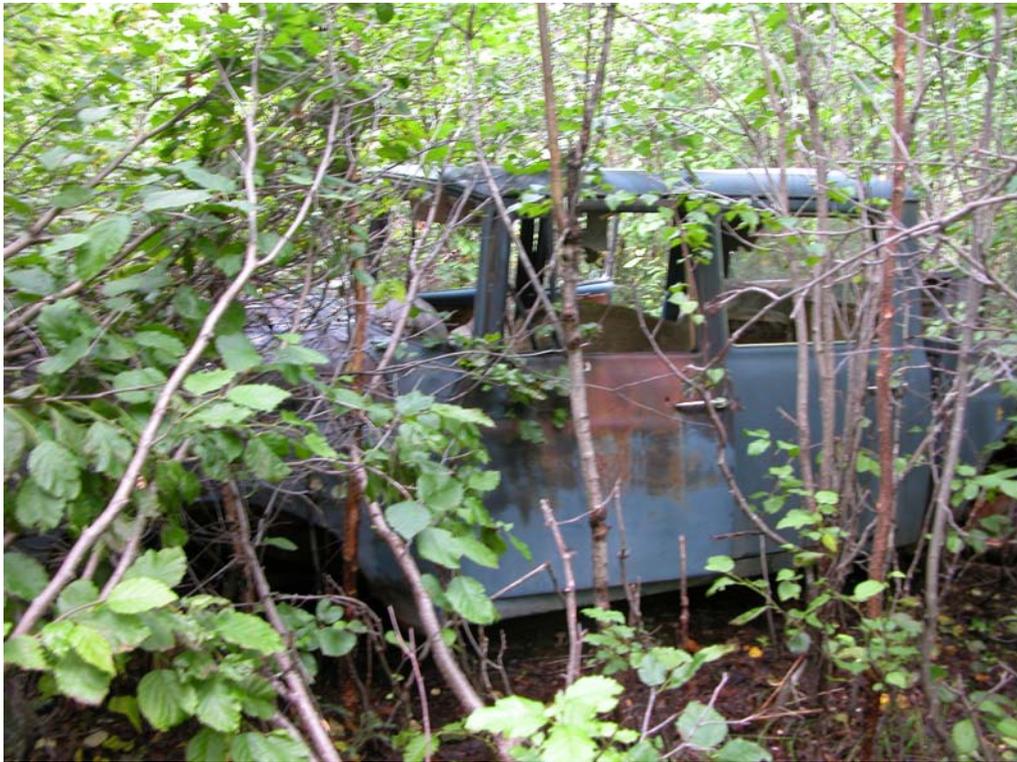
- It appears all containerized hazmats have been removed.
- There is no evidence of oil spills at the site, except probably a small release under the derelict truck.

Derelict truck near the Ball Mill.

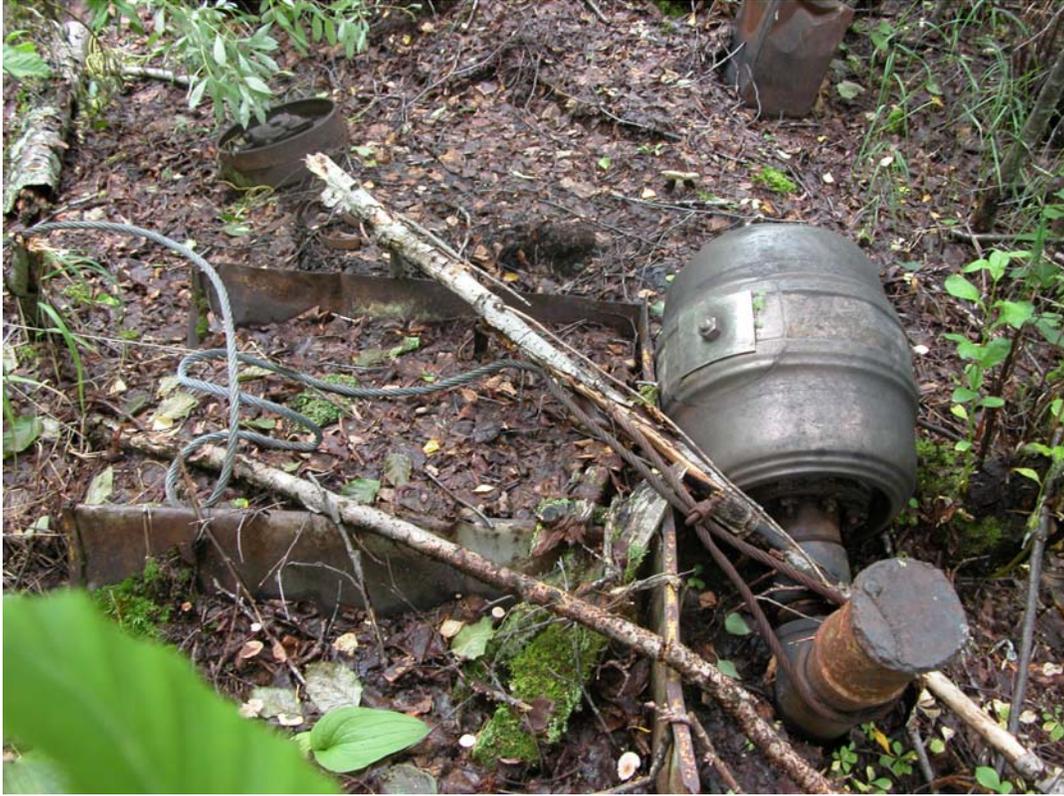
- On-site evidence supports the EPA PA statement that retorting was conducted at the site, possibly at multiple locations around the site at different times.

Beer Keg device at the suspected retort facility near the Camp Area

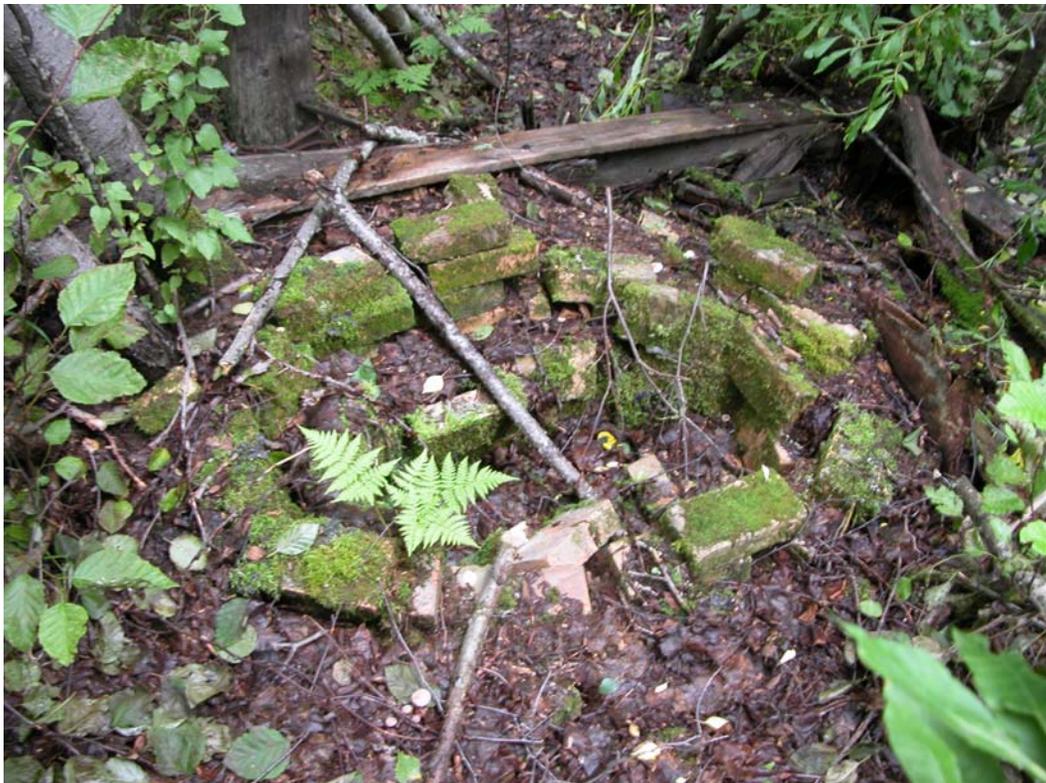
Firebrick lined pit at the suspected retort facility.

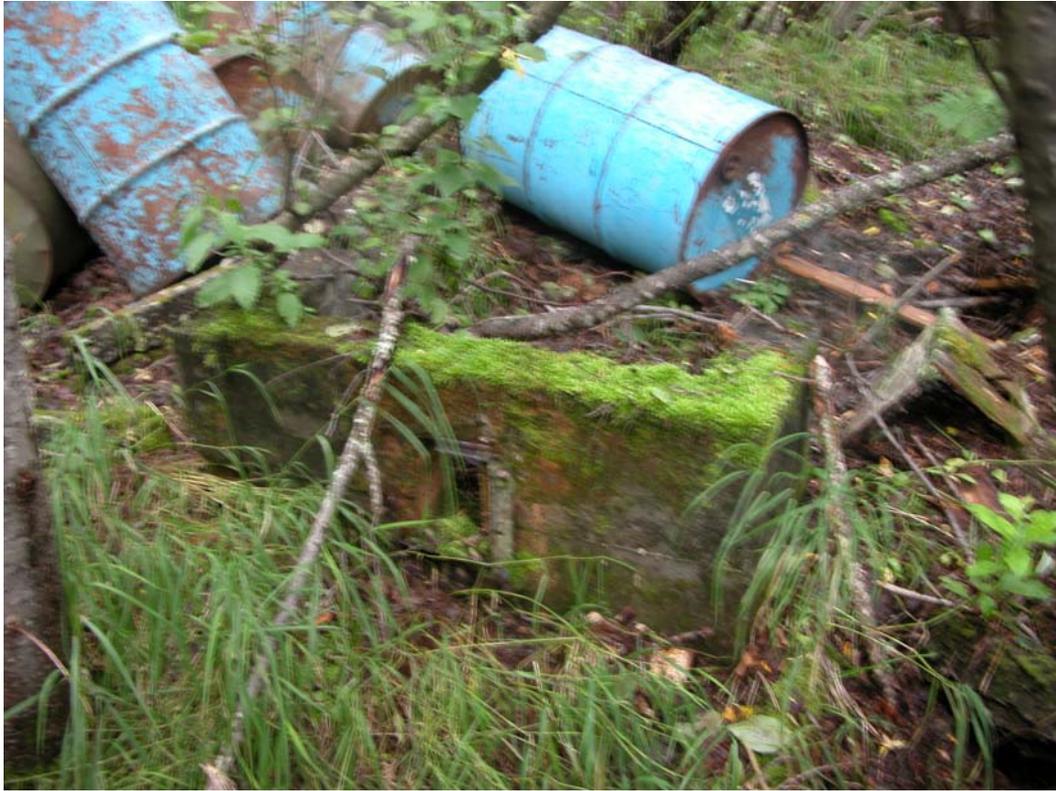
Low concrete and brick wall with a hearth-door? at suspected retort facility.

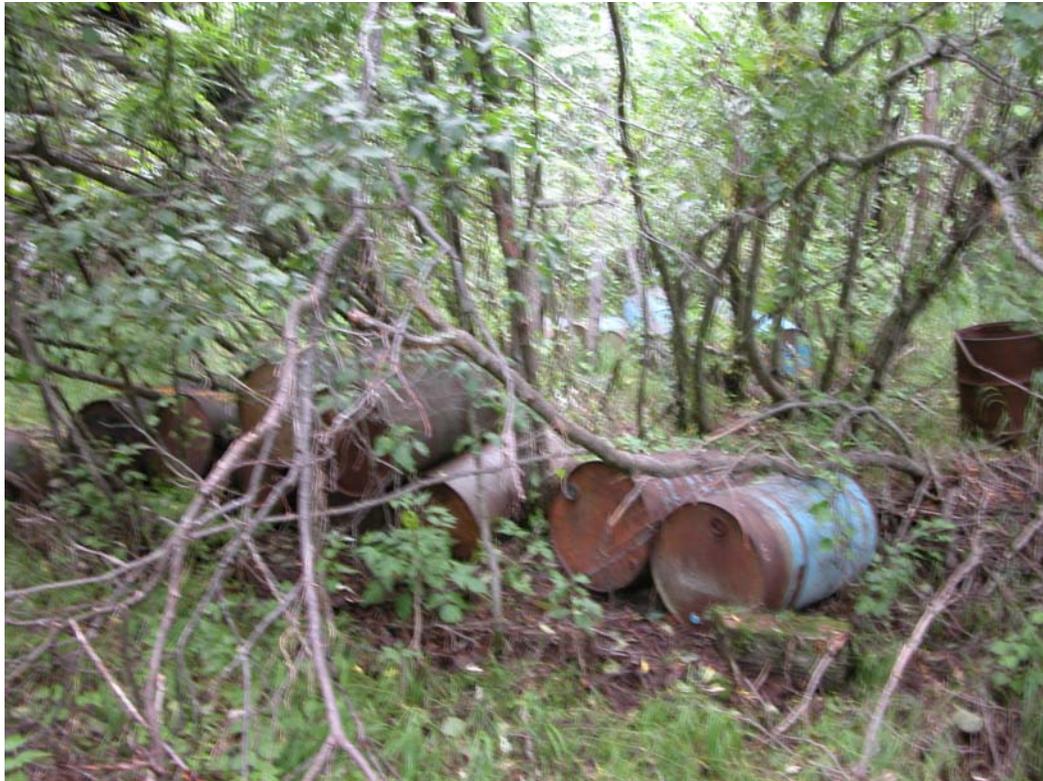
Piles of drums. Numerous piles like this are scattered in the general vicinity of the suspected retort facility. All drums inspected were empty with no sign of spills.

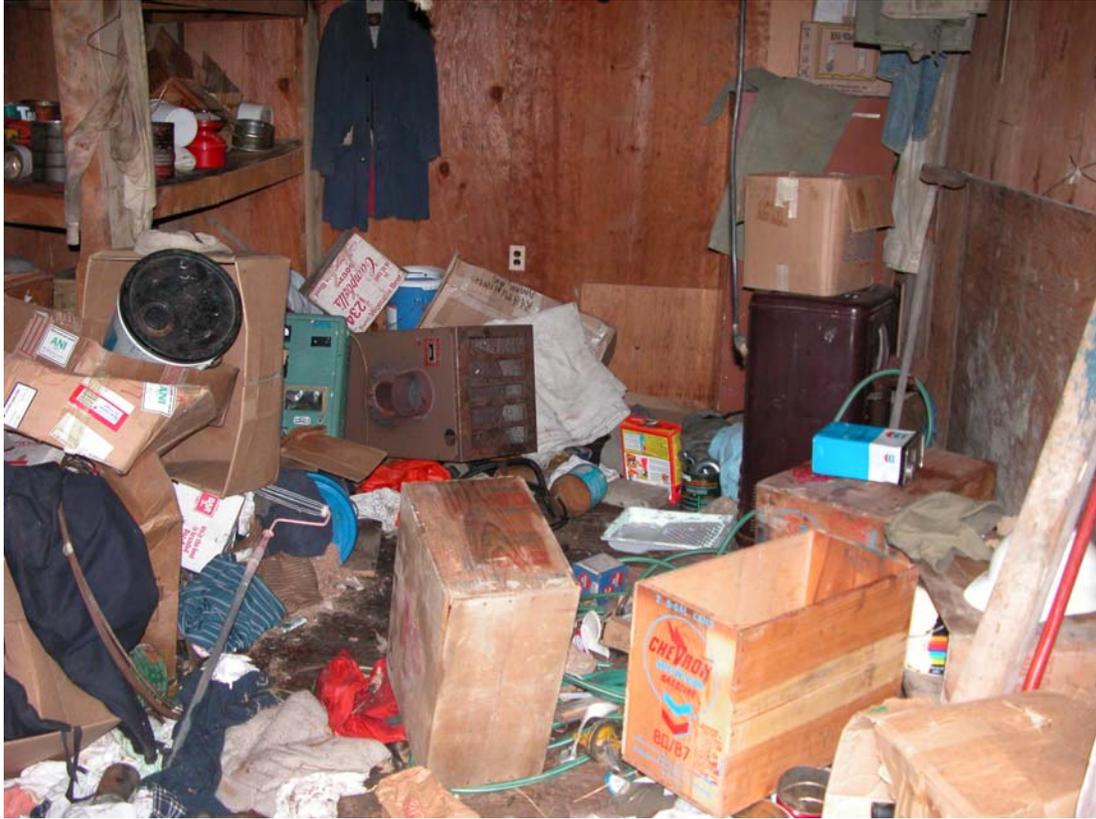
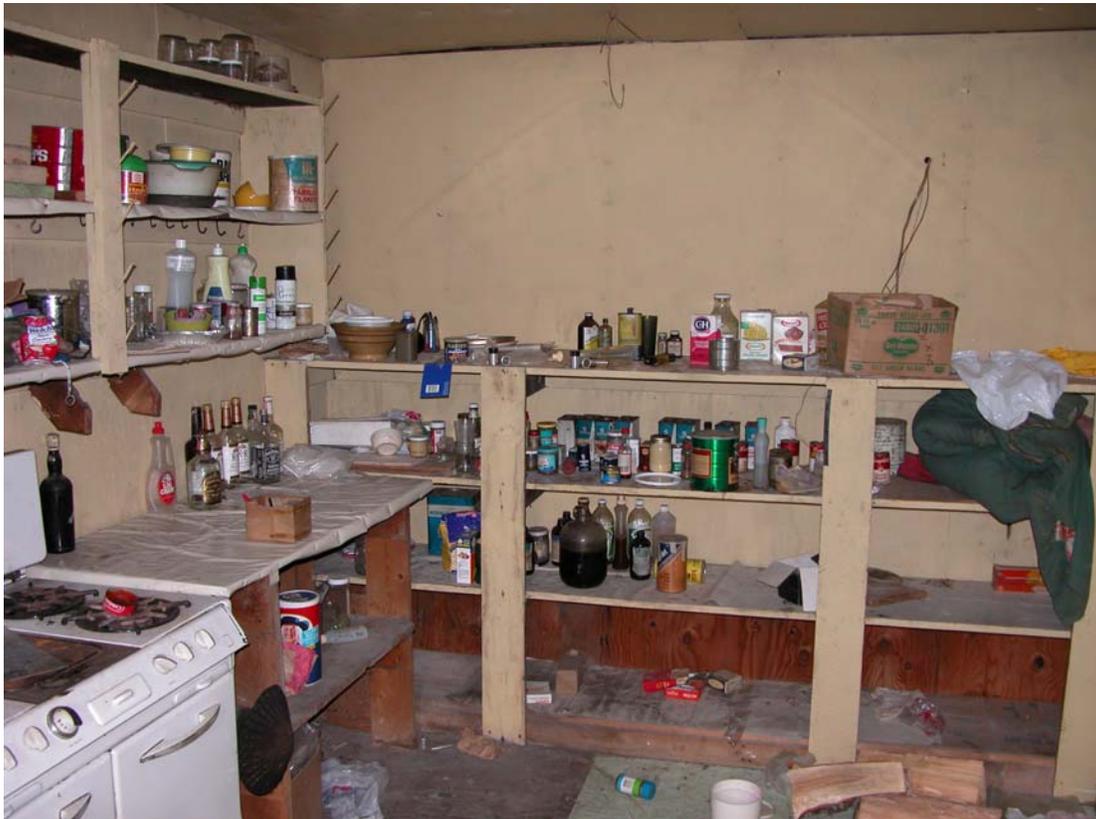
Interior condition of two of the three cabins

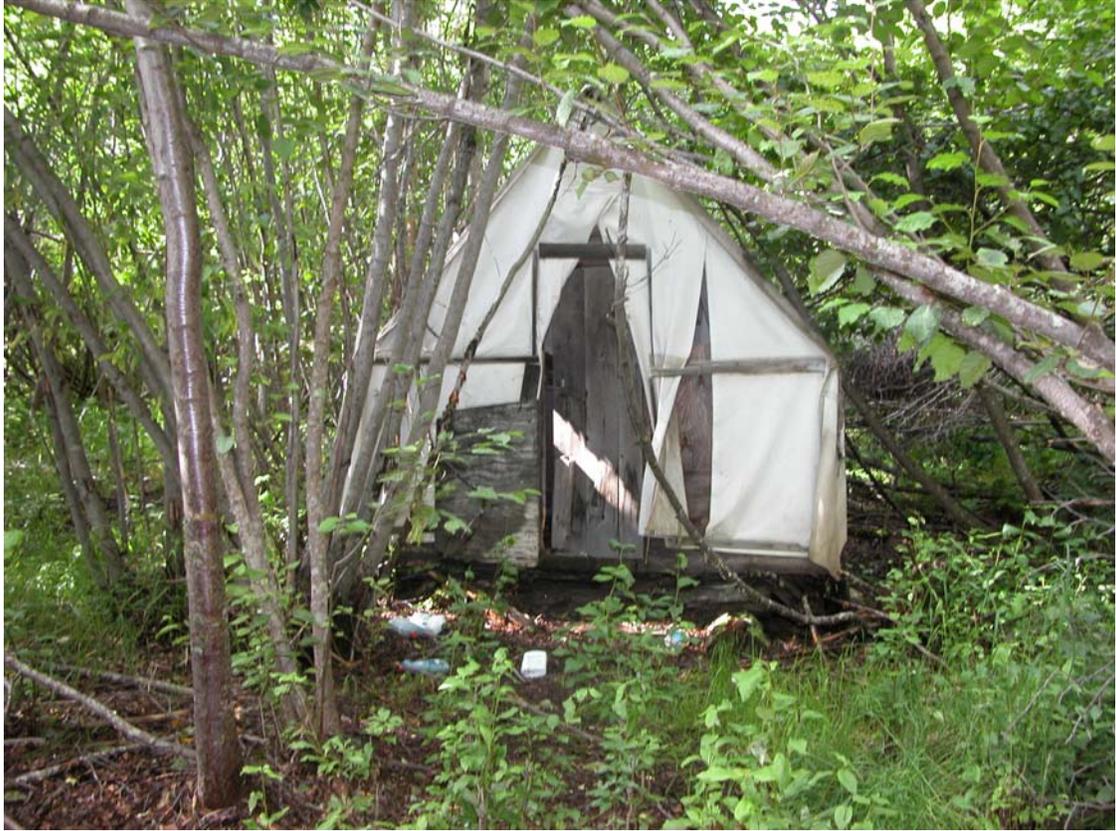
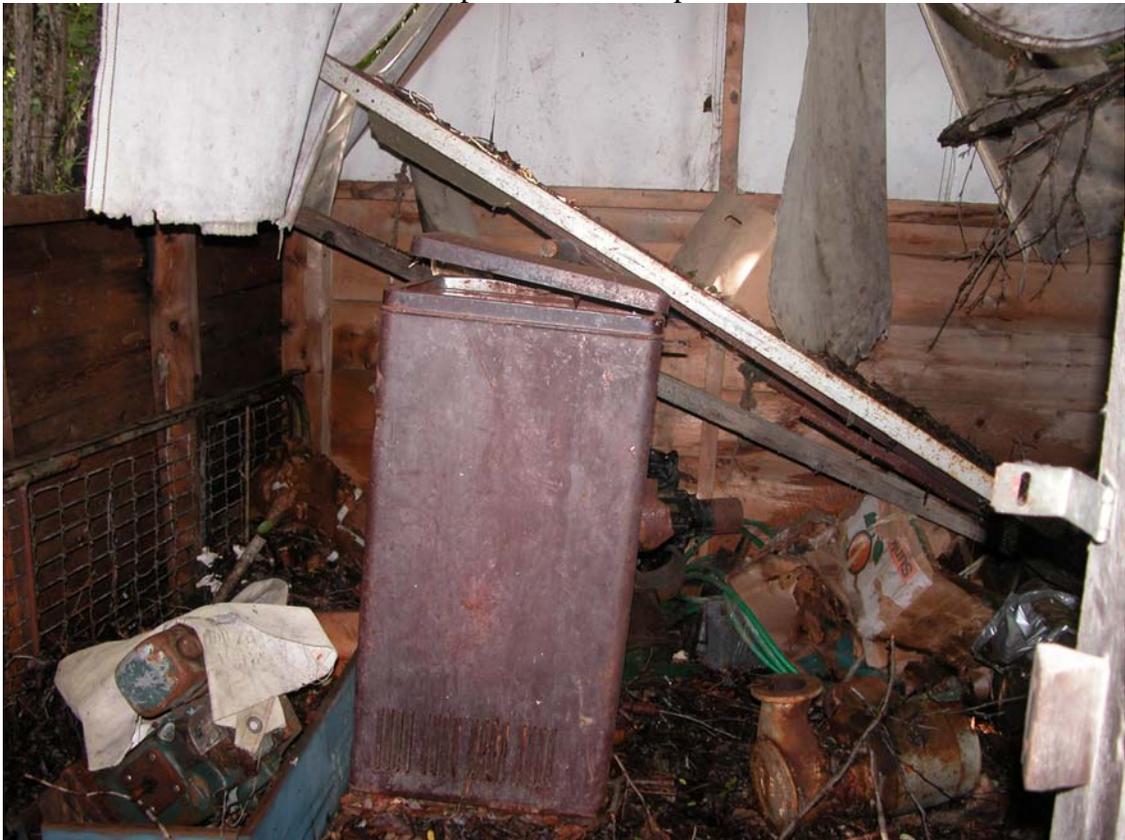
Wall tent in the Camp Area. Bottom photo is the interior.

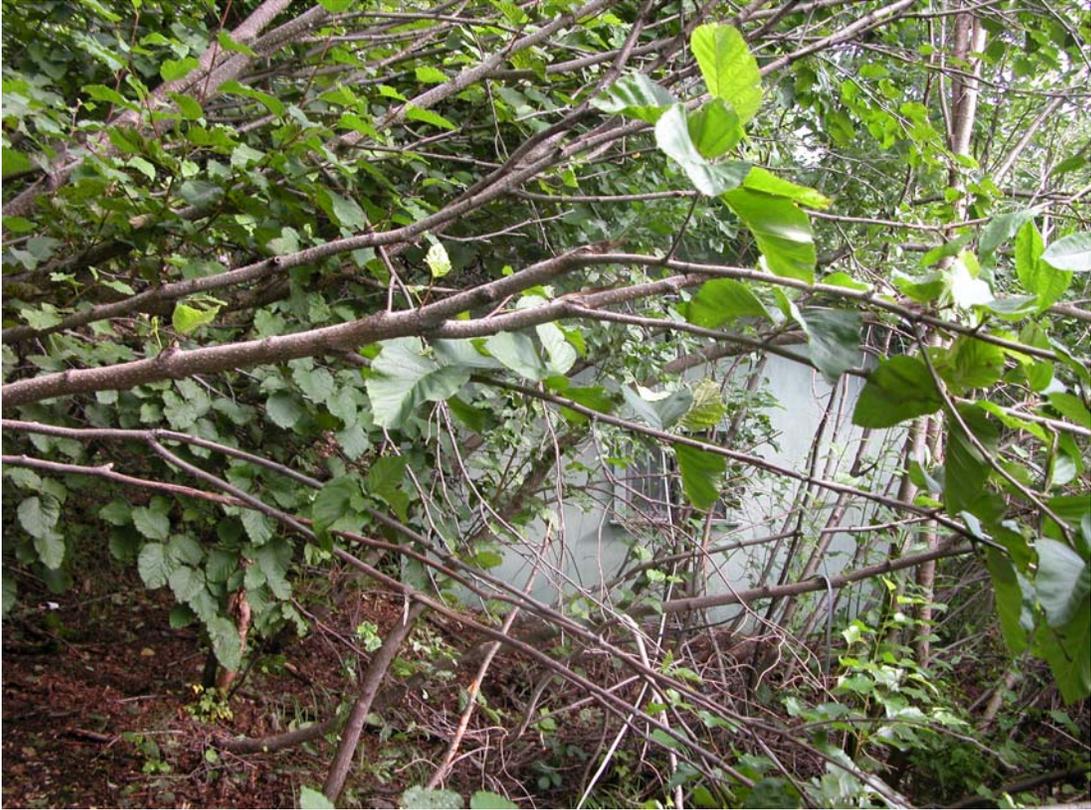
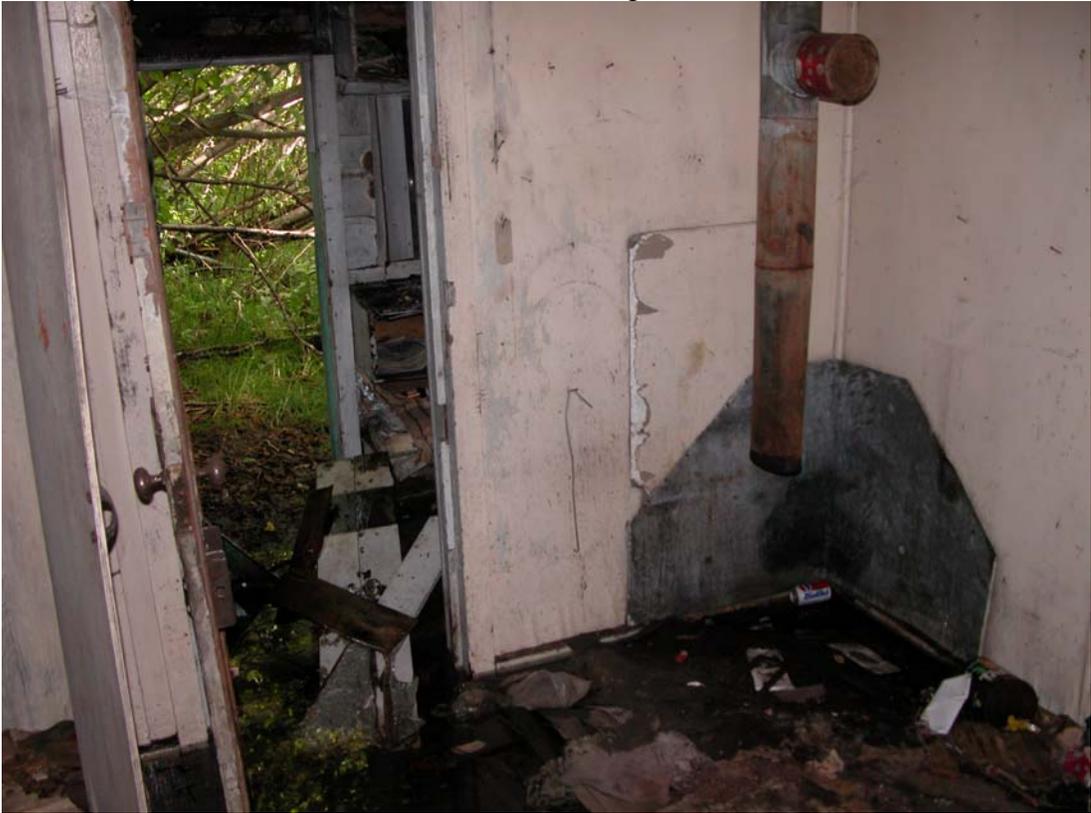
Mr. Leary labeled this cabin as the “Mine Manager’s House”. Interior view below.
