Appendix B

2010 EE/CA Field Investigation

Photograph Log

**Site Features
 Chicago Research Site
 Lake County, California**
 Engineering Evaluation/Cost Analysis Report
 The Chicago Research Site

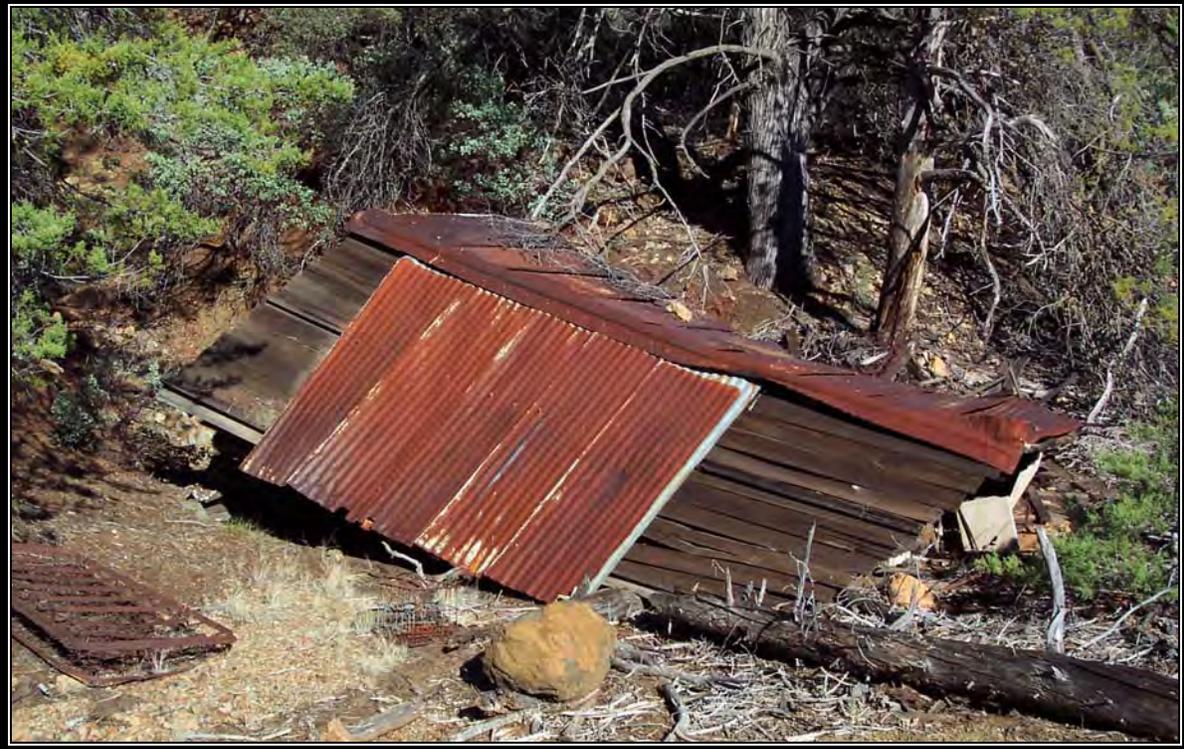
Photo 1: Collapsed Processing Cabin at the Chicago Mine

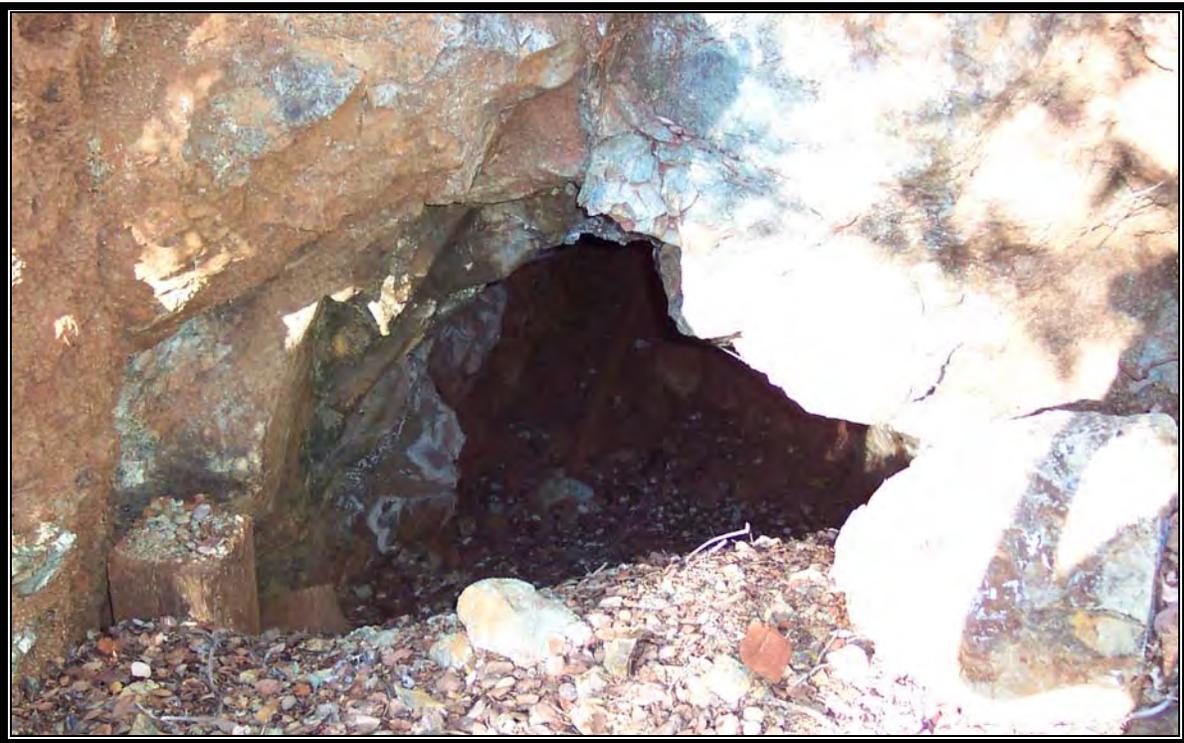
Photo 2: Lower Adit at the Chicago Mine

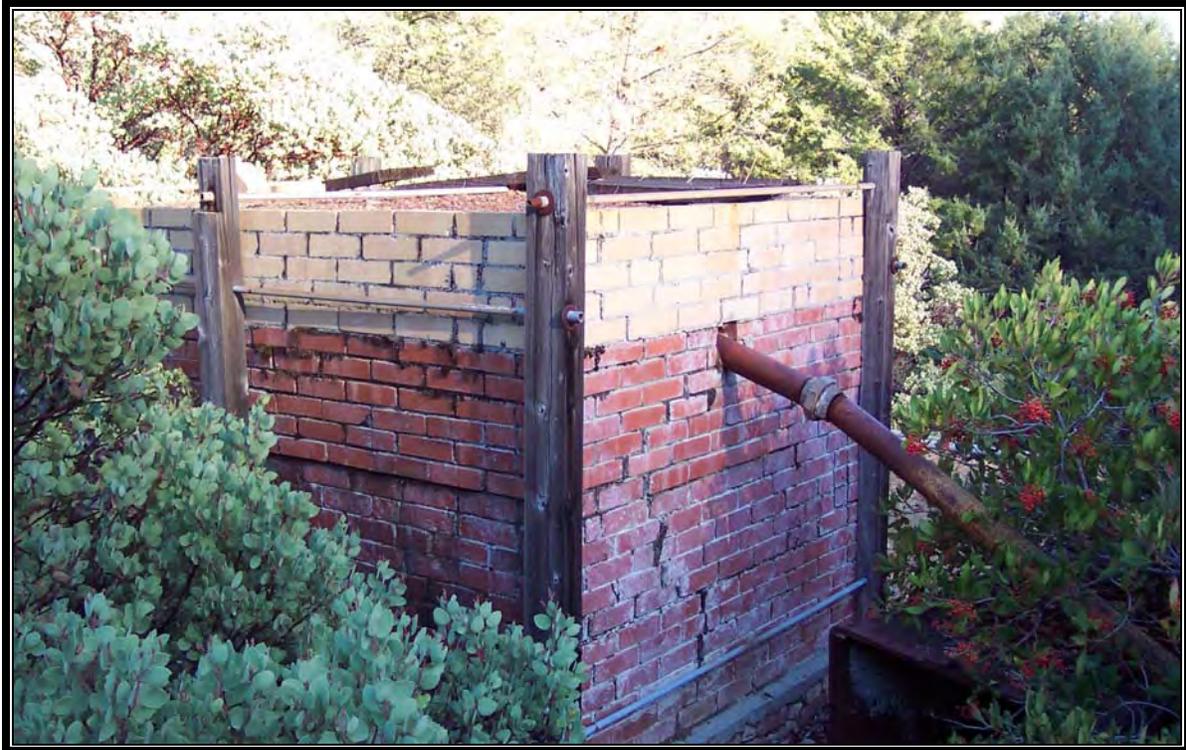
Photo No. 3: Chicago Mine Furnace

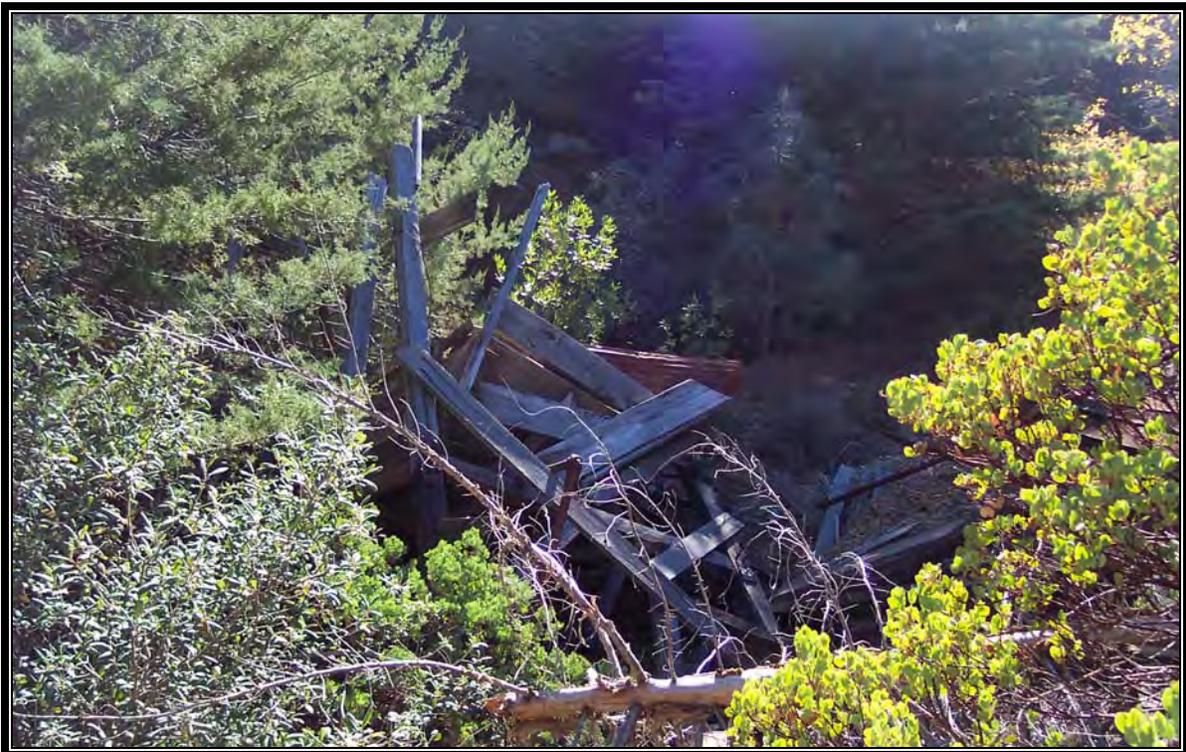
Photo No. 4: Hosting Structure at the Chicago Mine

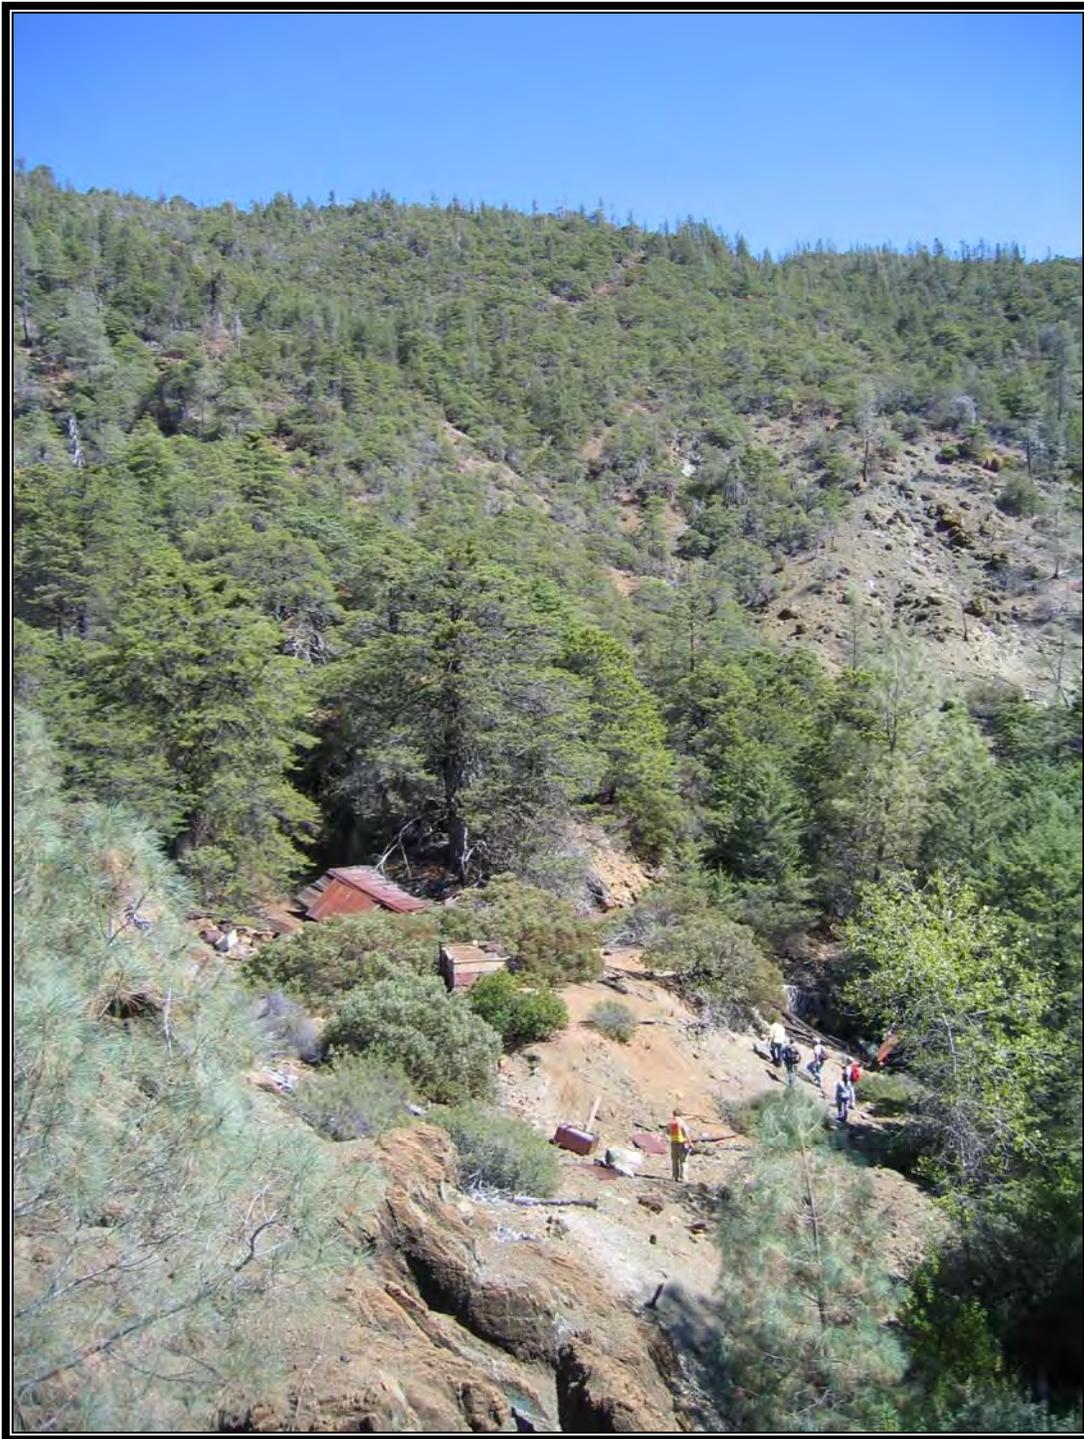
Photo No. 5
Wide-shot of Ore Processing Area at the Chicago Mine

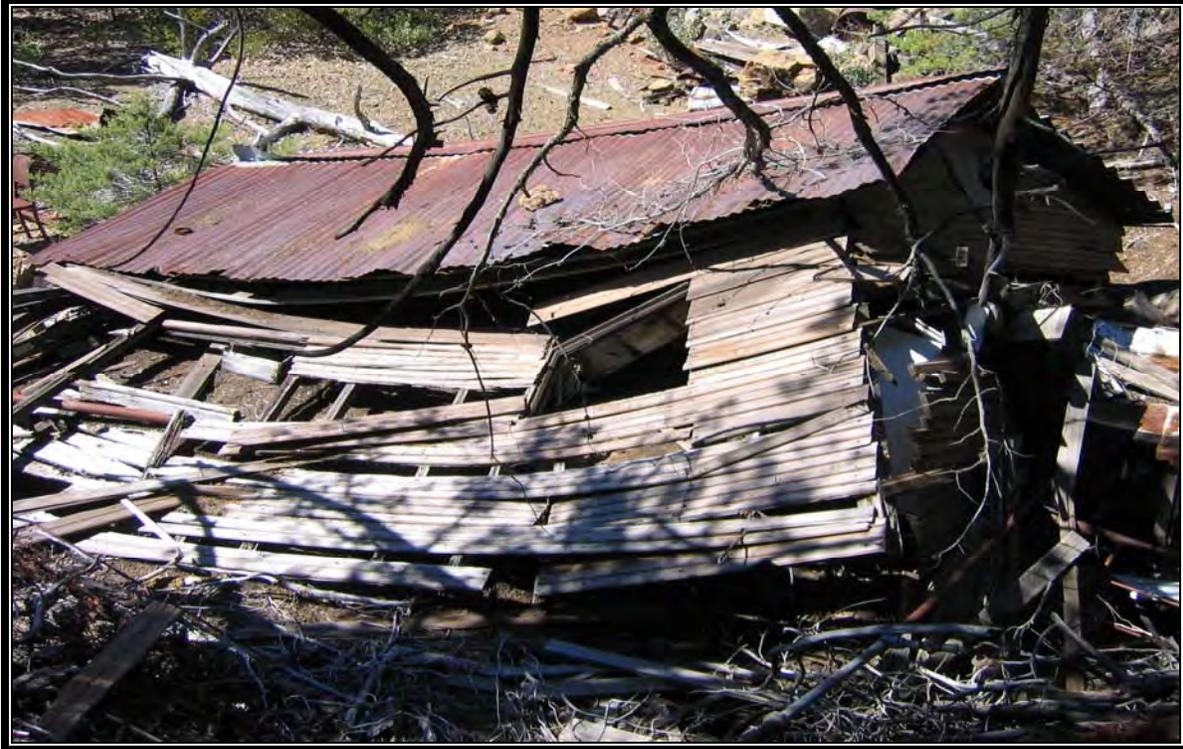
Photo No. 6: Partially Collapsed Processing Cabin at the Chicago Mine

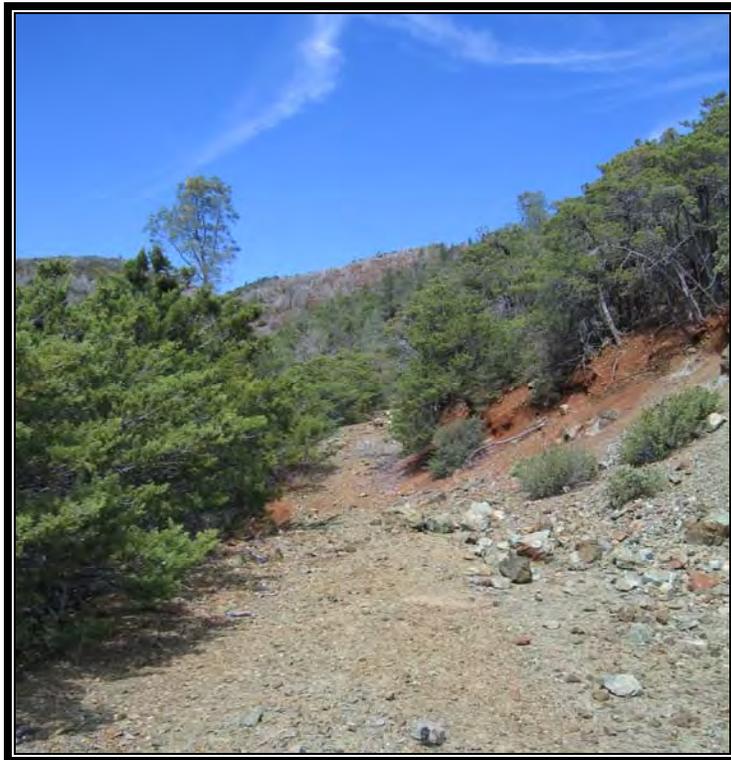
Photo No. 7: Chicago Mine Prospect Road

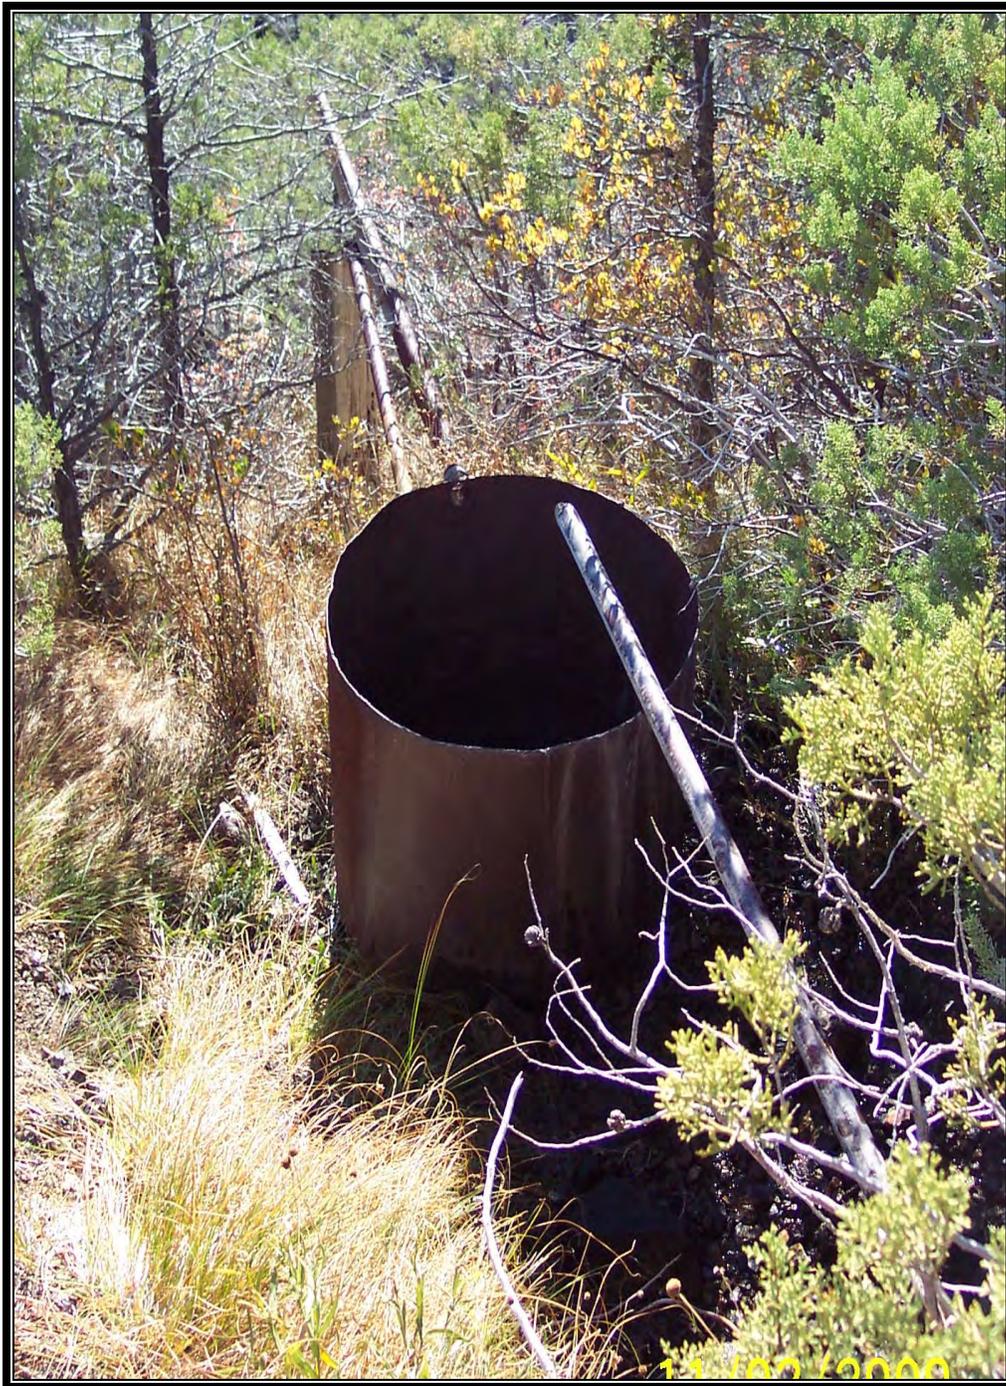
Photo No. 8: Upper Spring Above Chicago Mine

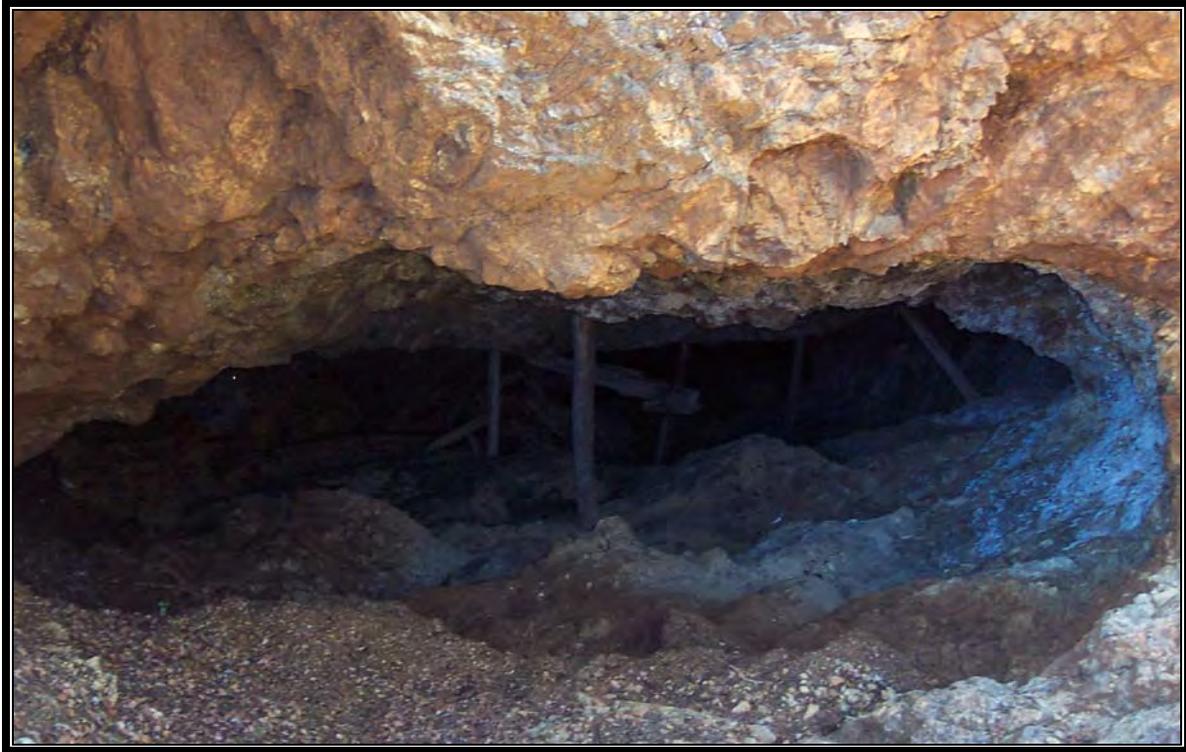
Photo No. 9: Stope at Chicago Mine

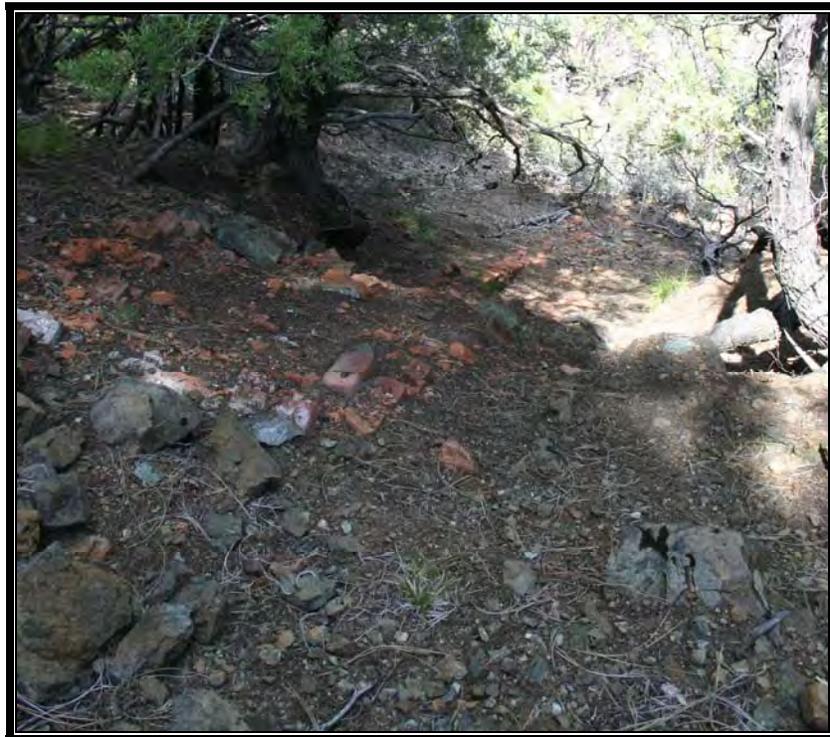
Photo No. 10: Brick Feature at the Research Mine

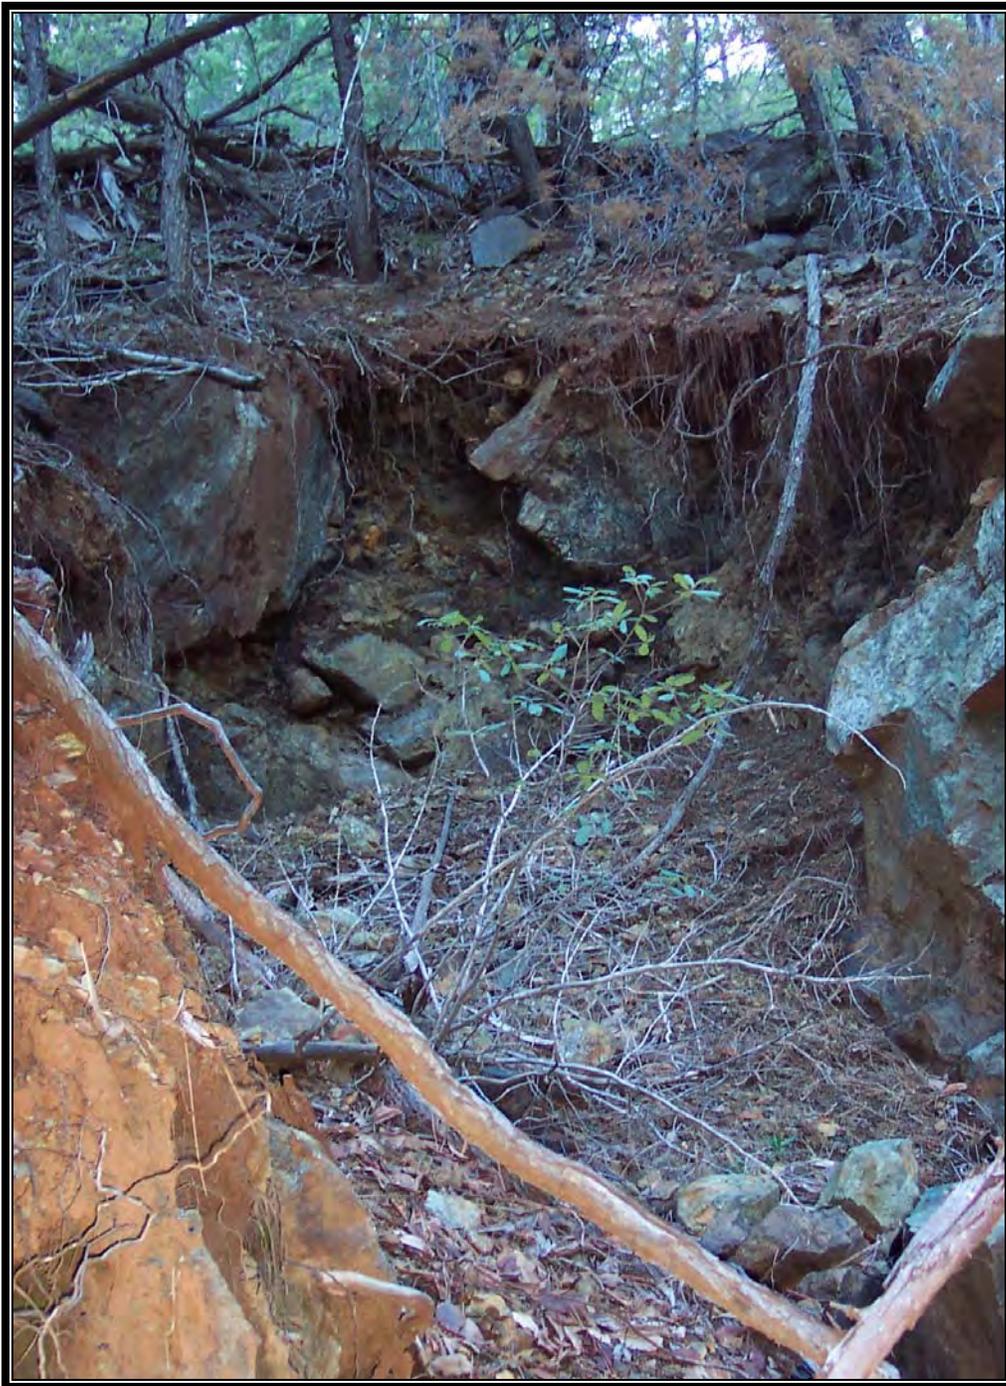
Photo No. 11: Research Mine Collapsed Adit

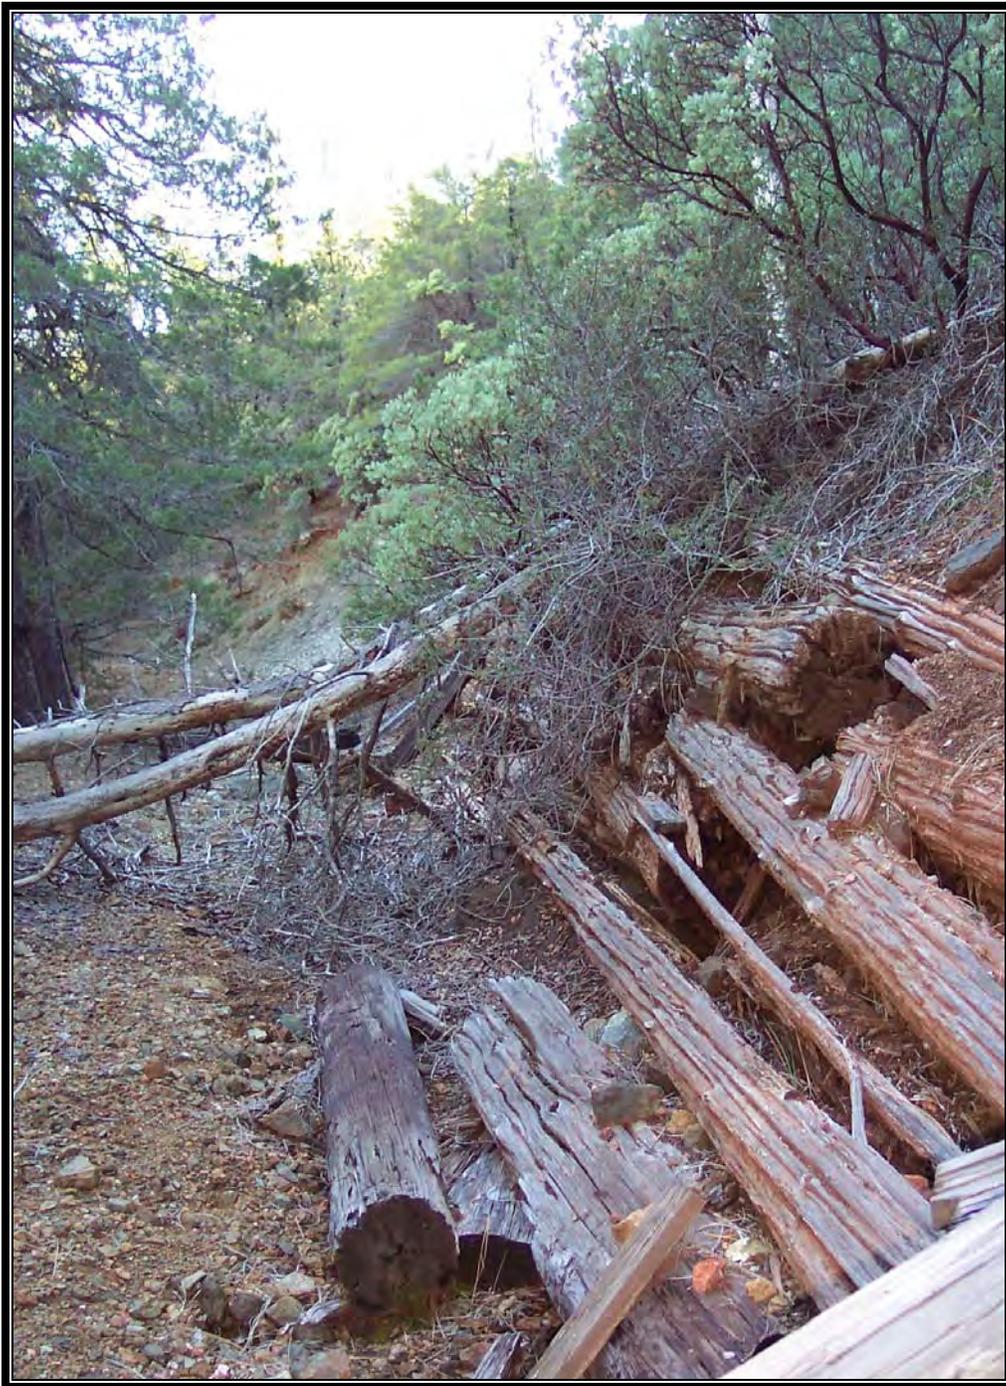
Photo No. 12: Retaining Wall at the Research Mine Furnaces

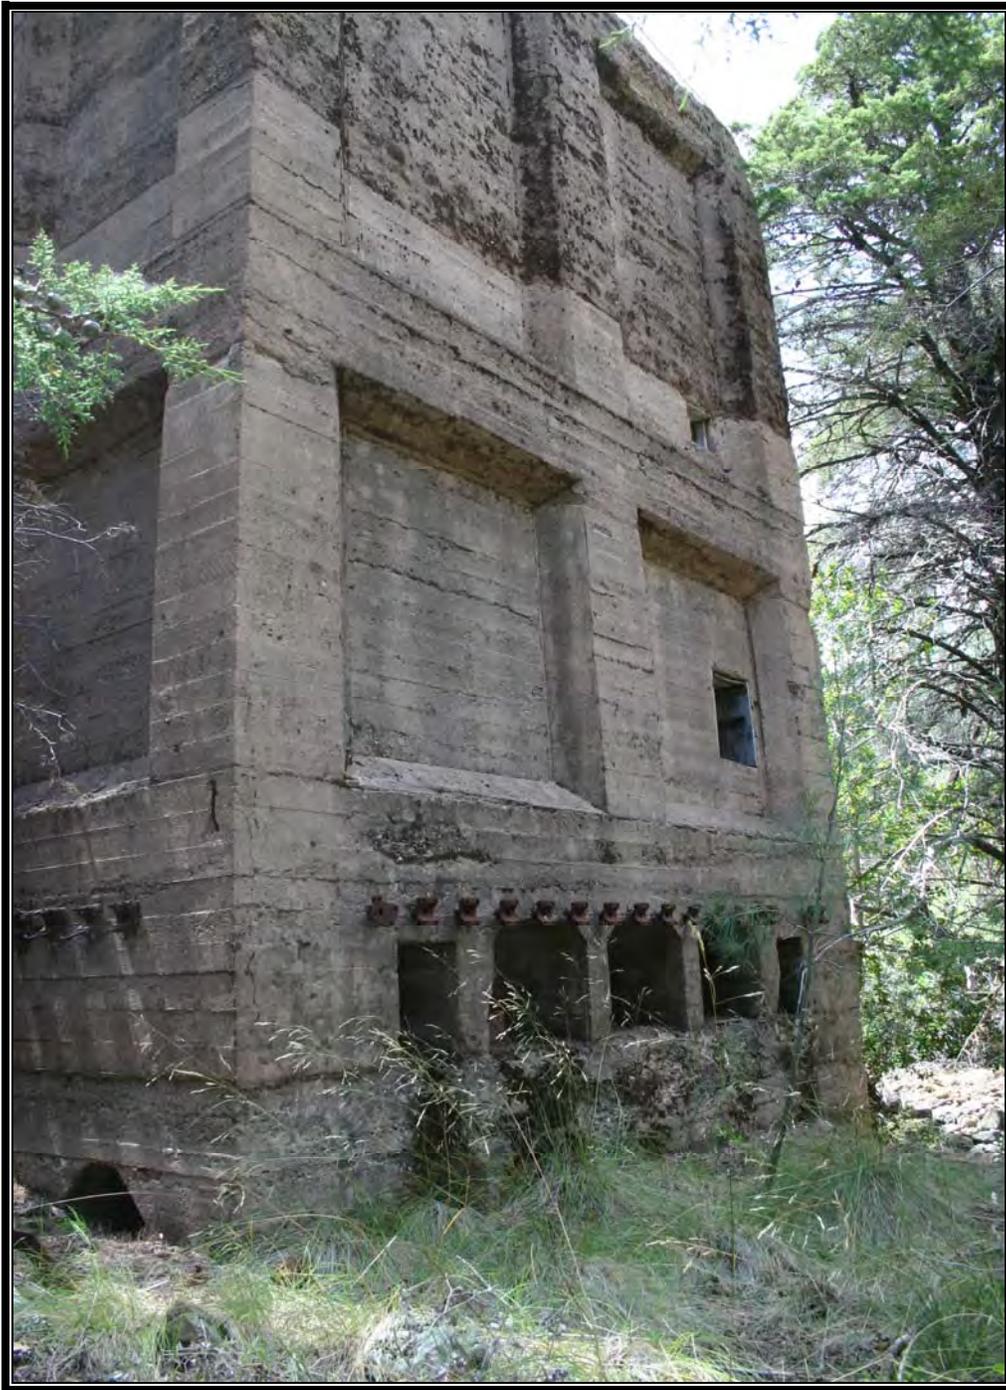
Photo No. 13: Upper Standing Furnace at Research Mine

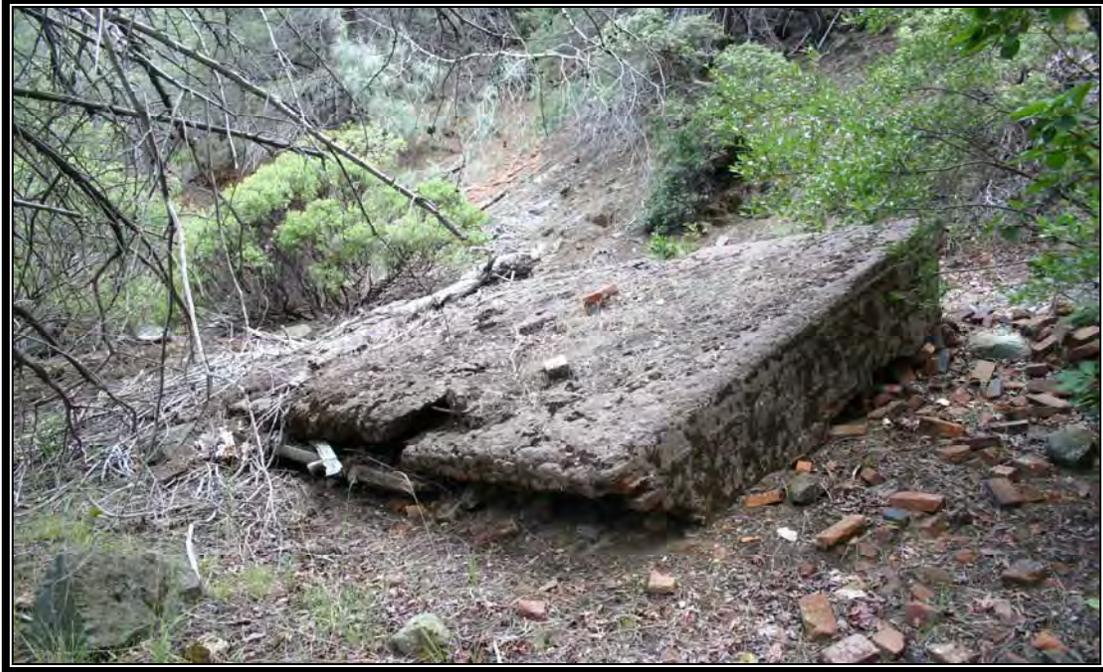
Photo No. 14: Collapsed Furnace at Research Mine

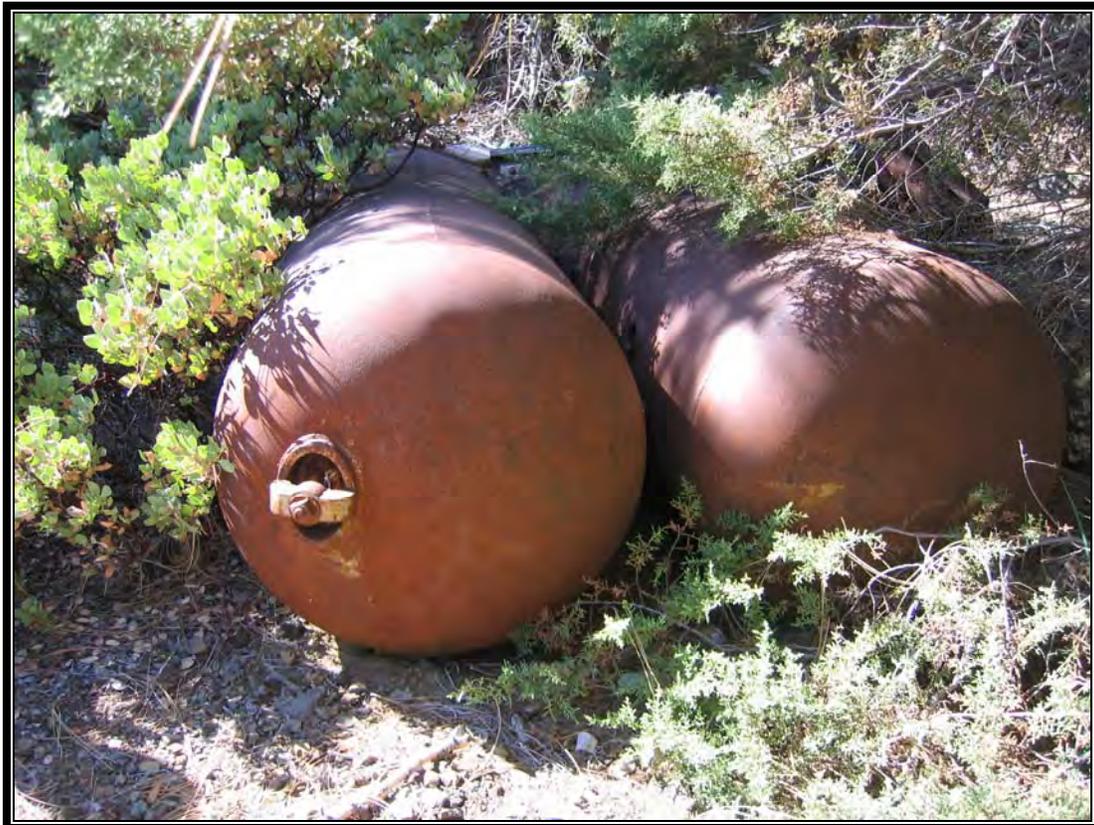
Photo No. 15: Compressor Tanks at the Research Mine

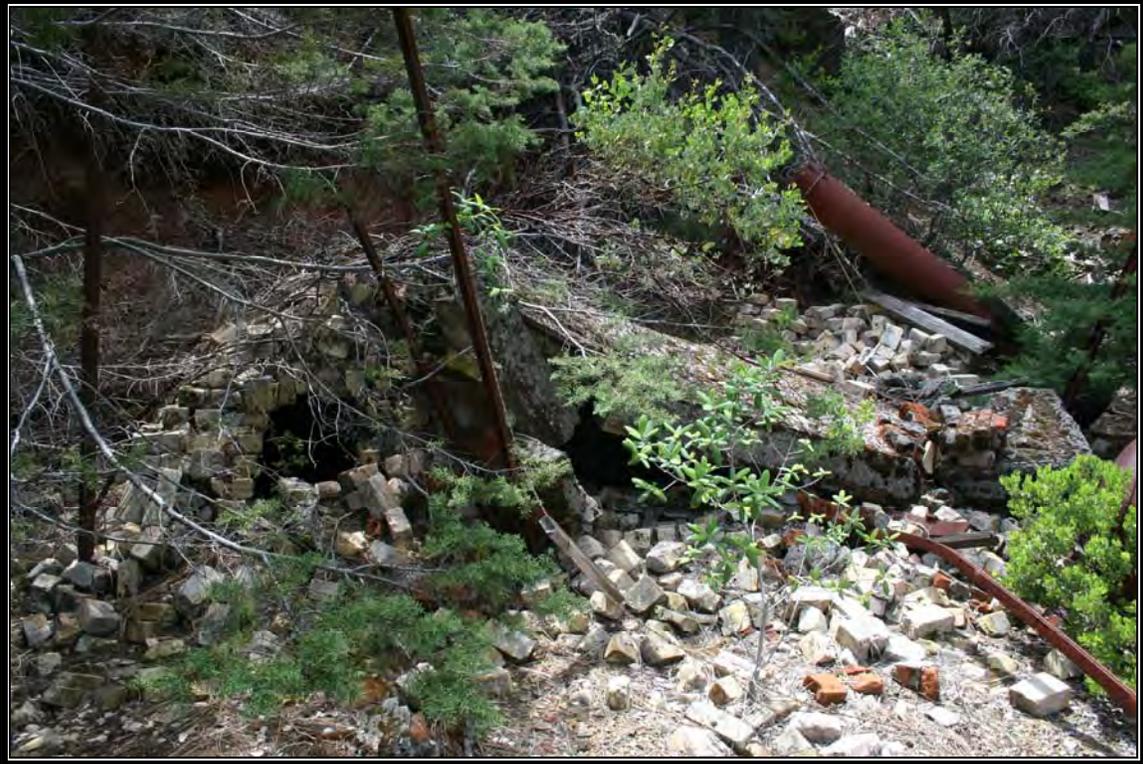
Photo No. 16: Lower Furnace at Research Mine

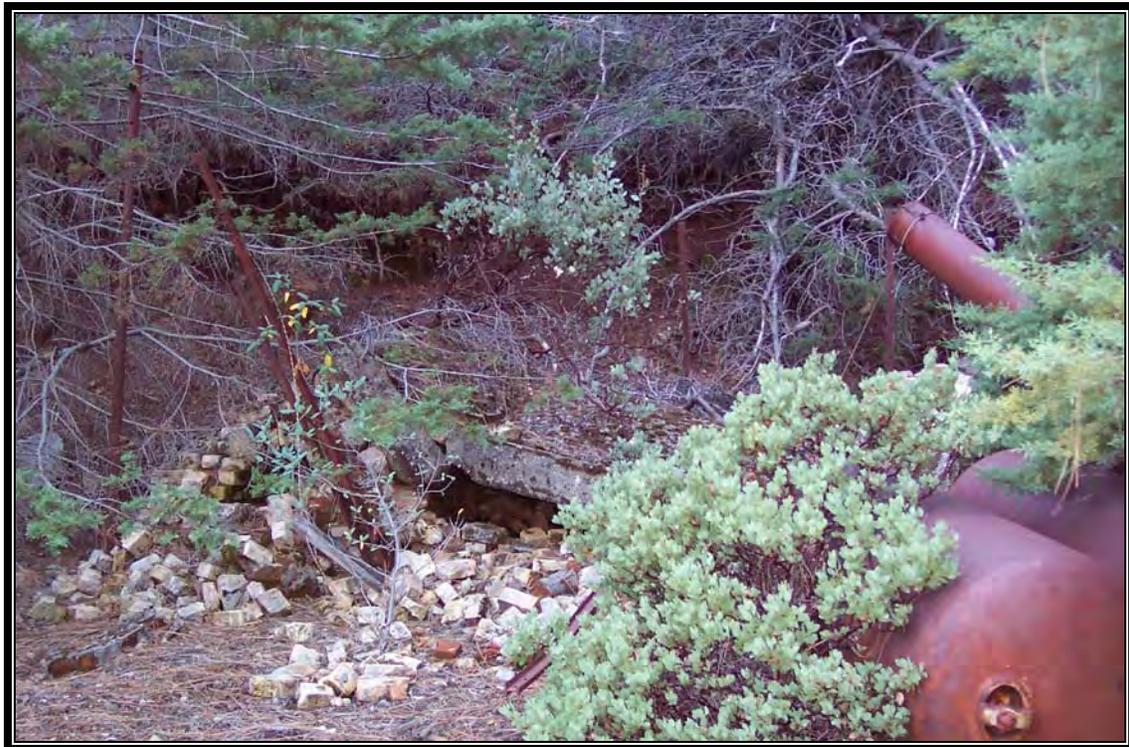
Photo No. 17: Compressor Tanks and Lower Adit at Research Mine

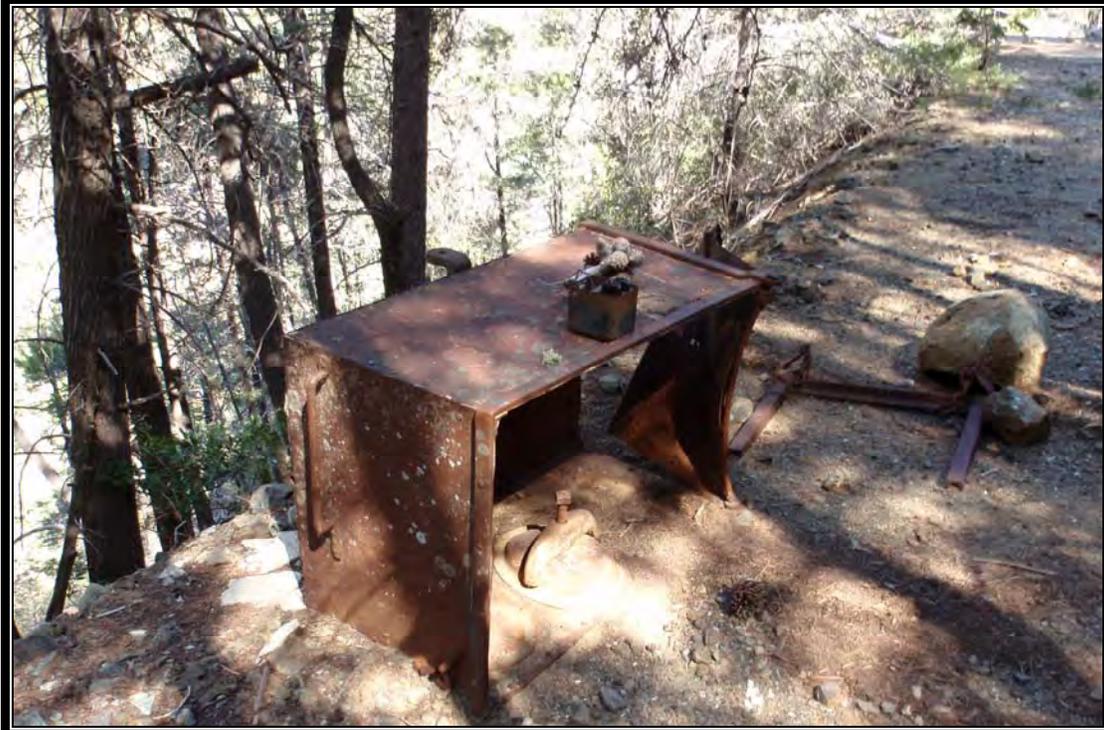
Photo No. 18: Ore Cart on Abandoned Mine Road at Research Mine

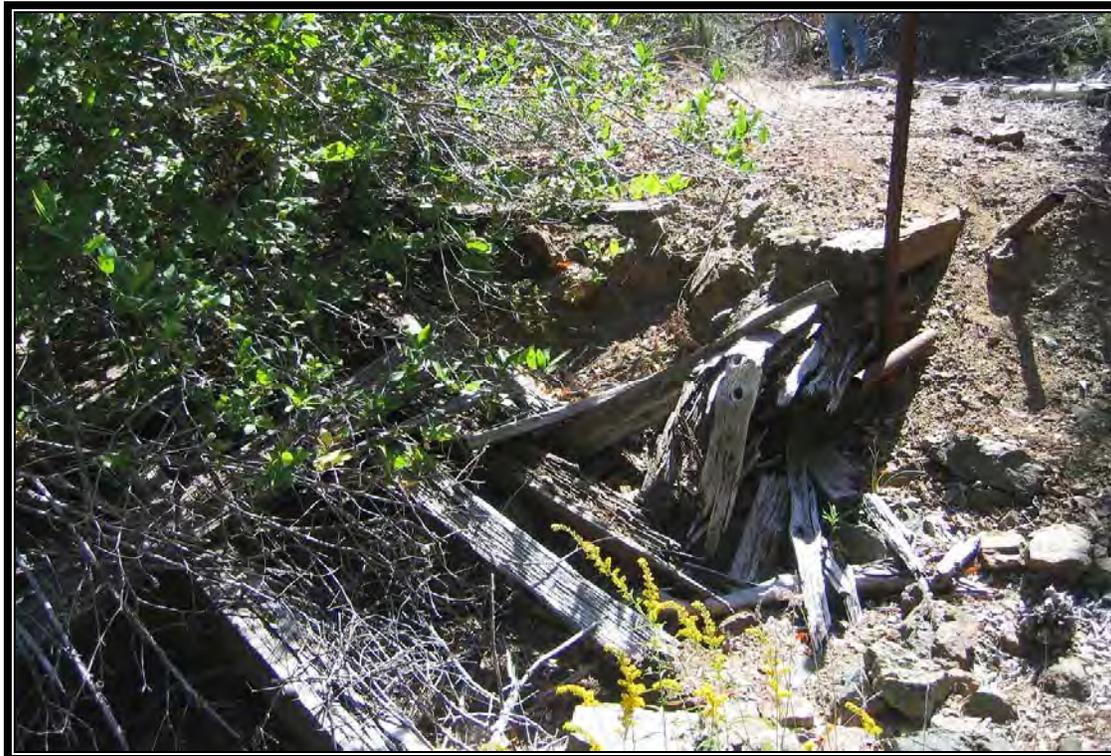
Photo No. 19: Bridge Abutment at Research Mine

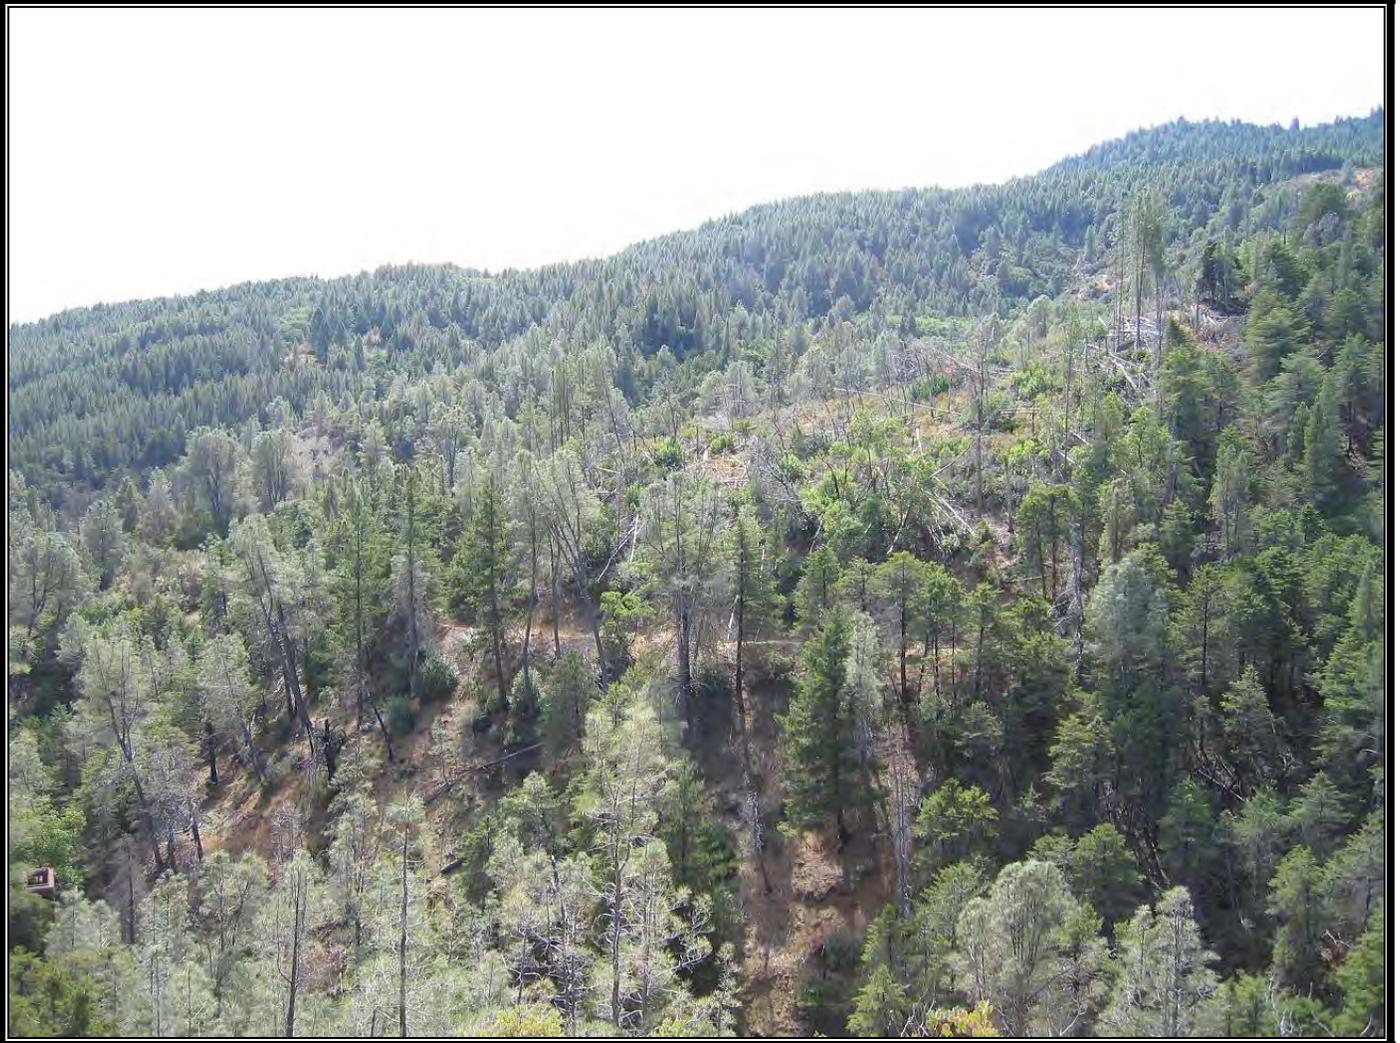
Photo No. 20: View of Main Access Road to Research Mine
