# Helen Mine Photographs

HELEN MERCURY MINE  
Lake County, California

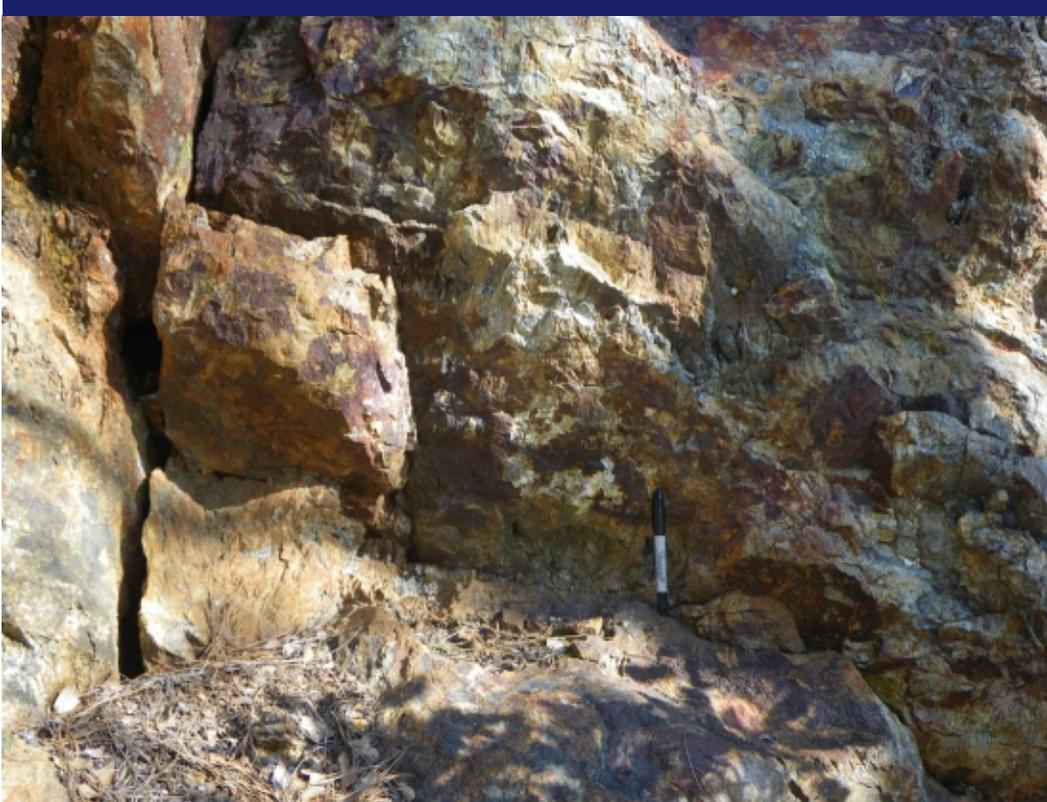
Photo 1 Location of background sample 01HM-BG.

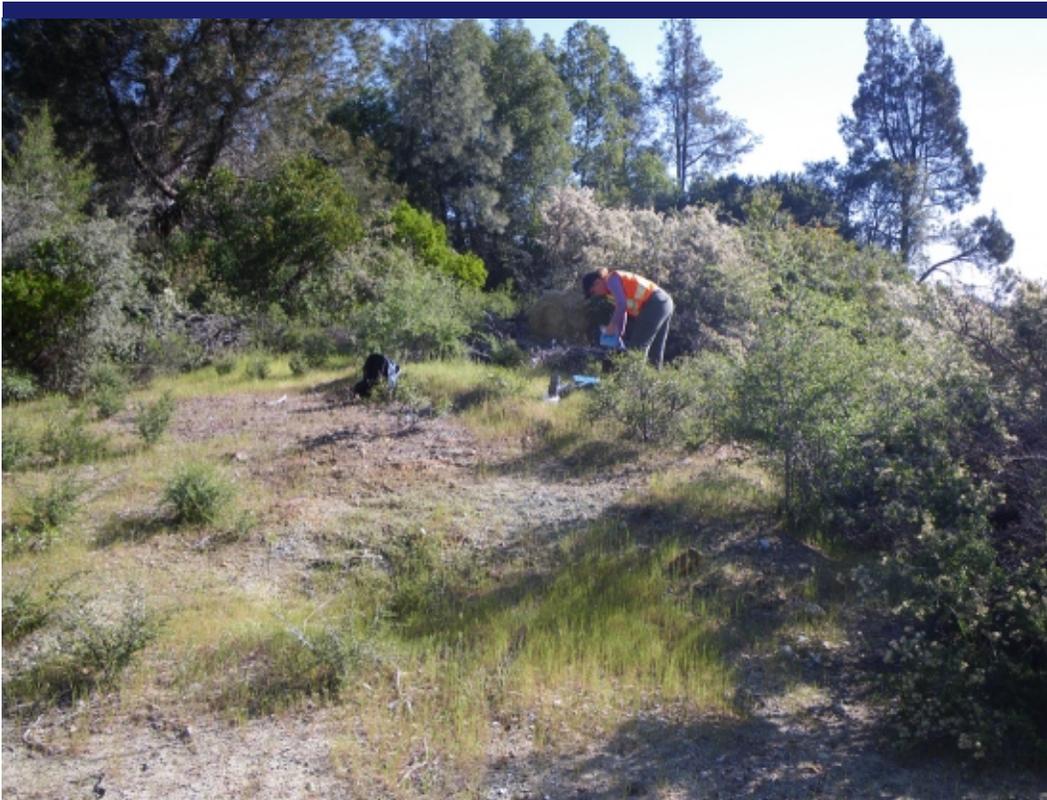
Photo 2 Location of background sample 02HM-BG.

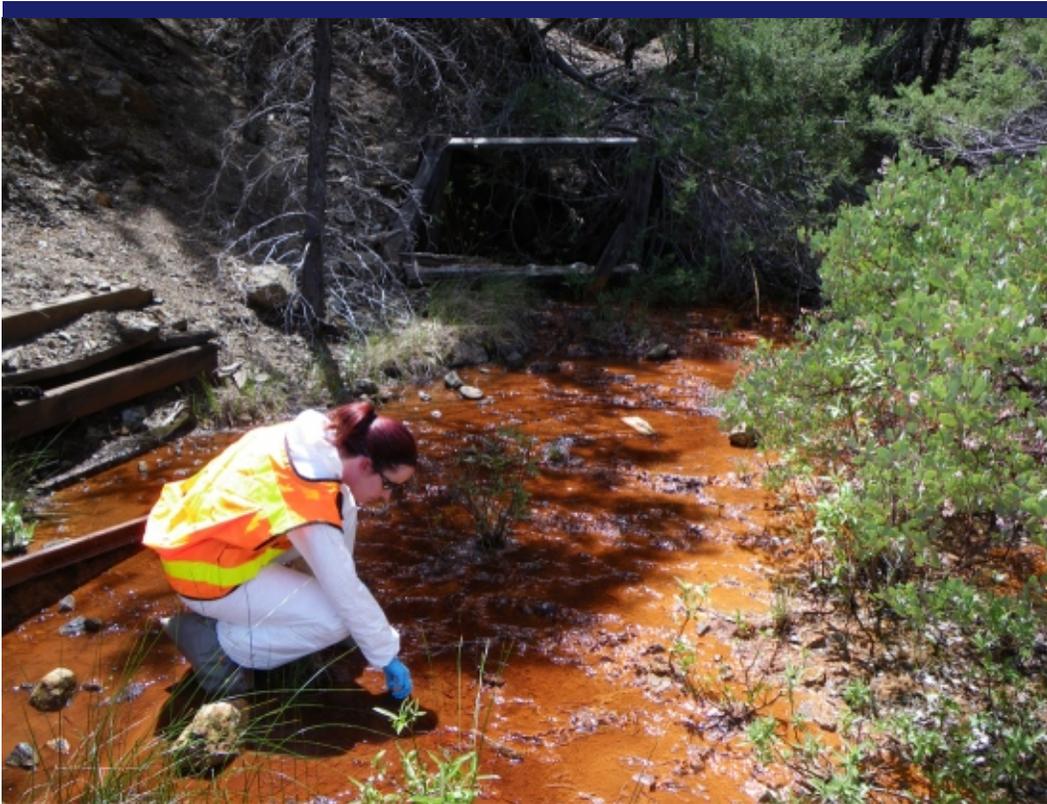
Photo 3 Collecting sample 01HM-SD at the main adit.

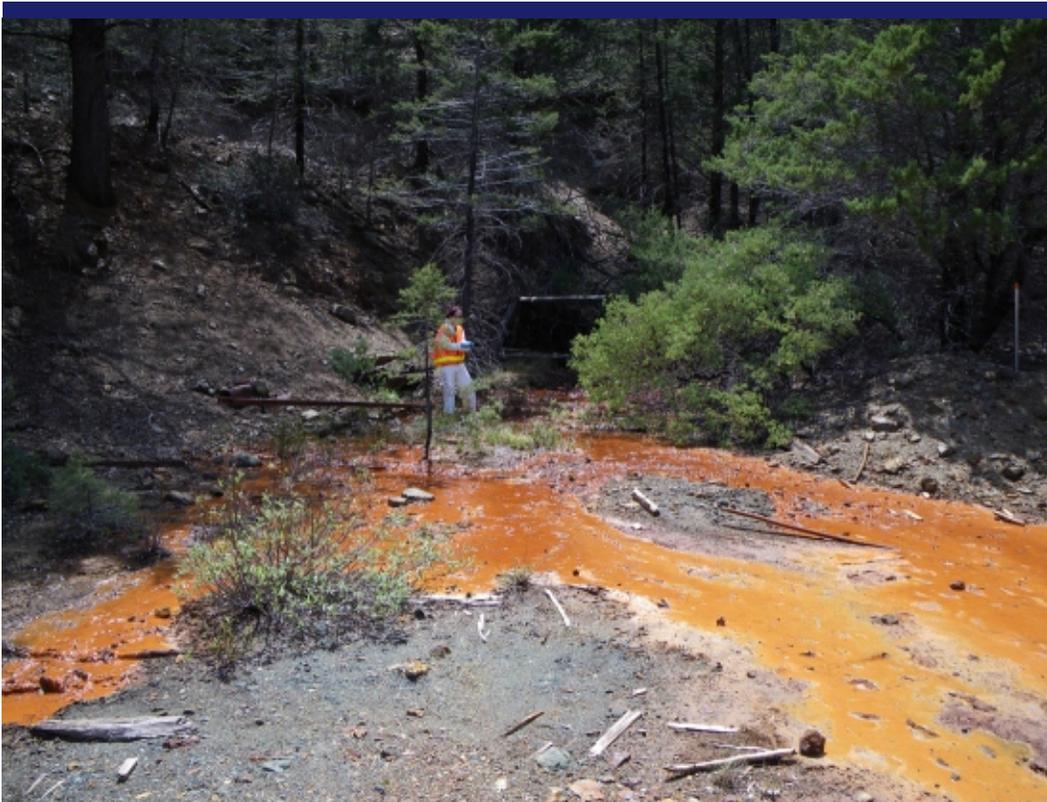
Photo 4 Collecting sample 01HM-SD at the main adit.

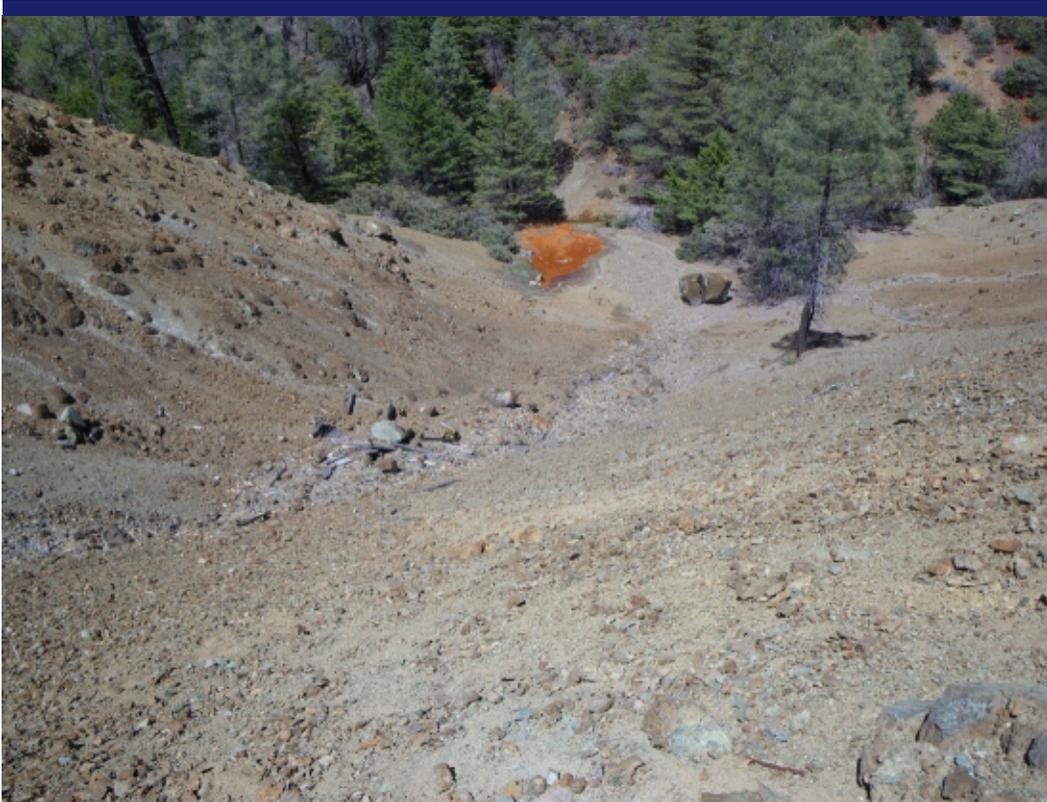
Photo 5 Looking down the southern disturbed area to the lower seep.

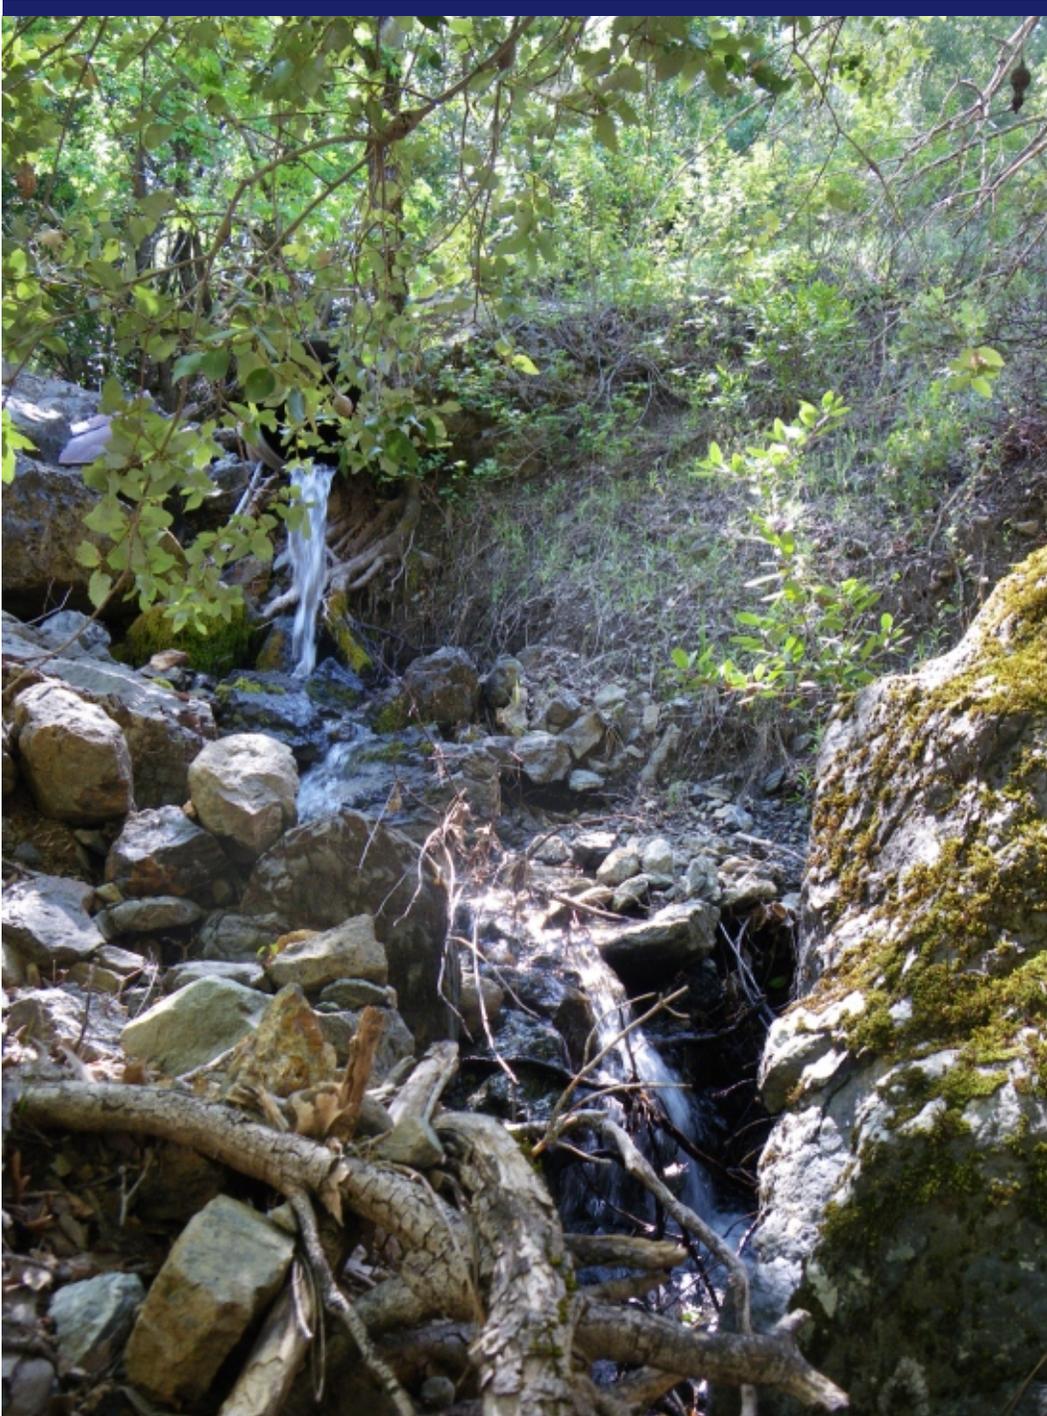
Photo 6 Looking up Helen Mine Tributary from the location of 02HM-SD.

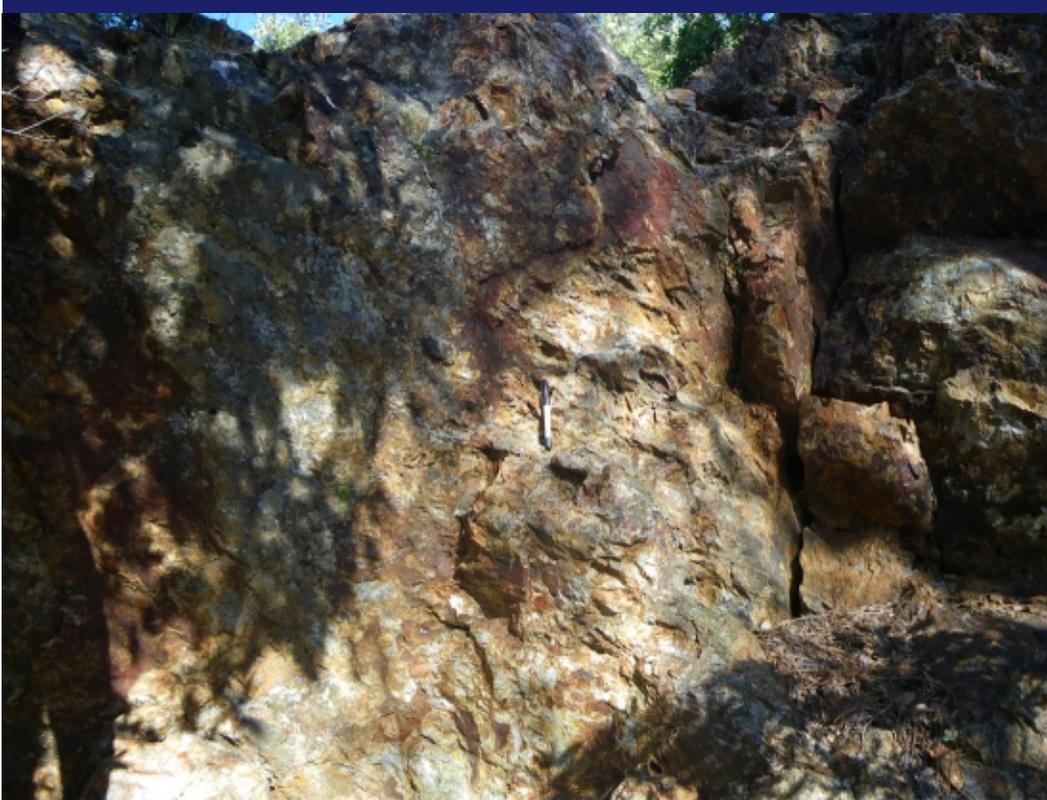
Photo 7 Outcrop of hydrothermally altered serpentinite next to location of 01HM-BG.

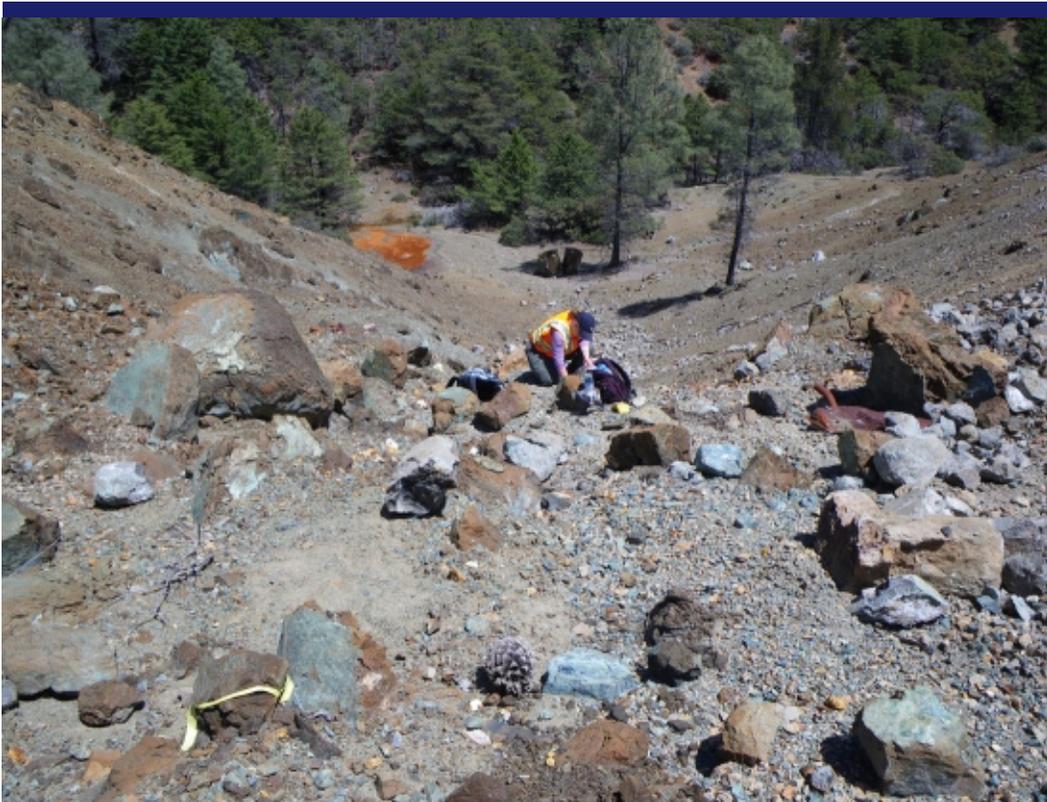
Photo 8 Looking down the drainage channel in the middle of the southern disturbed area. (Collecting sample 07HM-SS).

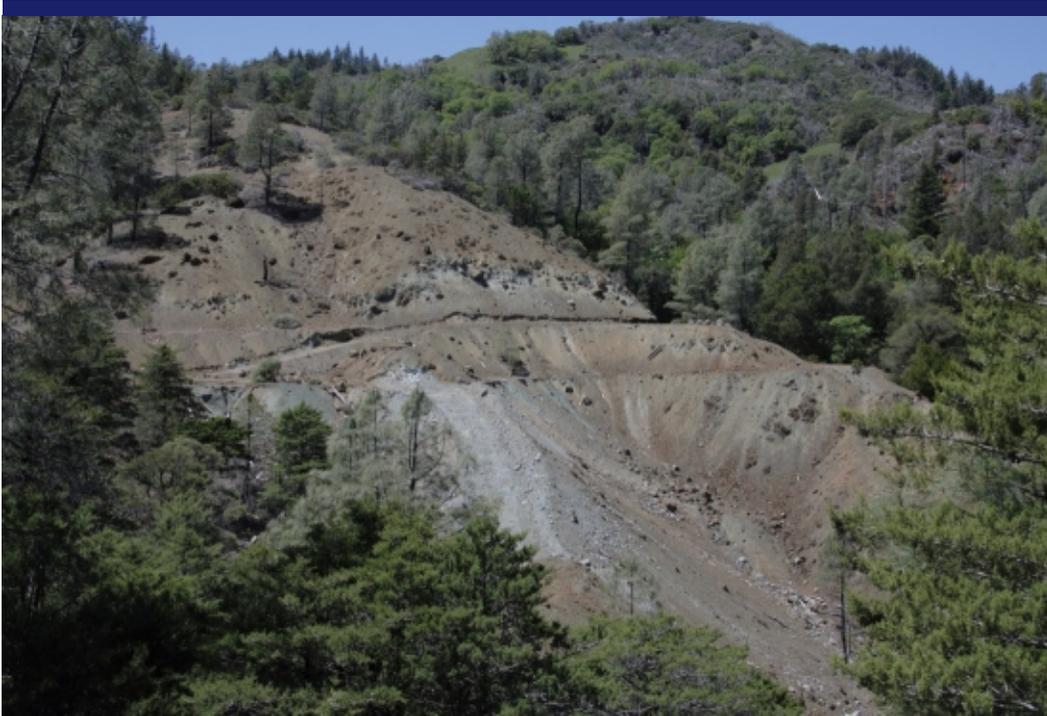
Photo 9 Overview of southern disturbed area at Helen Mine.

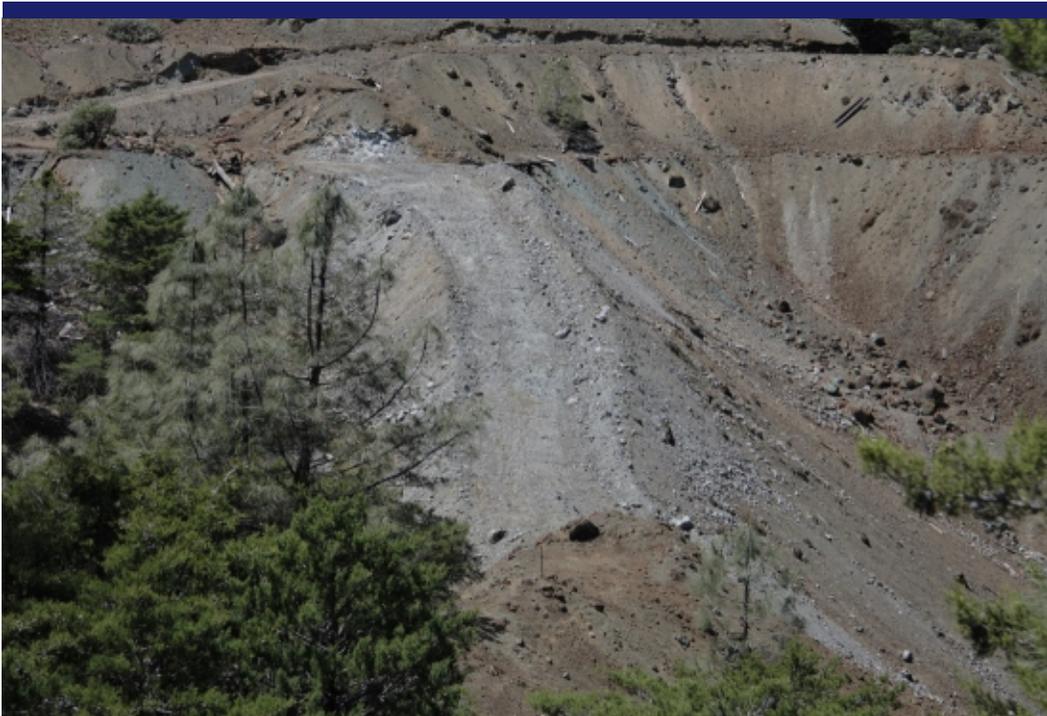
Photo 10 Soil boring 08HM-SB was installed at the top of ramp. Serpentinite was identified down to 30 feet below ground surface.

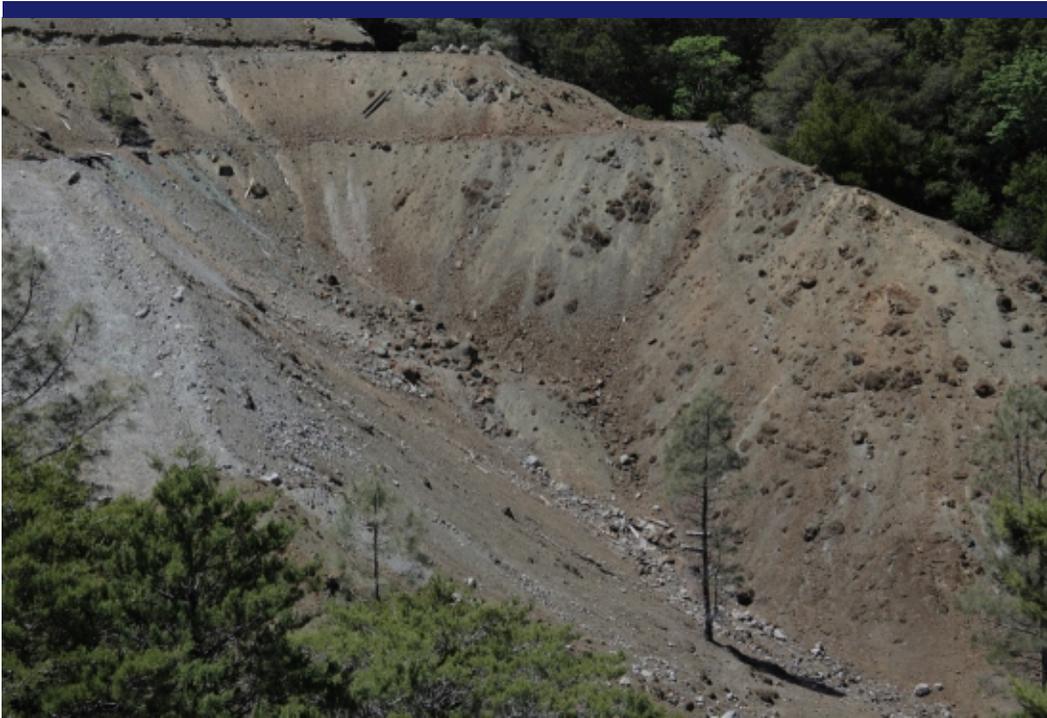
Photo 11 Soil sample 07HM-SS collected from the material in the bottom of the valley indicated elevated levels of mercury.

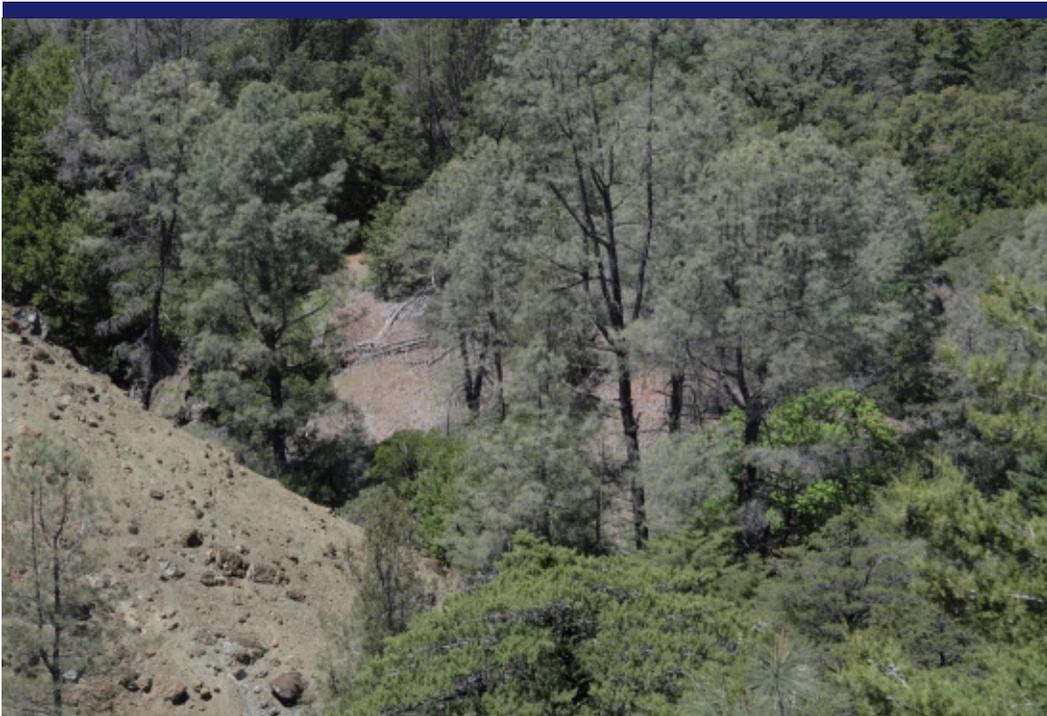
Photo 12 Red-brown colored soil is the middle tailings pile.

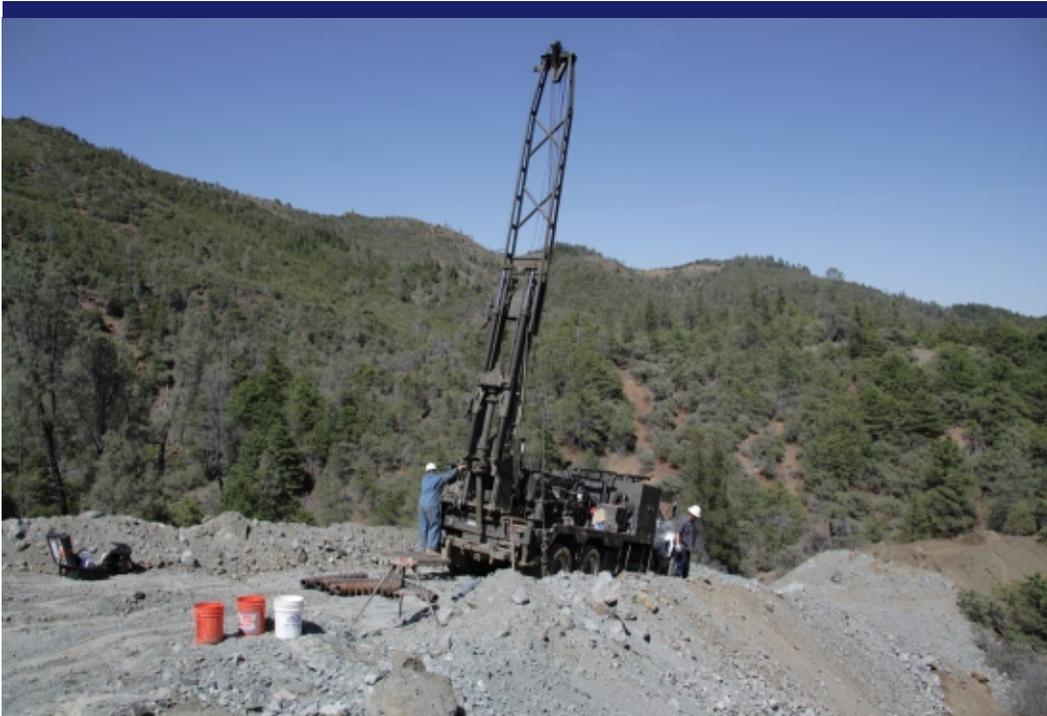
Photo 13 Location of soil boring 08HM-SB.

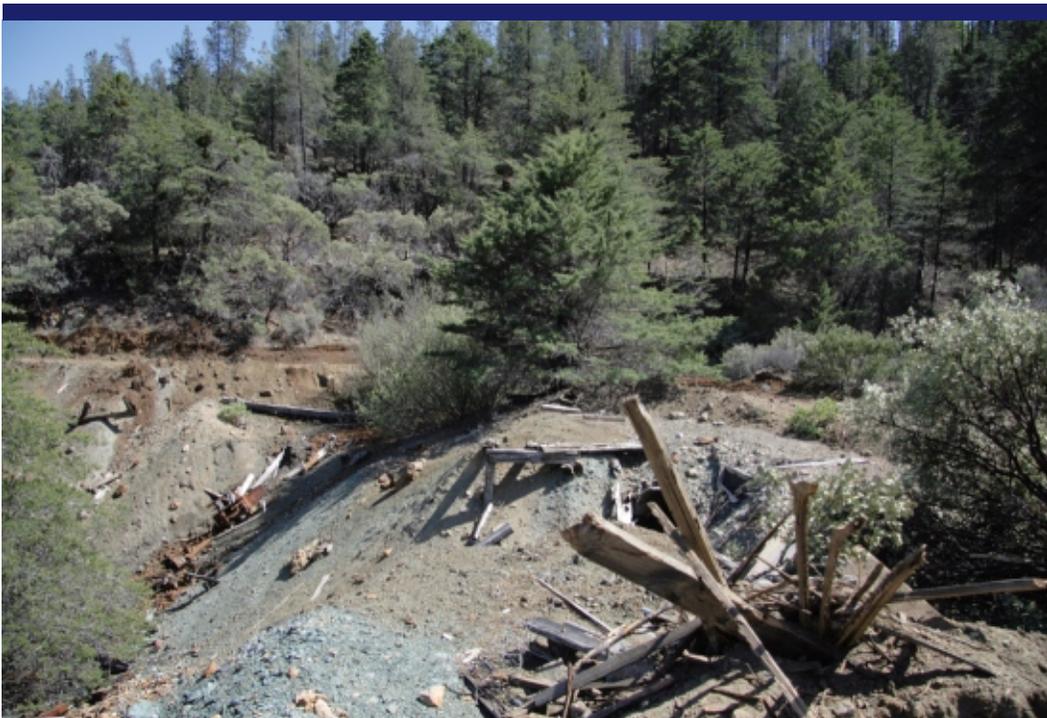
Photo 14 Debris present at the wash that originates from the main adit.

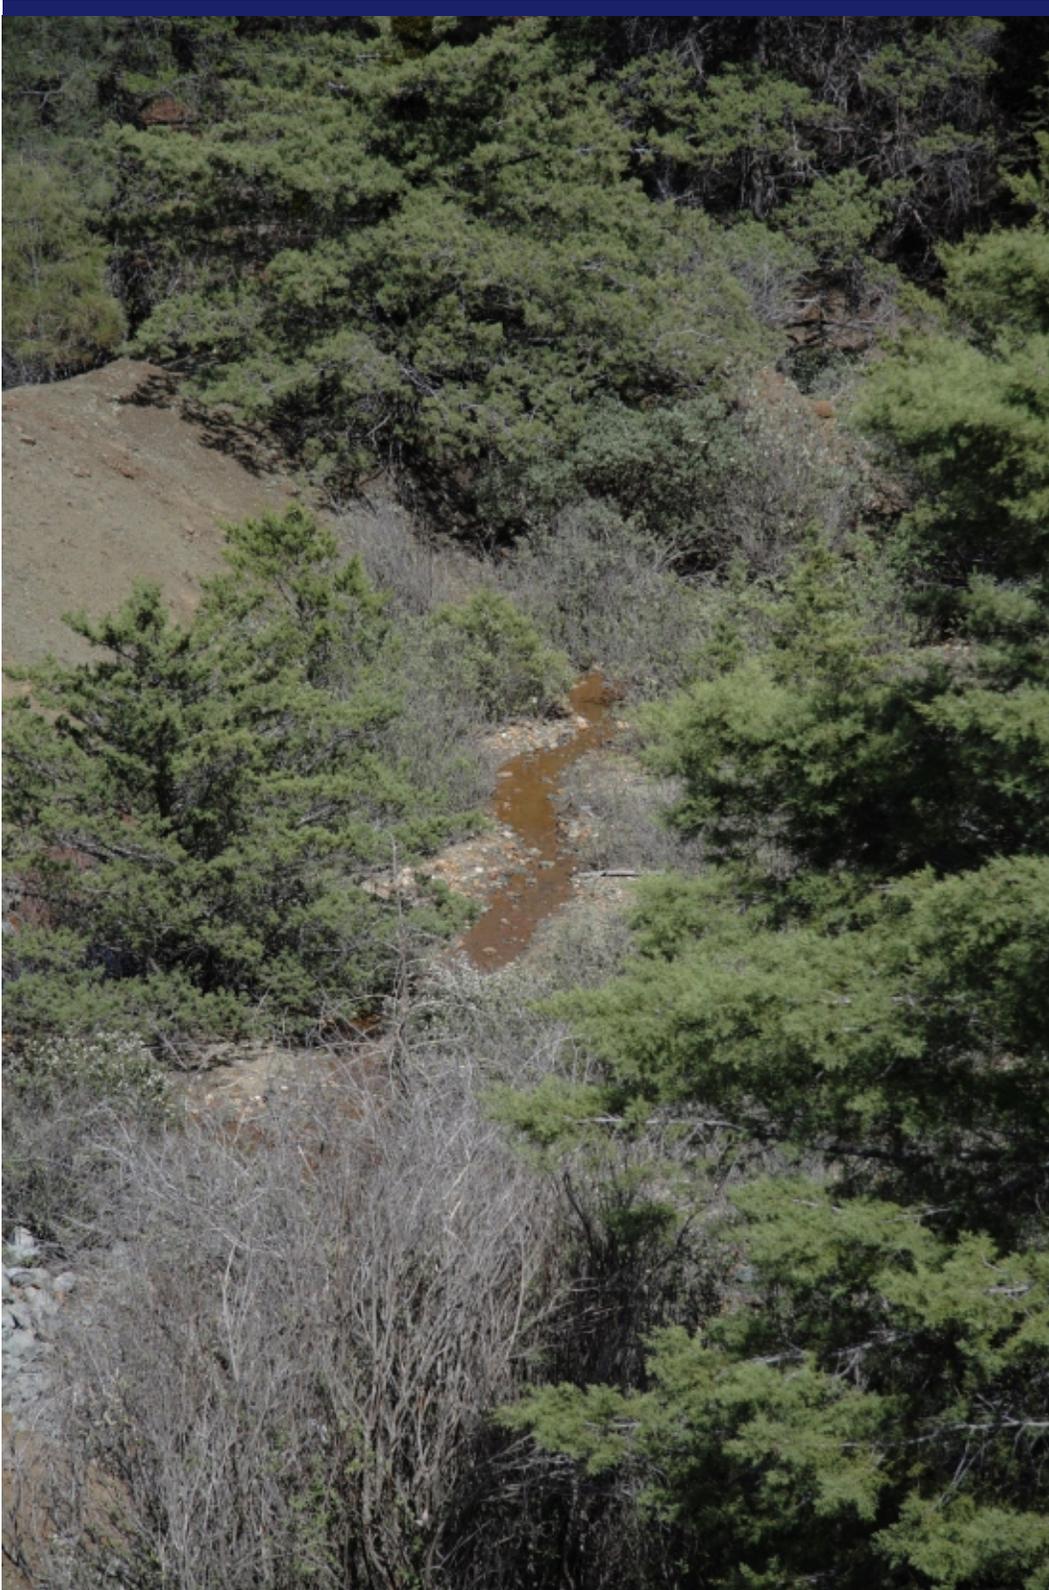
Photo 15 Yellow Boy is present in the wash that originates from the main adit.

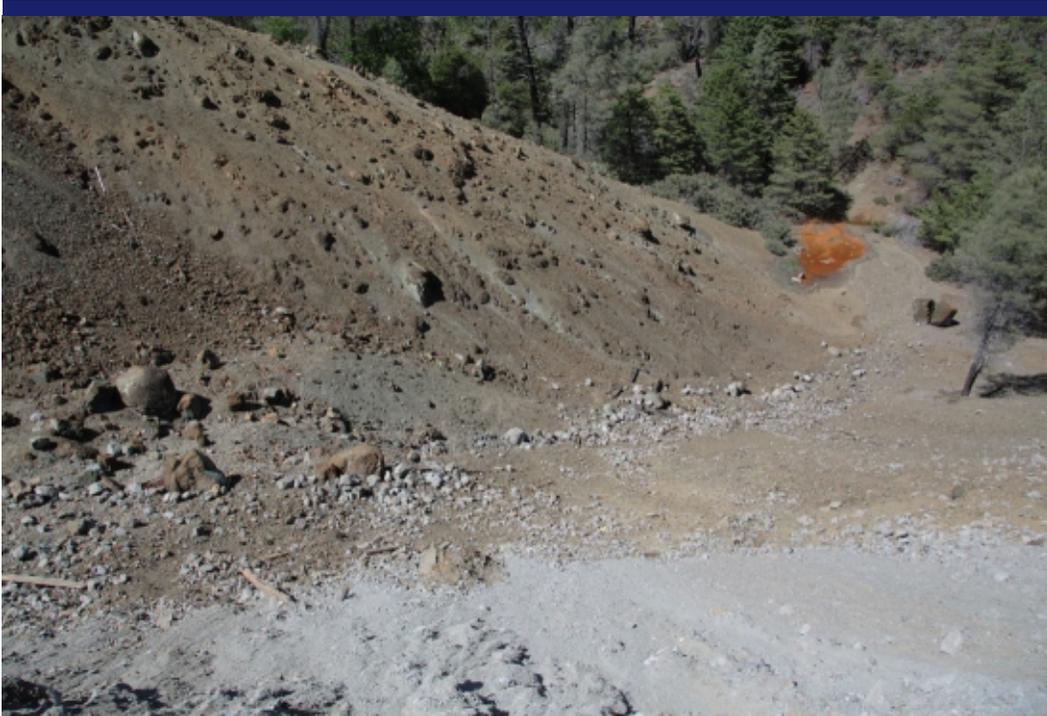
Photo 16 Yellow Boy is present at the bottom of the wash between the two ridges at the southern disturbed area.

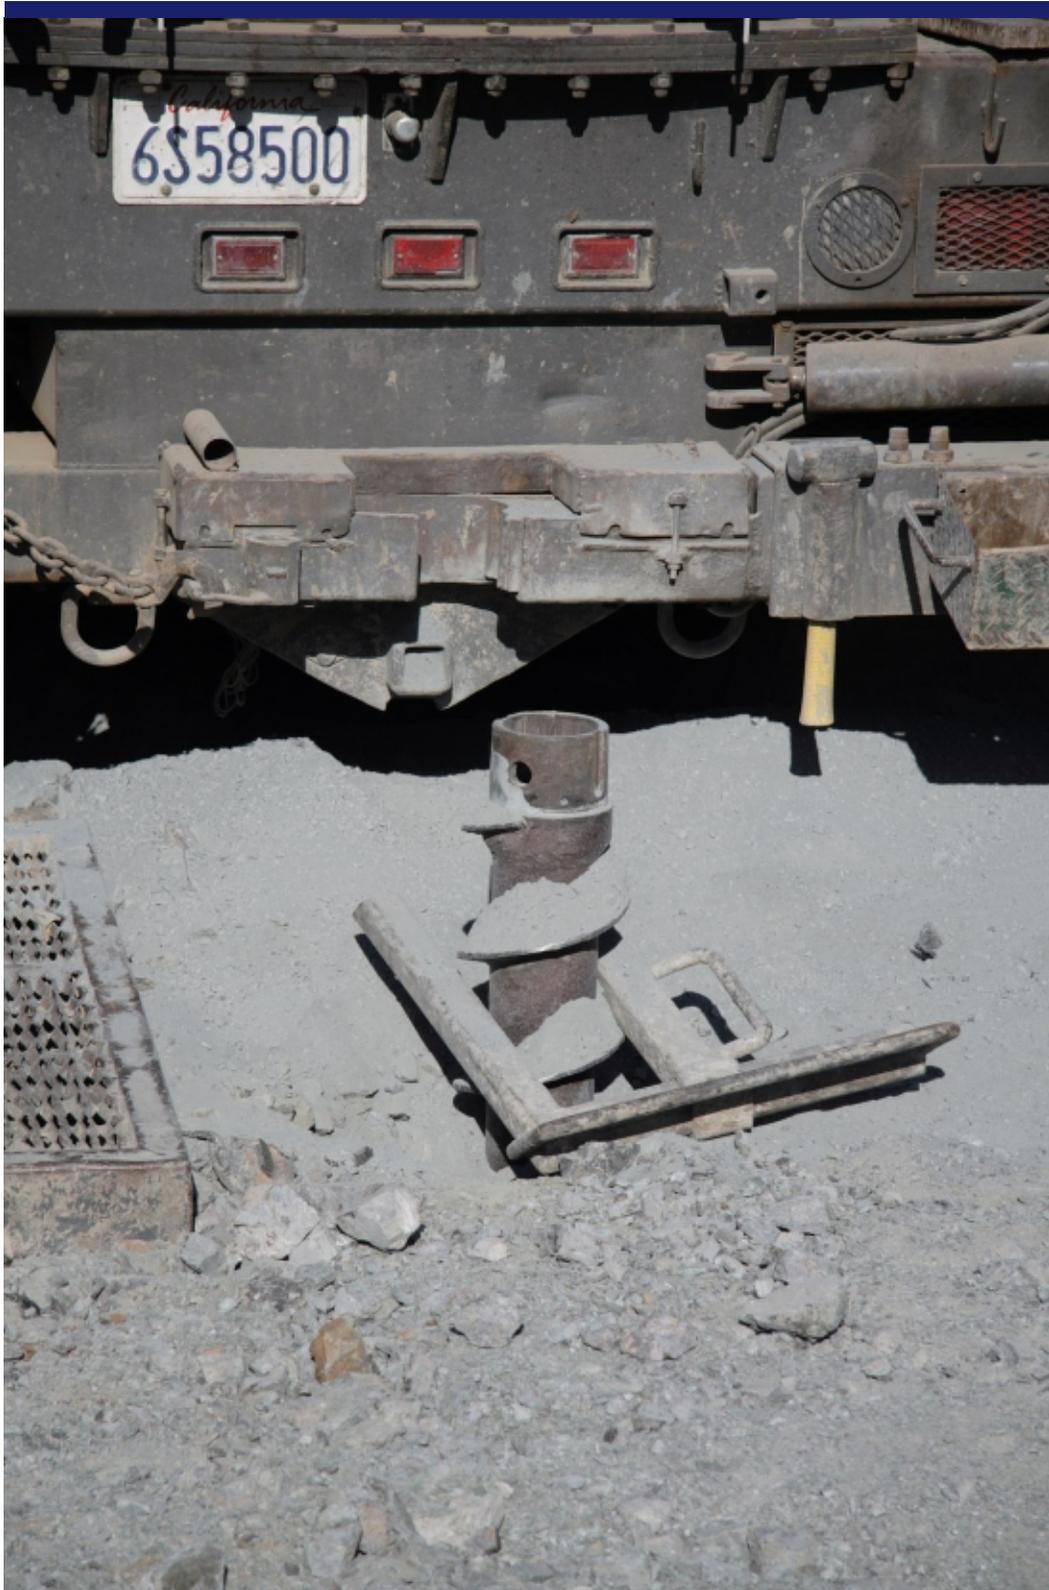
Photo 17 Fine gray drill cuttings at soil boring 08HM-SB are indicators of drilling in serpentinite bedrock.

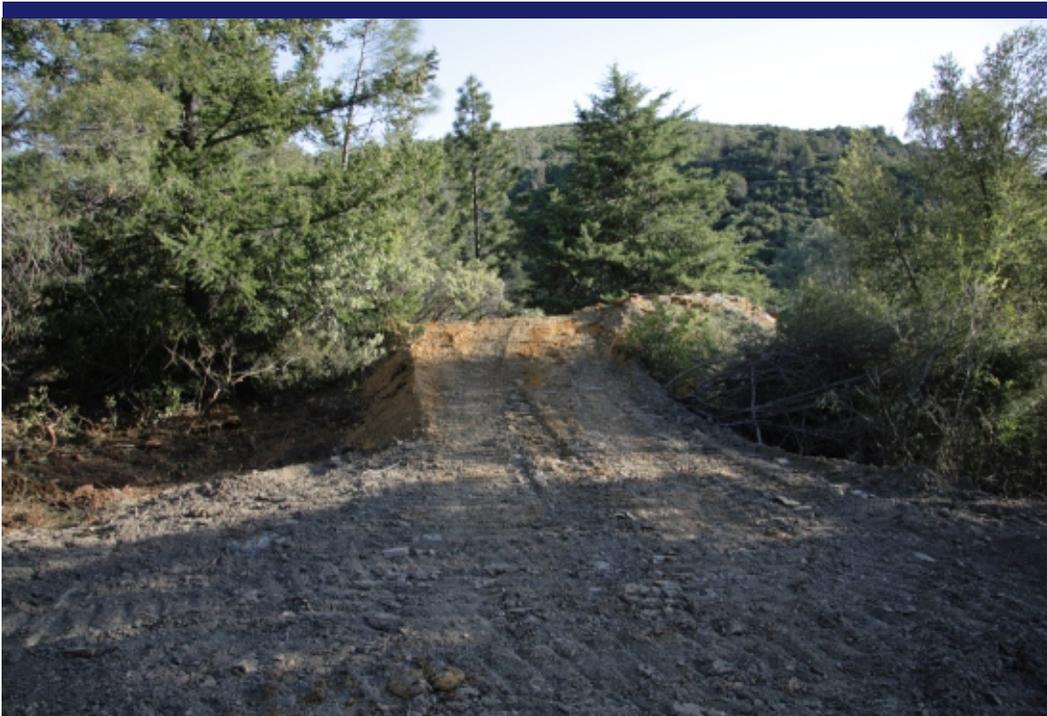
Photo 19 Soil boring 02HM-SB was installed at the top of the northern tailings pile.

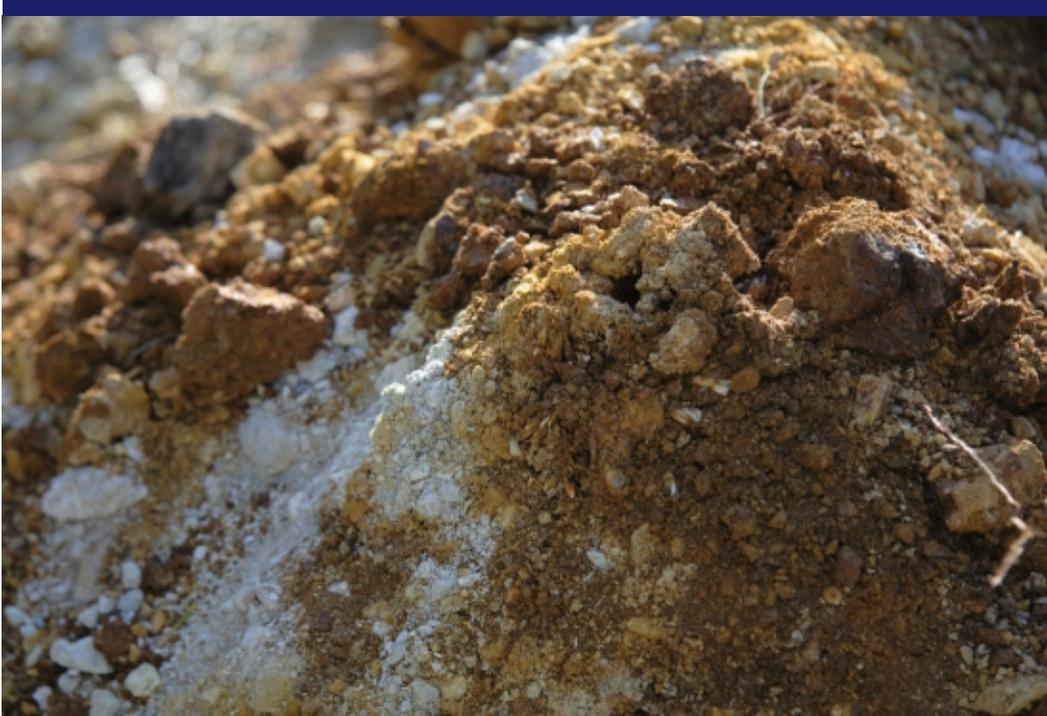
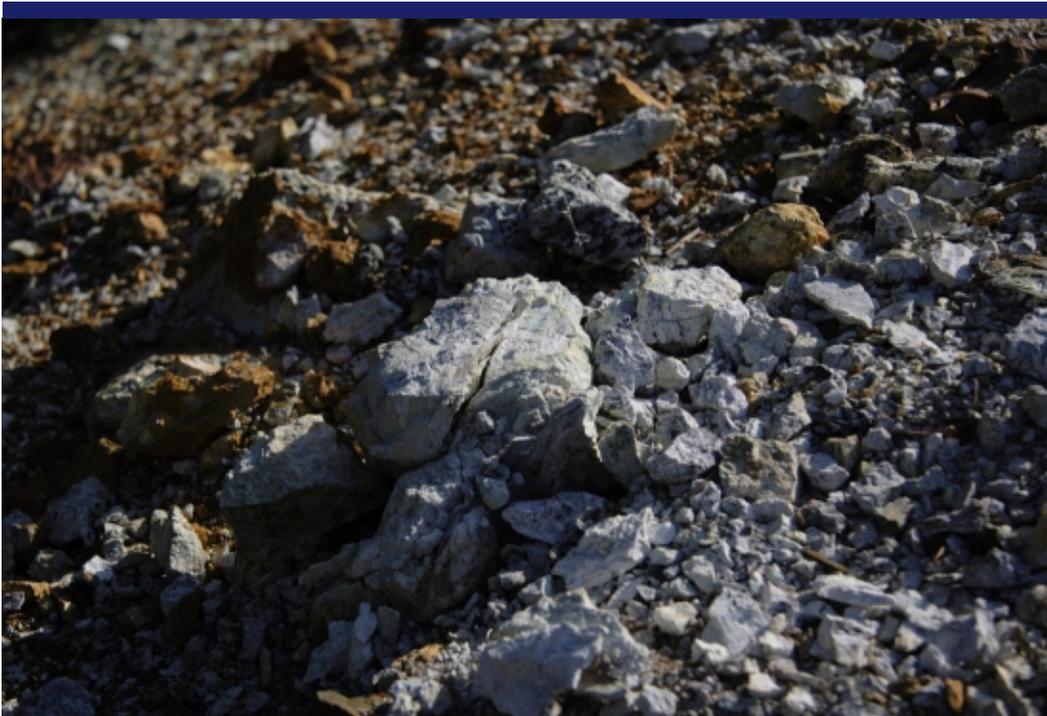
Photo 20 Close-up view of the "cooked" tailings.

Photo 21 Close-up view of the "cooked" tailings.

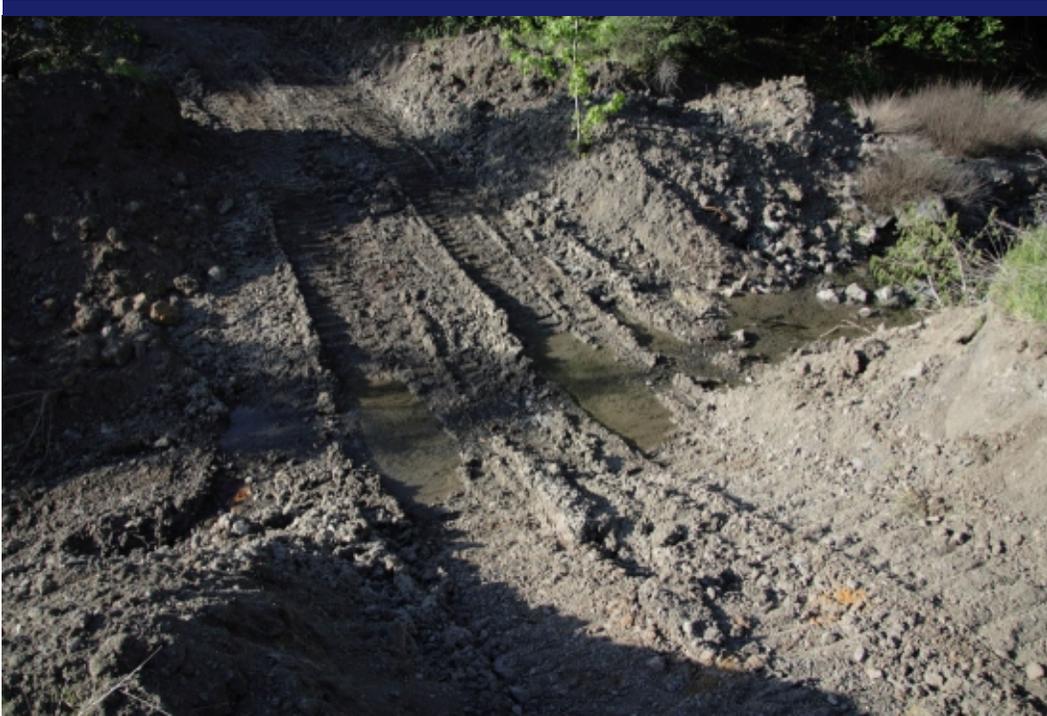
Photo 22 Serpentinite at the bottom of this soil core indicates the tailings - native material interface.

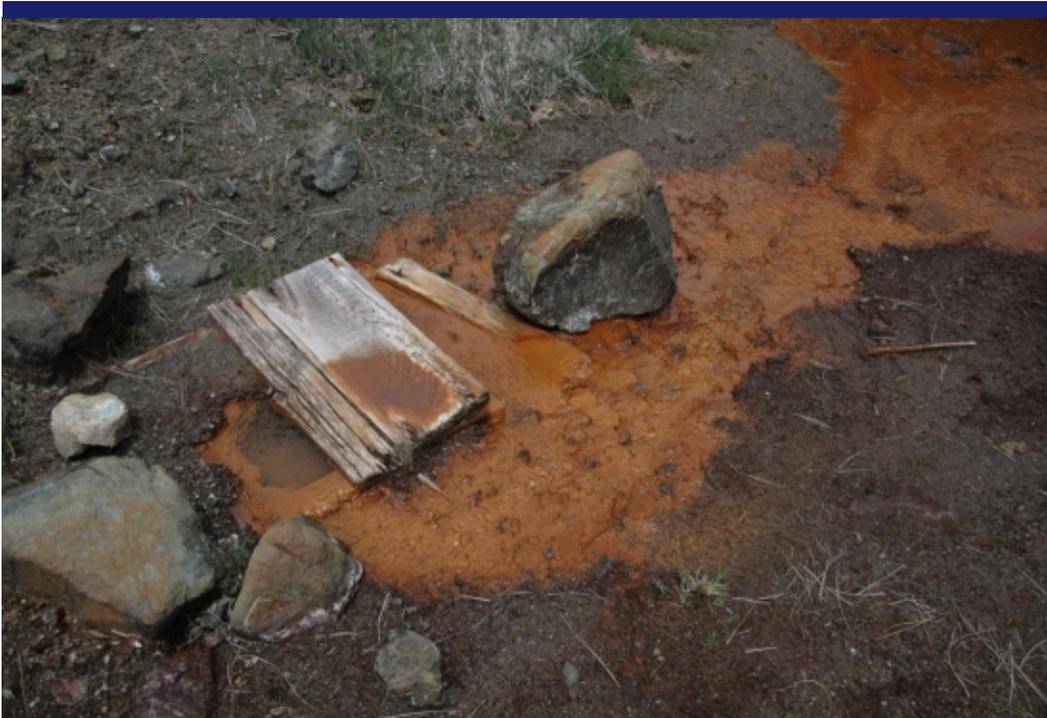
Photo 26 Source of the seep present at the bottom of the southern disturbed area.

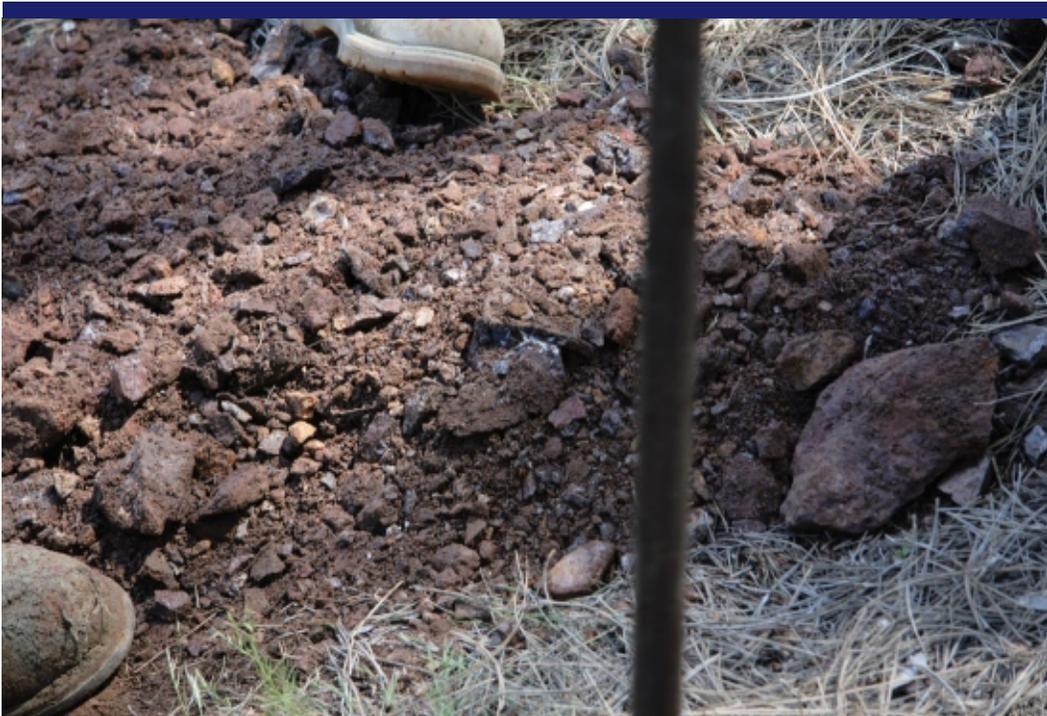
Photo 29 Hand auger cuttings from soil boring 05HM-SB.

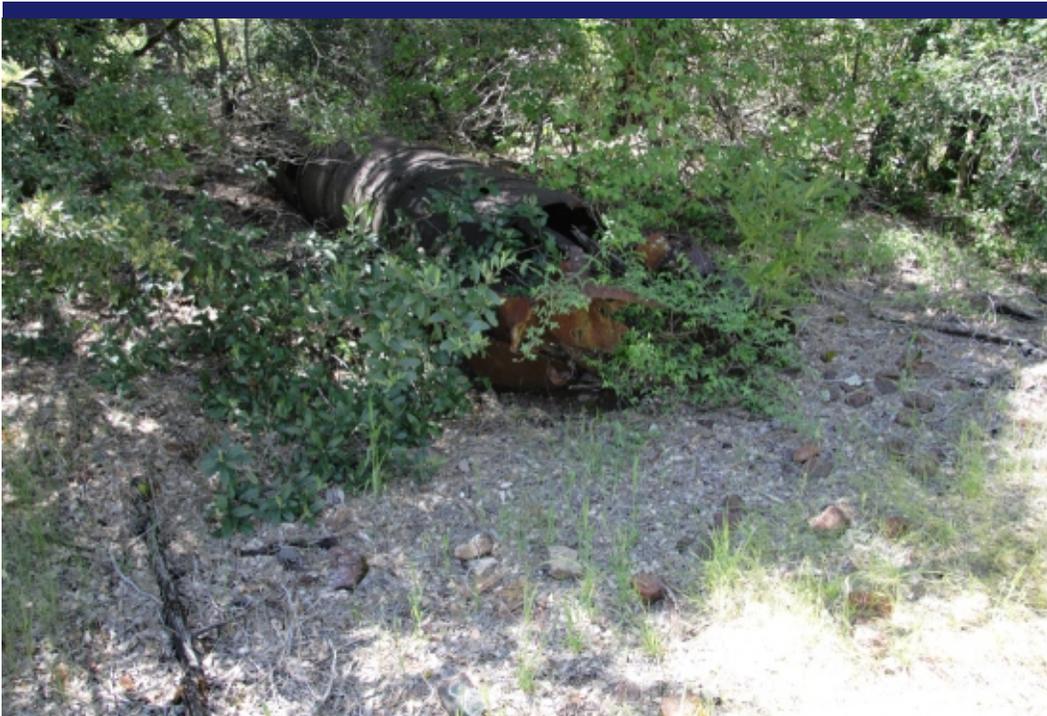
Photo 32 Area where rusted "Storage Tanks" are present.

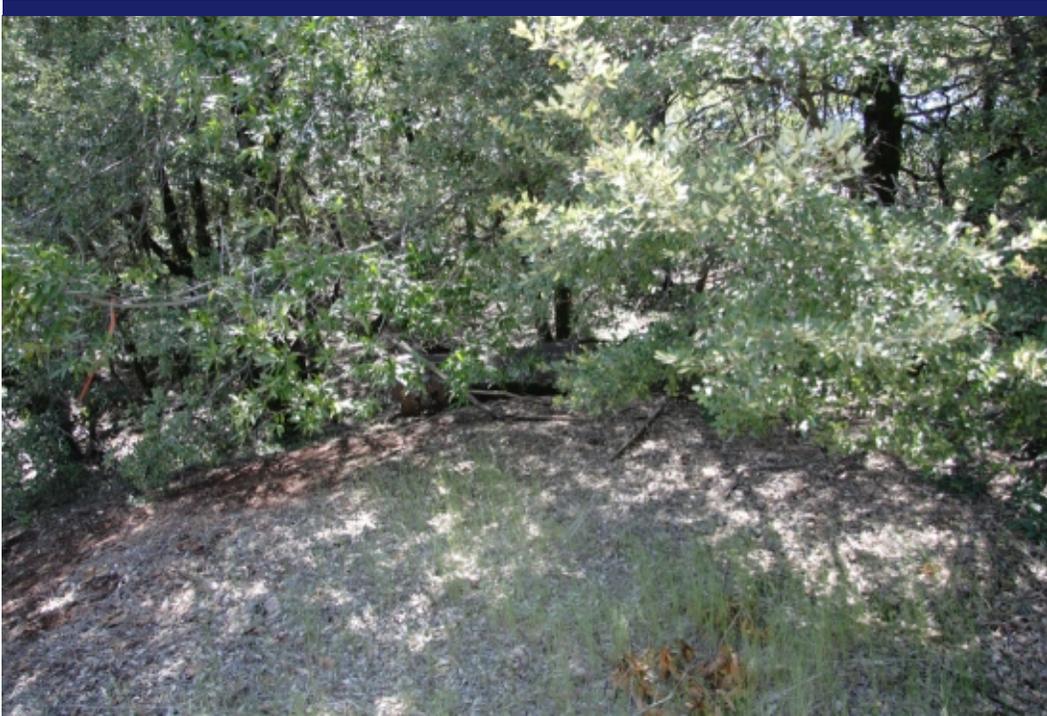
Photo 33 Area where rusted "Storage Tanks" are present.
