# Helen Mine Photographs

HELEN MERCURY MINE  
Lake County, California

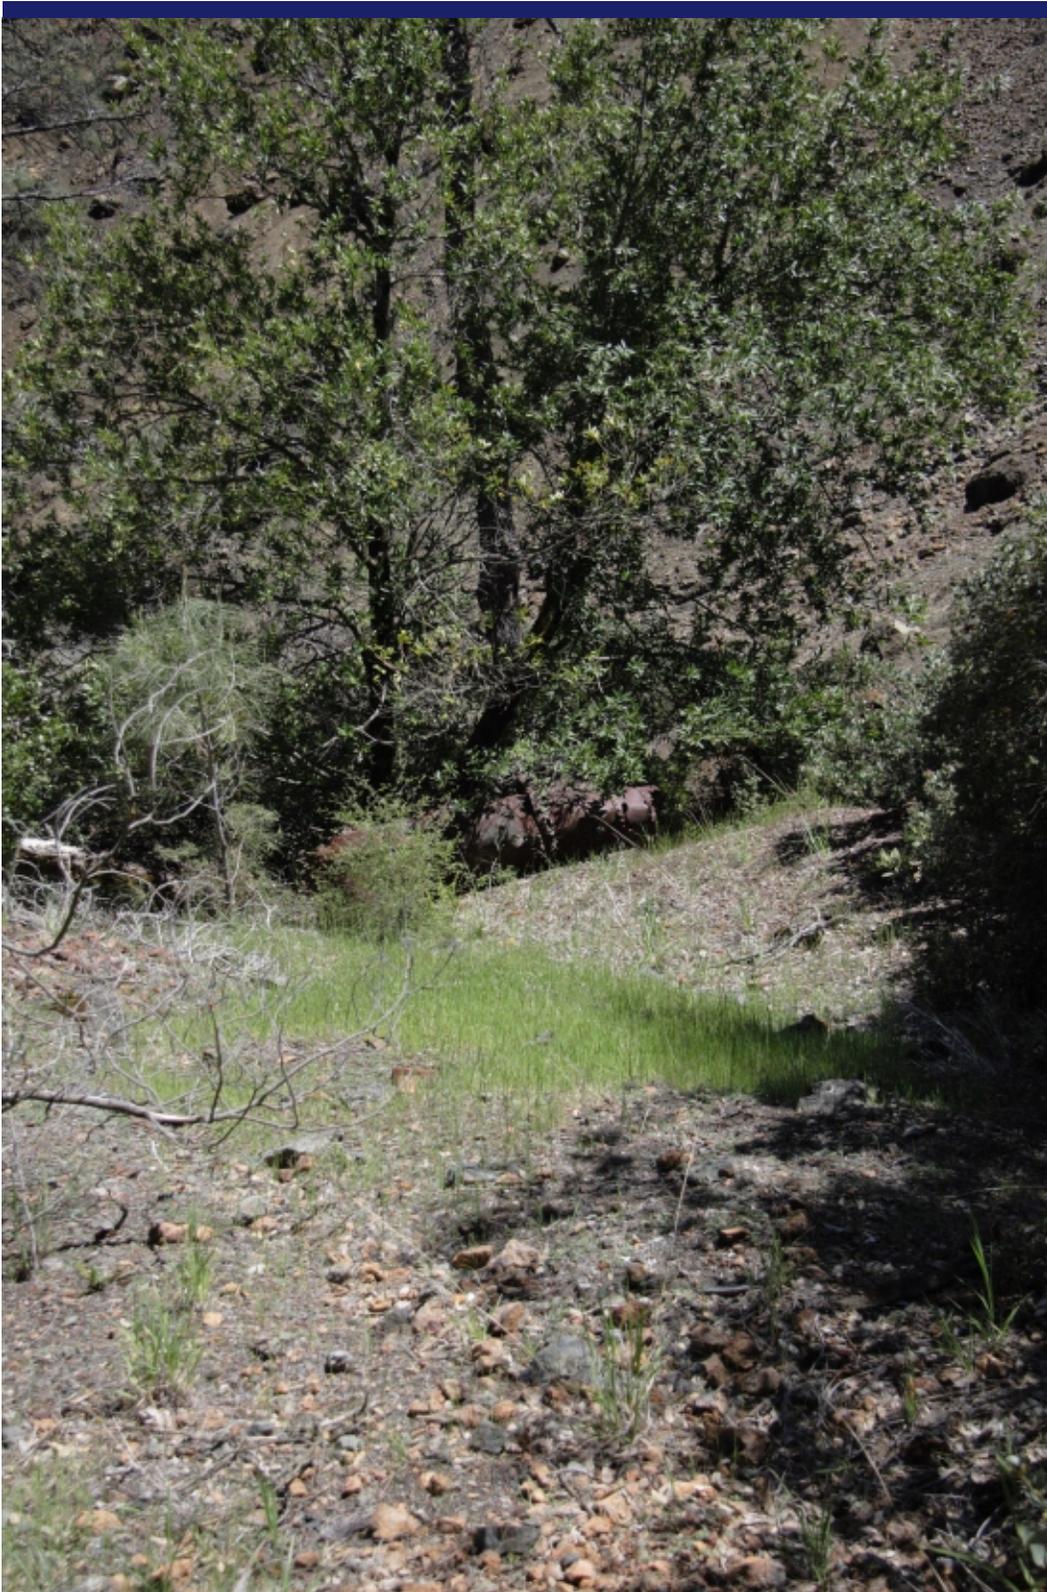
Photo 34 Area where rusted "Storage Tanks" are present.

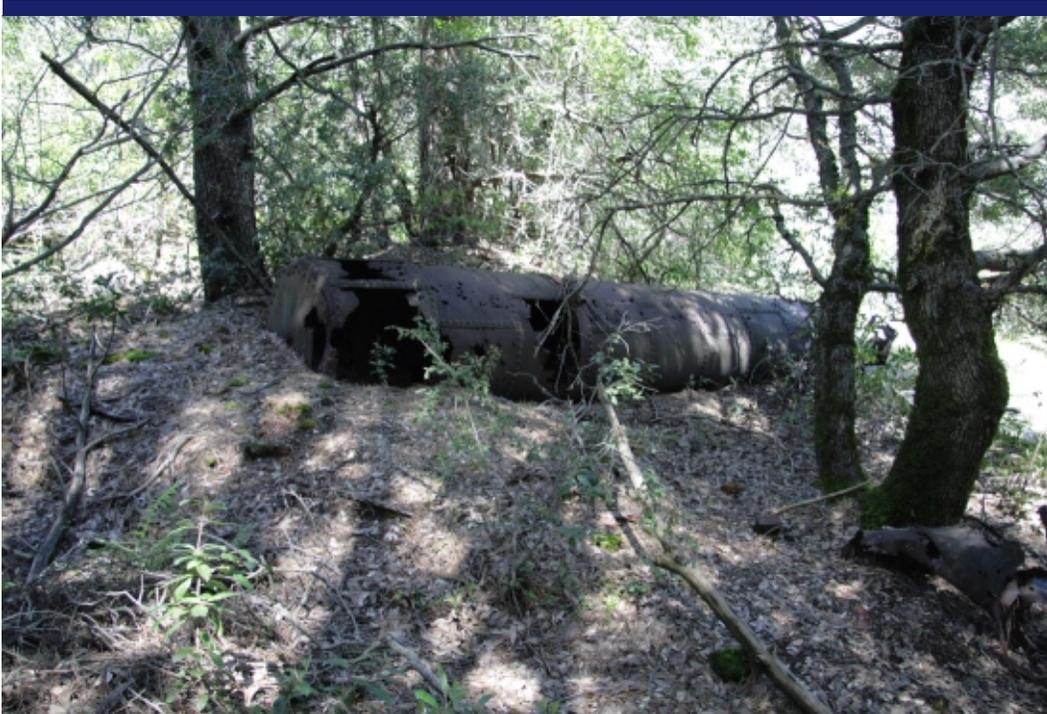
Photo 35 Area where rusted "Storage Tanks" are present.

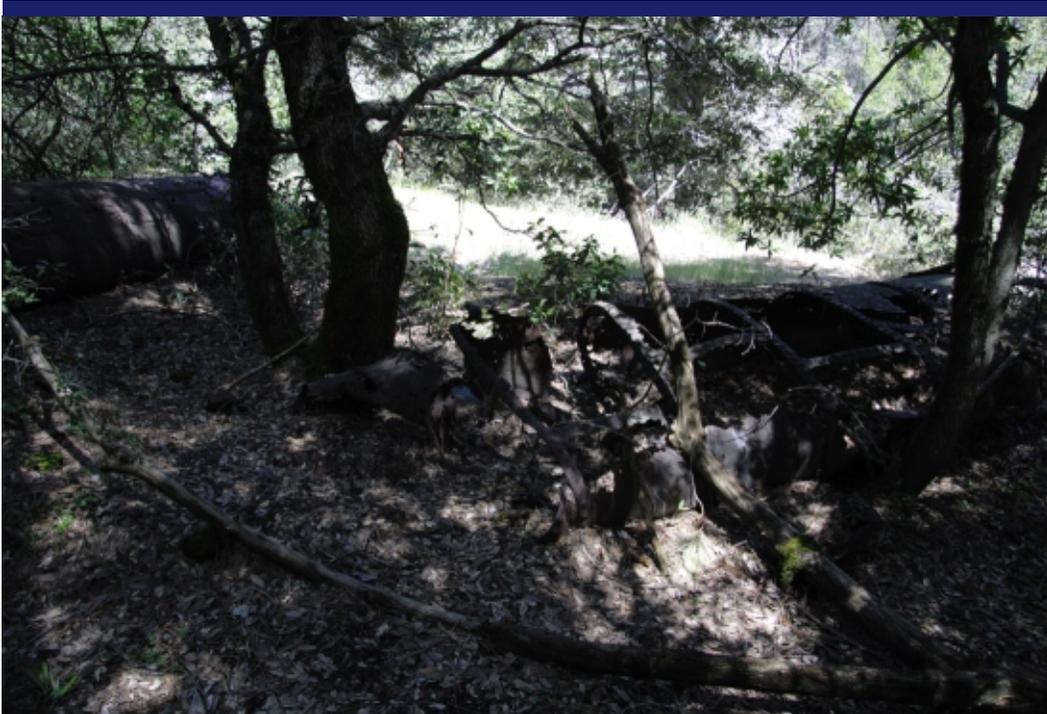
Photo 36 Area where rusted "Storage Tanks" are present.

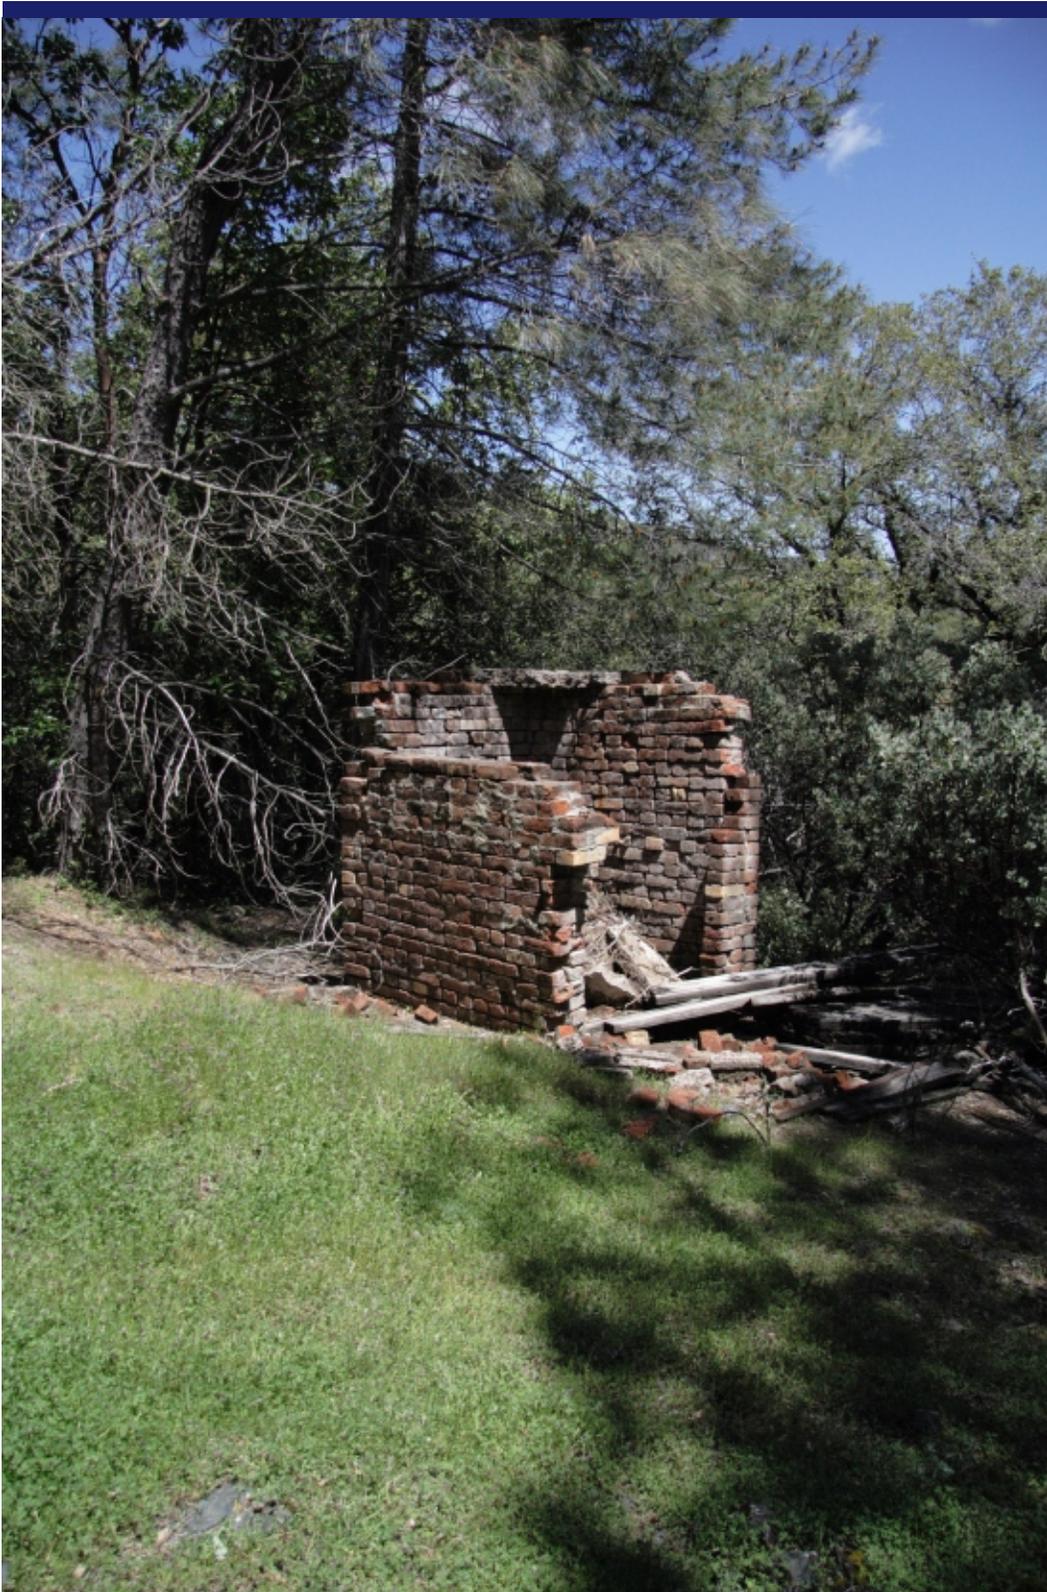
Photo 37 Small brick furnace was used to retort creosote/cake that would form in the chimneys to the main rotary furnace.

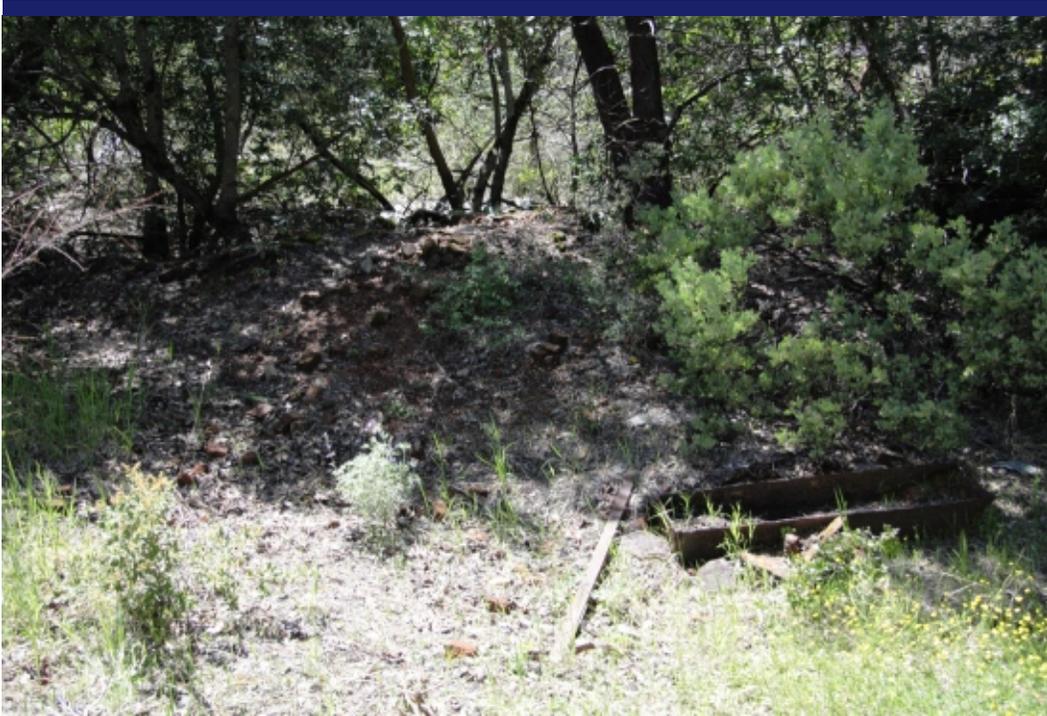
Photo 38 A pile of soil and bricks was present near the small brick furnace.

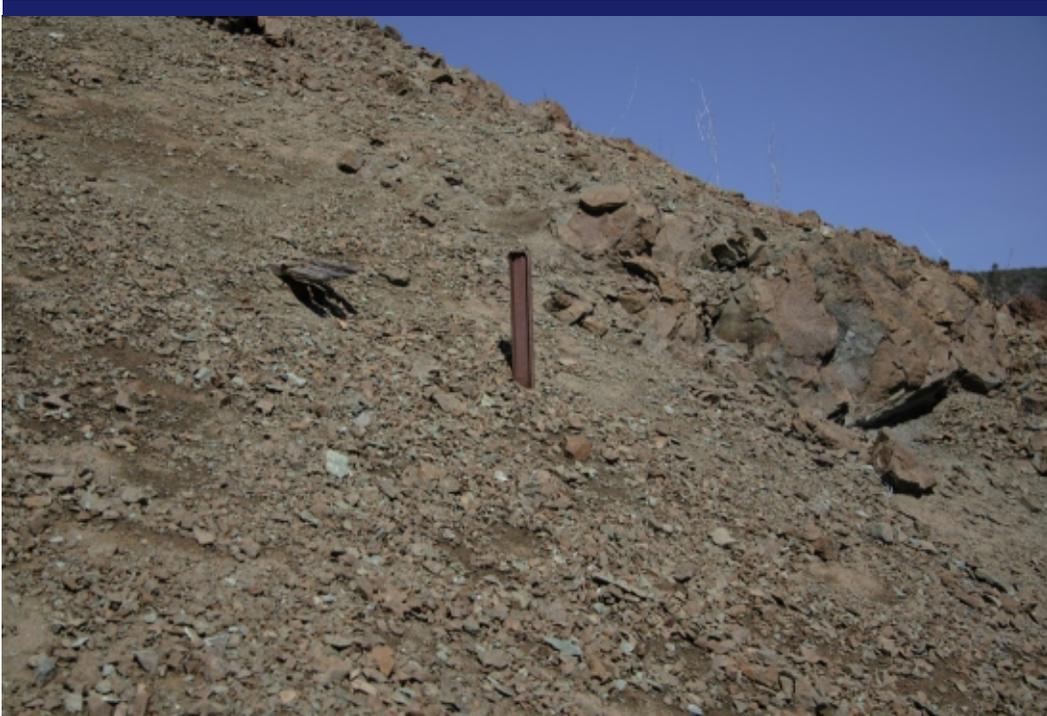
Photo 40 Railroad track piles and wood were present on the hillside above the southern disturbed area. This was the likely location for the main rotary furnace.
