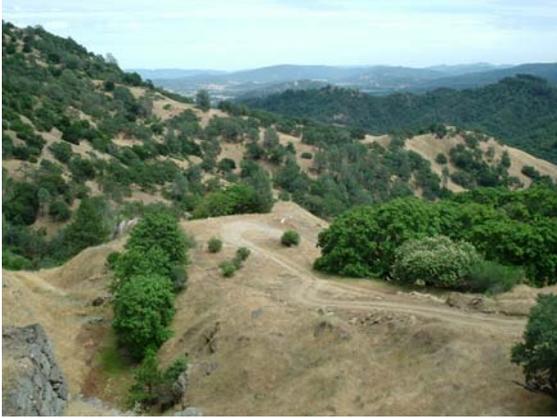
Photograph 1:  
View from Northwest corner of  
the site, looking East from top of  
rock wall.

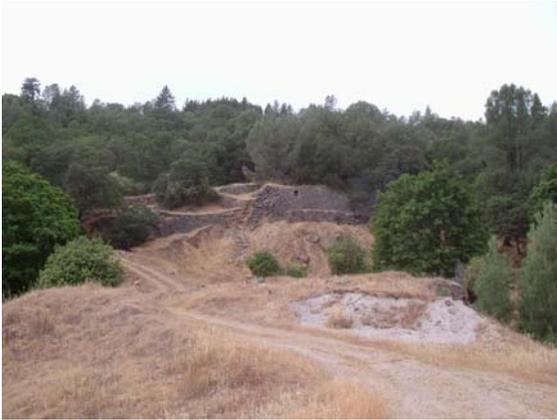
Photograph 2:  
View from middle of large pile  
looking back up towards rock  
wall.

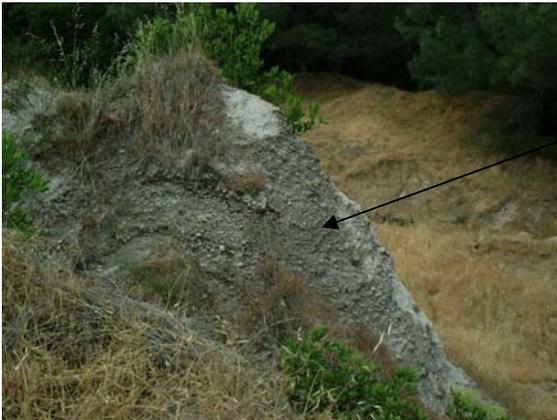
Photograph 3:  
White and grey fine material in  
mounds at large pile.

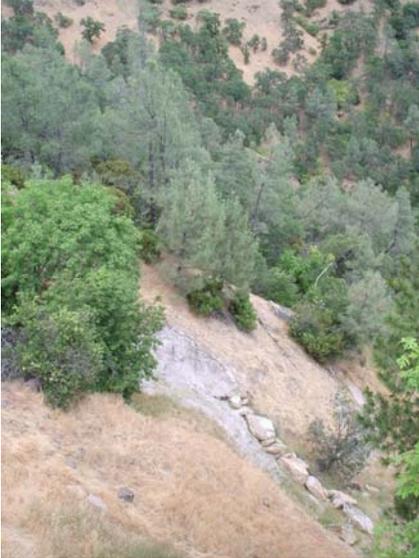
Photograph 4:  
East facing slopes of large pile.

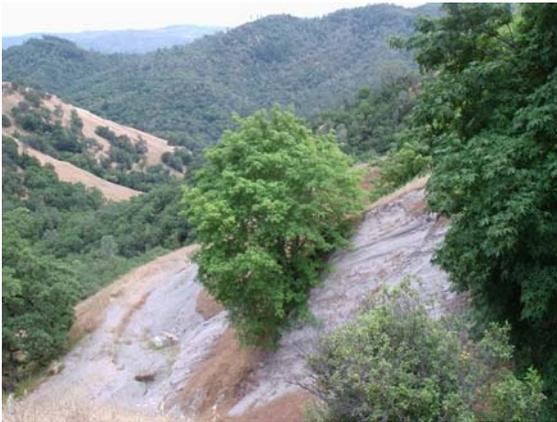
Photograph 5:  
View from large pile toward the  
valley below (looking East).

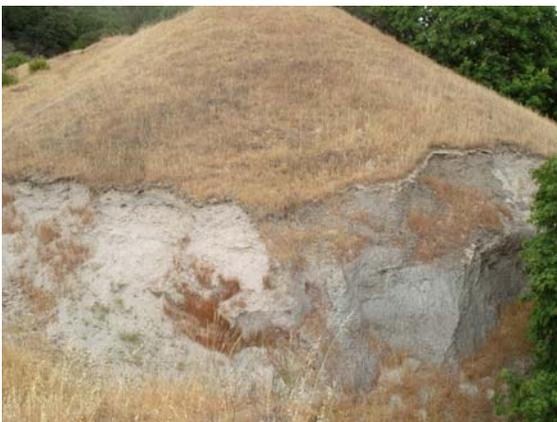
Photograph 6:  
Sloughing of steeper slopes  
exposes white and grey fine  
material under vegetated  
surface.

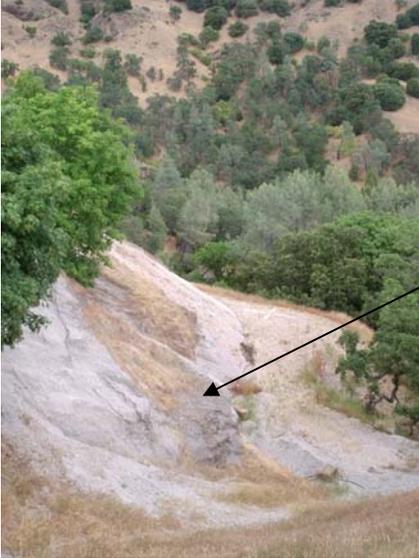
Photograph 7:  
Steep slopes at large pile.  
Erosion evident above road  
cuts.

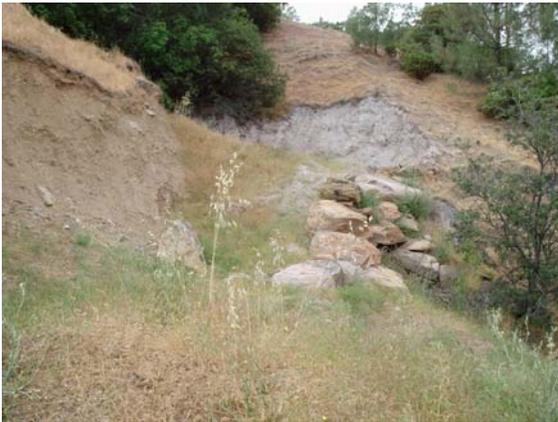
Photograph 8:  
Eroded areas in steep portions  
of large pile.

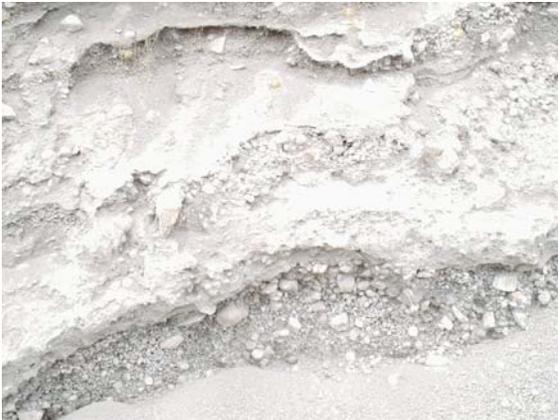
Photograph 9:  
Close up of white and grey  
material.

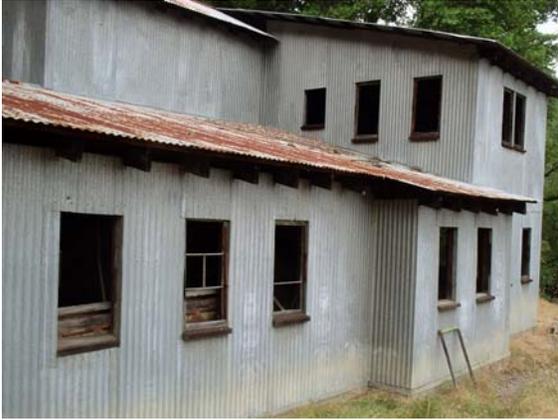
Photograph 10:  
Mill building located in West  
portion of site.

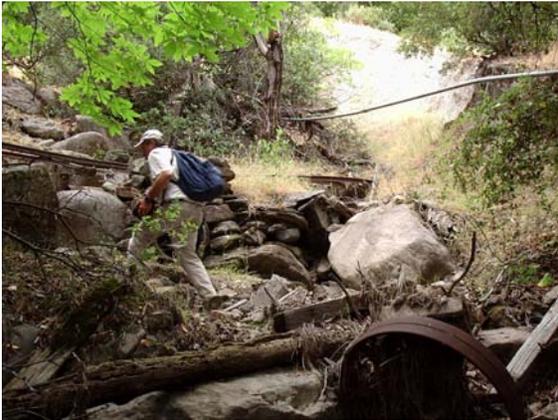
Photograph 11:  
Scattered debris and  
abandoned mining equipment  
found in gully below mill  
building.

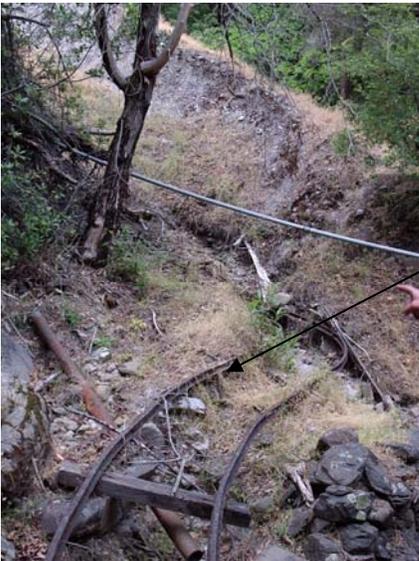
Photograph 12:  
Remains of cart and tracks.

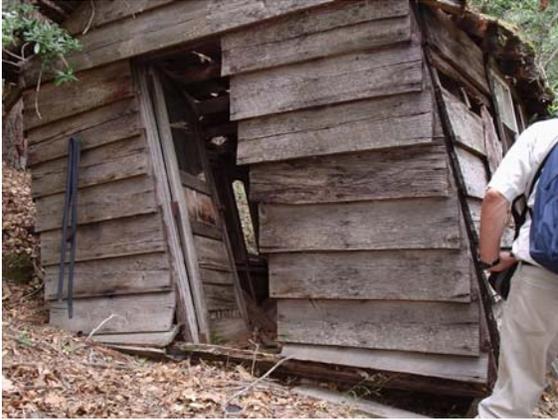
Photograph 13:  
Wooden structure located in  
West portion of site.

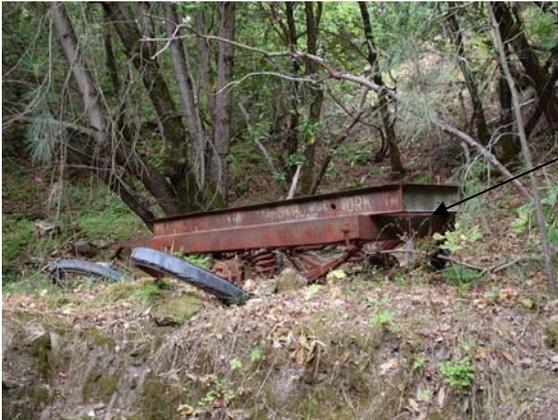
Photograph 14:  
Remains of mining equipment.

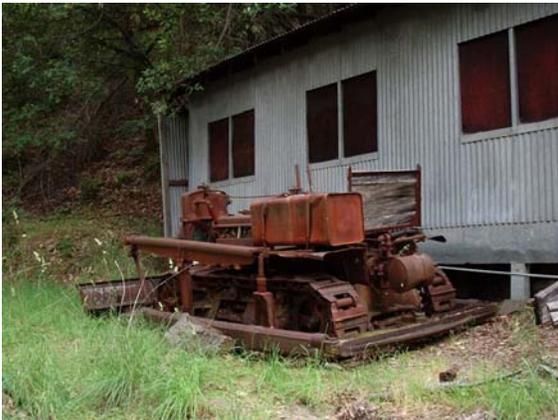
Photograph 15:  
Shed and bulldozer.

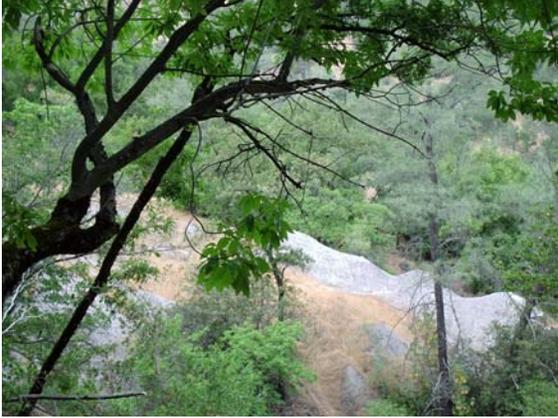
Photograph 16:  
View of smaller waste piles  
within Southern portion of the  
site.

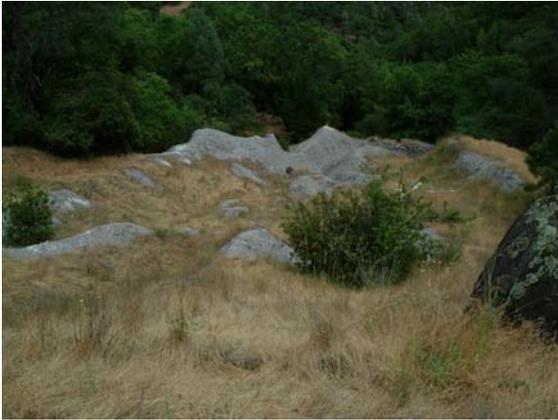
Photograph 17:  
Waste material is fairly well  
revegetated in Southern  
portions of the site.

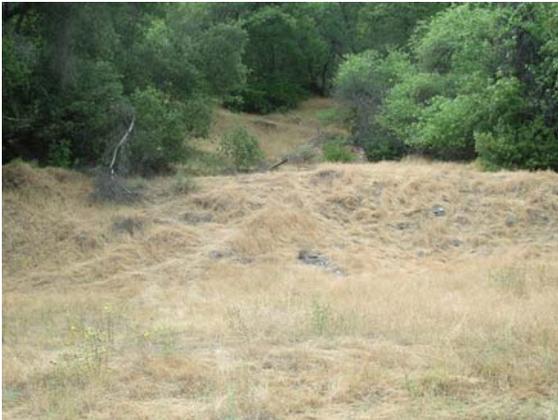
Photograph 18:  
Revegetated cover at Southern  
piles.

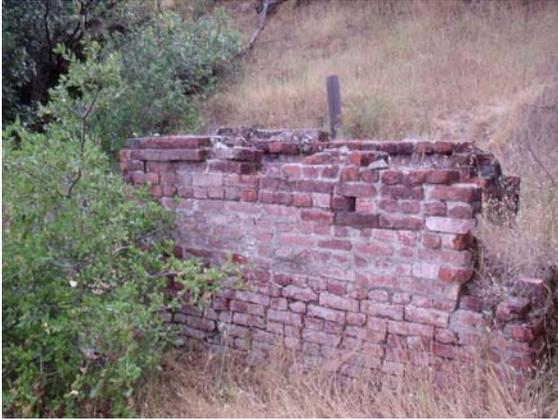
Photograph 19:  
Remains of brick retort.

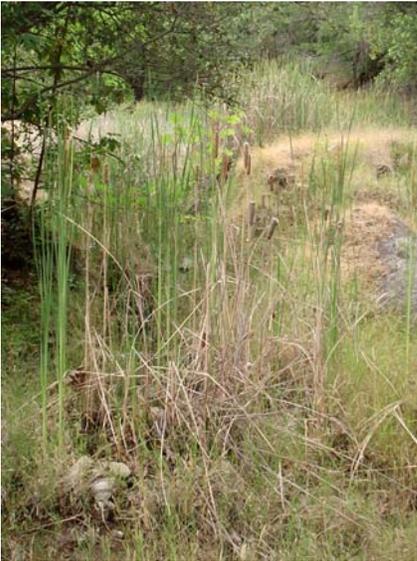
Photograph 20:  
Wetland located in central  
portion of the site.

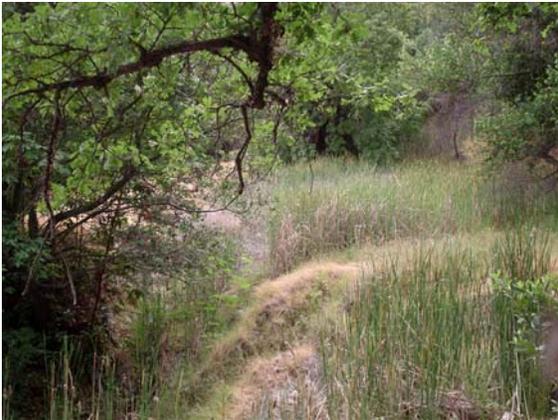
Photograph 21:  
Vegetation in and around  
wetland area.
