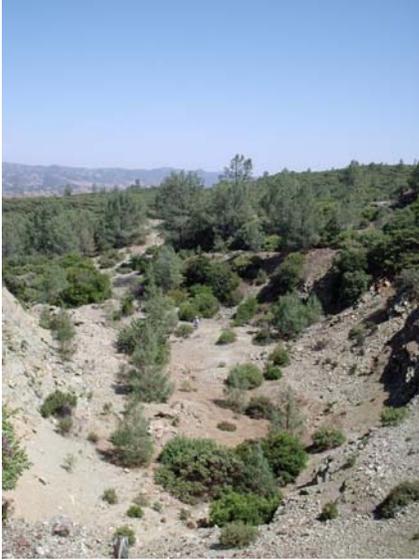
Photograph 1:
View from atop Petray North (PN)
waste rock dump looking east

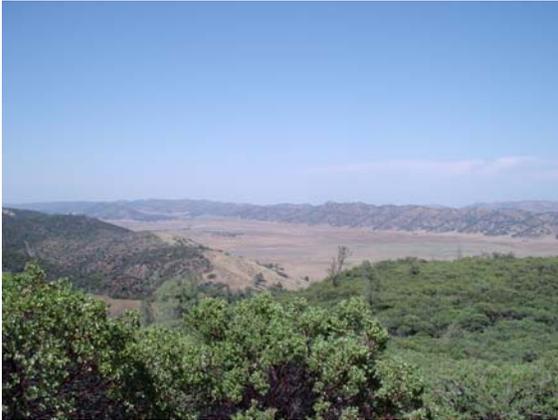
Photograph 2:
View from hilltop at northern end of
site; looking north toward Deadshot
Canyon

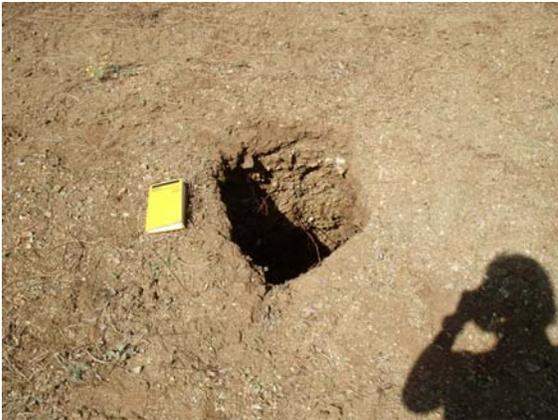
Photograph 3:
Hole/collapse in center of PN pit;
surrounded by fine sediment
deposit; source/cause unknown

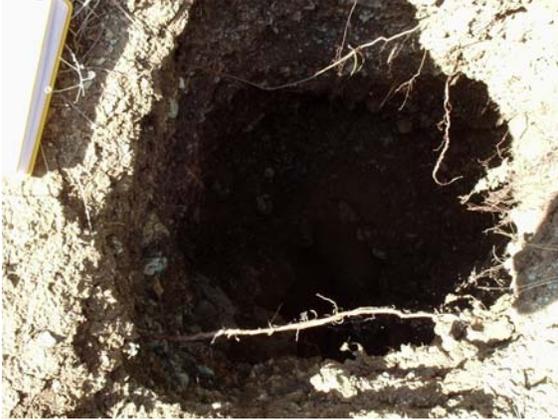
Photograph 4:
View into hole/collapse; bottom not visible

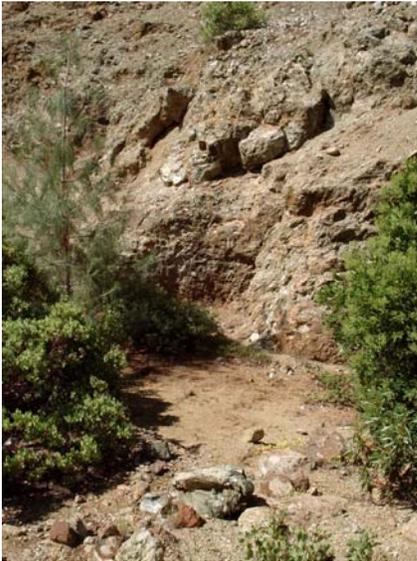
Photograph 5:
Bottom of PN pit; fine, light brown material; area appears to collect runoff from surrounding slopes

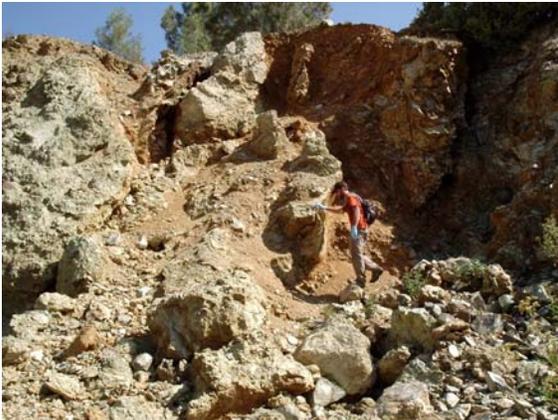
Photograph 6:
Fault line in wall of PN pit; sampled material with potential to contain higher levels of mercury

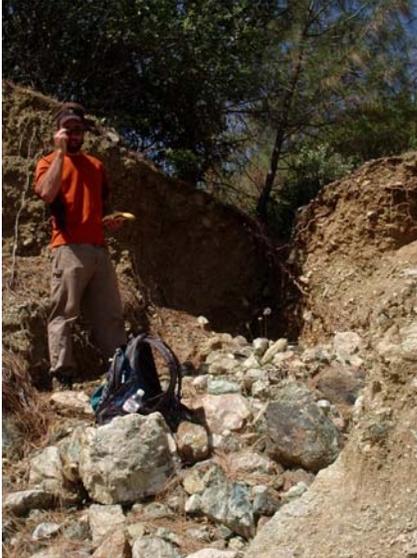
Photograph 7:
Sample of material in top/mouth of
eroding canyon at PN; looking west
(uphill)

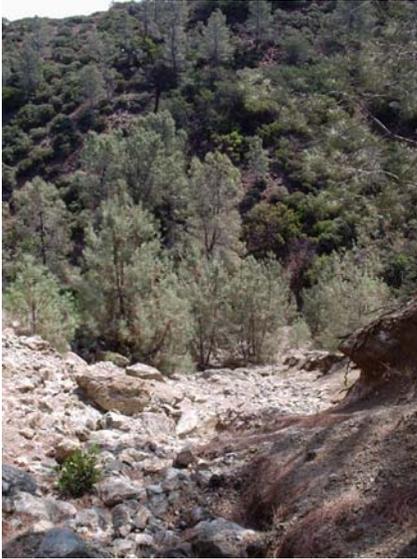
Photograph 8:
View from top/mouth of eroding
canyon at PN; looking east
(downhill)

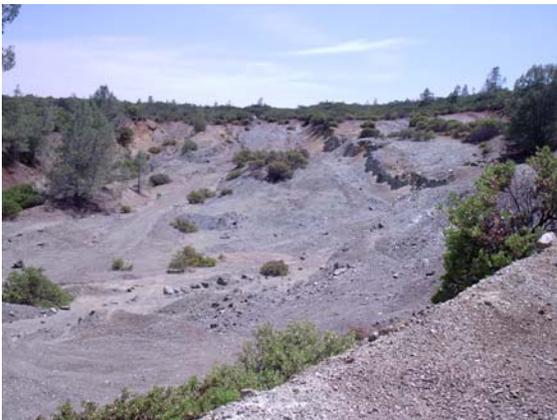
Photograph 9:
View of Petray South (PS) looking
south; majority of pile/dump in photo

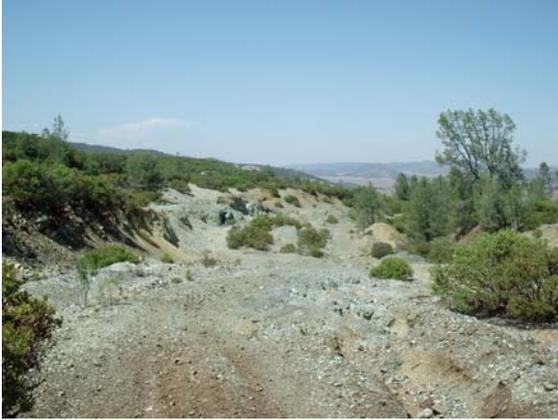
Photograph 10:
View of PS from top (south end),
looking north

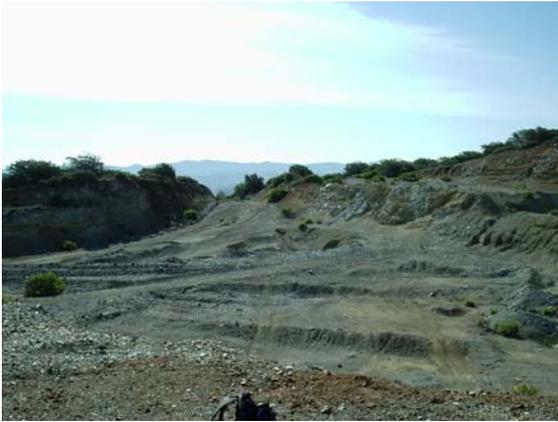
Photograph 11:
Rathburn North (RN); looking into
main pit, toward southeast

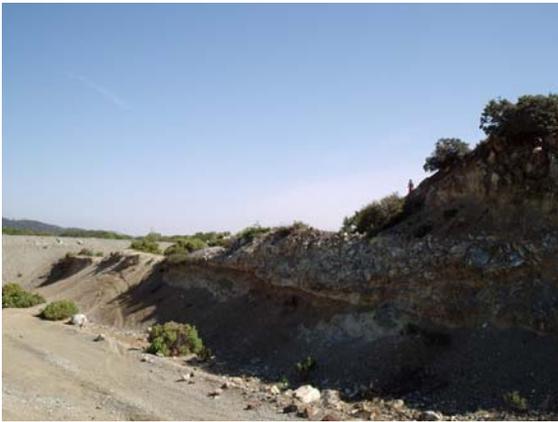
Photograph 12:
East side of RN pit; material piled
and pushed from west to east for
dumping

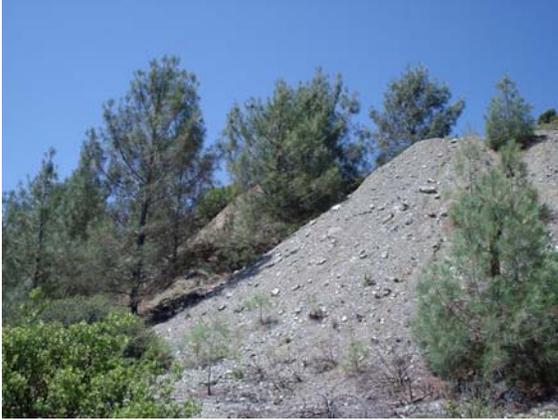
Photograph 13:
Scattered waste rock piles north of
pit berm pile at RN.

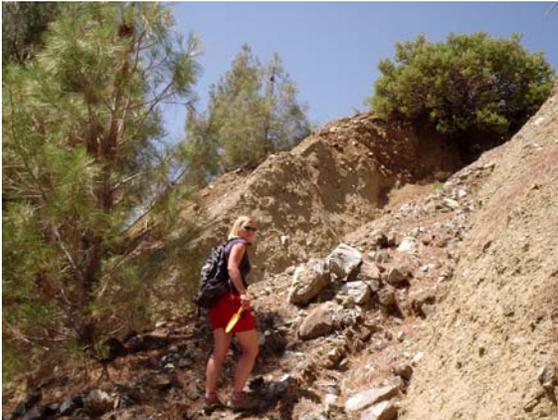
Photograph 14:
East dump drainage gully at RN

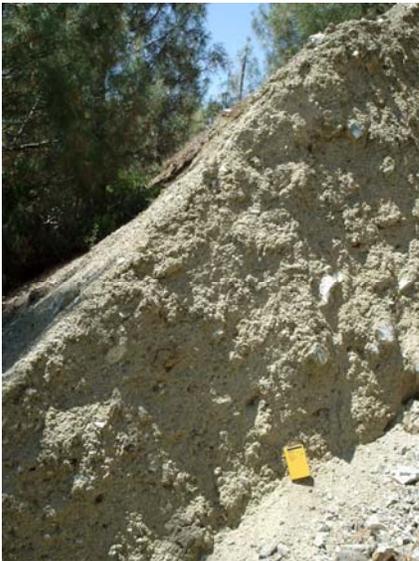
Photograph 15:
East dump drainage gully at RN
(field book for scale)

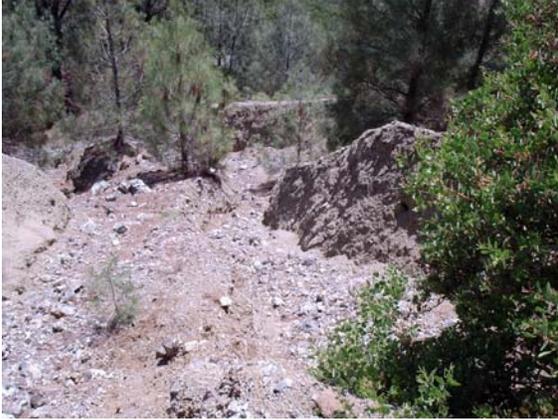
Photograph 16:
View from top of east dump of RN
looking east

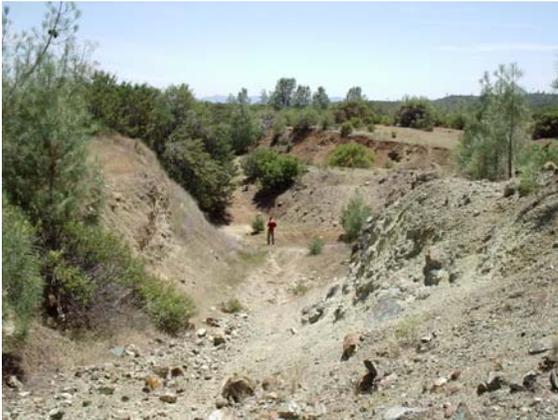
Photograph 17:
Main pit at Rathburn South (RS)
location

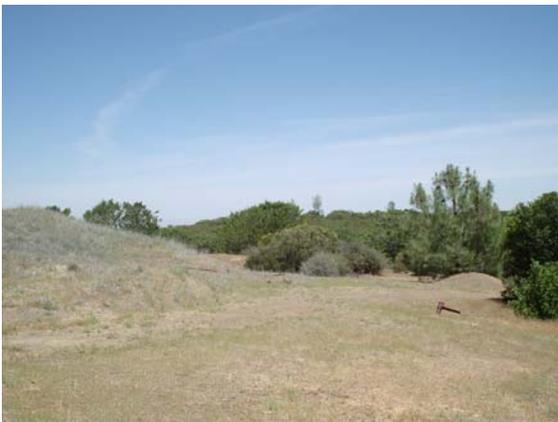
Photograph 18:
Several waste rock piles at RS;
various remains of structures and
equipment scattered over site

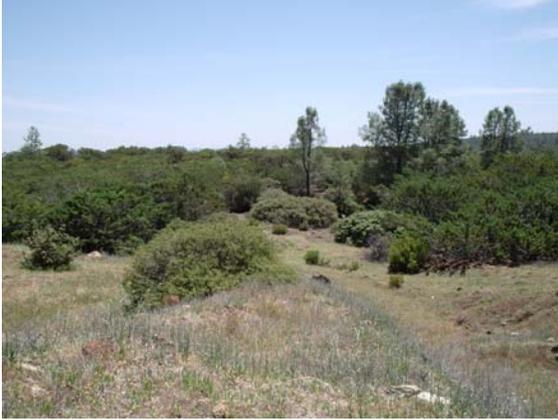
Photograph 19:
Waste rock piles at RS displaying
successful natural revegetation
(grasses and shrubs)

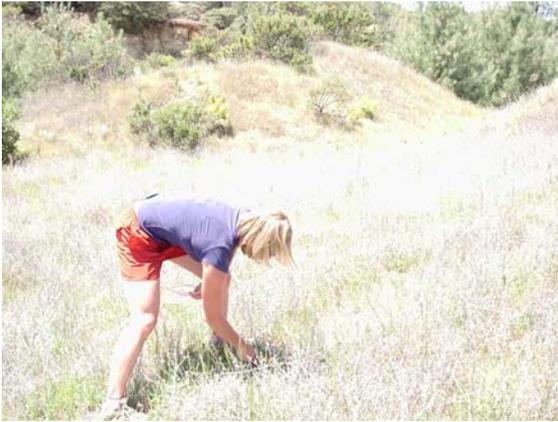
Photograph 20:
Sample collection from waste rock
pile in RS area

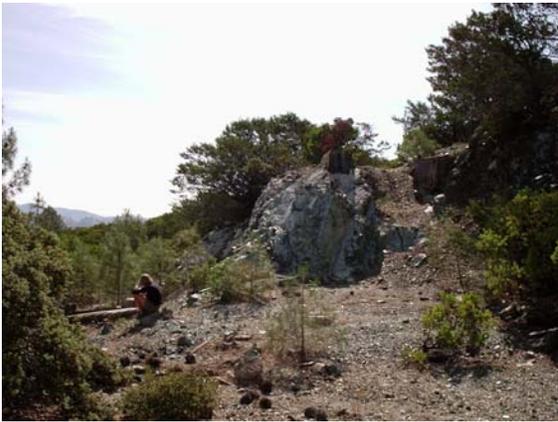
Photograph 21:
Discovered remains of mill site
located northwest of PS area

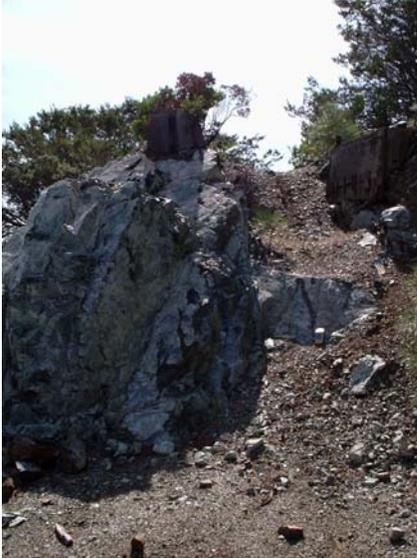
Photograph 22:
Foundation of mill or processing structure

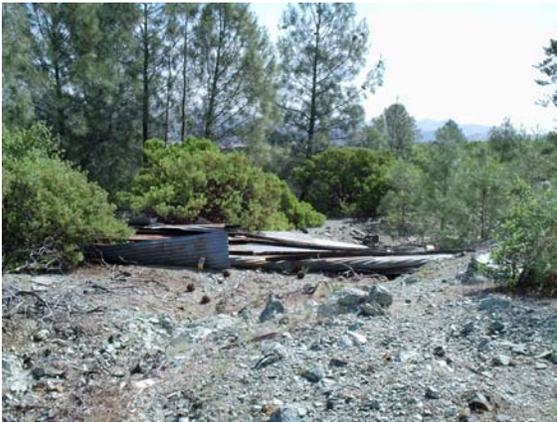
Photograph 23:
Waste rock piles above and below foundation remains

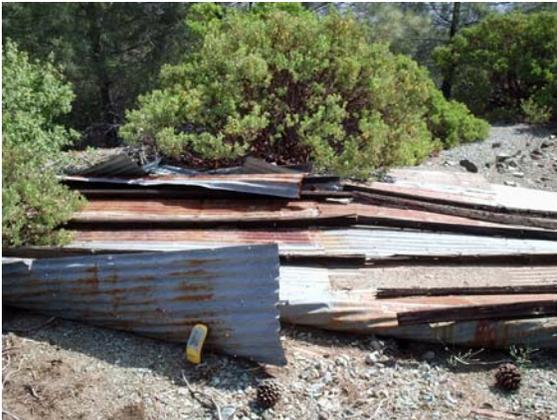
Photograph 24:
Remains of metal roof

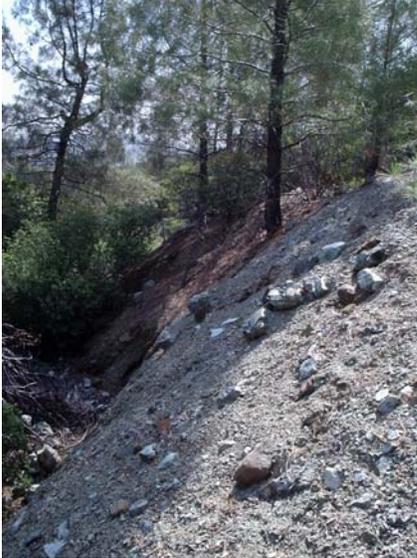
Photograph 25:
Waste rock pile below mill spills into
draining gully

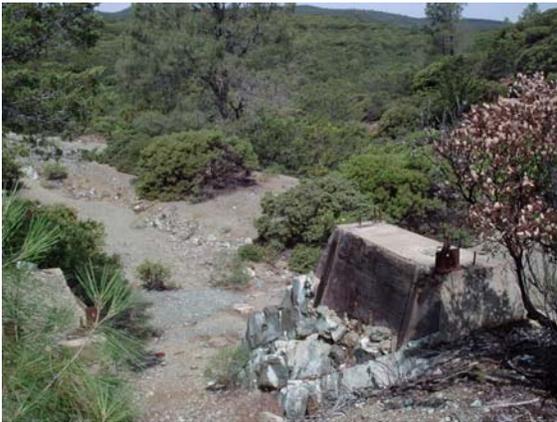
Photograph 26:
Top of waste rock pile at suspected
mill site

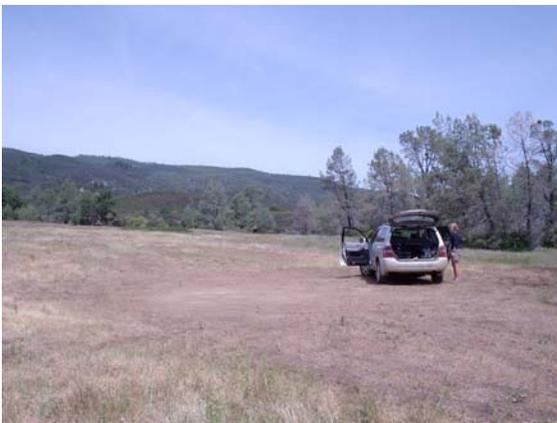
Photograph 27:
Potential borrow source material;
flat grassy meadow off site access
road

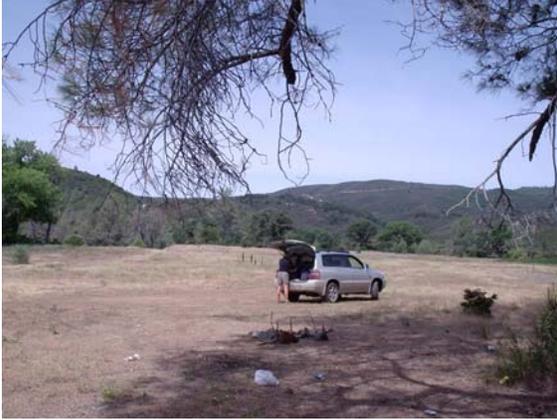
Photograph 28:
Potential borrow source material
found on north and south sides of
road at west access to site

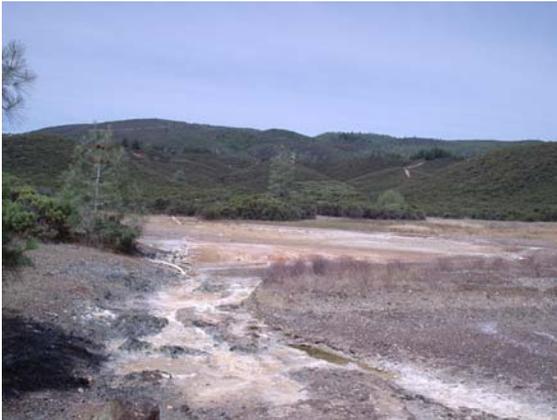
Photograph 29:
Discovered spring northwest of
potential borrow material fields

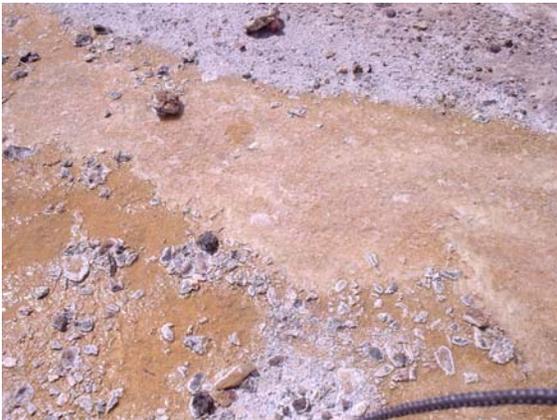
Photograph 30:
Spring deposition on surface; hard,
yellow/orange/red solids

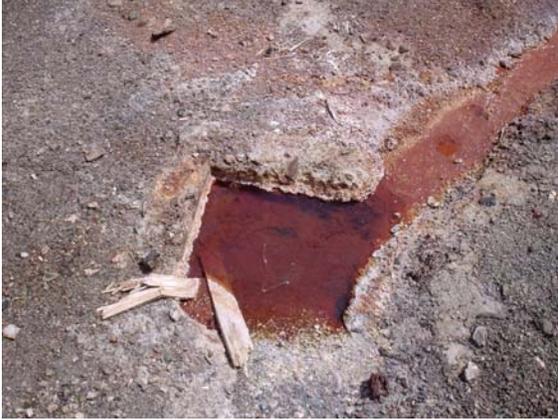
Photograph 31:
Spring surface effluent
