Alternatives

Arena/Stable Rehabilitation Meadowood Special Recreation Management Area Lorton, Va

April, 2008

OC Project Number
AE-ES-007

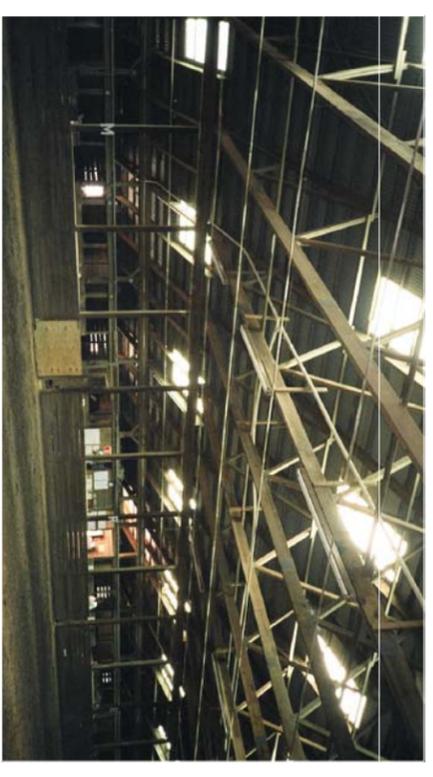
B INTERIOR VIEW-TRUSS
NO SCALE

Structural: The roof framing has some deficiencies, but in general the structure appears adequate to support current loads as well as the new sprinkler piping. The arena roof joists (2X4's) should be doubled, additional bracing should be applied to the arena trusses and some of the truss anchor points require additional blocking which is in place at most areas, but for some reason left off at others.

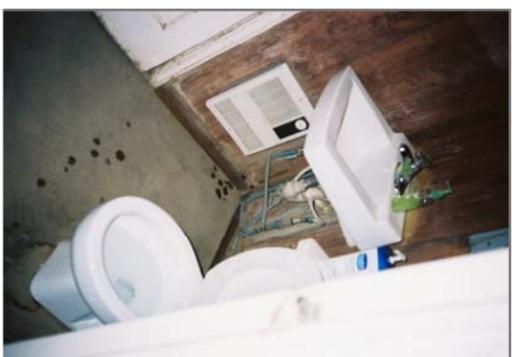
G BATHROOM
NO SCALE

Bathroom: The current bathroom has dated fixtures, poor layout and does not meet accessibility standards.
