Fairfax County
Department of Public Works and Environmental Services
Capital Facilities/Land Development Services

Meadowood Special Recreation Management Area
Bureau of Land Management
10406 Gunston Road, Lorton, VA 22079
Parcel Identification. no.: 11430 01 0040

Barn/Arena Assessment

December 2010

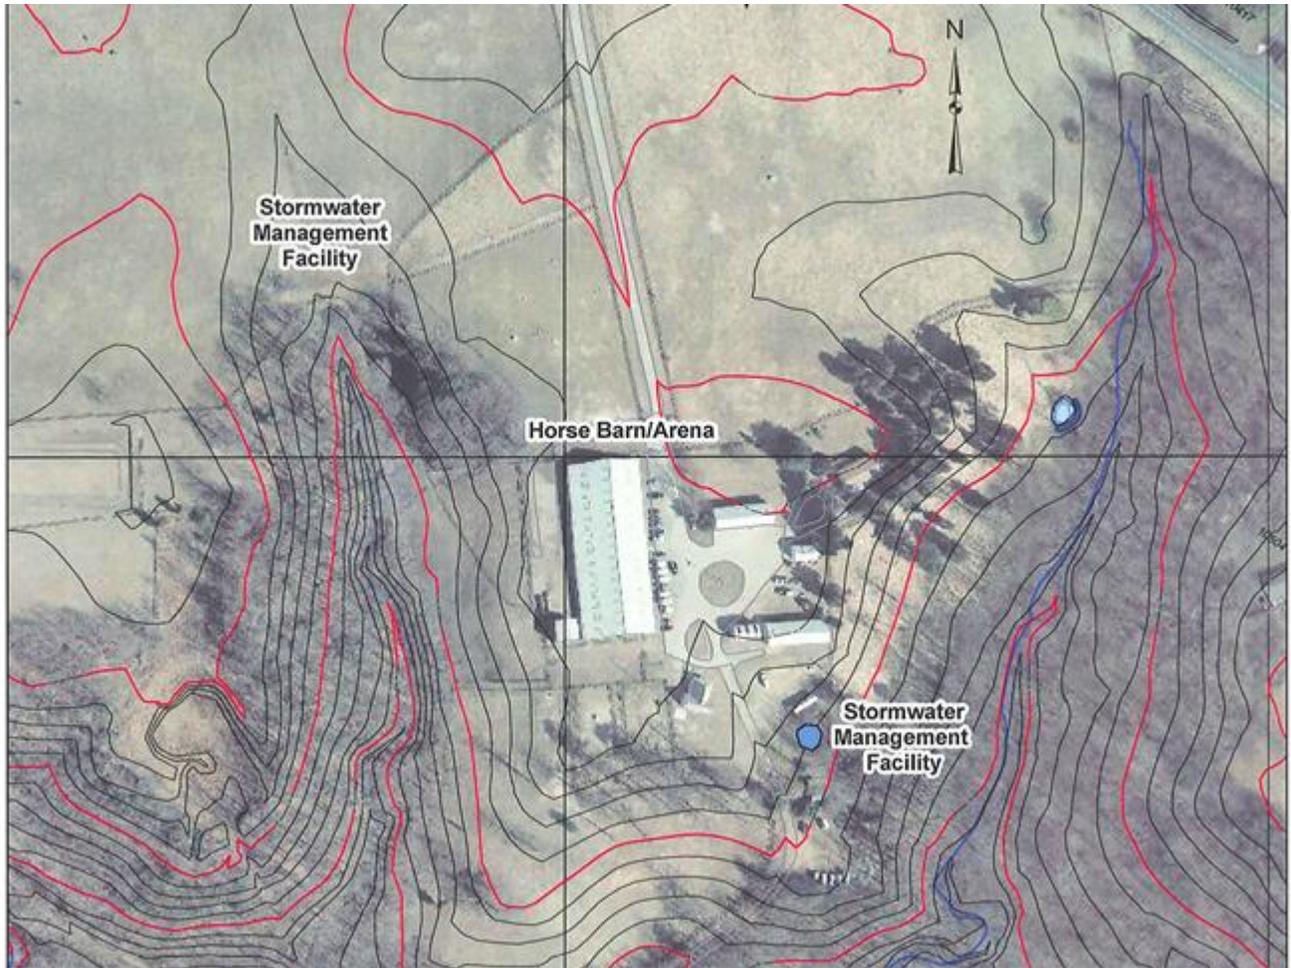
At the north end of the arena, the runoff from the roof drains sheet flow around the building to the west. BLM staff noted that the stalls at the north end of the site often get flooded during large storm events. See image below:

Aerial view of Meadowood Barn/Arena

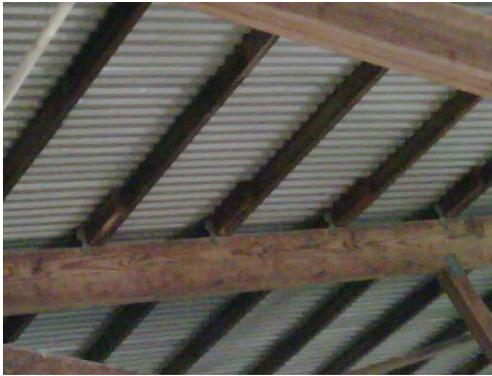
- **Roof Diaphragm-** The roofing is 4'-0" wide corrugated metal panels with interspersed translucent panels for light. The panels bear on purlins spaced at 2'-0" oc. The short span is anticipated to allow the panels to carry the load to the purlins. The metal panels as a whole act as the main diaphragm of the structure delivering the horizontal load to the main wind force resisting system (MWFRS).
- **Arena Purlins-** The purlins are placed on the roof trusses and span the 8'-0" truss spacing. The purlins are oriented in the strong direction (heel-up) to allow a better capacity for the span. The POZ report indicates the stringers are 2x4's. See image below:

Arena Purlins

- **Purlins-** A simple calculation should be performed to determine if the purlins are adequate to carry the load for 8'-0" span in the strong direction and the 4'-0" span in the weak direction. All clips connecting the purlins to the trusses must be maintained to ensure a full load path. Purlins subject to moisture infiltration should be checked for rot and mold growth.

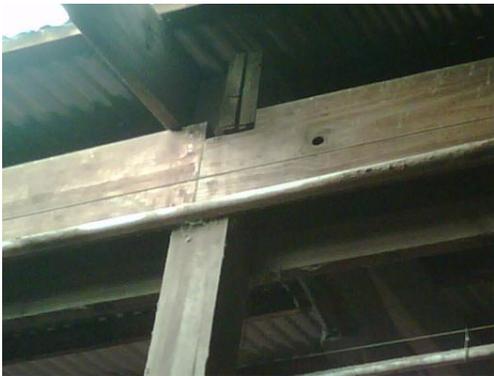
- **Stable Rafters-** The rafters in the stable/walkway area per the POZ report are 2x10 at 4'-0" oc.
- **Beams-** The rafters and trusses bear on 2x12 beams nailed to each side of the column as described in the POZ report. While the beams are made up of two 2x12s, they do not act as a two-ply beam as commonly seen in modern construction. The beams are also notched at the very location where they experience their highest concentrated loads. See image below:

Location of concentrated loads: truss, rafter, beam, post.

- **Beams-** The connection of the 2x12 beams to the 6x6 columns must be strengthened after a complete investigation and analysis of the current conditions. If notching has compromised the beams' shear capacity, then the beams must be strengthened accordingly.

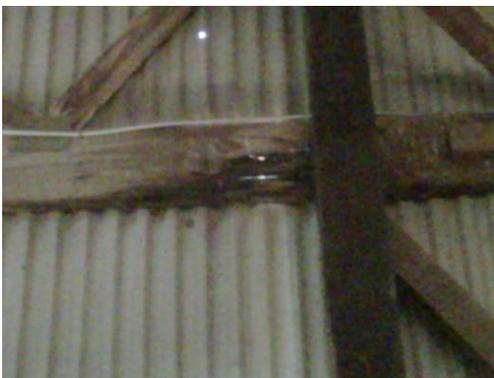
- The wood in the trusses at the north end of the barn are experiencing severe wood rot due to water infiltration. It is not prominent throughout, but is serious in multiple locations and should be addressed. See image below:

Daylight can be seen through rotten areas of truss chord members

- **Arena Trusses-** An analysis must be conducted to ensure the trusses have a capacity to resist the current loads (snow, dust control water pipes, various wood supports, etc.) and future loads, such as a sprinkler system. The bracing should also be checked to ensure truss stability is maintained. **The north end trusses experiencing wood rot must be replaced or repaired immediately.**

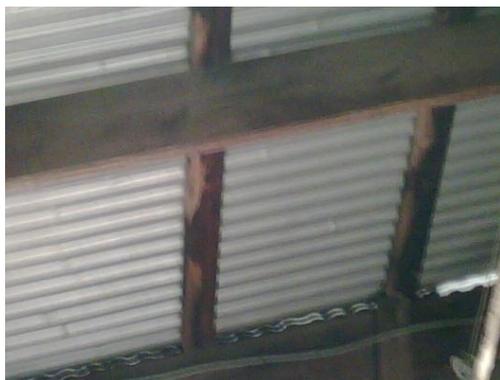
- Evidence of water infiltration along the south side can be seen in the discoloration on the roof purlins. See image below:

Evidence of water infiltration

One of the main forces reducing the structural integrity of the horse barn/arena is the water infiltration from the walls and roof. To reduce the threat of structural collapse, leaks in the roof and walls must be abated. A structural analysis, the reinforcement of structural members and the adequate fastening of cladding to structure will not be worthwhile if water infiltration were allowed to continue.
