Missouri River PFC Assessment

Past...Present...Future

Step 2 – Field Evaluation

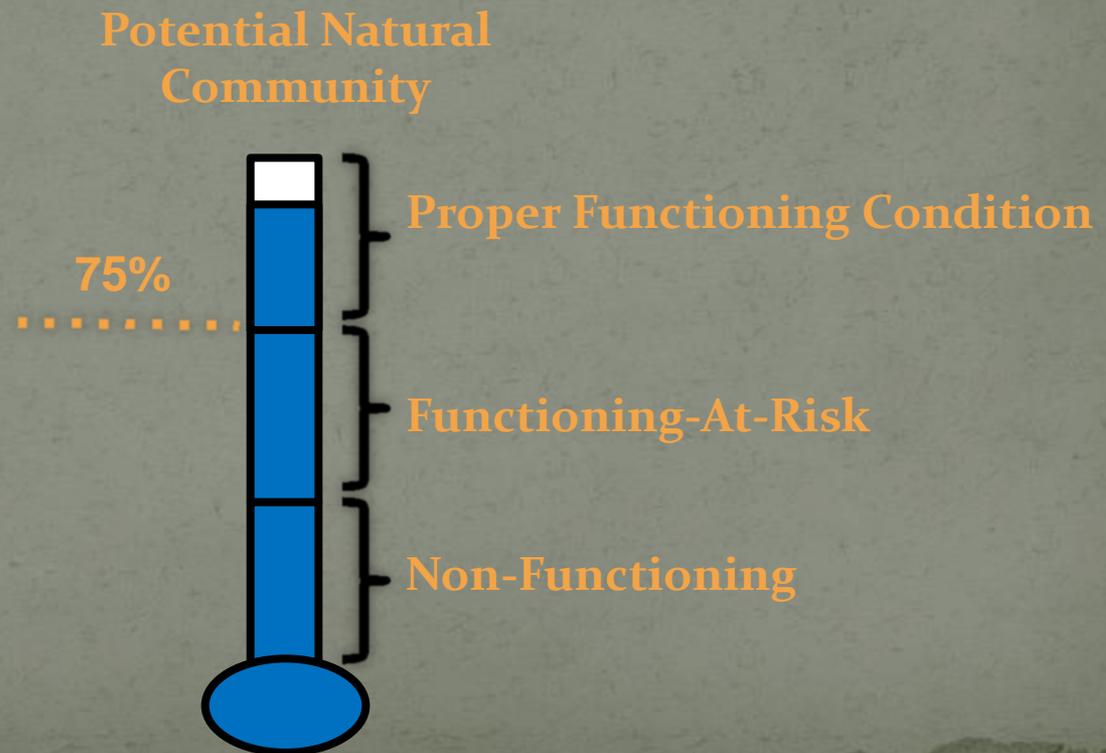
Reach #1 Summary Determination

- Proper Functioning Condition
- Rated well above proper functioning condition and nearly at potential based on vigor, diverse mix of riparian-wetland species, well vegetated banks and expected channel shape

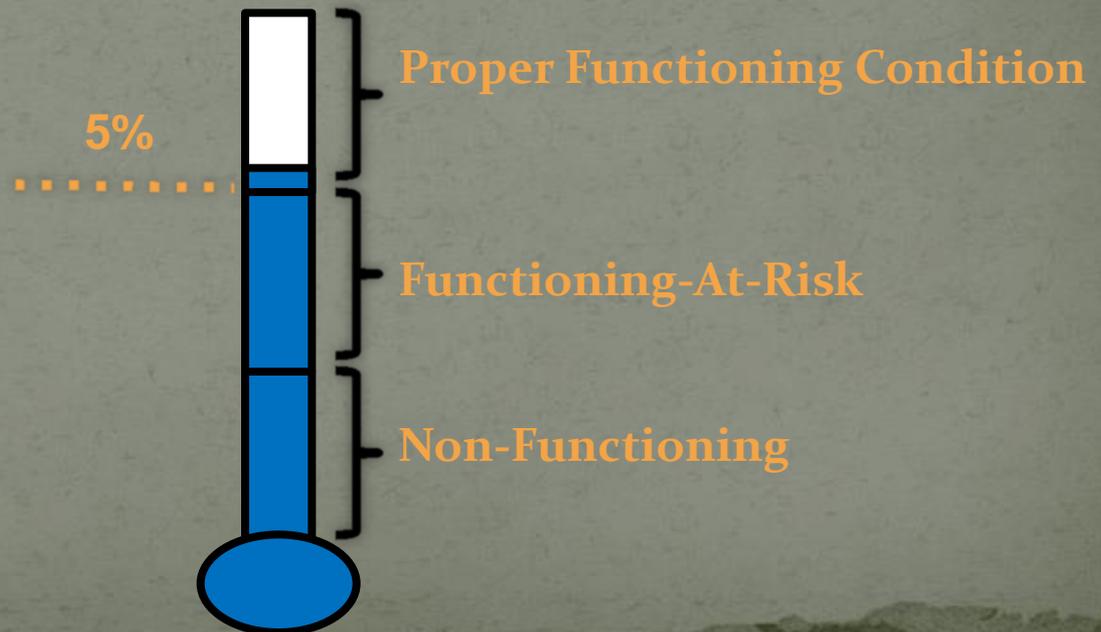
Reach #2 Summary Determination

- Proper Functioning Condition
- Sites well vegetated with diverse riparian-wetland plants. Streambank stability affected by invasive species and noxious weeds

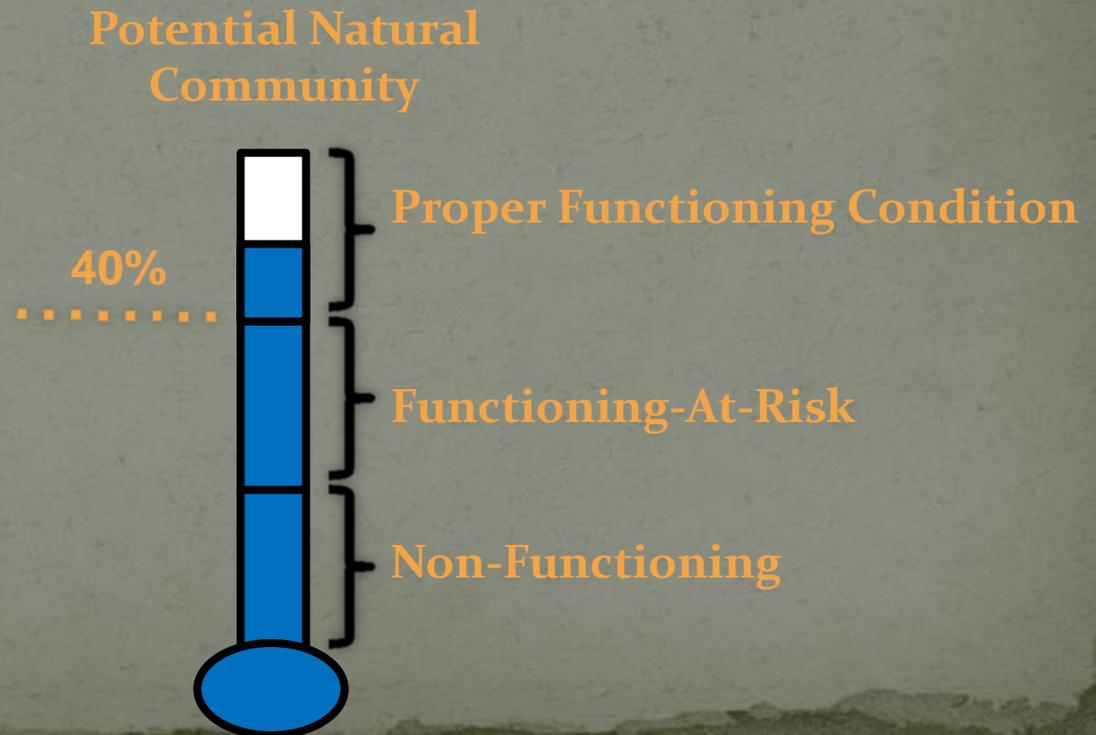
Reach #3 Summary Determination

- Proper Functioning Condition
- Banks well vegetated, moderate to high stability plants, healthy and robust, good response after water levels dropped. Invasive species and noxious weeds competing with more desirable vegetation at some sites

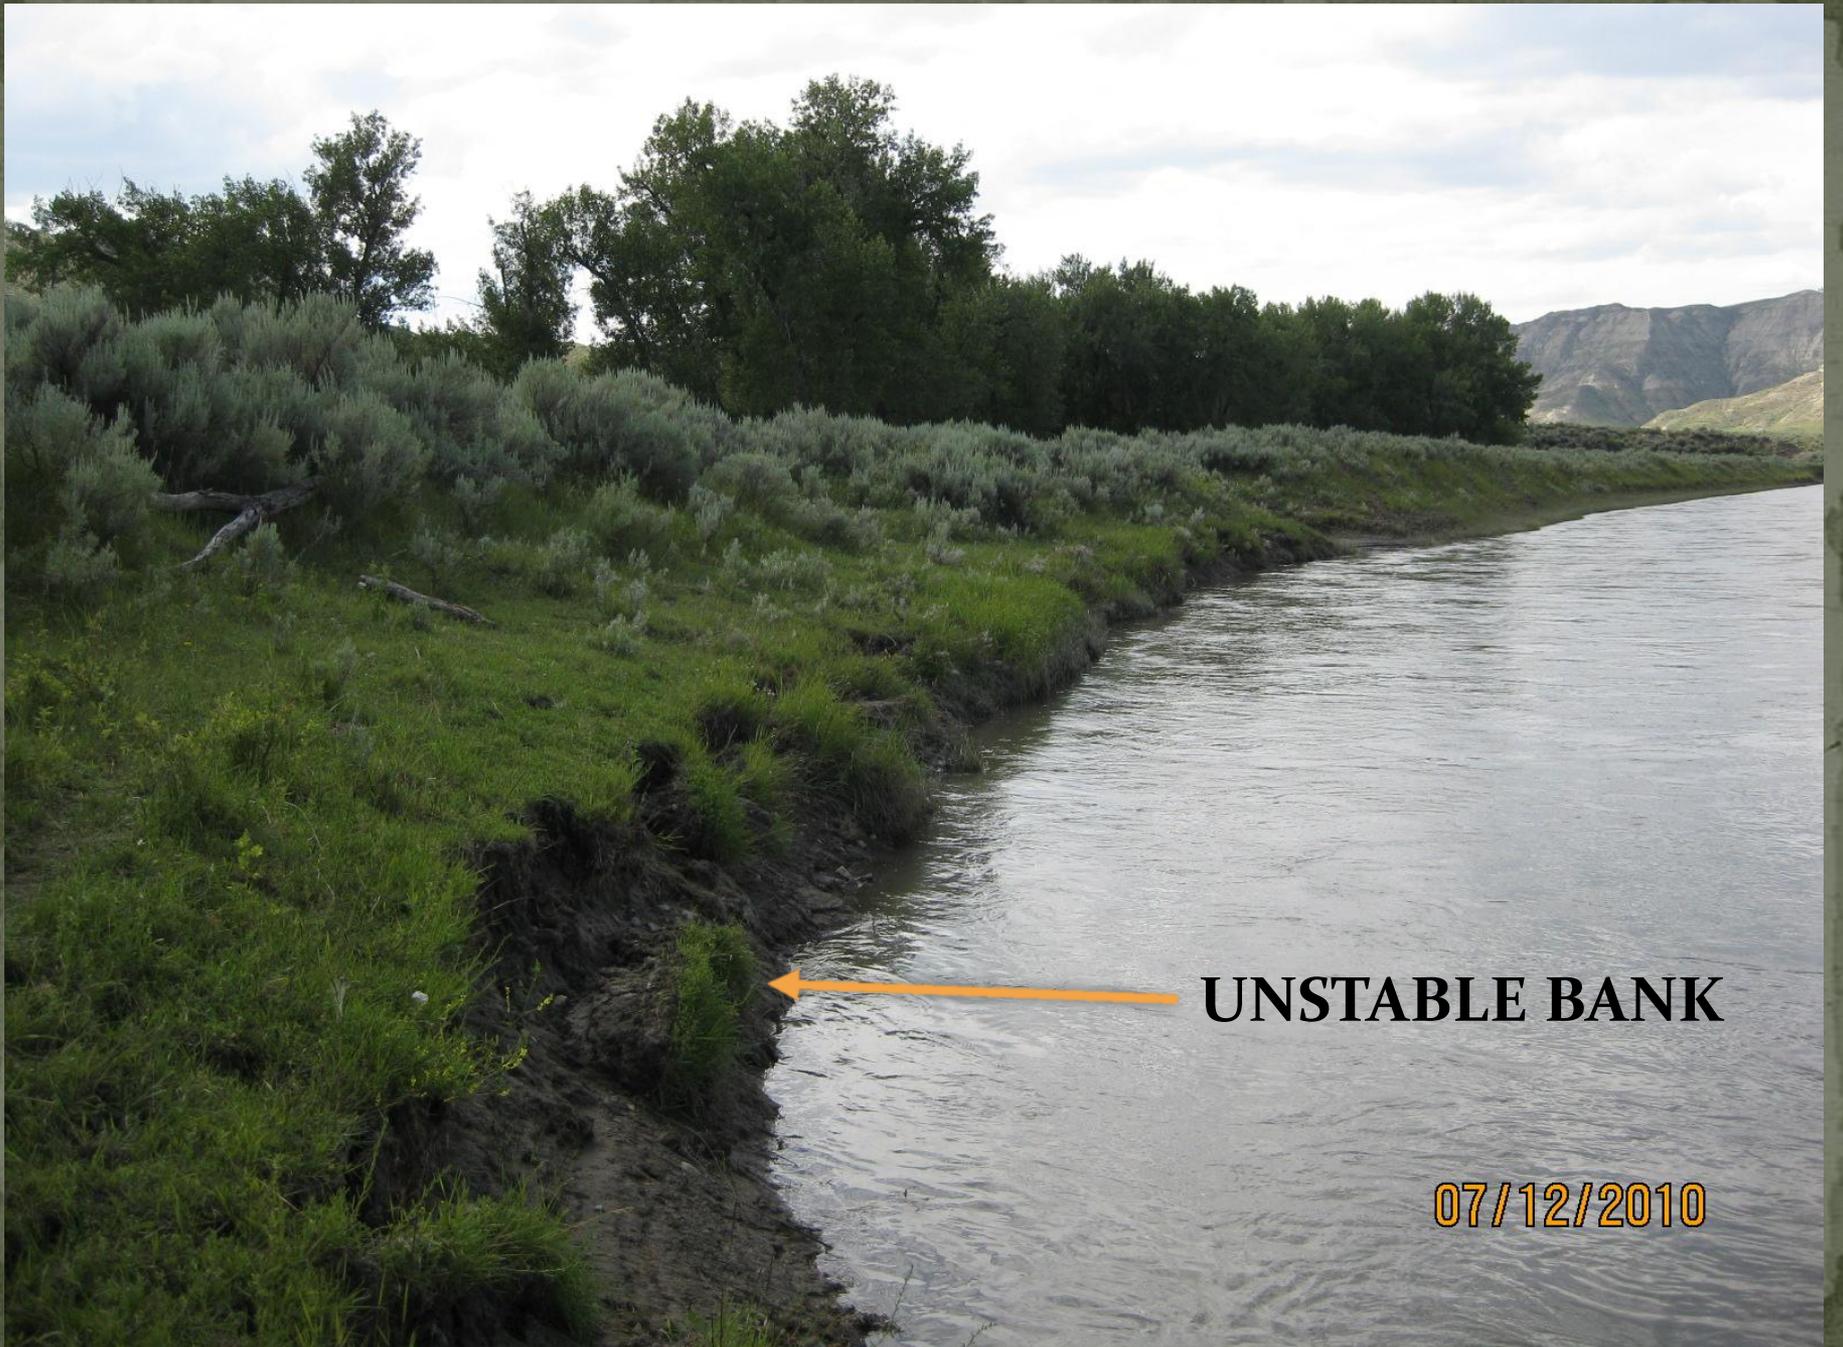
UNSTABLE BANK

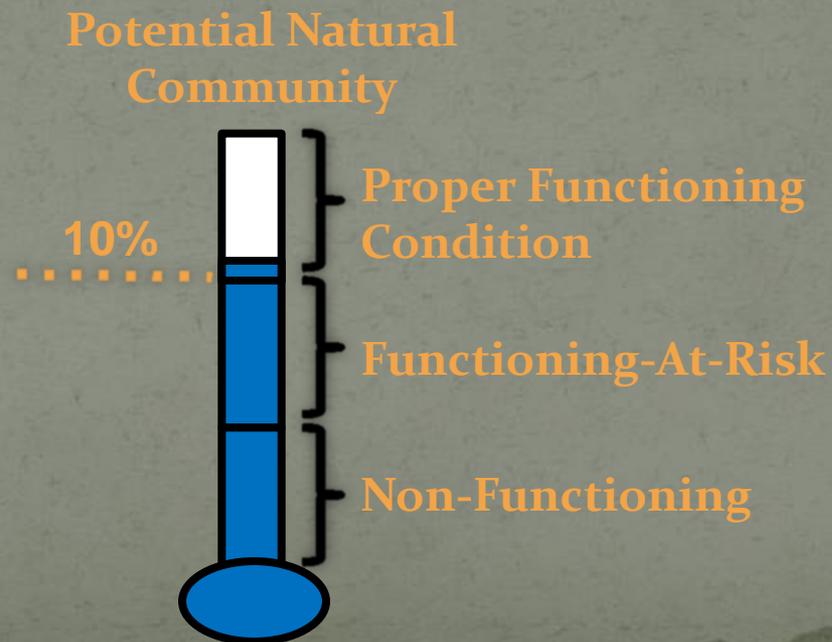
Reach #4 Summary Determination

- Proper Functioning Condition
- River banks well vegetated with diverse mix of bank stabilizing plants. At some sites noxious weeds and non-native plants affecting bank stability

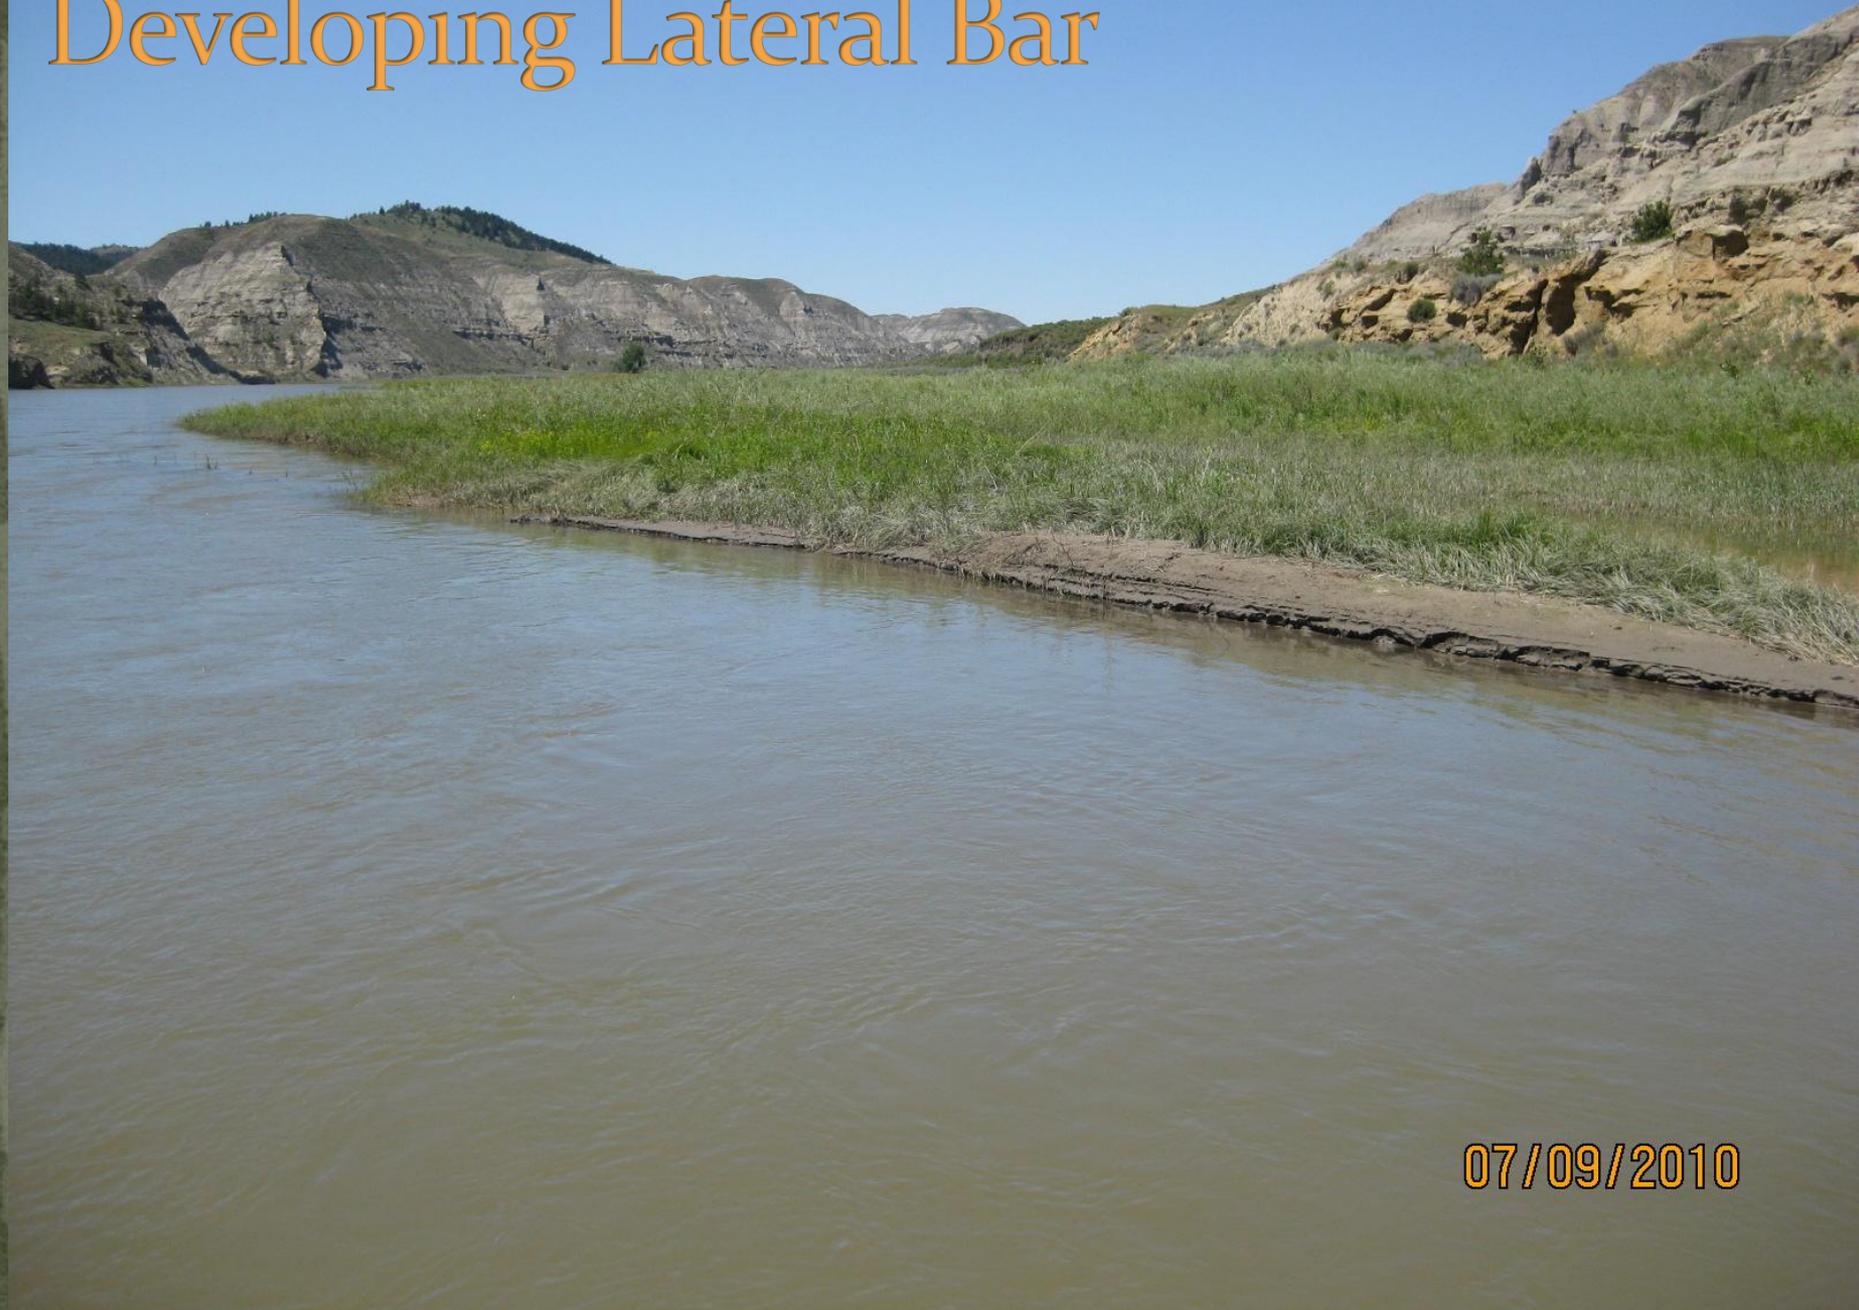
Developing Lateral Bar

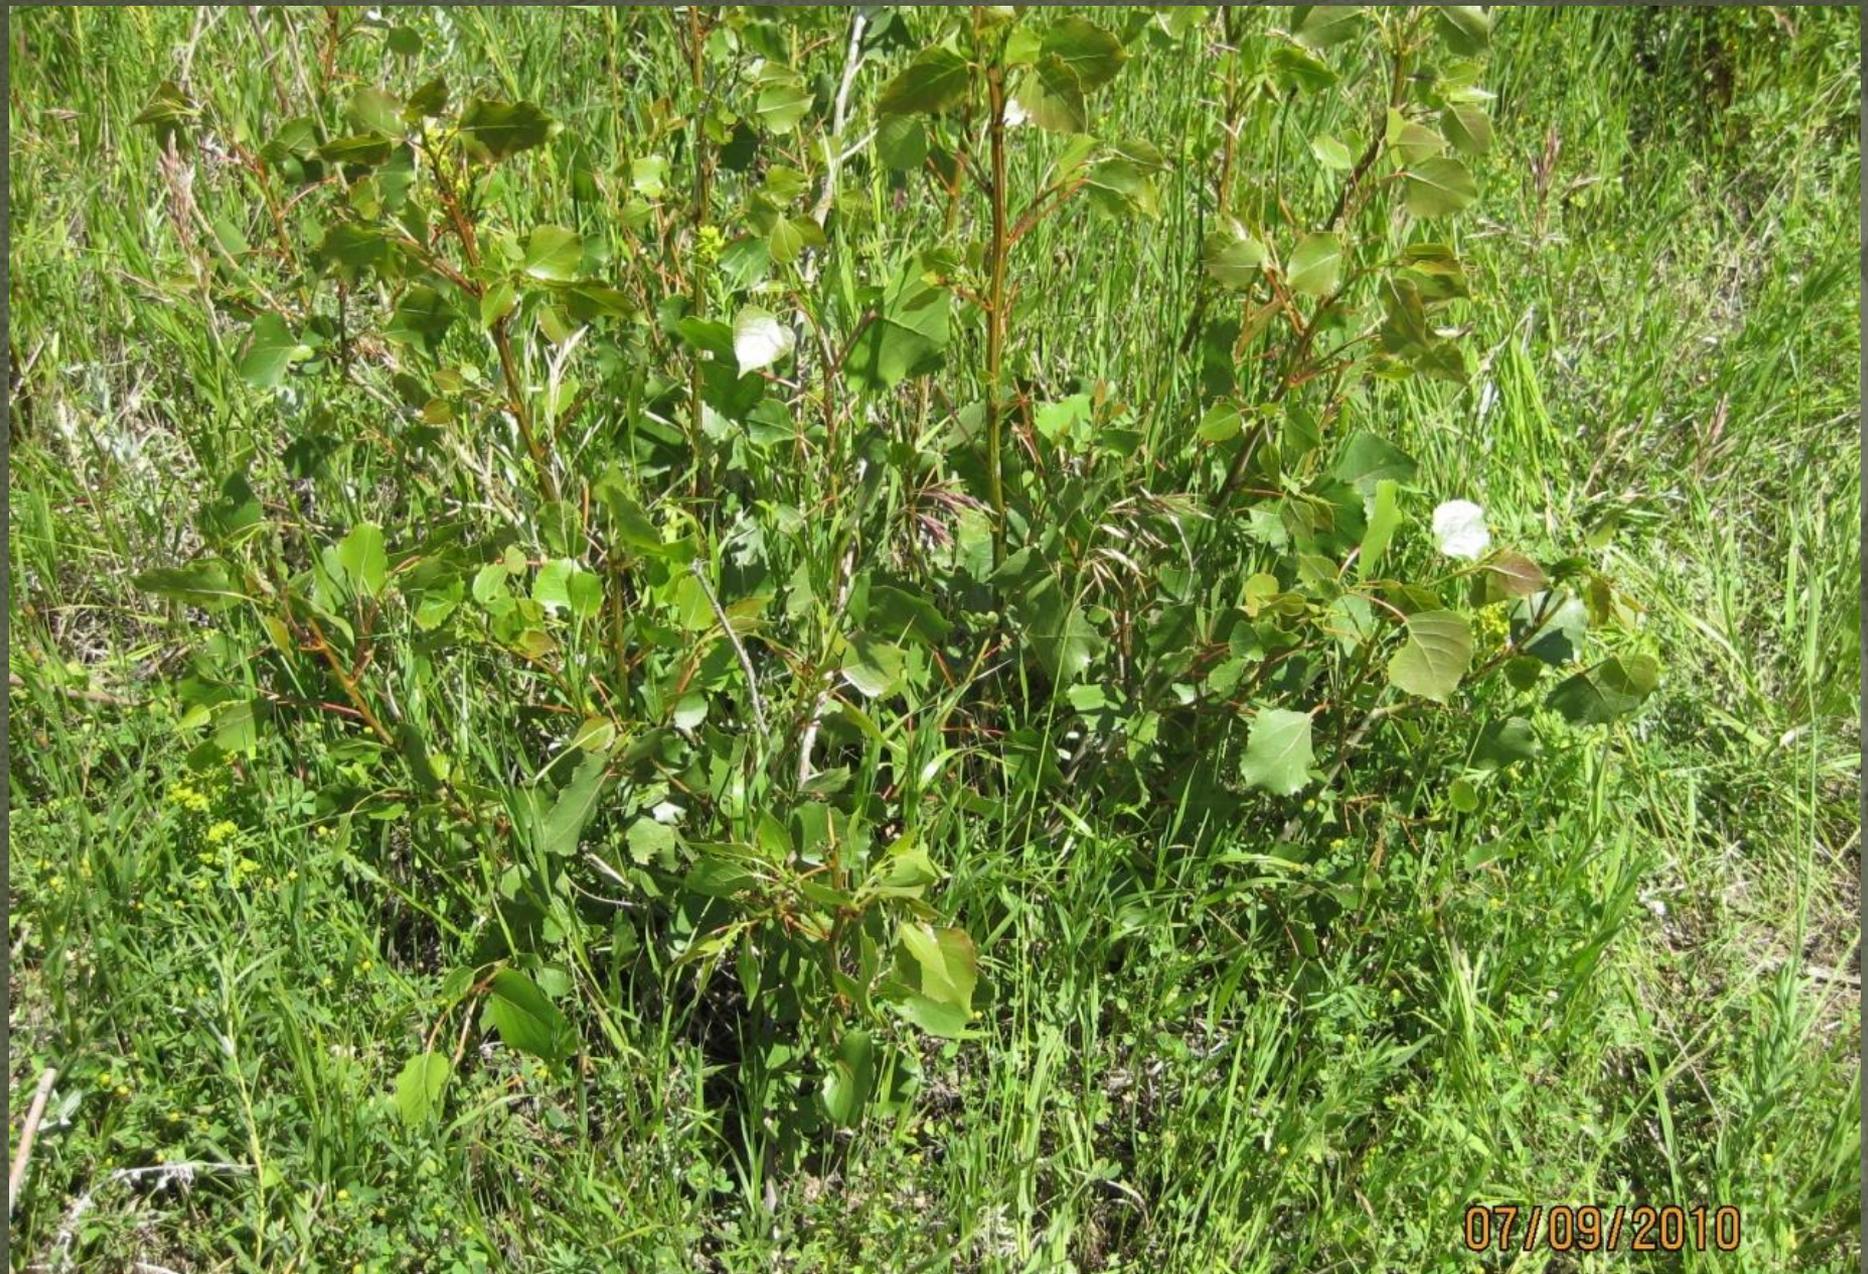
Multi-Stemmed or Clump Growth Form Cottonwood

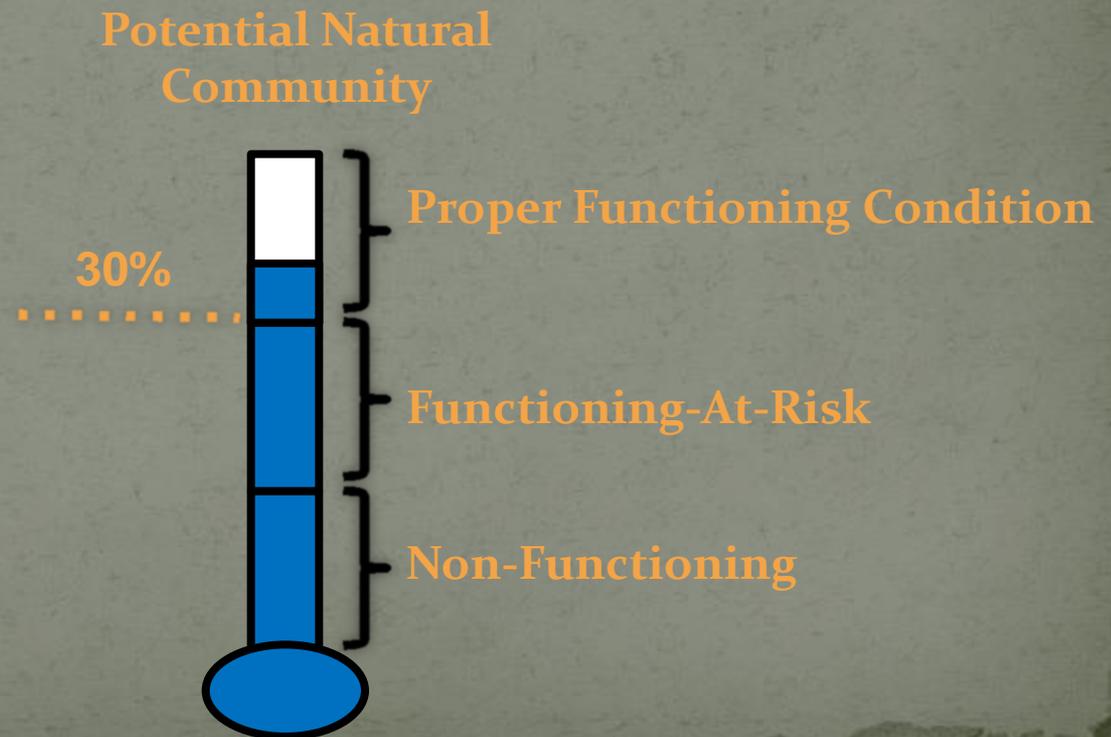
Reach #6 Summary Determination

- Proper Functioning Condition
- Diverse plant communities, banks well vegetated, healthy and vigorous, noxious weeds and invasive plants affecting bank stability
