MINE SITE VISIT REPORT
New Mexico AML Program

Date of Visit : August 30, 2007 **Weather :** Sunny 85°
Mine/Project Name: Barbara J # 1 Mine – Northwest of Grants, New Mexico
Duration of Visit : 1.0 hour (10:00 am to 11:00 am)
Purpose of Visit : Maintenance inspection to the Barbara J # 1 mine, part of the legacy site assessment for AML project sites.
Observations : Travel to the project site; access to this site was from the west using a two track road. Location: SW1/4, NW1/4, NE1/4 of Sec. 20 T.13N., R.9W., Dos Lomas Quad. UTM Zone 13, E243060 N3913260, Uranium Mine. This site is on BLM land.

Date of Visit : August 22, 2007 **Weather :** Sunny, hot, windy 95°
Mine/Project Name: Barbara J # 2 Mine – Northwest of Grants, New Mexico
Duration of Visit : 1.0 hour (2:00 pm to 3:00 pm)
Purpose of Visit : Maintenance inspection to the Barbara J # 2 mine, part of the legacy site assessment for AML project sites.
Observations : Travel to the project site; access to this site was from the west off Haystack Road. Access was via a two track dirt road. Location: NE1/4, SE1/4, NW1/4 of Section 30 T.13N., R.9W., Dos Lomas Quad. UTM Zone 13, E 242410 N 3912960, Uranium Mine. This site is on BLM

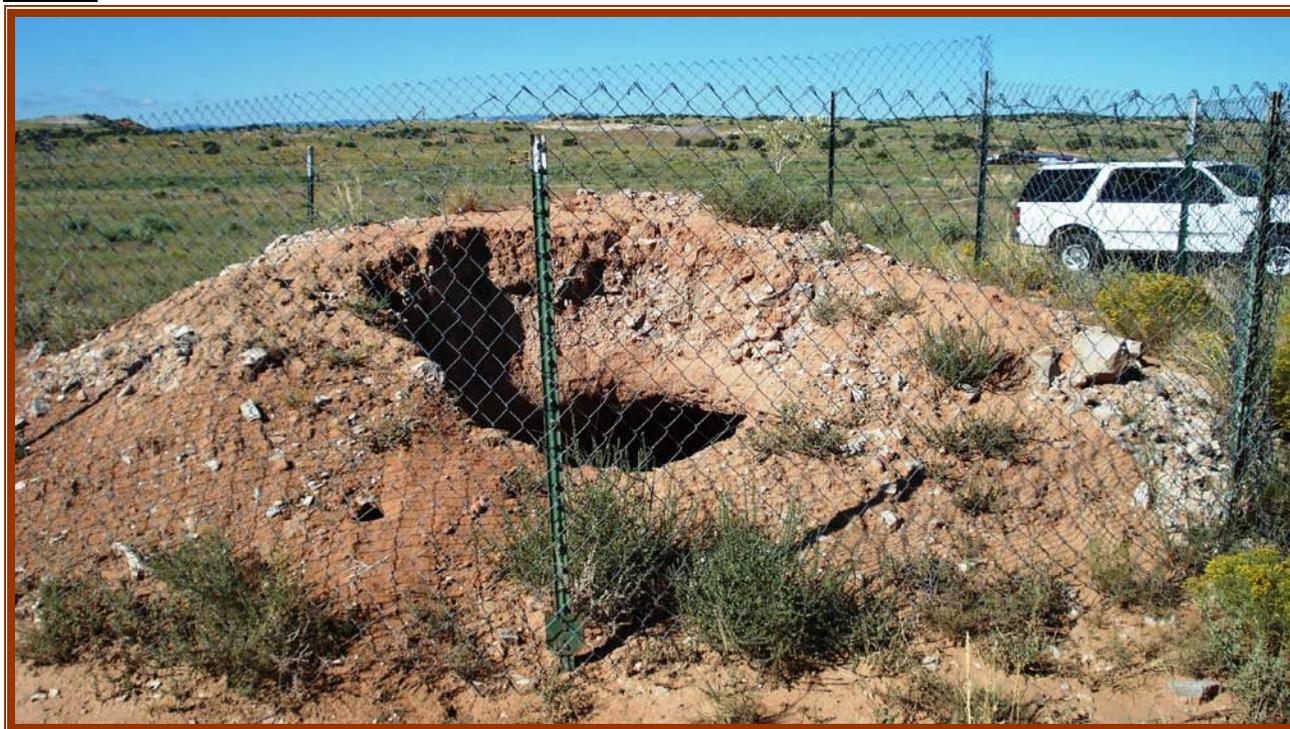
Signs of human activity were not recent. Vegetation is similar to undisturbed areas except for waste piles which lacked vegetation. Land use appears to be limited grazing for cattle but not recently. Previous reclamation is obvious. The shaft is fenced and subsided. Total site area is approximately 6 acres. The nearest residence appears to be over 1-mile away in the southern direction.

Mine Shaft Subsided Looking Southwest

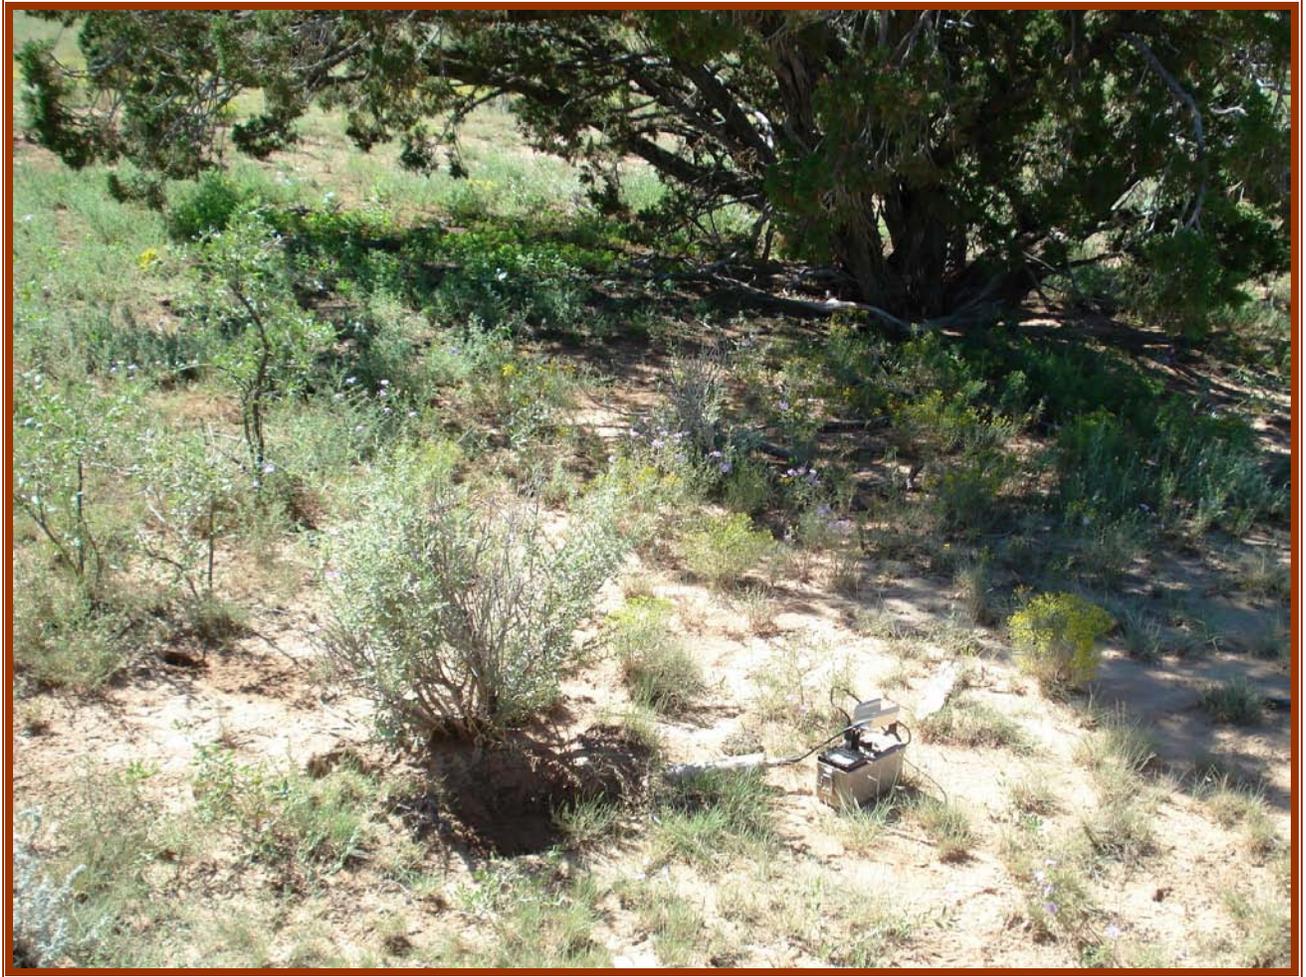
Background radiometric levels of 29 $\mu\text{R/hr}$ at both 1-meter and ground level, were read utilizing a Ludlum Model-14C survey meter with a NaI Model 44-2 Gamma Scintillator probe and were taken at the drill hole pictured below. The overall waste and ground within the middle portion of the disturbance area have radiometric levels of 114-257 $\mu\text{R/hr}$ at 1-meter and 200-429 $\mu\text{R/hr}$ at ground level.

Mine Drill Hole Looking East

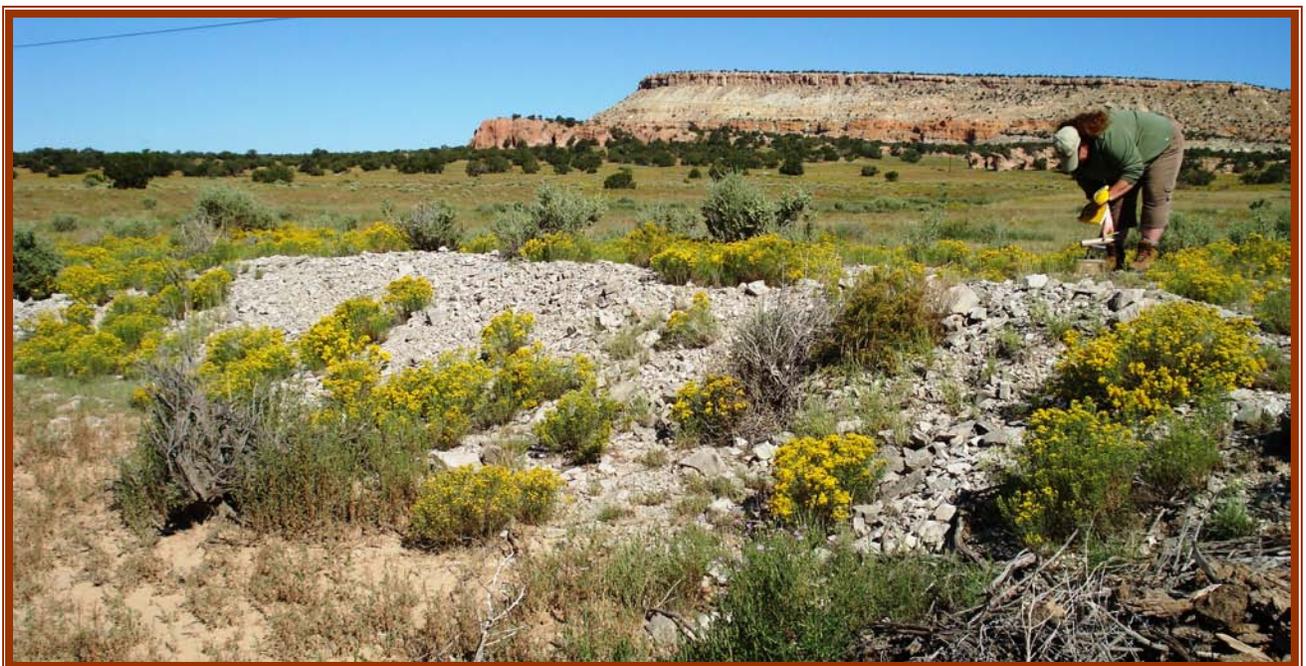
Mine Waste Pile Looking Northwest

Further action recommended to mitigate radiometric levels. No other safety concerns at this time.

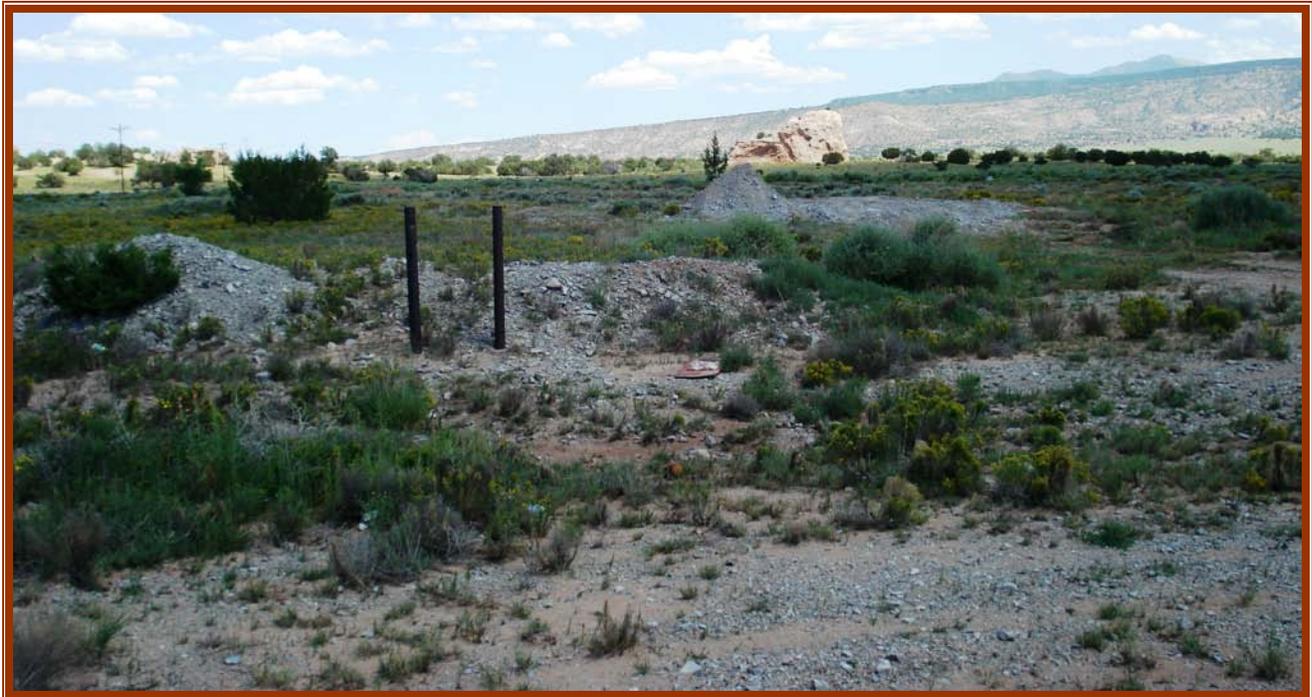
Background radiometric levels of 20 & 21 $\mu\text{R/hr}$ at 1-meter and ground level respectively, were read utilizing a Ludlum Model-14C survey meter with a NaI Model 44-2 Gamma Scintillator probe and were taken near the Piedra Trieste site. The overall waste and ground within the middle portion of the disturbance area have radiometric levels of 100-157 $\mu\text{R/hr}$ at 1-meter and 100-214 $\mu\text{R/hr}$ at ground level.

Mine Waste Looking East

Further action recommended to mitigate radiometric levels. The open vent shaft needs to be backfilled.

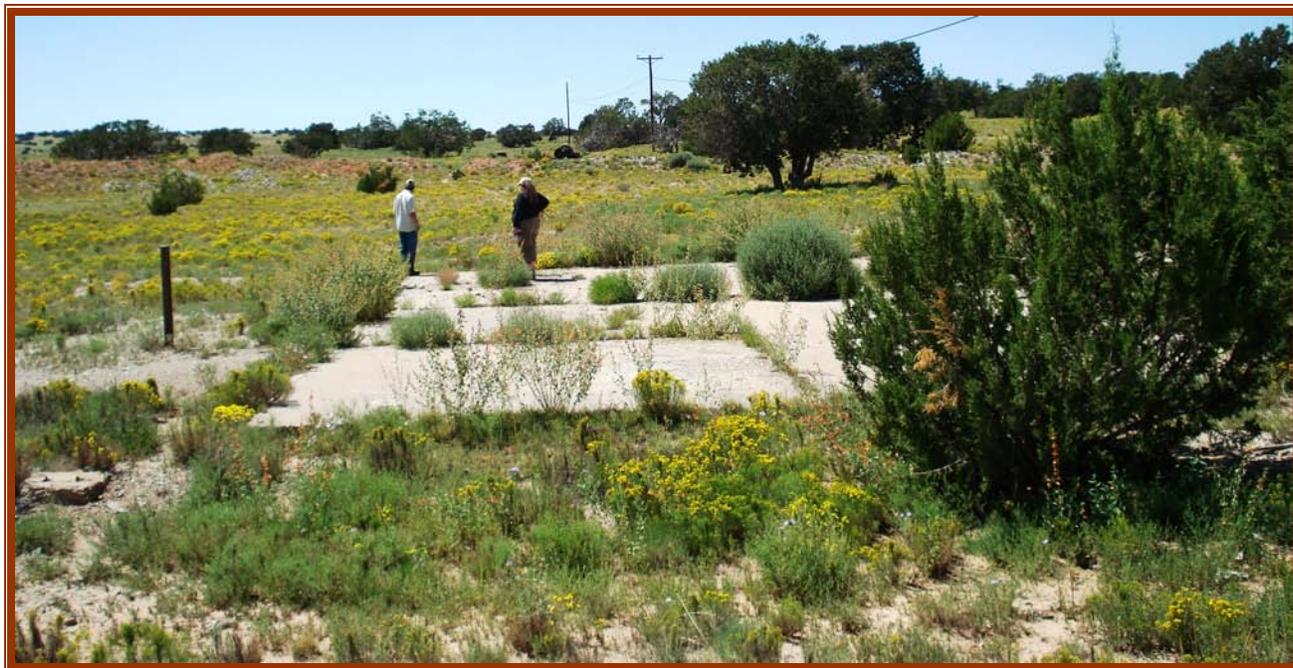
Concrete Pads Looking West

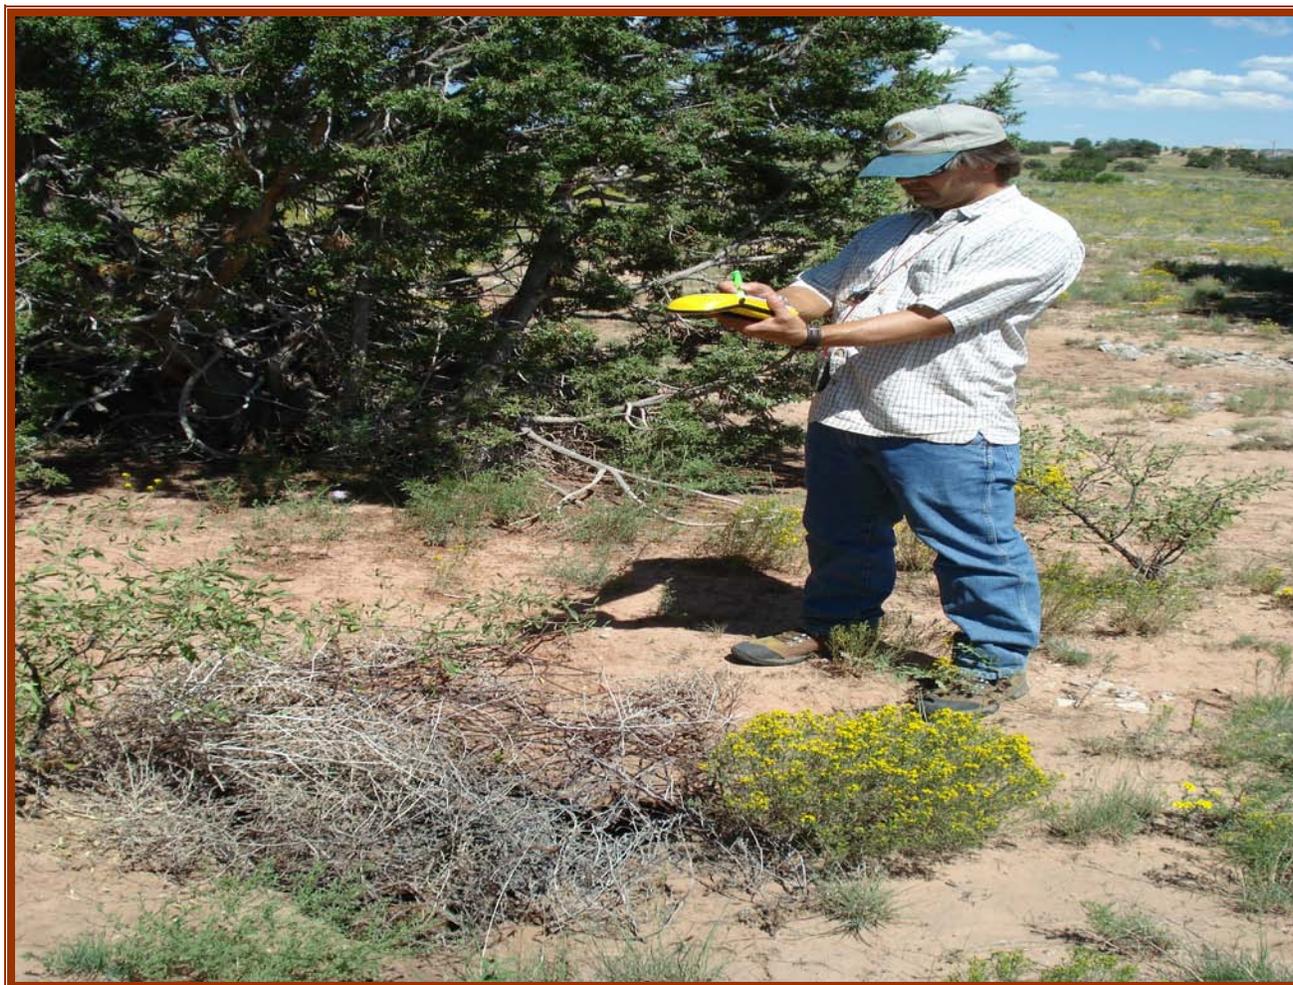
This site has areas of mounded waste and multiple concrete pads as well as some hoist equipment. There was one open vent shaft on this site. For complete details see topographic GPS info using the MapGuide map found at http://164.64.103.6/mmdtest/AML_Uranium-DEV.htm

Open Vent Shaft Looking North

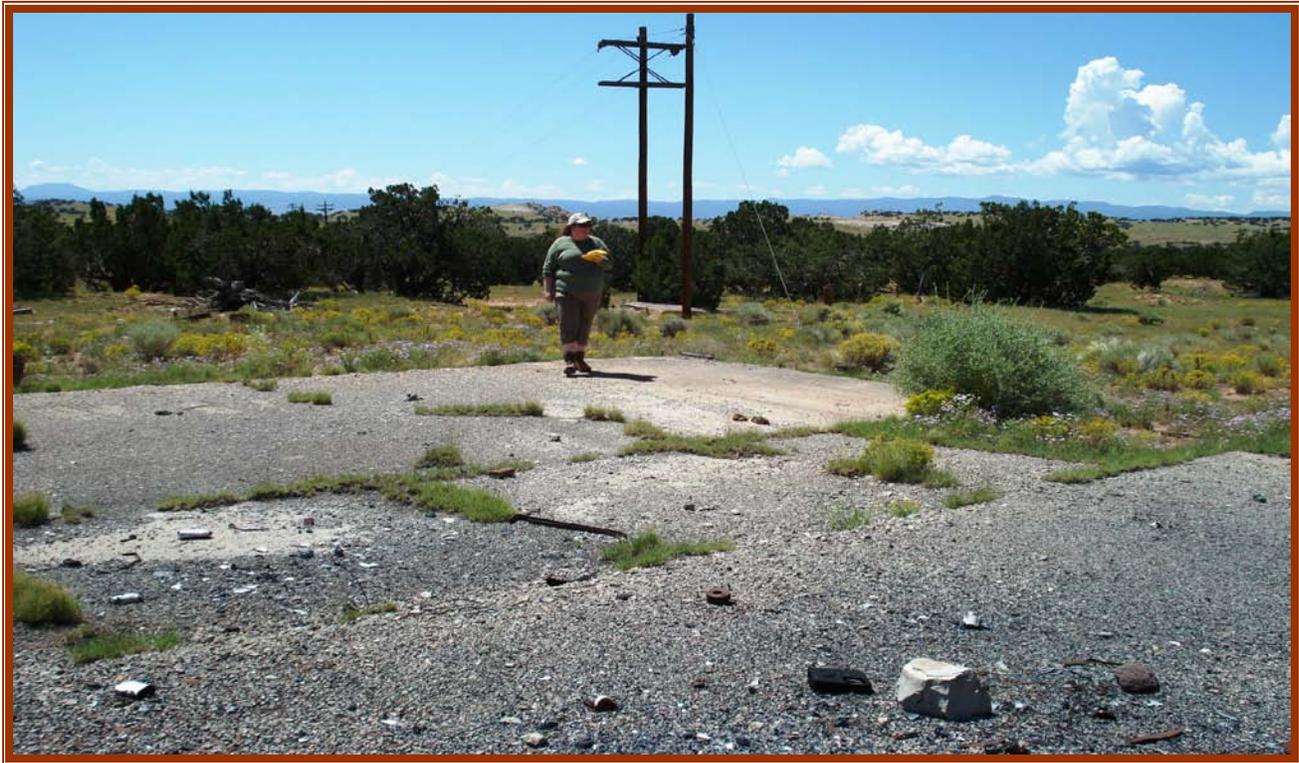
Concrete Foundations Looking South

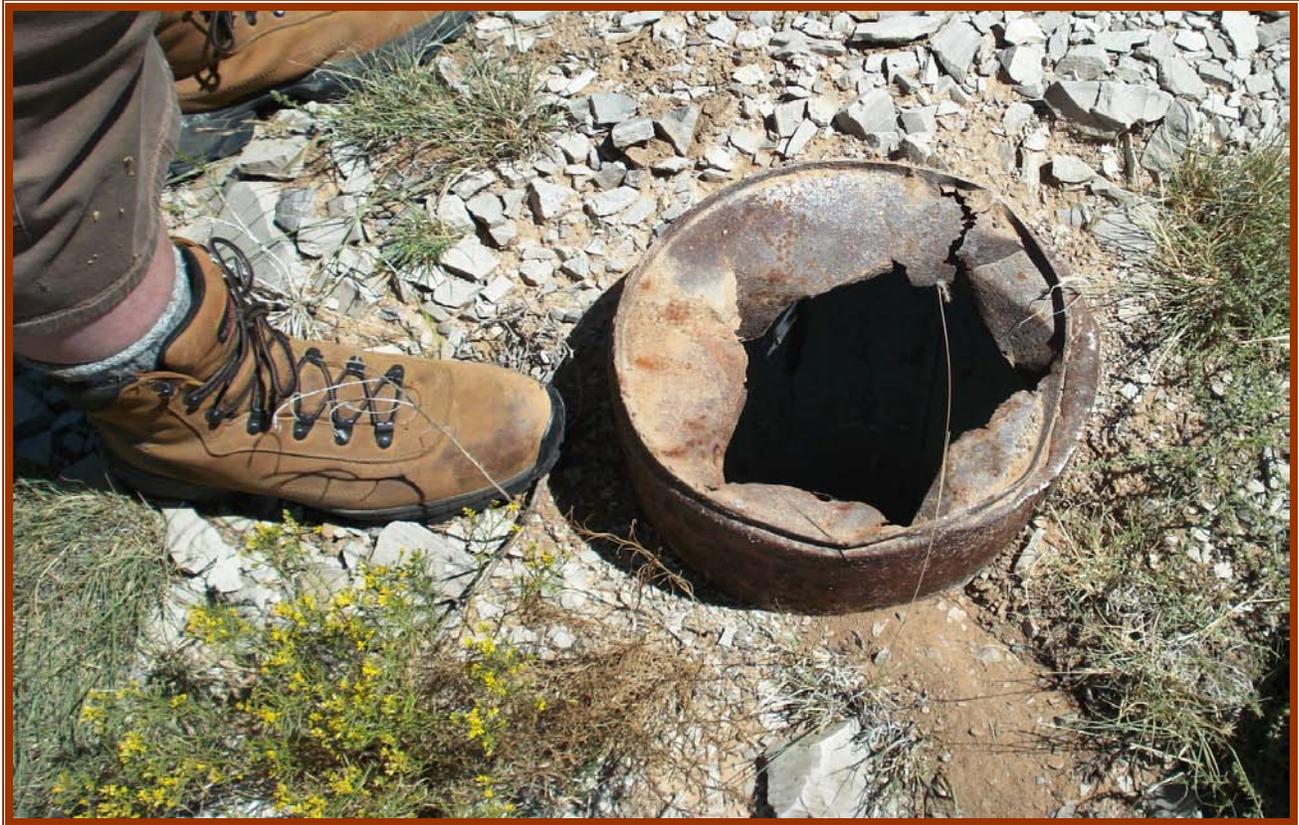
Metal Lined Vent Shaft With Rock Cover Removed Looking Down

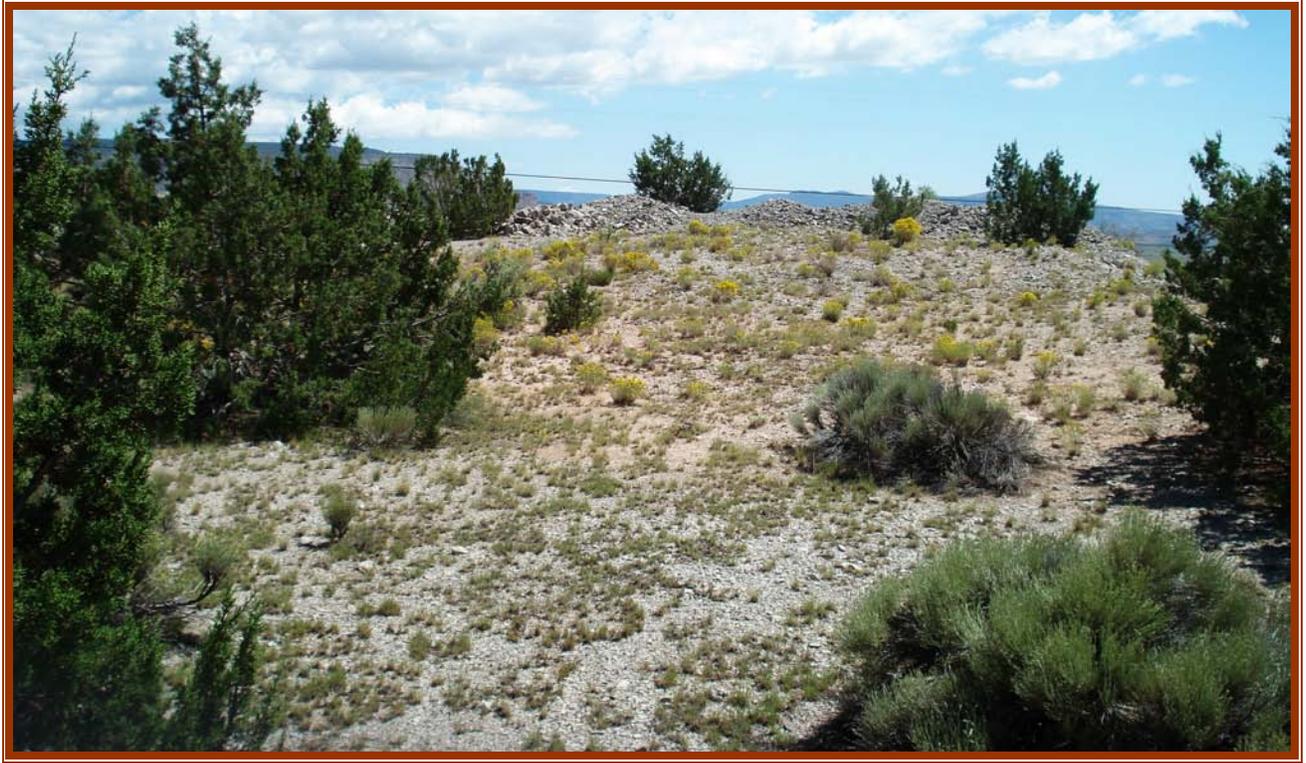
Top of Large Waste Pile Looking East

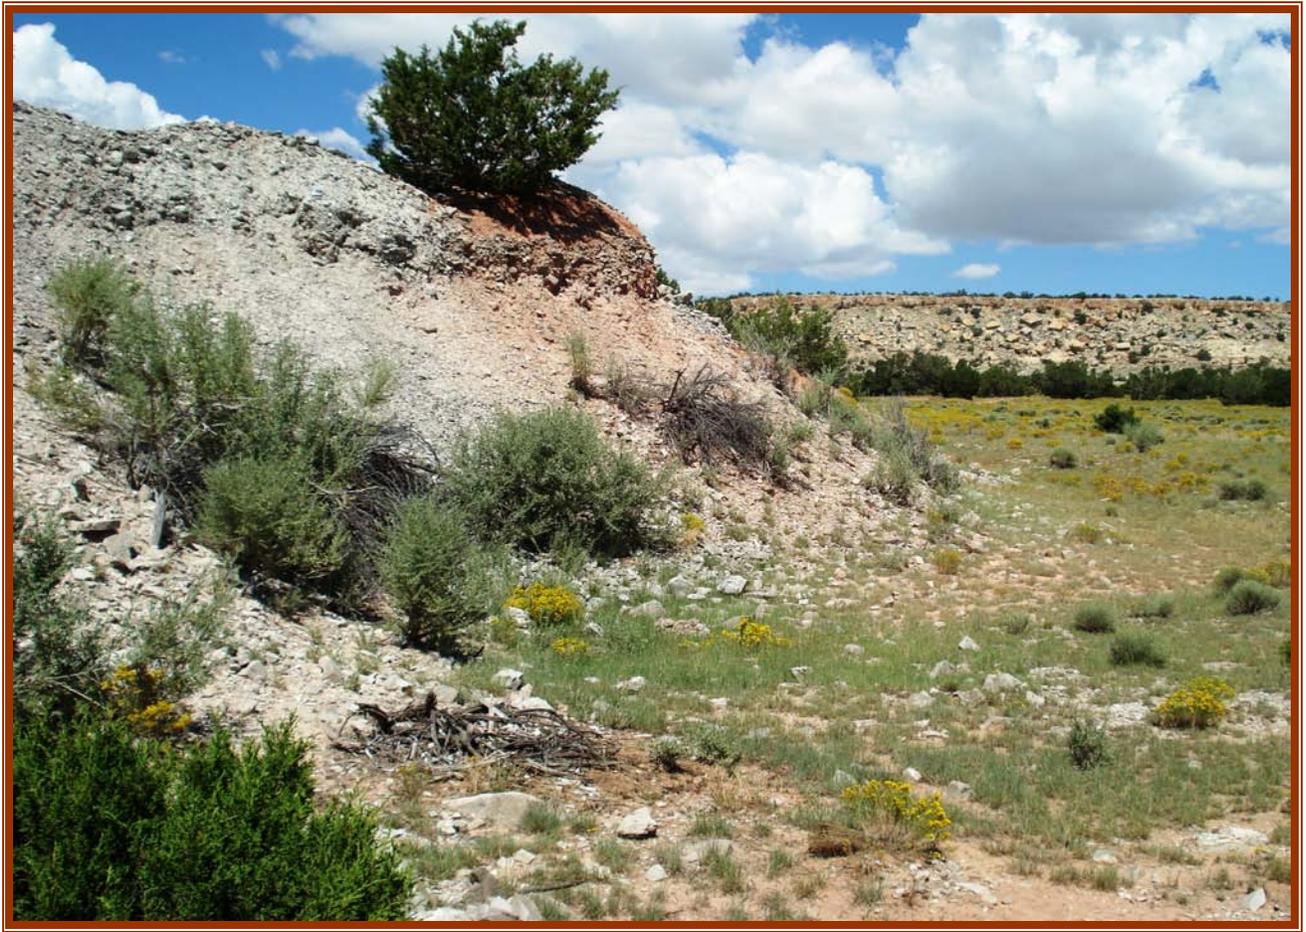
Bottom of Large Waste Pile Looking North

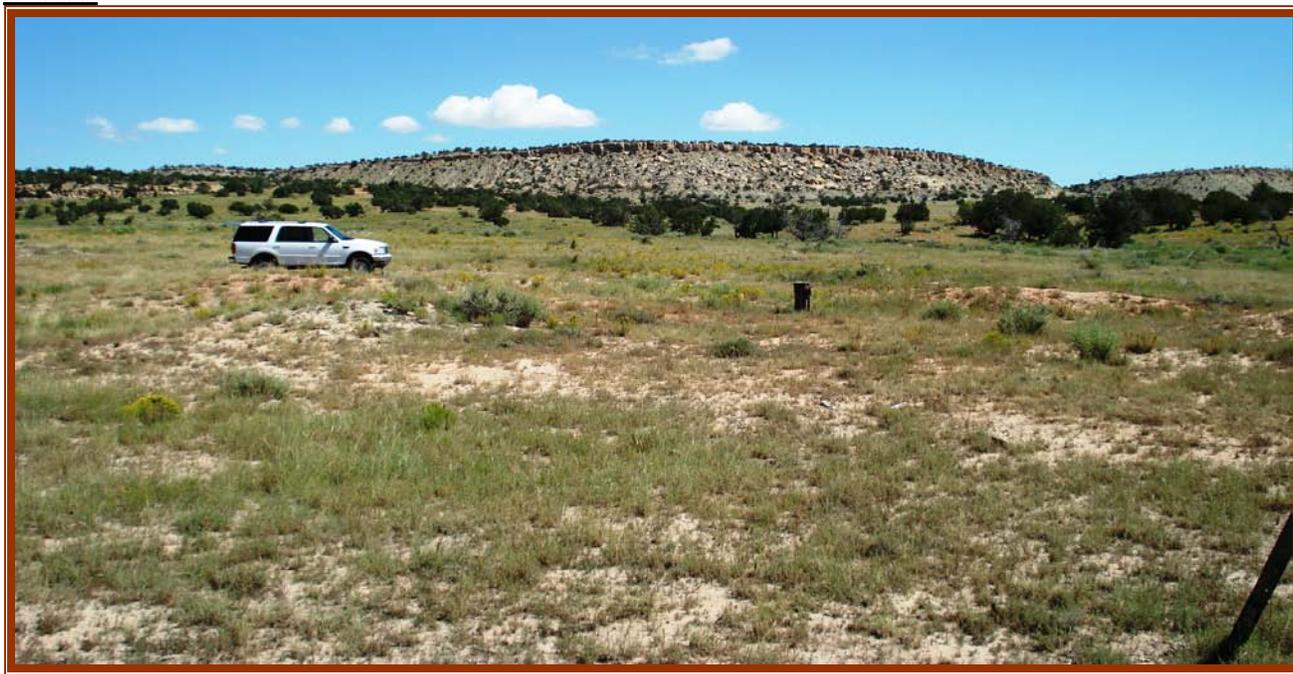
Overall Mine Site Looking Southeast

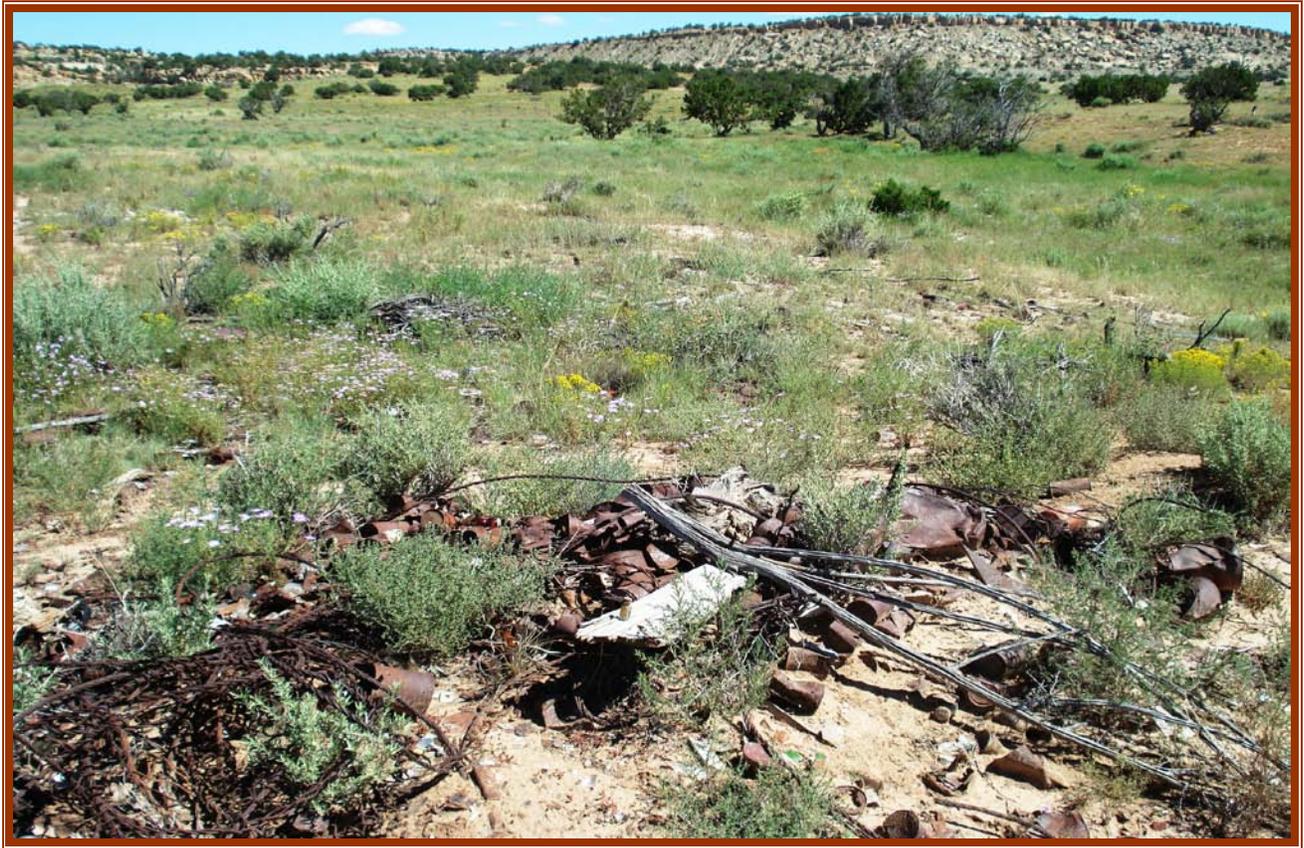
Catchment Pond and Artifacts Looking East

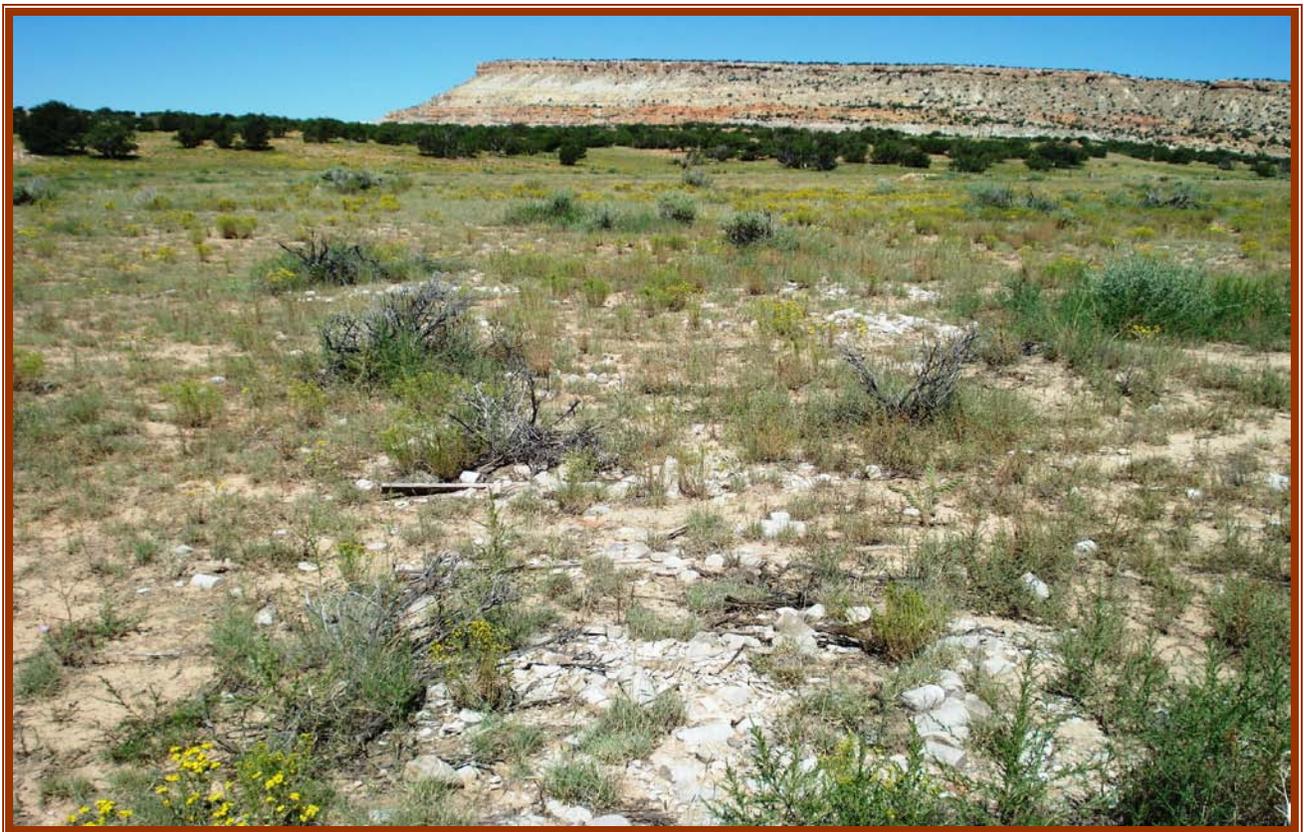
Background radiometric levels of 29 $\mu\text{R/hr}$ at both 1-meter and ground level, were read utilizing a Ludlum Model-14C survey meter with a NaI Model 44-2 Gamma Scintillator probe and were taken at the drainage and catchment pond. The overall waste areas within the middle portion of the disturbance have radiometric levels of 243-857 $\mu\text{R/hr}$ at 1-meter and 443-1429 $\mu\text{R/hr}$ at ground level.

Scattered Mine Waste and Core Samples Dump Looking North

Further action recommended to mitigate radiometric levels. No other safety concerns at this time.
