FEDERAL ENERGY REGULATORY COMMISSION FIELD INSPECTION REPORT

Dates of Inspection June 25-27, 2013

Project Ruby Pipeline, L.L.C.
Ruby Pipeline Project
Wyoming, Utah, Nevada, and Oregon
Docket No.: CP09-54-000
Authority: Section 7(c)

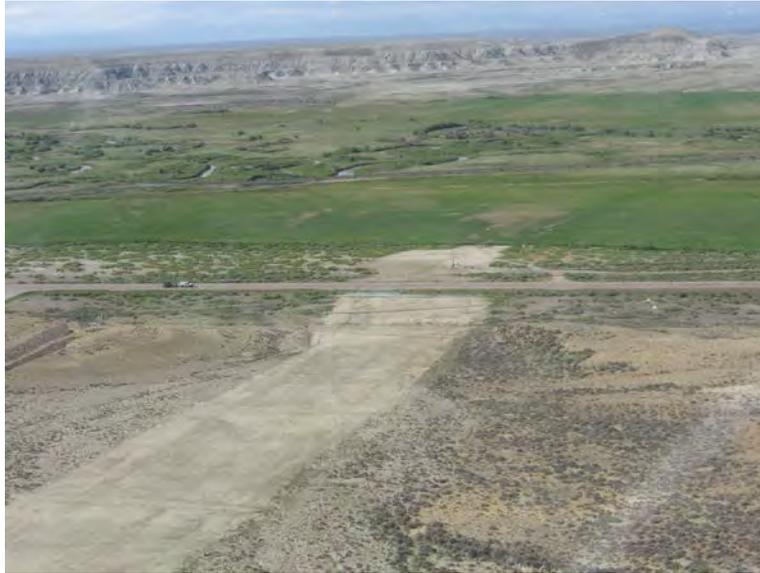
1) MP 0

1-4) Bare right-of-way in eastern Wyoming

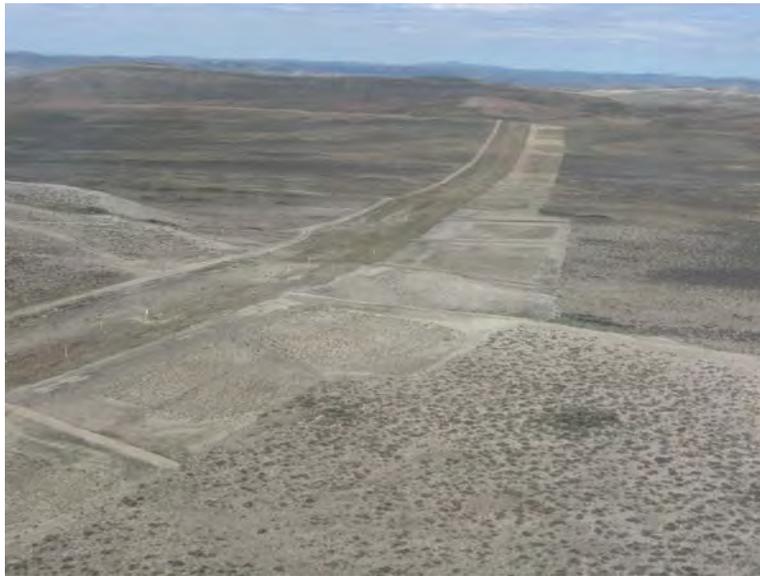
3) MP 12.3; starting to see some revegetation

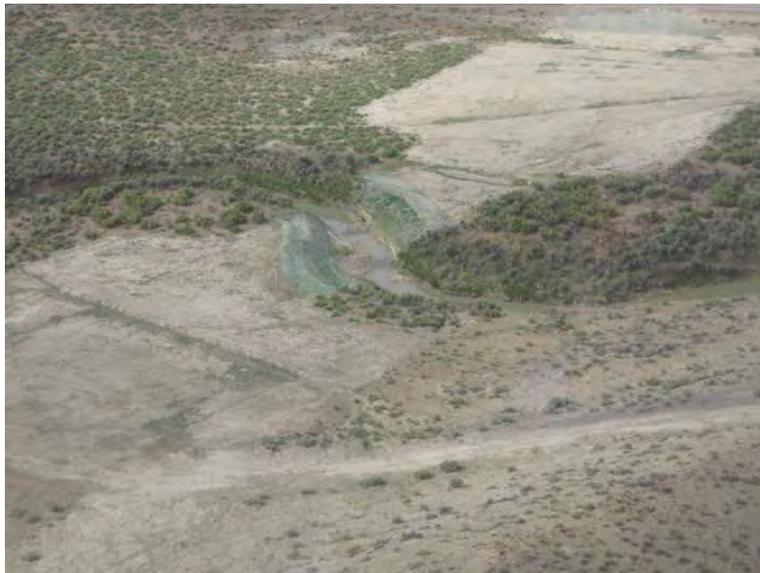
4) MP 19.6; with restored crossing of Little Muddy Creek

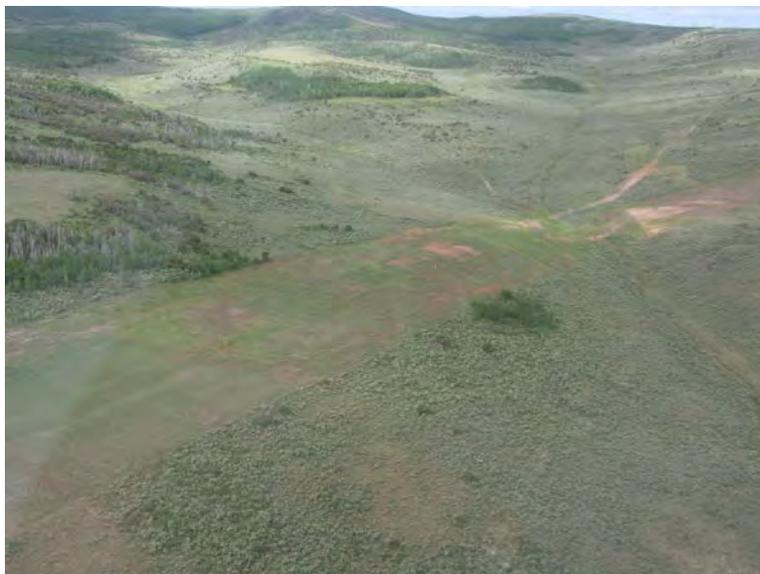
6) MP 37

5-8) Western Wyoming exhibits more greening of ROW in higher elevations, though patchiness is common

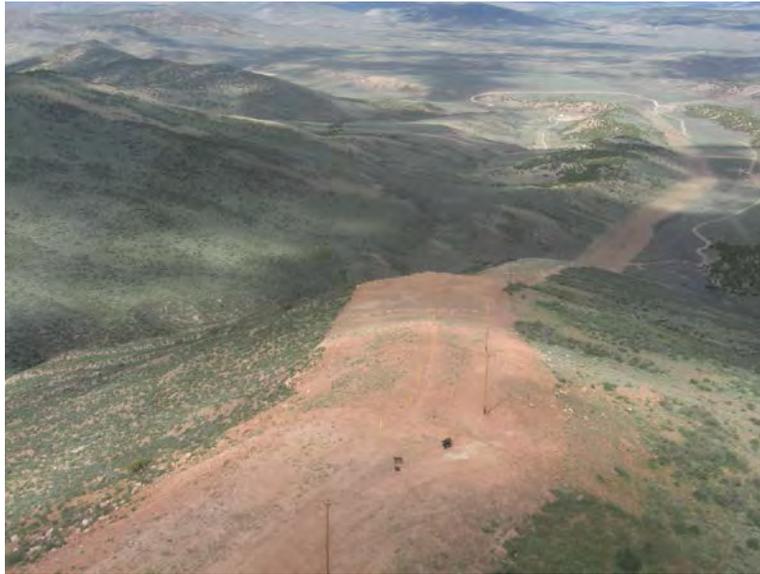
7) MP 40; downslope is greener than ridge top

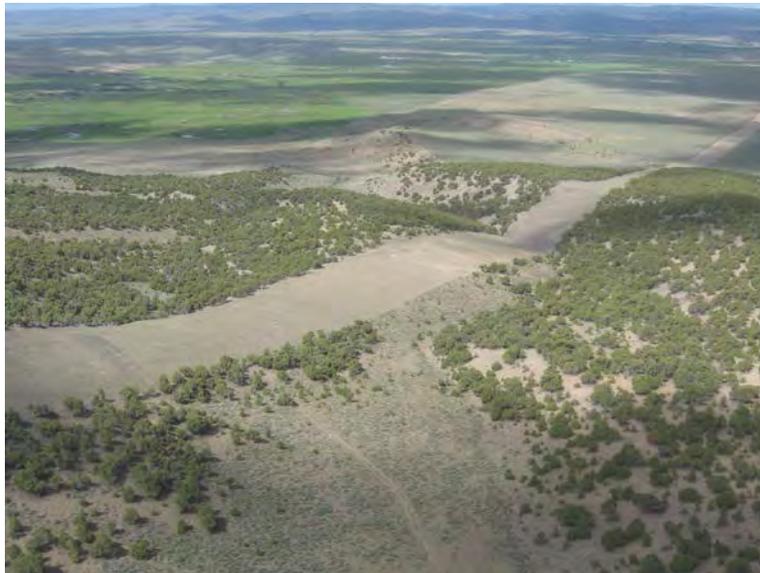
8) MP 47; greening is more uniform

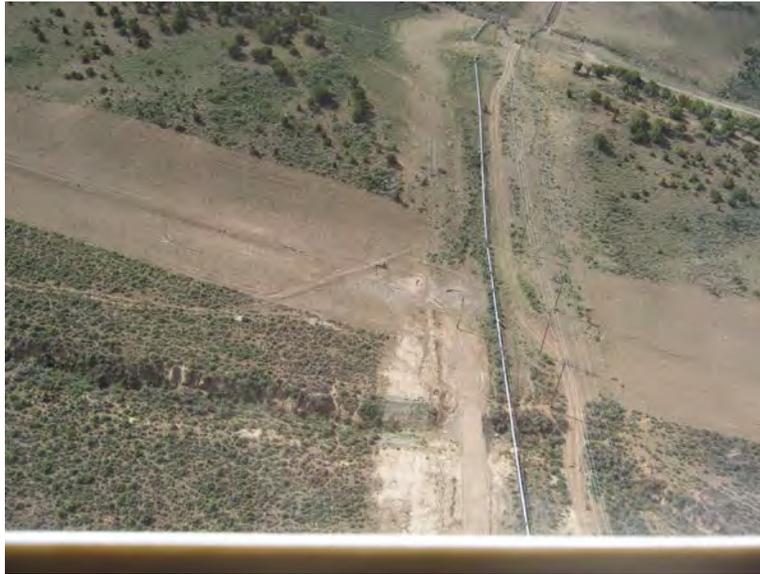
9) MP 41.3; subsidence issues remain at this location

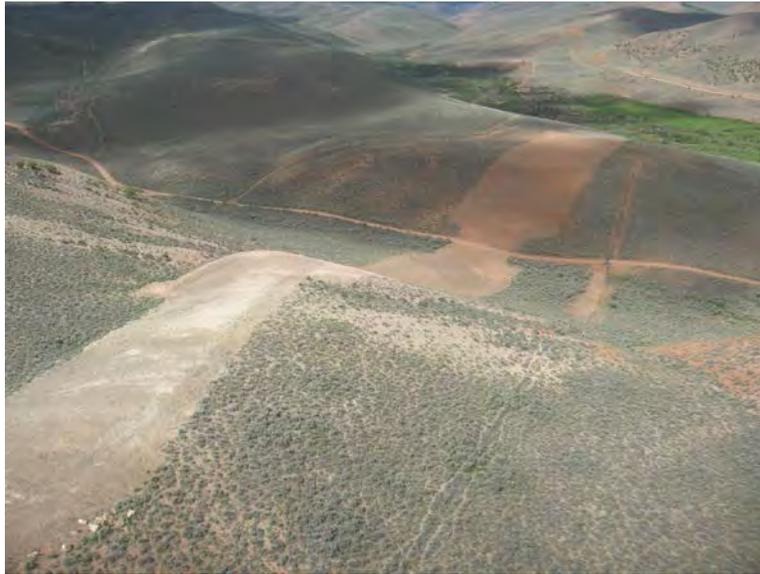
15) MP 60.5

14-25) Some of the Utah route exhibited patchy revegetation or bare areas. The further West, the more chance for bare right-of-way.

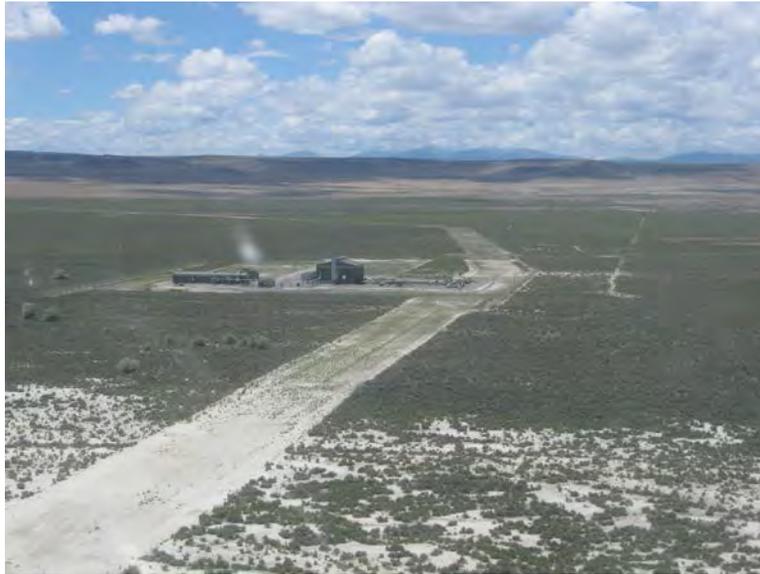
21) MP 172.5; approaching the Wildcat Hills Compressor Station

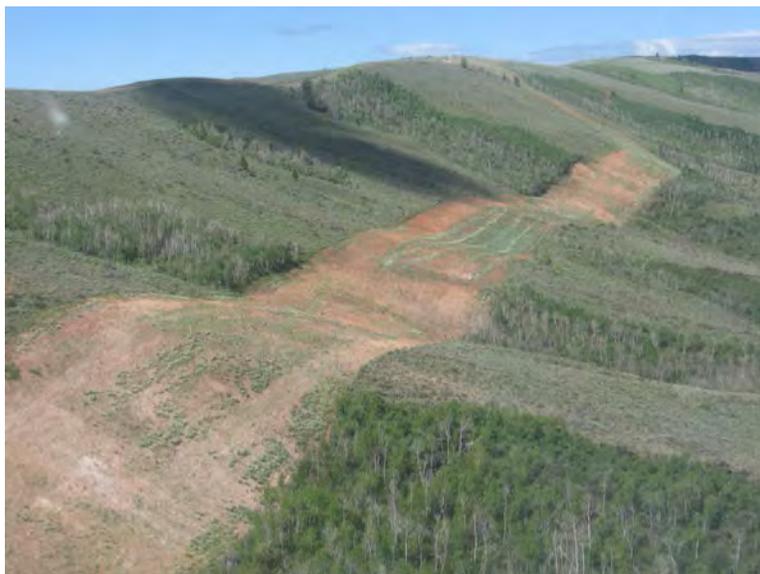
26) MP 64

26-27) Side slopes were stable; revegetation sporadic

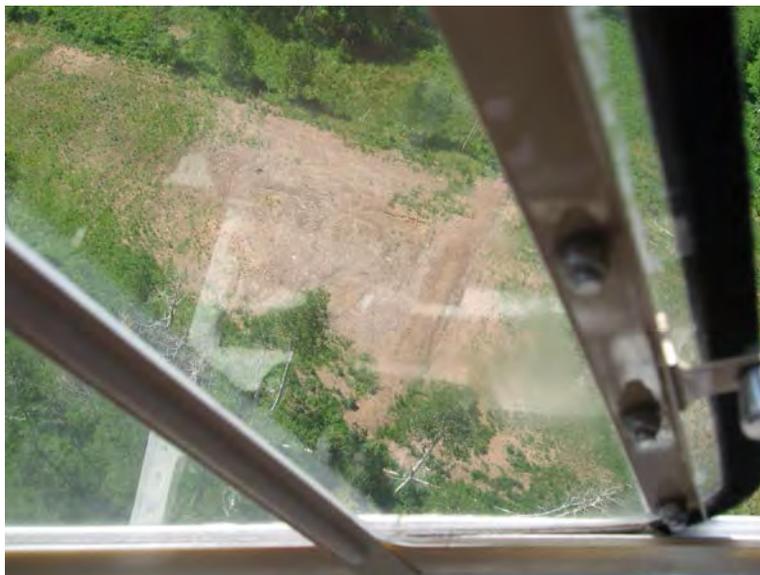
28) MP 75.1; subsidence issue from 2012 persists

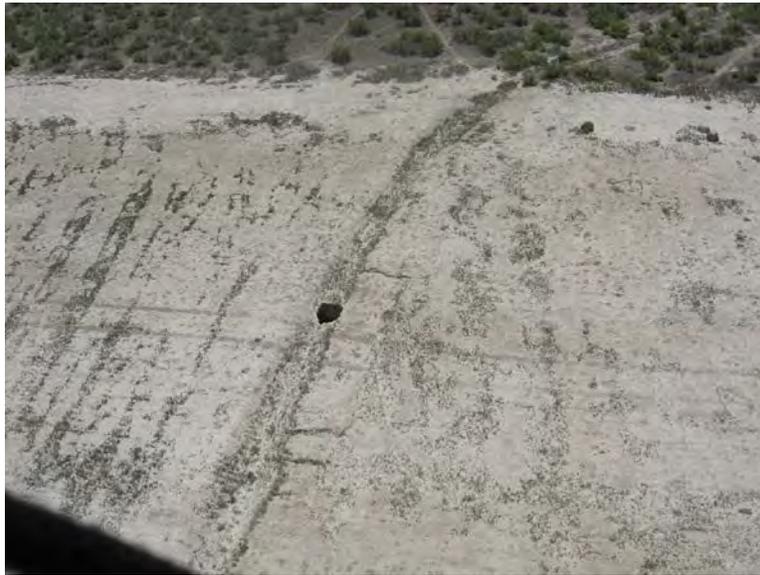
29) MP 149.5

29-30) New subsidence issues documented

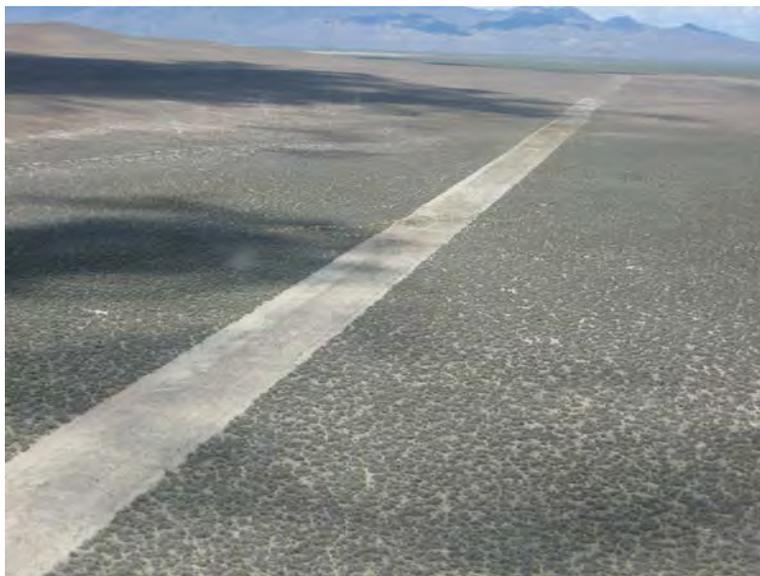
58) MP 465.3; little revegetation

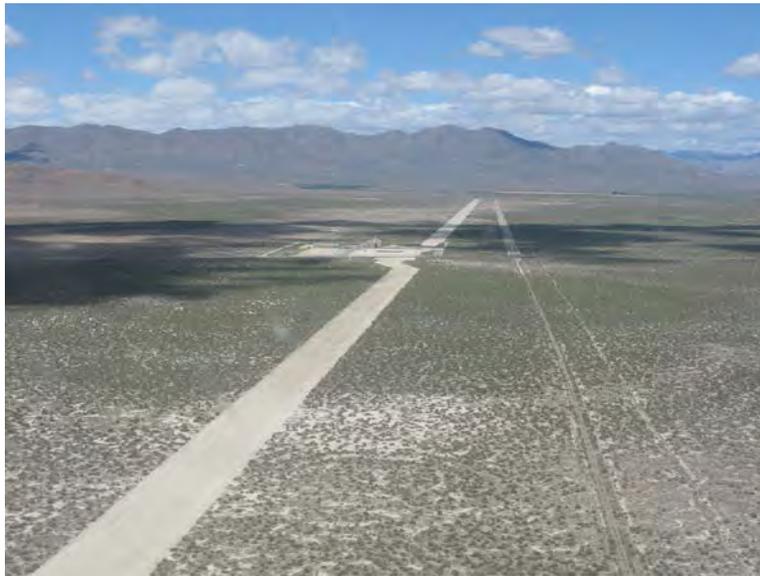
59) MP 484.4; bare right-of-way around the Desert Valley Compressor Station

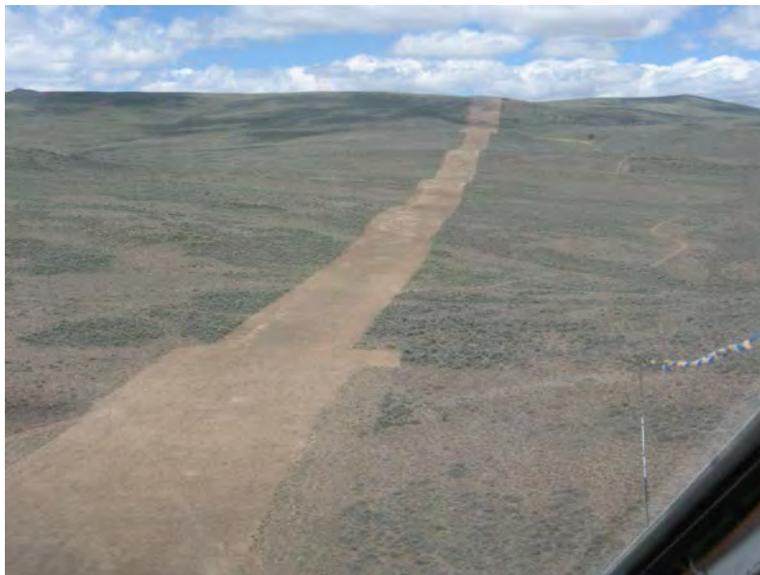
64) MP 547

62-65) lack of sufficient revegetation in Washoe County, NV

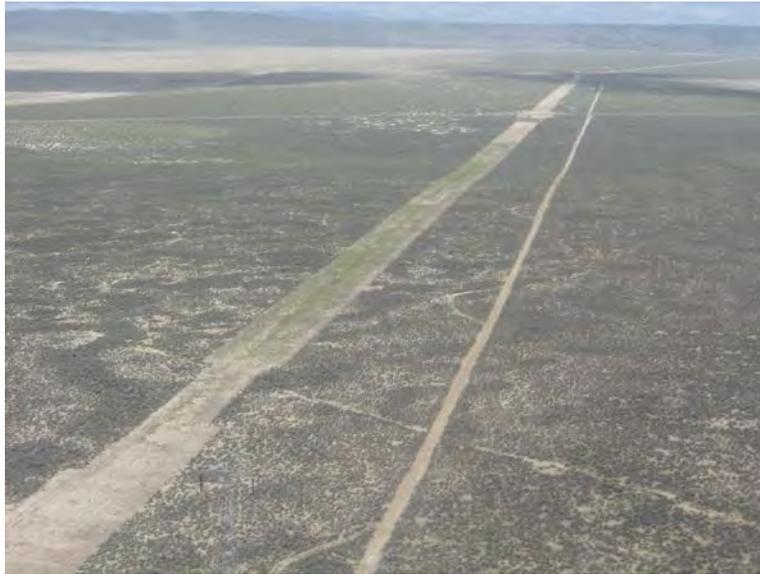
65) MP 568.7; with a green patch

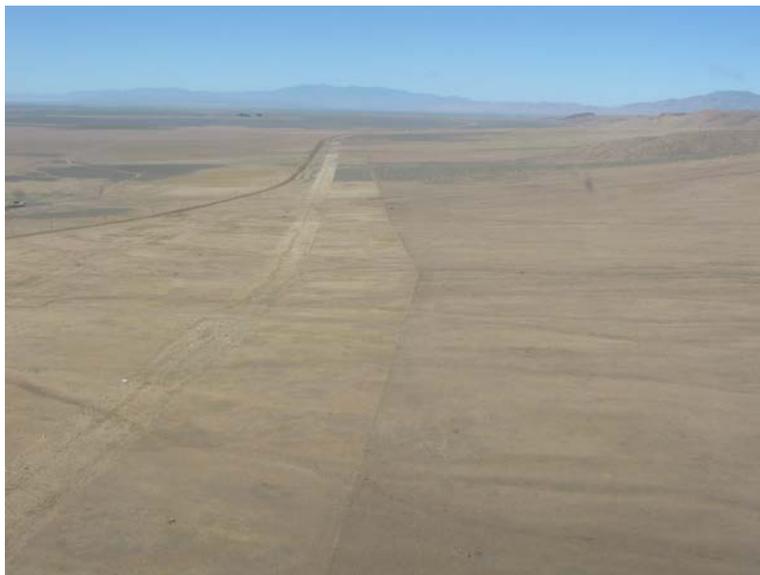
66) MP 395.7

66-67) Cheatgrass is present in certain areas, both on and off right-of-way

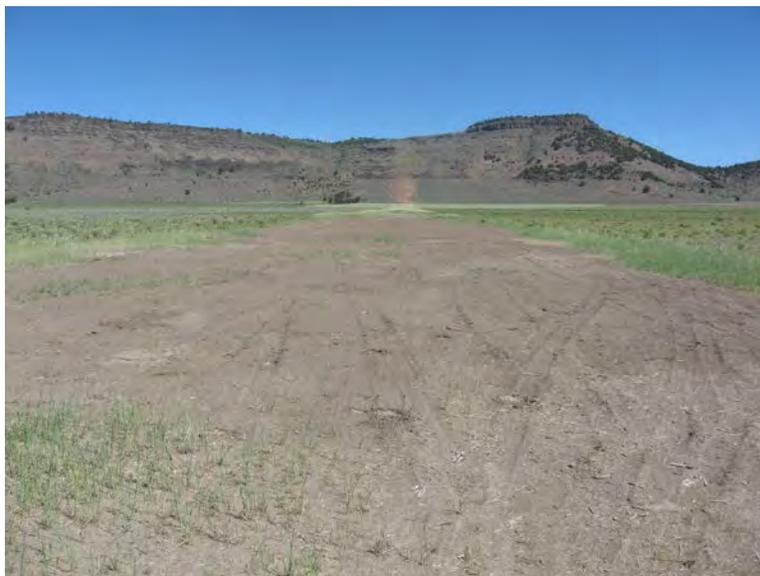
78) bare patch where recent work was done to repair subsidence and remove debris

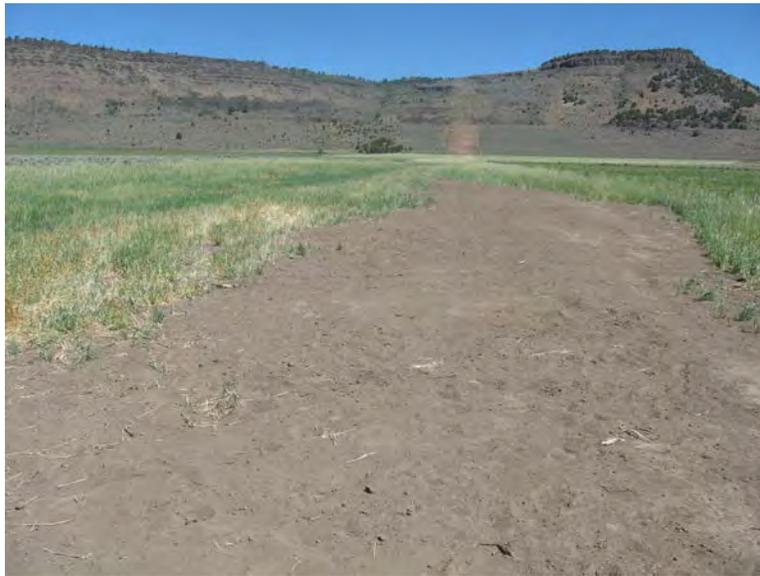
79) recent repair of low spot/erosion area

Ruby states that it has brought in numerous trucks of topsoil in an effort to replace lost soil and fill in low spots. Ruby reports it will reseed these locations. This appears satisfactory. However, I have instructed Ruby to compare topsoil and compaction readings on and off right-of-way to ensure soil conditions are comparable to the surrounding area.

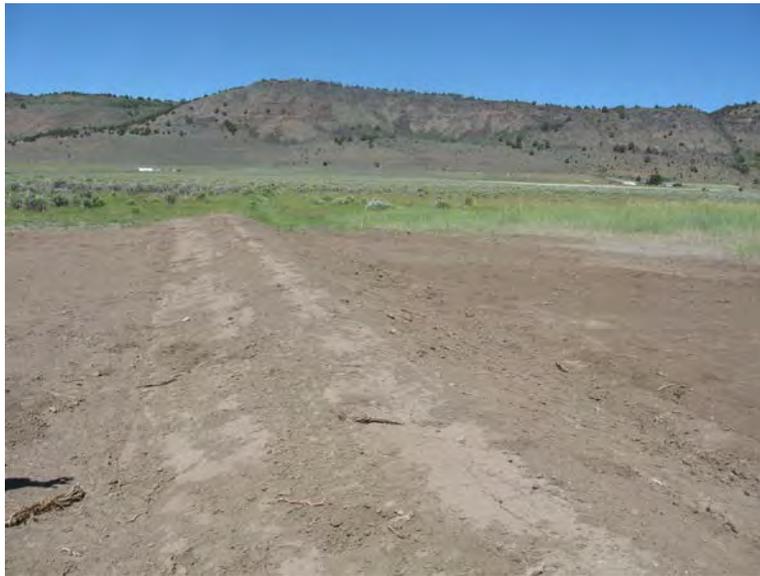
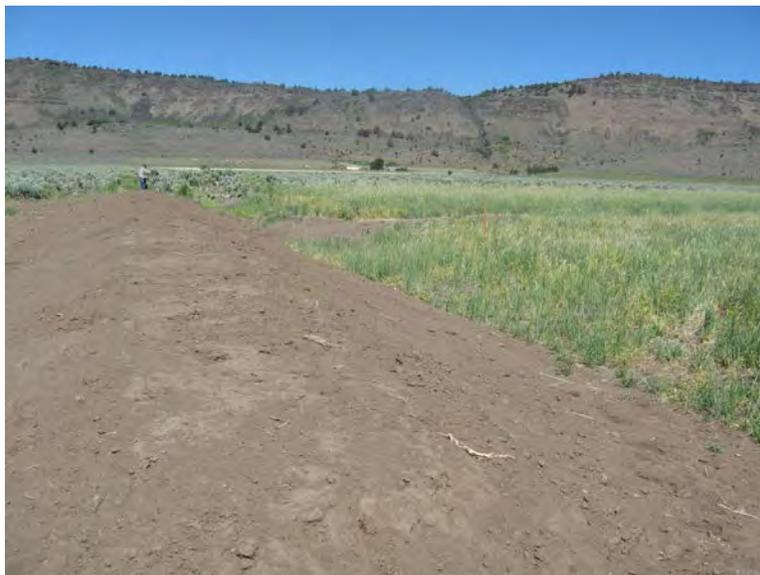
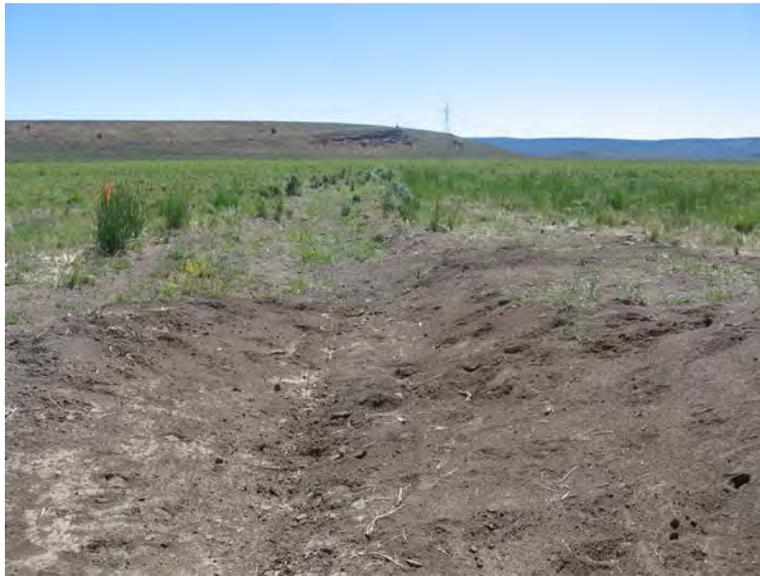
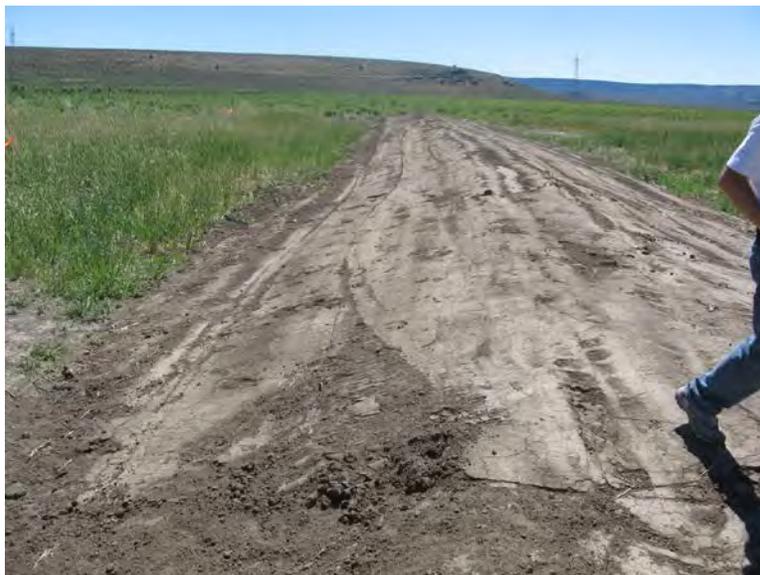
Photos 81-84 show where channels have been recently reinforced with earthen berms. Ruby reports that project engineers designed the berms in consultation with Mrs. Gladwill for the purpose of ensuring proper drainage of water off the right-of-way. The berms appeared to be quite high, which may or may not be satisfactory to Mrs. Gladwill. There was no evidence of any remaining debris, mats, silt bags, etc. on or off the right-of-way, except for a small stack of mats/timbers Ruby left for the landowner upon her request (**photo 85**). **Photo 86** shows debris recently collected by Ruby from the right-of-way.

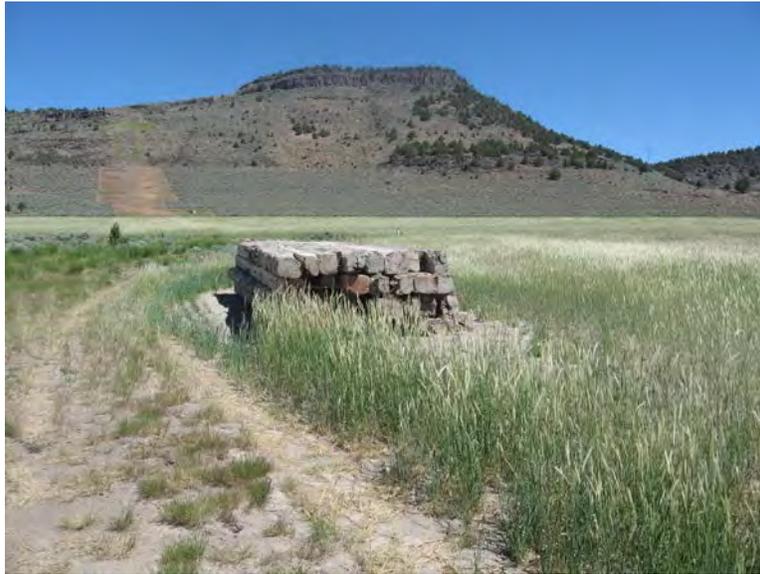
85) Mats/timbers left at the request of the landowner

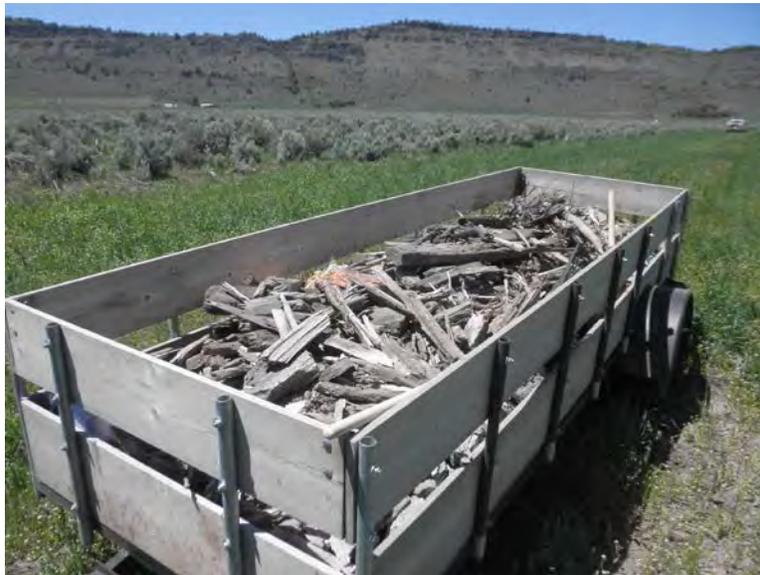
86) Debris collected by Ruby from the right-of-way
