***Denali Mine On Valdez
Creek, South Central Alaska:
A Cultural Resources Evaluation***

by Beth E. Walton
Cheryl A. McCaffrey

Bureau of Land Management
Alaska

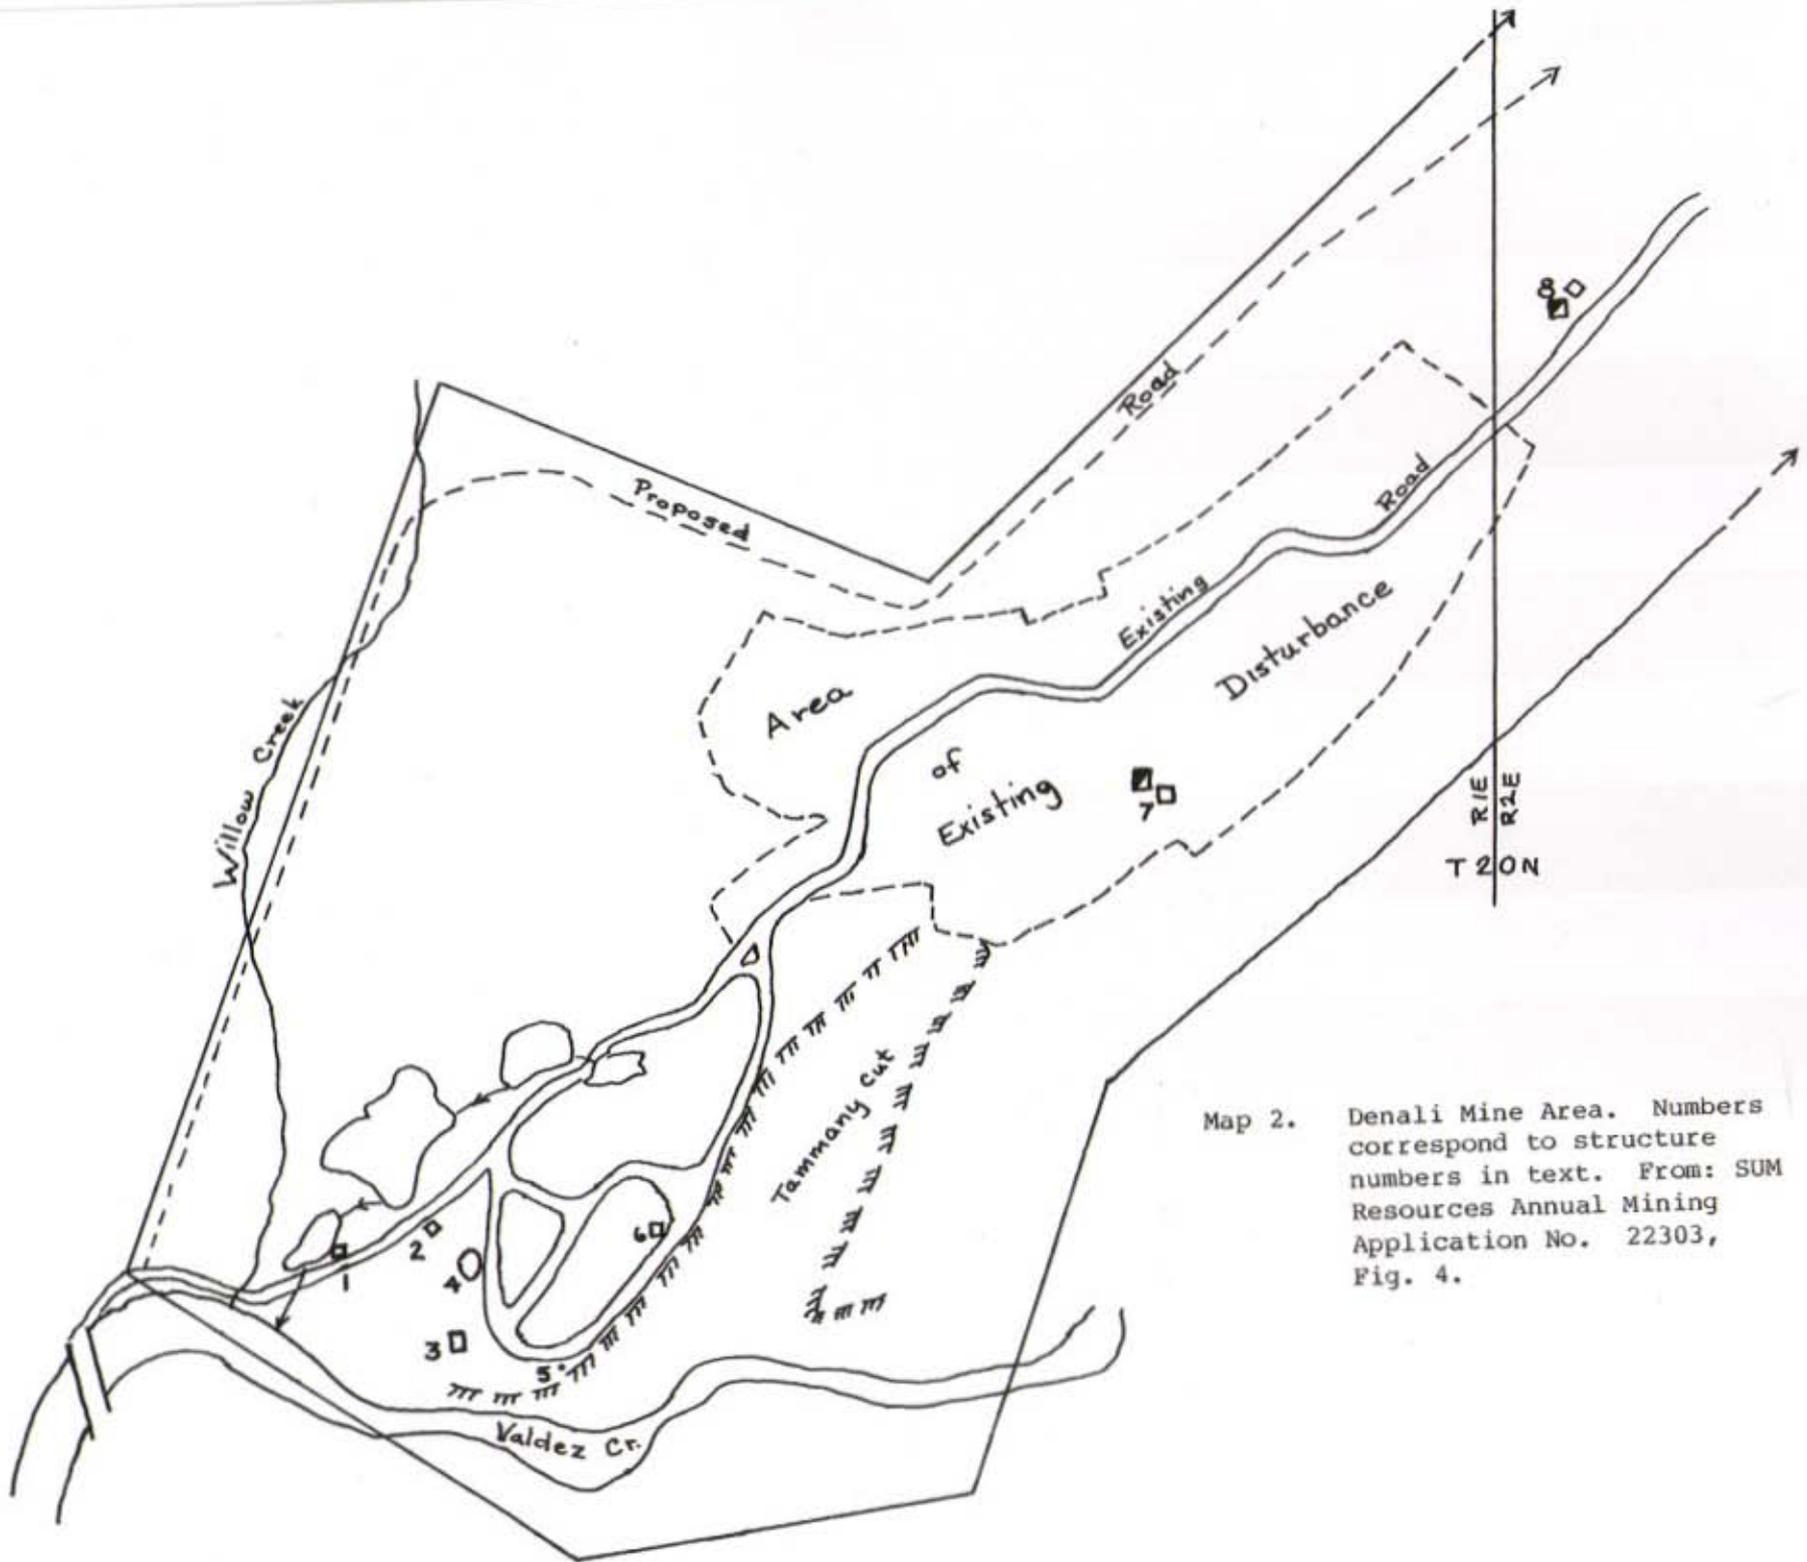
Map 2. Denali Mine Area. Numbers correspond to structure numbers in text. From: SUM Resources Annual Mining Application No. 22303, Fig. 4.

- 1 Cabin ruin: logs, trash, broken bottles, broken china and a wood stove. The structure is completely destroyed.
- 2 Dog kennels: four simple sloped roof structures remain. All are in poor (unusable) condition.
- 3 Graves: white picket fences about 8' long, 5' wide and 4' high surround each of two graves. Both graves are in good condition. Fences are made of 4x4 corners and 2x4 rails with 4x1/4 pickets. The east grave is identified by a horizontal, bronze(?) plaque (approximately 12" x 8") that reads

- 4 Sled dump: The remains of sleds used to haul in supplies are primarily of running gear; no beds were observed. Tundra vegetation has obscured many pieces. There are likely more than ten and fewer than thirty pieces.
- 5 Three-hole Privy: This 9' x 6' shiplap plank structure is still in occasional use. The roof is gabled and there are 1 x 8" cornercaps. The interior has two partitions for semiprivacy of multiple occupants.
- 6 Superintendent's house: The roof and east wall of this three-room log cabin have fallen in. Dessauer and Harvey (1980: 89, 98-99) noted that this structure was partially collapsed in 1977. Observations in 1984 are at variance with the details given in their 1980 report, particularly in the floor plan (compare Fig. 1, p. 4 with Dessauer and Harvey, Fig. 5).

- 7 Shack at Shaft No 1: This single room structure is 14' x 10'. The entry is in the west side of the south wall as is one 3/3 casement window. The exterior saltbox shape is modified to a gabled ceiling on the interior. The exterior planks were covered by tar paper and battened. The roof is corrugated tin. The three board door is locked with a new looking padlock.

- 8 Shack at Shaft No 3: This board and batten one room structure measures 10'x10'. The entry is in the middle of the south wall. There is a 2/2 sliding casement window slightly south of center in the west wall. The interior has a table on the west wall and an open overhead rack in the northeast corner.

The historic settlement of Denali no longer has sufficient integrity to be considered a historic district. The remaining ruins (cabin, superintendent's house, sled dump, and kennels) do not preserve the feeling or association of a mining settlement; they are merely vestiges of the past. The superintendent's house had a certain elegance of architectural detail that was unusual in such mining camps. Unfortunately, the structural failure of roof and walls has destroyed the integrity of the house to the point that preservation is not prudent. These details were recorded here to complete the historic documentation. The shacks at Shafts 1 and 3 are in good condition but there is no demonstrable association of these structures with the historic mining period or with any specific person. Based on the plan of operation and discussion with the mine operator, the operations will not disturb the graves, kennels, sled dump, superintendent's house, or privy. The cabin ruin between the access road and proposed settling pond #4 may be disturbed or may sluff down; since this structure is ruined, further disturbance is inconsequential. The shack at Shaft No. 1 may be disturbed in overburden removal. The shack at Shaft No. 3 is not in this year's plan area but may be disturbed in a future year. Although in good condition, these structures lack association with the historic (1903-1930) period or with known persons and their disturbance would be inconsequential. Measurements taken in this survey will serve to document their structural characteristics.

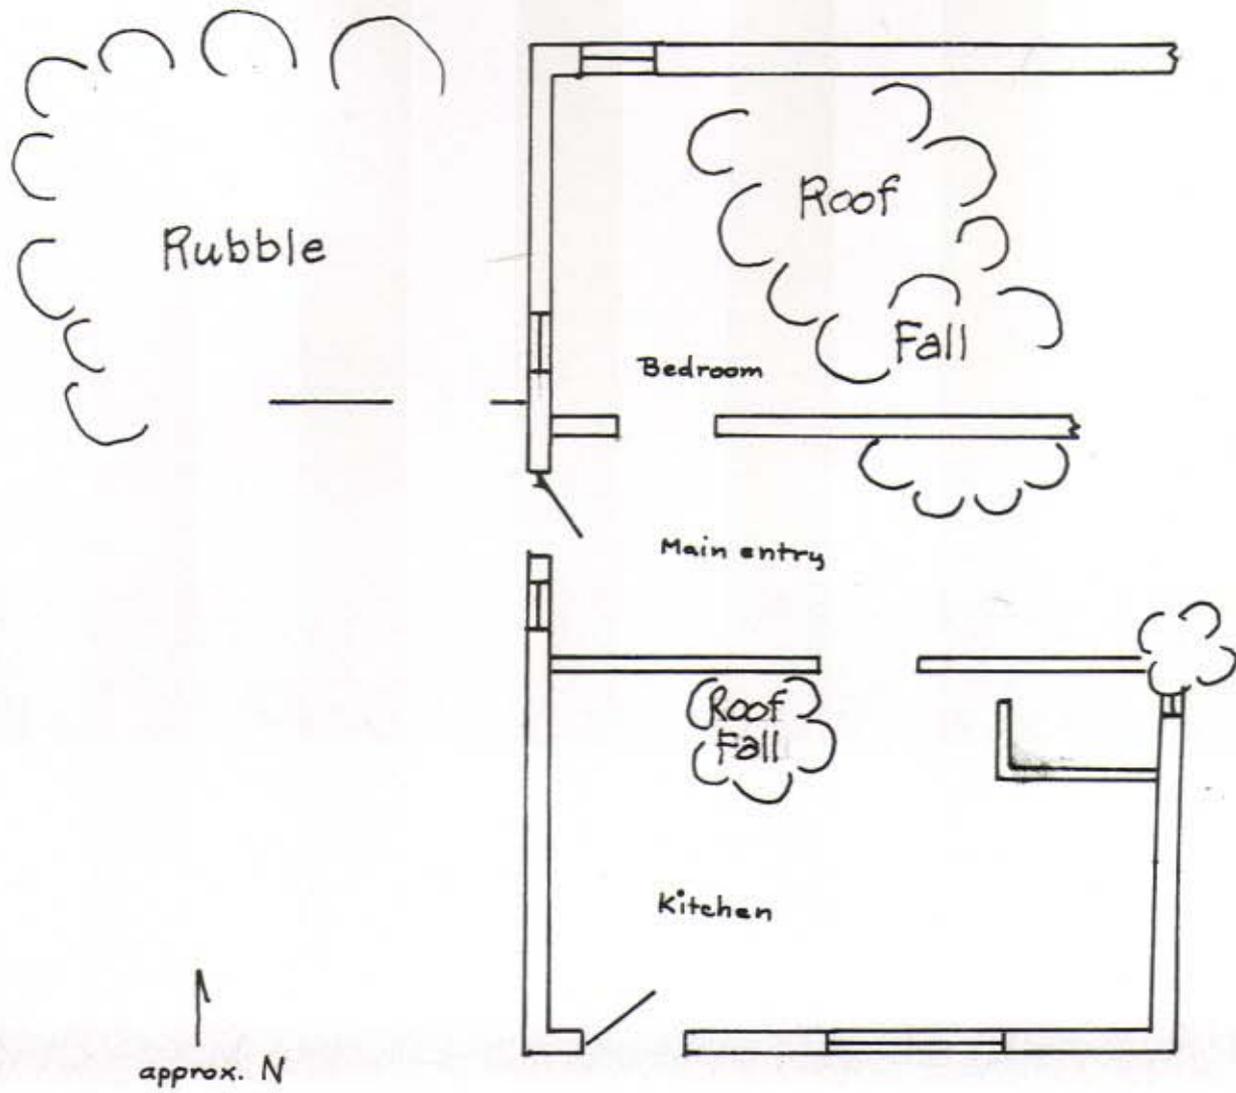
Fig. 1. Superintendent's House

Exterior: walls are log (approximately 8" diameter) chinked with sphagnum and burlap. Sawdust was used as insulation in the ceiling. On the east side, vertical bark slabs close the space between the bottom log and the present ground surface.

The main entry, a four horizontal over two vertical panel door, is nearly centered in the west wall of the structure. A second (kitchen) entry is in the south wall. This door is Z-braced, patterned tongue-and-groove (Fig. 2). There is one long 4/4 fixed window in the south wall. In the west, there is a 2/2 window beside the main entry door and a 2/2 window near the south corner of the bedroom. The standing remnant of the east wall has a small 2/2 window. The north wall has a 2/2 window near the west corner. All these windows are double hung. All remaining exterior frames are simple 1x6 casement painted a deep amber yellow.

Interior: Exterior logs were smoothed on the interior side. The interior floor space (Fig. 1) was divided into three rooms and a small walk-in pantry. Walls and ceiling were covered with canvas tarps. This, in turn, was overlain with patterned oilcloth on some ceilings and, at least in the main entry area, a wainscot of brown burlap. Windows and doorways had cornice treatments (Fig. 2).
