Wilderness Inventory Unit Index of Documents
Jaca Reservoir OR-036-054, 33 total pages

Year: 2011 **Unit Number/Name:** OR-036-054—Jaca Reservoir

Unit Number/Name: OR-036-054—Jaca Reservoir

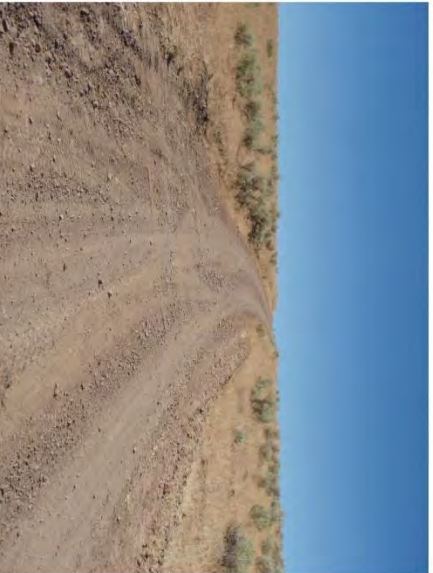
036-RT8-A-W.JPG

BLM has conducted maintenance to BLM Road 6368-00 over time as needed to keep this route passable. Earthen berms on the edge of the road in photographs 036-RT8-A-W, B-NE, H-NE, J-N, K-N, K-SEC, 6368-0-00-B-E, B-W, C-W, E-E, and F-W show maintenance work that has been performed on BLM Road 6368-0-0 in the past since the road was constructed. Although it has been many years since maintenance has been performed on the entire length of BLM Road 6368-00, it is evident from photographs BLM has taken, that little to no maintenance is needed to keep the roadbed in good operational condition.
