Wilderness Inventory Unit Index of Documents
West Fork Bendire OR-034-007, 60 total pages

Prepared by:
U.S. Department of the Interior
Bureau of Land Management
Vale District Office
100 Oregon Street
Vale, Oregon 97918

Year: 2010 Unit Number/Name: OR-034-007 — West Fork Bendire

FORM 2 -- DOCUMENTATION OF CURRENT WILDERNESS INVENTORY CONDITIONS

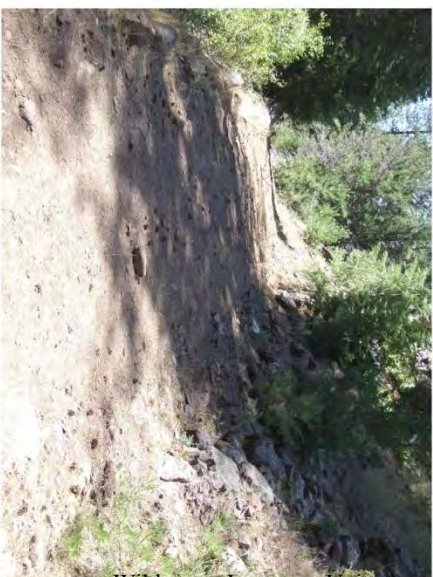
034-RT64-C-NW.JPG

034-RT64-C	SE	Route	7/22/09	Route washed out, inaccessible. Unmovable boulder in route.
034-RT64-C	NW	Route	7/22/09	Side cut.
034-RT73-A	NW	Route	7/22/09	Front.
034-RT73-A	SE	Route	7/22/09	Back.
034-RT73-B	NW	Route	7/22/09	Rocks moved off route.
034-RT73-B	SE	Route	7/22/09	2-track.
034-RT73-C	NW	Route	7/22/09	End of route. Disappears into grass.
034-RT73-C	SE	Route	7/22/09	End of route looking back.

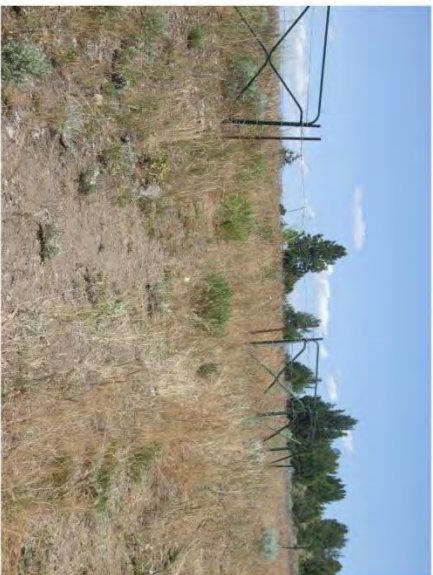
034-RT69-C-N.JPG

Describe: The dead-end route 034-RT72 – which branches from the through route 034-RT63 (what in 2010 BLM determined is a MPT) -- terminates about 850 feet from a developed spring (Hunter Creek No.1) and about 1,200 feet from a 2004 55-acre fuels pile and burn project. Another 2004 fuels pile and burn project (48 acres) included portions of two previously existing dead-end spurs (of 3, total) of 034-RT69. BLM photo 034-RT69-C-N shows a rangeland fence which the route drives through. The dead-end
