APPENDIX B – INVENTORY AREA EVALUATION

BURTON-NINEMILE (OR11-44-49) FORM 2

Area Unique Identifier **OR11-44** and **OR11-49** (**BURTON BUTTE - NINEMILE PEAK**)

APPENDIX D - PHOTO LOG

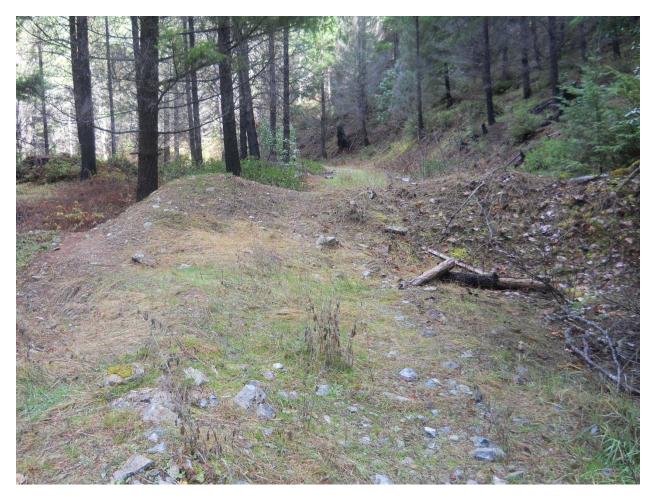
Frame 13

"	13	N	Shot of berm at south end of spur 39-4-13.1 from Star Gulch Rd					
"	14	E-NE	Looking upslope from 39-4-13.1	N42 10 43 W123 07 57				BN7
"	15	S	View looking down road on 39-4- 13.1					BN7
cc	16		Tank trap at bottom of obliterated portion of Ladybug Gulch rd (39-4-2.3)	@ jnctn Ladybug Gulch and Star Gulch Rd				
"	17	NW	Looking up-trail on obliterated portion of Ladybug Gulch rd	N42 10 26 W123 09 08				BN8
"	18	SE	Looking down-trail on obliterated portion of Ladybug Gulch rd					BN8
"	19		Shot of mine claim tag on tree by Ladybug creek	N42 10 30 W123 09 19				BN9
"	20	NW	Shot of another claim sign	N42 10 43 W123 09 34				BN10
"	21		Shot of tank trap at N end of obliterated portion of Ladybug					BN10

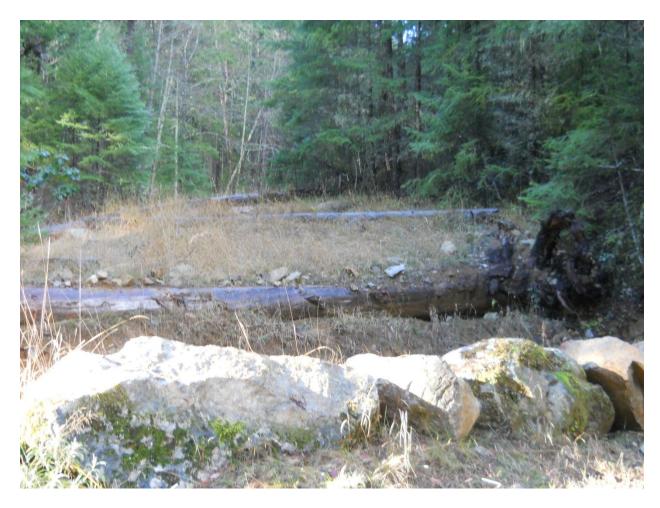
Frame 16

The decommissioned portion is stable, replanted, revegetating, and provides scenic non-motorized opportunities along Ladybug Creek, as well as non-motorized access for hunting and access to mining claims along the creek (SEE PHOTOS BN_016-019). The remaining open portion at the north end provides drivable access for recreation and hunting, access to the mining claim (with cabin remains) (from the north, and administrative access (PHOTOS BN_20-22).

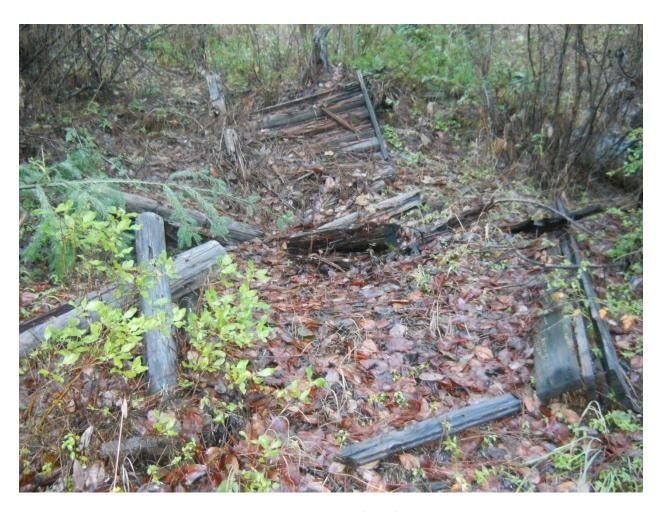
Frame 22, BN10 (west)

Date	Frame #	Camera Direction	Gulch rd (39-4-2.3) Description	GPS/UTM Location	Town-ship	Range	Sec.	Photo Point #
	"	22		Shot of old mining cabin remains				
cc	23	N	Shot of forested peak outside N bnd of Ninemile unit. Can move bnd up to ridge?	N42 09 39 W123 10 39				BN11
"	24	N	View of peak outside N bnd with older clearcut in foreground	N42 08 51 W123 10 58				BN12
"	25	N	Same as above, but zoomed in	cc				
"	26	W-NW	Looking down at lower Ninemile drainage					cc
"	27	E-NE	Zoomed out shot showing Tallowbox Pk in background	cc				cc
