BLM Alaska Open File Report 121
BLM/AK/GI-10/006+8340+F000
April 2010

Impacts of Truck Traffic across Unfrozen Tundra near Toolik Lake, Alaska

Martha K. Raynolds, Tim Craig, and Zachary Meyers

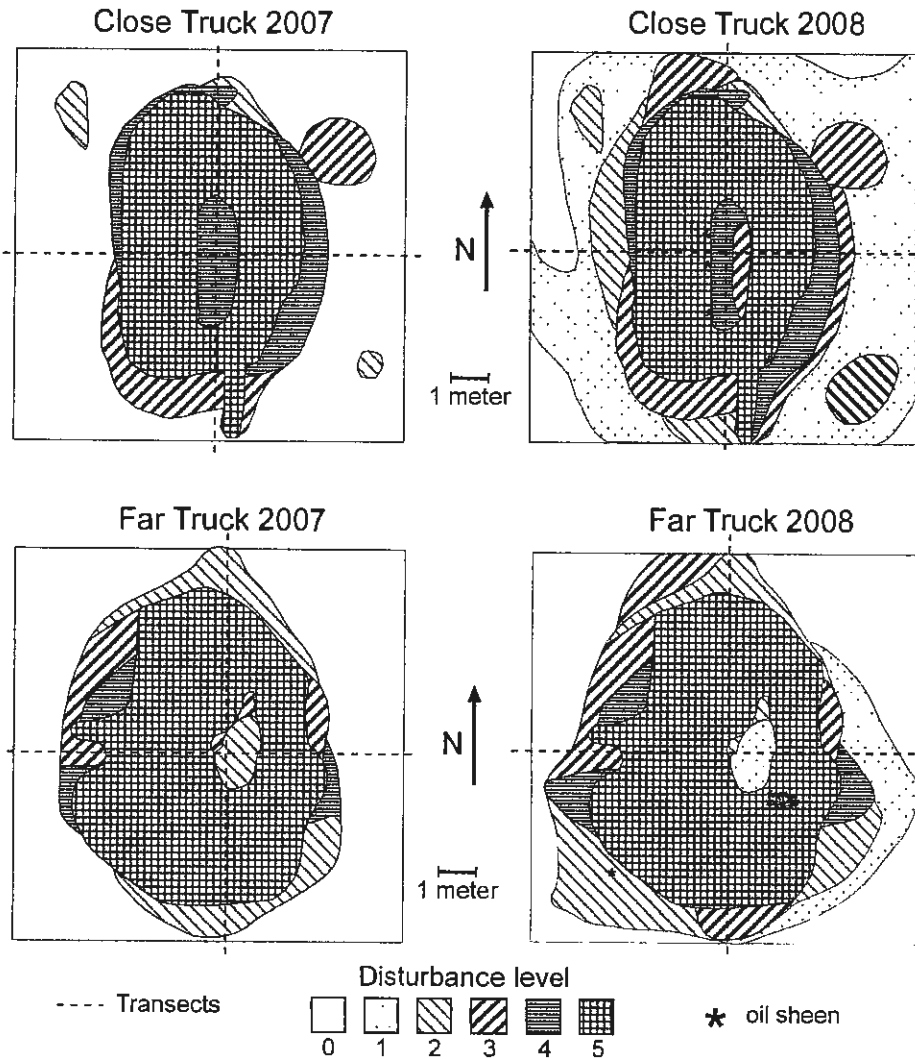
In 2007 the Close Truck excavation disturbed approximately 47.2 m² and the Far Truck excavation disturbed 54.3 m². Of the total 101.5 m² disturbed, 67 m² exhibited the highest level of disturbance (Level 5). The excavation areas were oval-shaped and included the footprints of the trucks and the excavation activities used to extract them (Figure 6). The centers had a less-disturbed area that was protected under the middle of the trucks. At both sites, original vegetation was missing in the areas that had underlain the wheels; in these areas the frozen, disturbed soil and vegetation had been removed during excavation and later returned. At the Close Truck excavation, the soil was gray silt. At the Far Truck excavation, the soil was organic peat. The edges of the excavation areas had lower levels of disturbance caused by activities such as foot traffic and vehicle traffic on frozen tundra.

Between 2007 and 2008, the area of the highest disturbance levels (Levels 3–5) changed little (Table 4, Figure 6). However, Level 1 and 2 disturbance was more evident and covered more area in 2008. Total disturbance of the excavation sites increased during this period from approximately 102 m² to 152 m², expanding outside the 10-m × 10-m plots we established in 2007. As was the case for the truck trails, this increase in disturbed area was due to deeper thaw and some subsidence, which increased water cover (Figure 7) and decreased plant cover. In 2008 water covered 0%–25% of the Level 3 disturbance, 50%–75% of the Level 4 disturbance, and 100% of the Level 5 disturbance.

Figure 6. Maps of vegetation disturbance within 10-m × 10-m areas where trucks were excavated in April 2007 after becoming stuck in unfrozen tundra in September 2006, Toolik Lake ACEC, Alaska. Central portions of the transects crossing the excavations are depicted by dashed lines. Mapping was completed in July 2007 and July 2008.

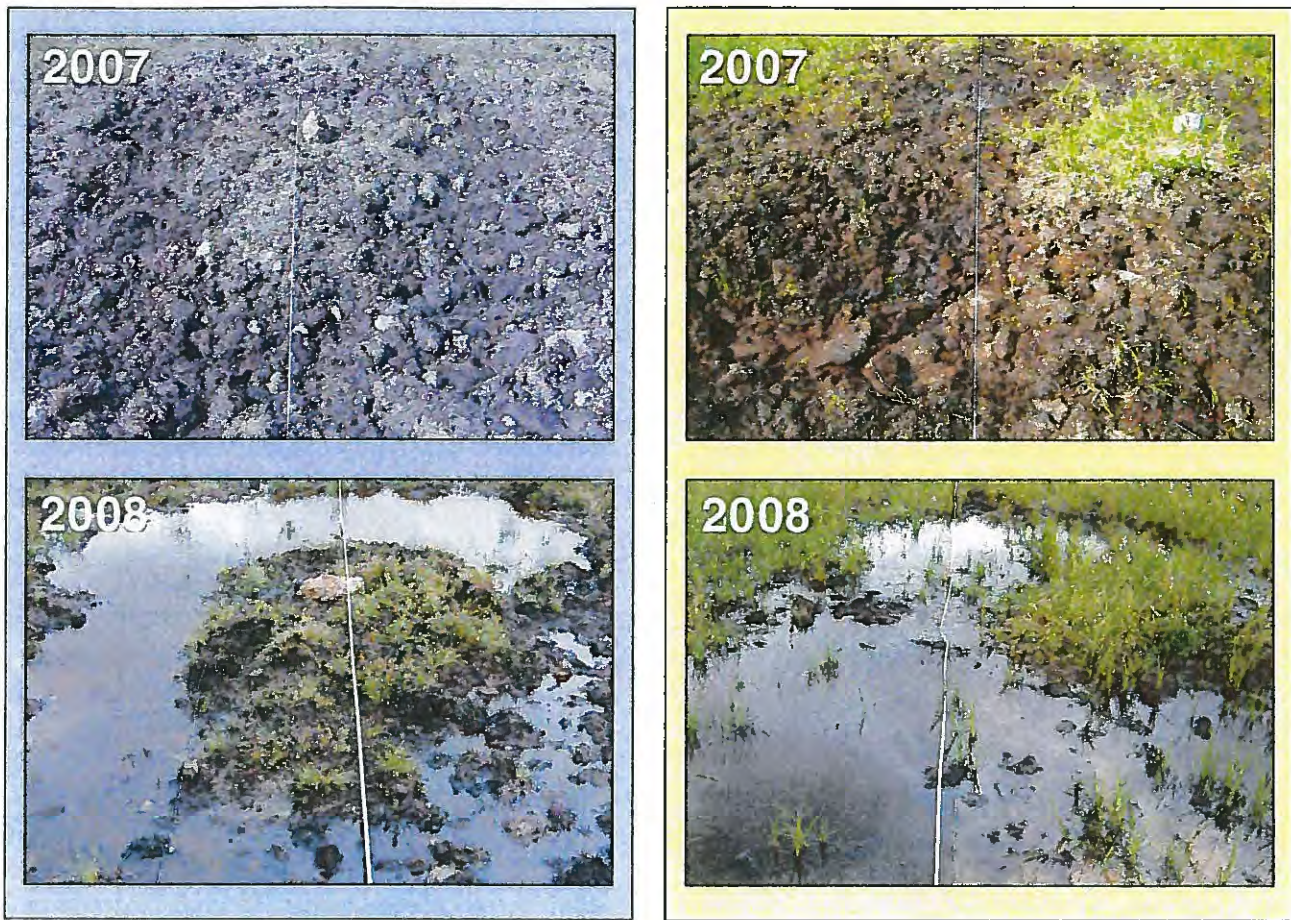
Figure 7. Photos taken in 2007 and 2008 at the Close Truck (left) and Far Truck (right) excavation sites, where habitat was disturbed by 2 pickup trucks that traveled on unfrozen tundra in September 2006, Toolik Lake ACEC, Alaska. All photos were taken from the southern edge of the excavations looking north, matching the orientation of the maps in Figure 6.

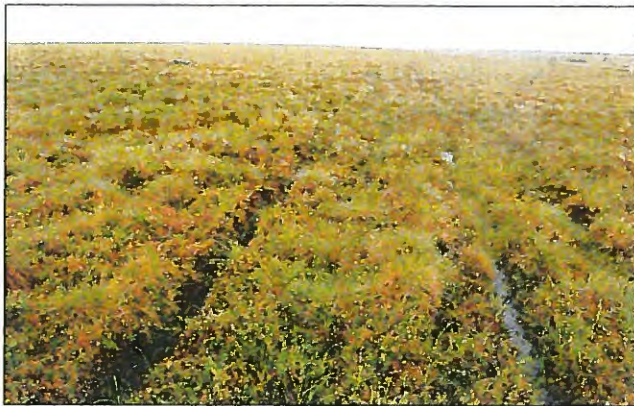
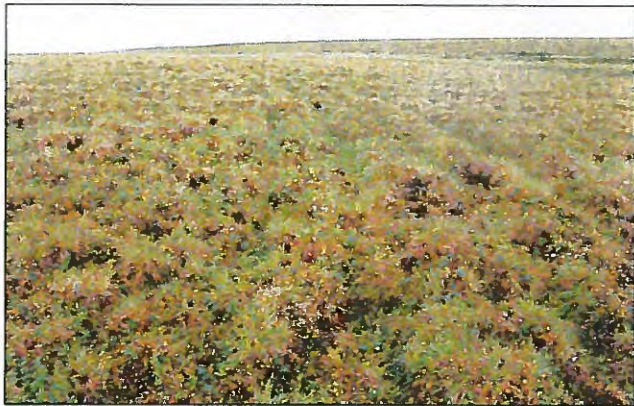
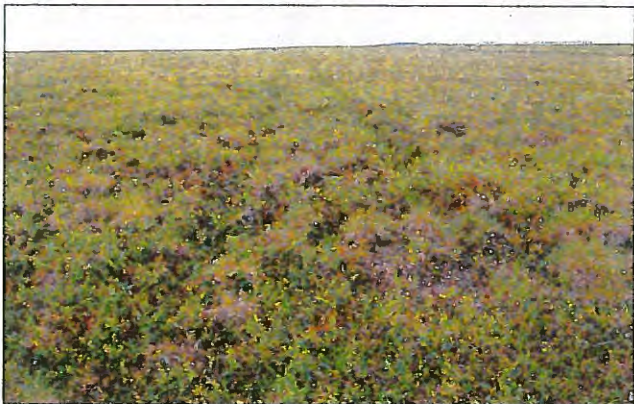
Photographs of the transects are included in the compact disc attached to this report and are listed in Appendix C. Example photos of the 3 trail sites are shown in Figure 11. We established a set of standard photo points to ensure that photographs are taken from the same sites and with the same field of view each year.

Figure 11. Photos of trails caused by pickup truck travel on unfrozen tundra in September 2006, Toolik Lake ACEC, Alaska. Top – Worst Trail, looking south. Middle – Double Trail, looking south. Bottom – Single Trail, looking south.
