# A Geophysical Investigation of Glacial Lake Outburst Potential of Nourse Moraine, Taiya River Watershed, Skagway, Alaska

BLM Open File Report 123  
September 2009

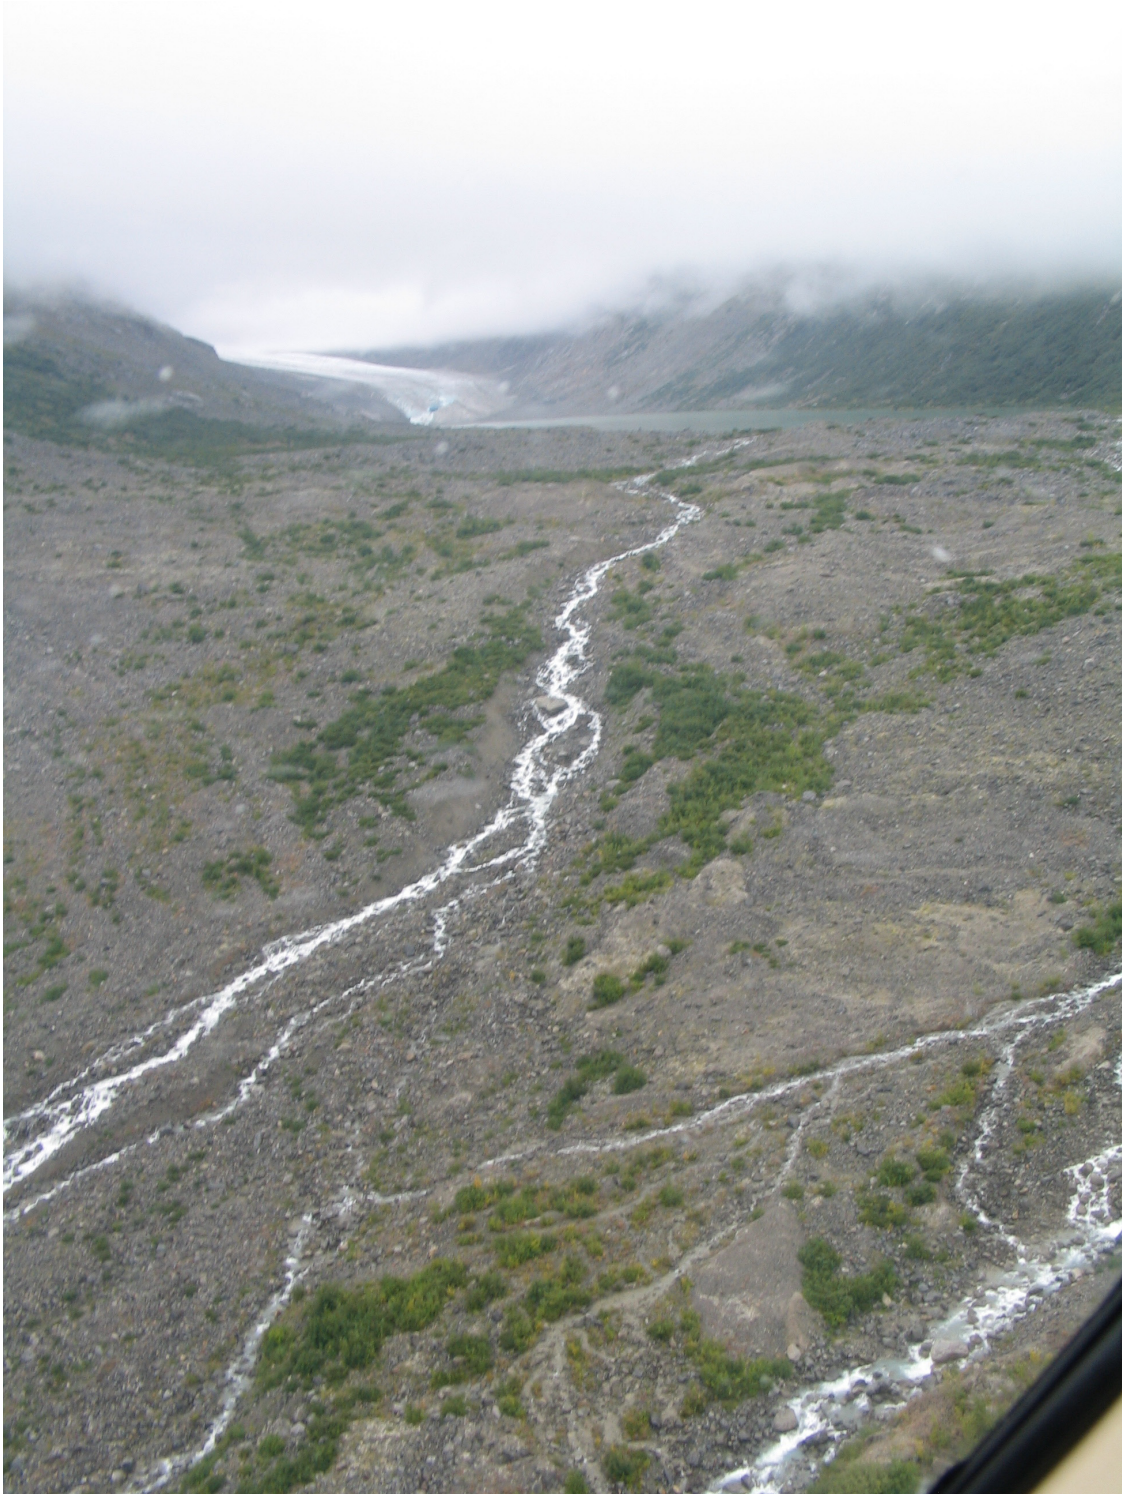
The Nourse Moraine (lat -135.4250, long 159.5693) impounds a large icy-blue proglacial lake known as Nourse Lake. The lake is estimated to occupy a surface area of 200 acres (80.94 ha) with a depth of 95 feet (28.956m) and spills over the moraine at two primary locations (Figure 1). With an estimated gradient of 14.5% (Capps, 2004), the outlets form high-gradient glacial streams that flow to a smaller unnamed proglacial lake. Eventually this watershed enters the Taiya River at a confluence approximately 8 miles (12.88 km) downstream. Located approximately 22 river miles (35.4 km) farther downstream is Dyea, Alaska. The broad, U-shaped Nourse and Taiya River valleys were carved out by past glacial events. Though the glaciers remain, they have significantly receded and mainly reside high in the mountains. The surface of Nourse Moraine is composed of multiple-size class sediments, including large boulders, cobbles, gravel and sand with clusters of dense vegetative growth, primarily common alder (*Alnus glutinosa*) (Figure 2). The Nourse Moraine has a measured length of 2640 ft (804 m), an average slope of 15%, and a calculated height of 396 ft (120 m) (Denton, 2005). The estimated width of the moraine is 2296 ft (700 m).

**Figure 1.** Two high-energy streams flow across the surface of Nourse Moraine to a downstream glacial lake. These streams initiate from a proglacial lake created by the retreat of the Nourse Glacier (*background*).

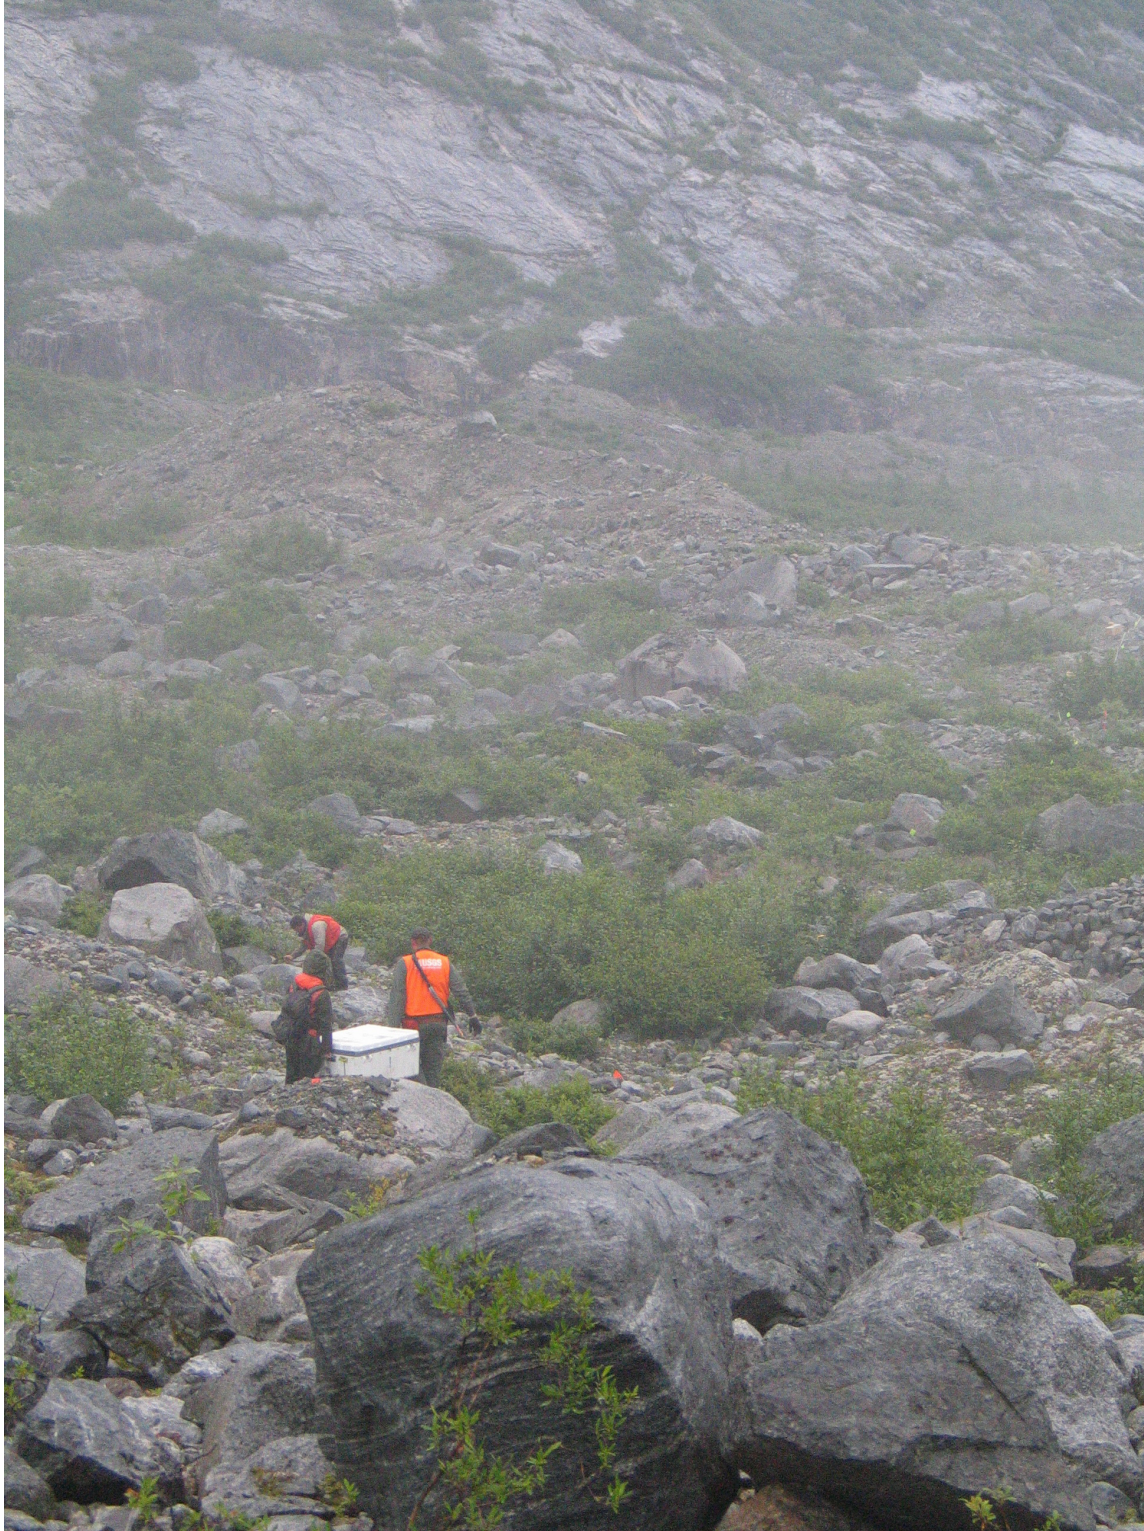
**Figure 2. Nourse assessment team carries equipment across moraine composed of multiple-size class sediments, including large boulders, cobbles, gravel and sand.**

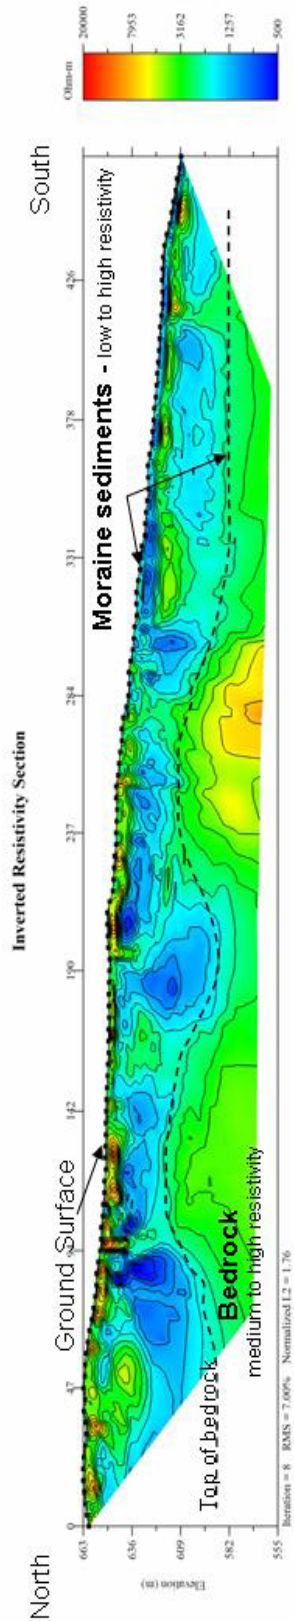
Figure 3. Resistivity profile of Nourse Moraine

### Preliminary Resistivity Profile of Nourse Moraine

An unconsolidated layer of moraine sediments consisting primarily of gravel and boulders extends from ground surface to a the top of bedrock, varying in thickness from 30 to 80 meters (96ft to 256ft).

The ground surface of the moraine is nearly flat. The presence of frozen material in the moraine is unknown, and is not indicated in the resistivity survey. The moraine is a "bull-nose" formation, pushed into place by glacial action. The pushing action probably tended to push the larger boulders together into intimate contact, forming a reworked rock mass with a high angle of internal friction. It is unknown if the boulders are well-rounded or angular. Angular boulders would have a higher angle of internal friction, hence higher stability.

With such a gently sloping ground surface, the most probable type of failure mode would be earthquake-induced liquefaction. But since no massive sand deposits are indicated in the resistivity survey, liquefaction would be an unlikely failure mode.

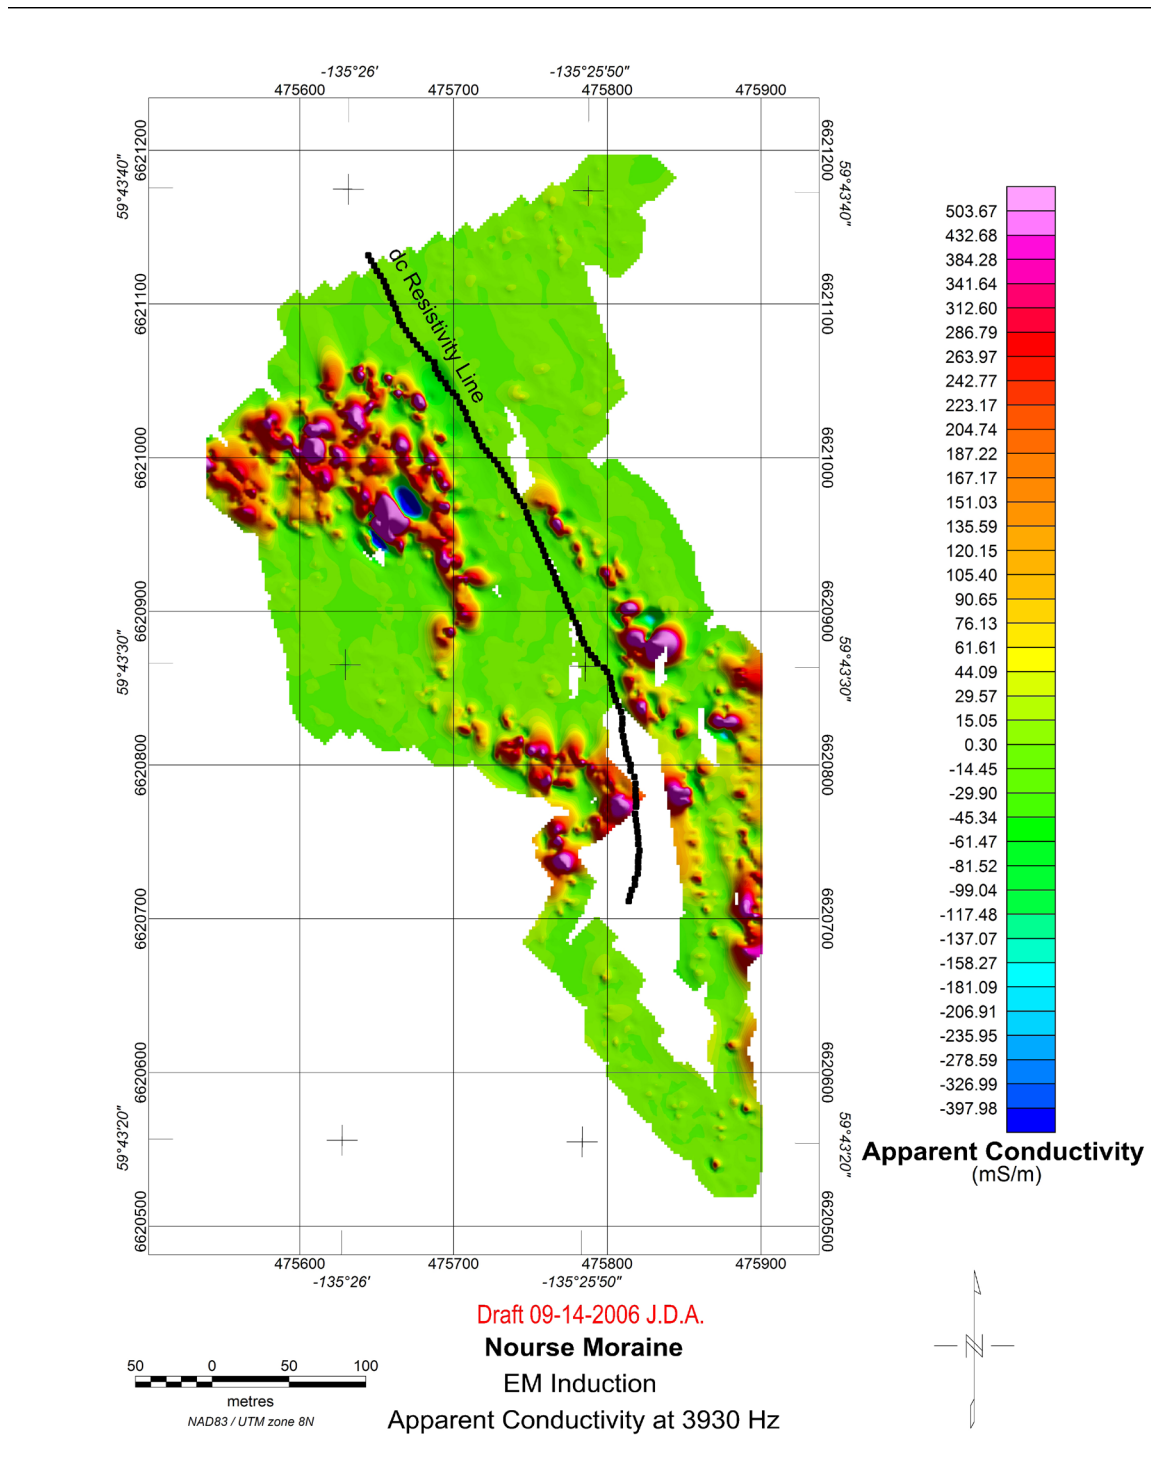
Figure 4. Map of EM Induction analysis and apparent conductivity at Nourse Moraine.

Although more time is needed to invert the EM information and obtain depth information, the preliminary data suggest the lack of an ice-core. The gravity meter rented from Scintrex is the best available gravity technology, but its battery problems significantly reduced the amount of gravity data collected. Though only 13 stations were acquired out of the 50 planned, the preliminary gravity data collected also suggest the lack of an ice-core.
