Form 1: Document Wilderness Characteristics Inventory Findings on Record

Form 2: Current Conditions: Presence or Absence of Wilderness Characteristics

Area Unique Identifier: COF-020-001, Badito Cone

Inventory Area Unique Identifier: **COF-020-001, Badito Cone**

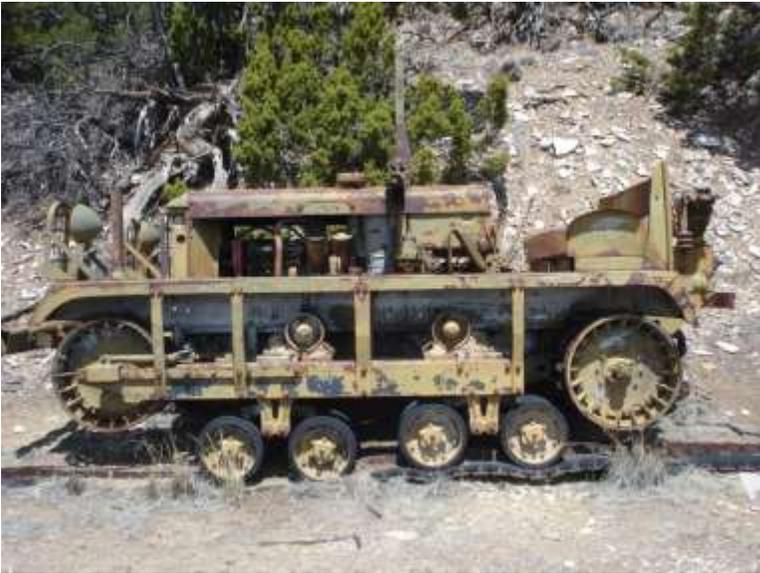
#2 old dozer

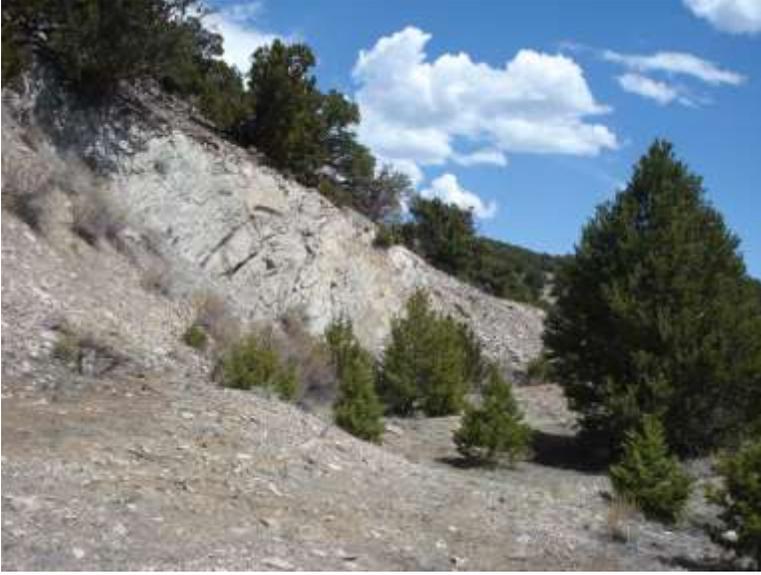
#3 Mine

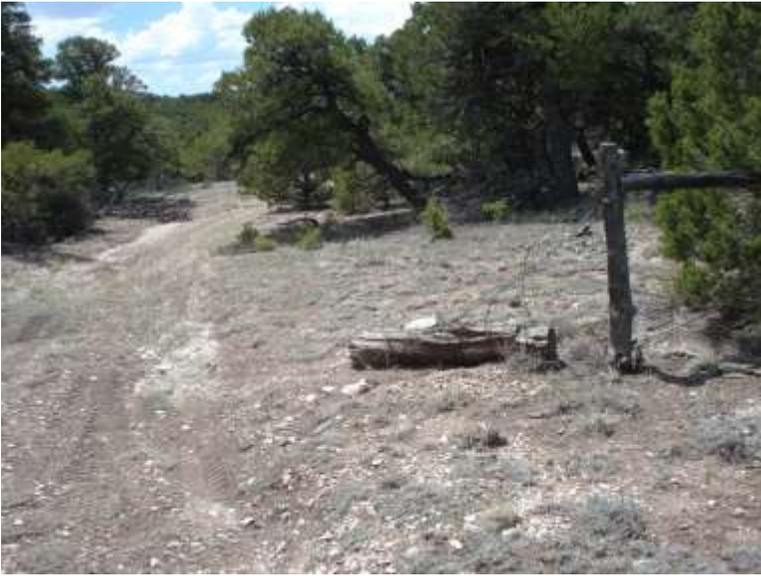
4 fence line

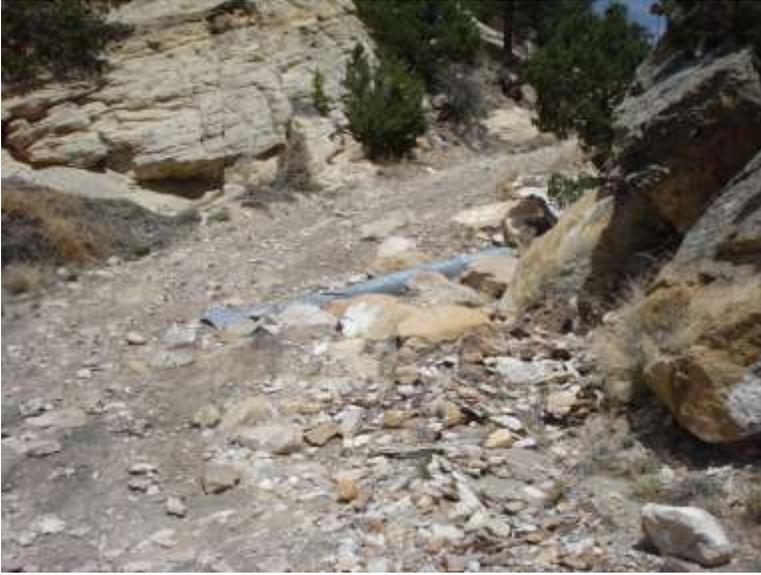
#5 culvert

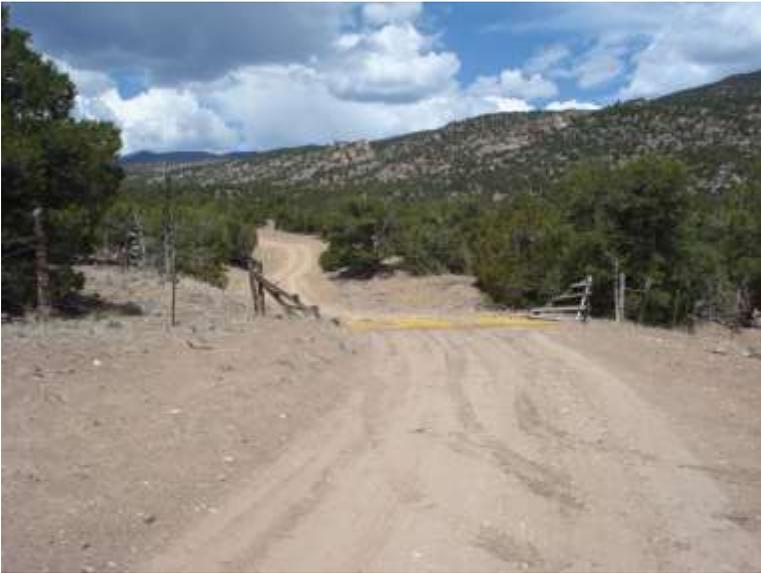
#6 culvert, enter BLM

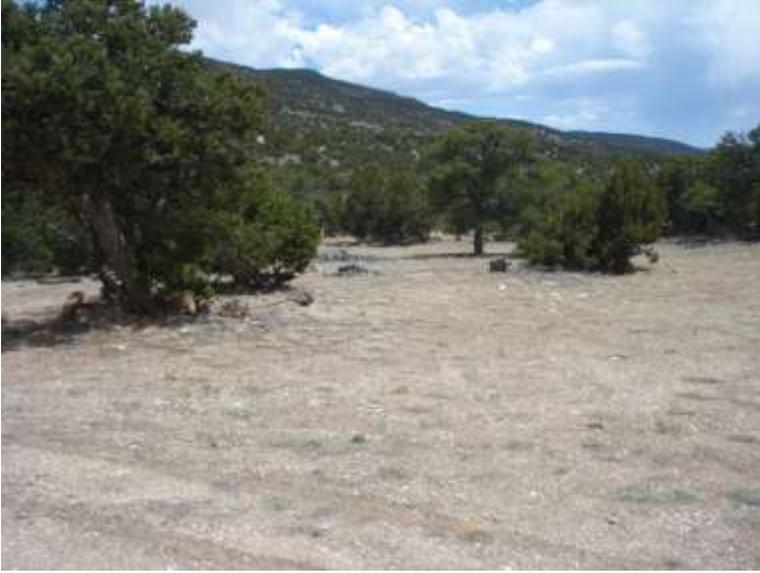
#7 fire ring

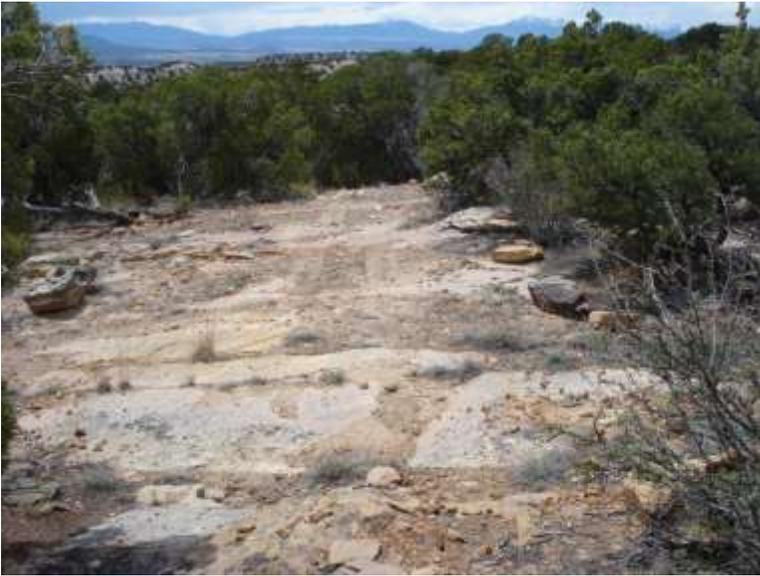
#8 User created route

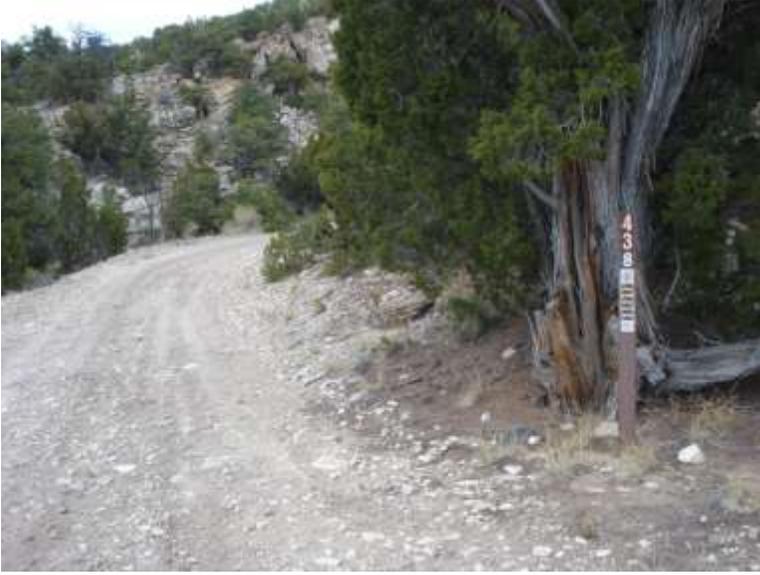
#9 USFS Rd 438

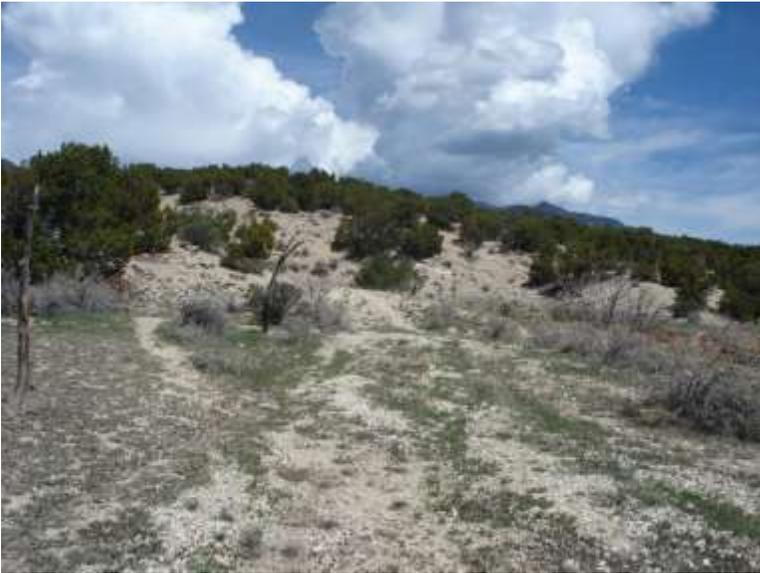
#10 User created route

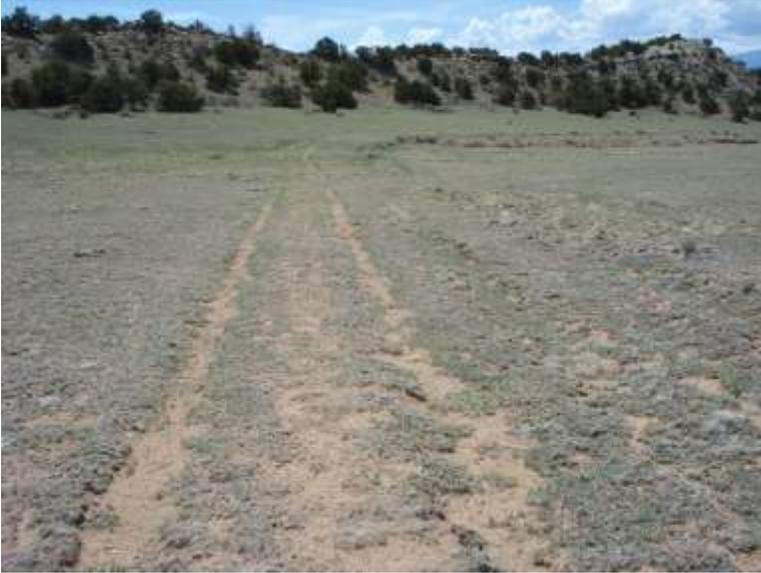
#11 Typical view of route looking N

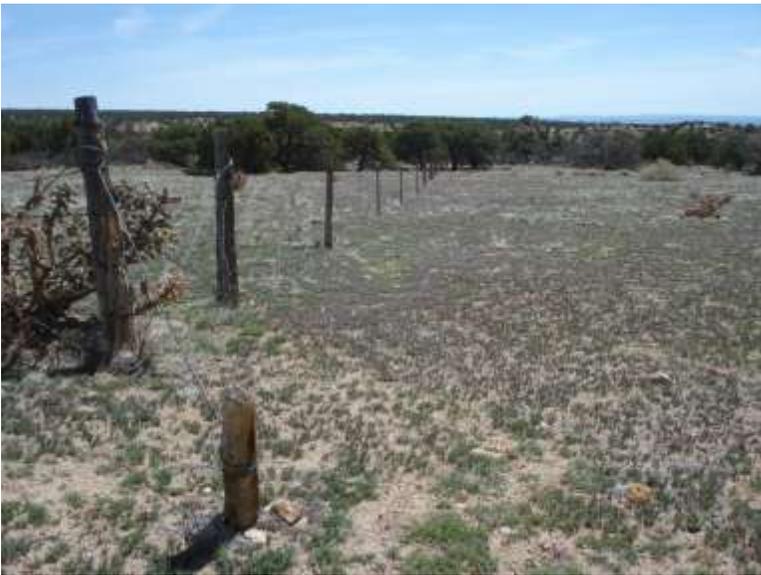
#12 Fence line

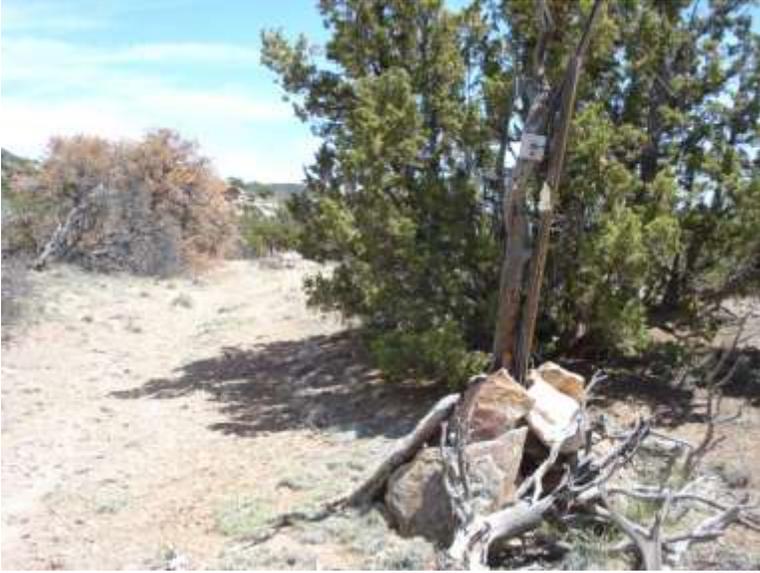
#13 mining claim

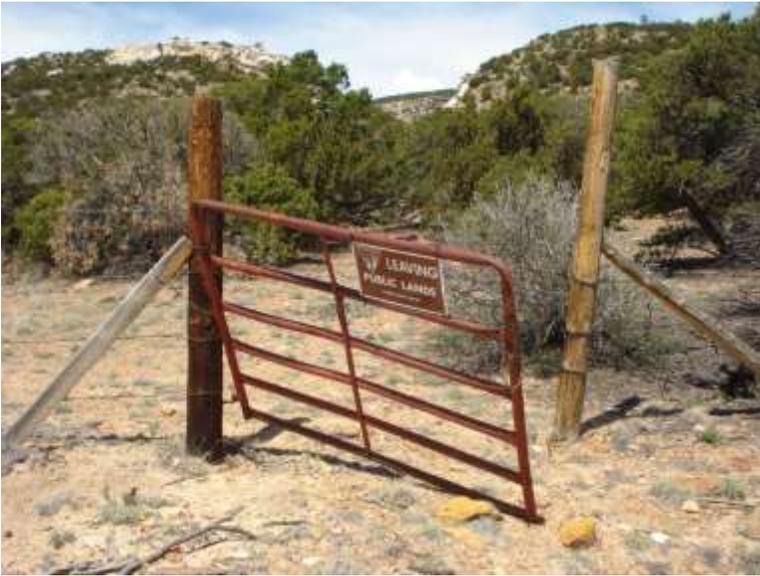
#14 walk through gate

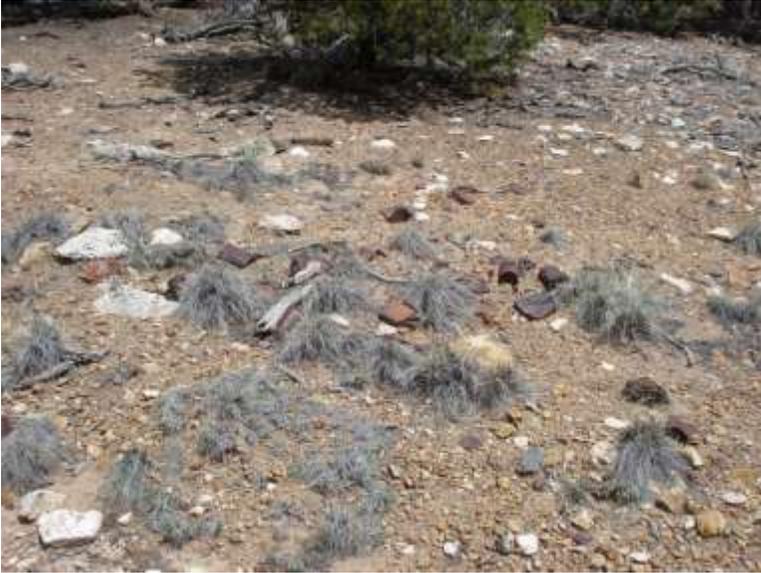
#15 trash remnants

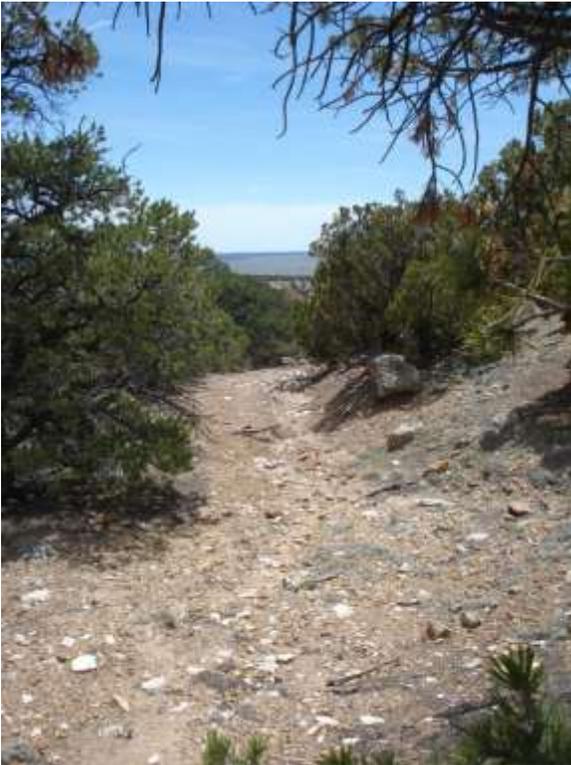
#16 typical view of route

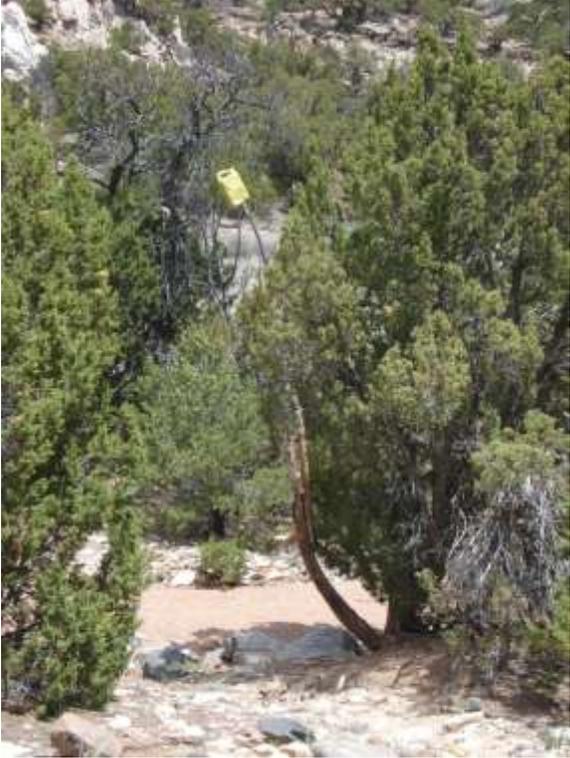
#17 marker

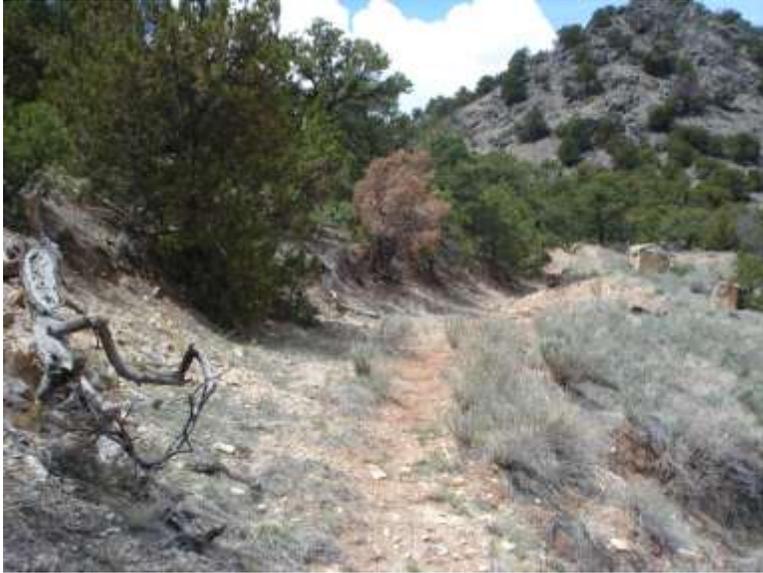
#19 Road cut

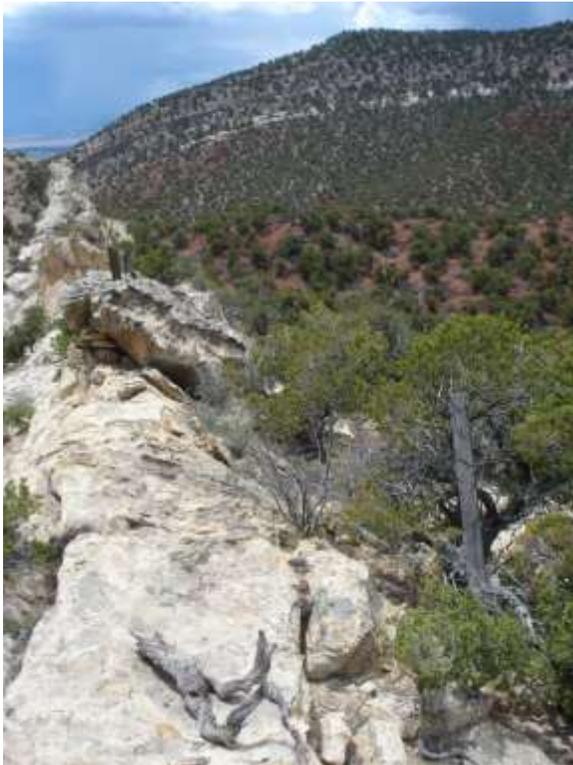
#20 milled wood marker

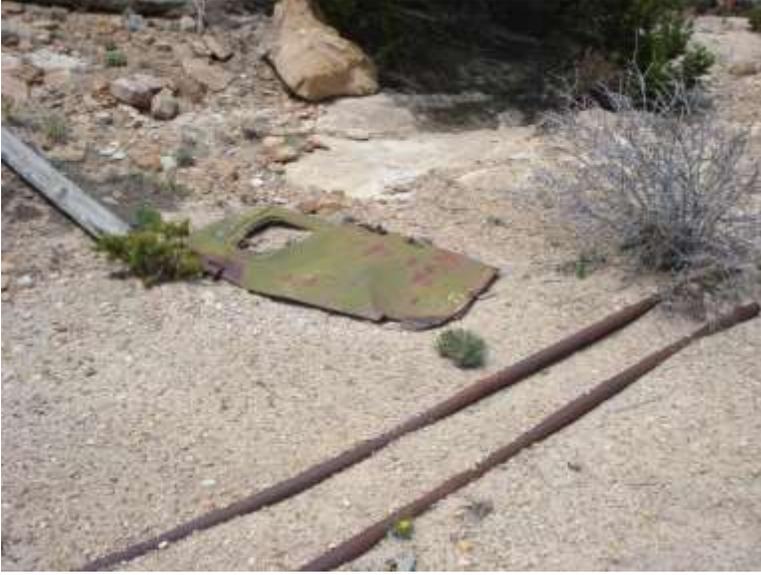
#21 piping

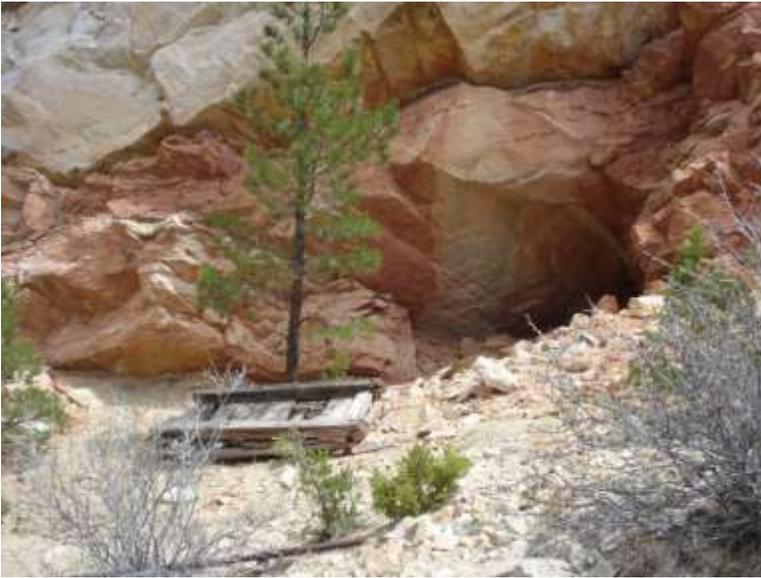
#22 mine site

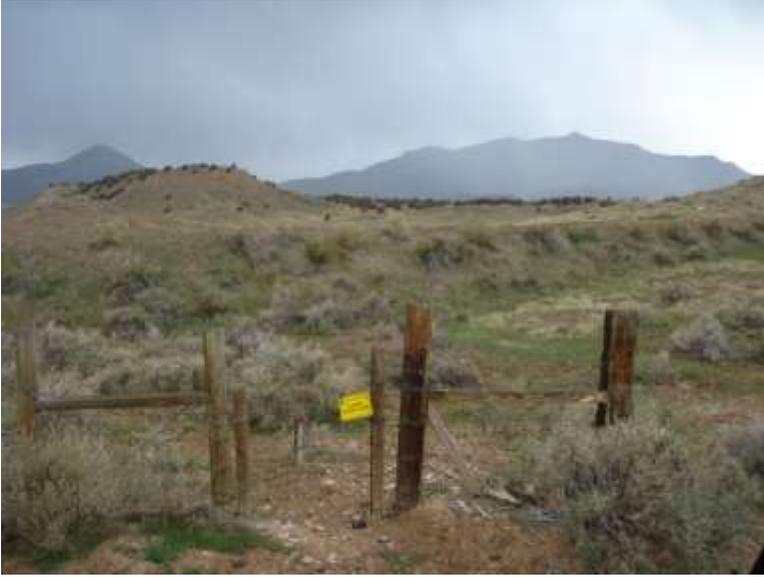
#23 walk through gate
