**Lands with Wilderness Characteristics Report:
Badito Cone
COF-020-001**

Area Unique Identifier: COF-020-001, Badito Cone

Royal Gorge Field Office Lands with Wilderness Characteristics Inventory, 2015: Evaluation of new information

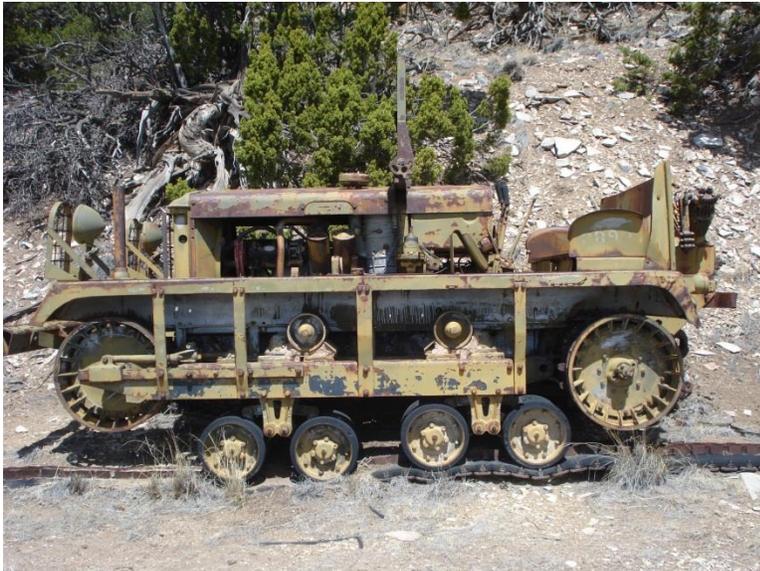
#2 old dozer

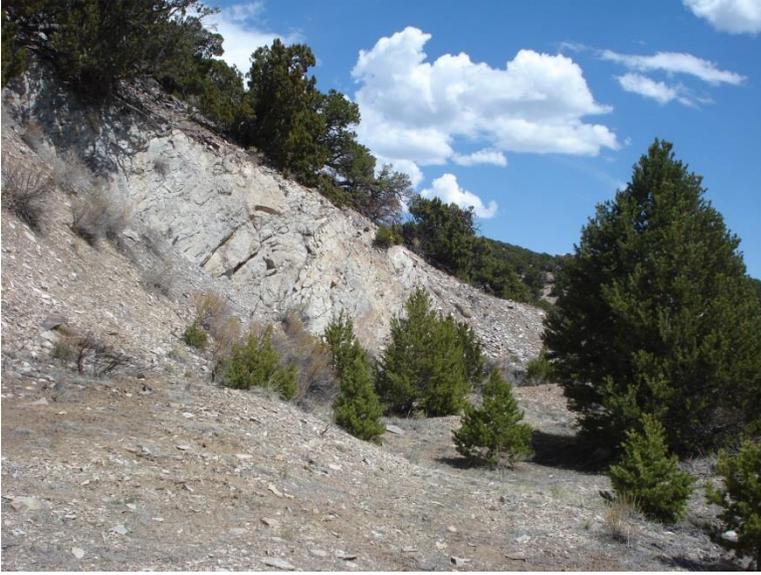
#3 Mine

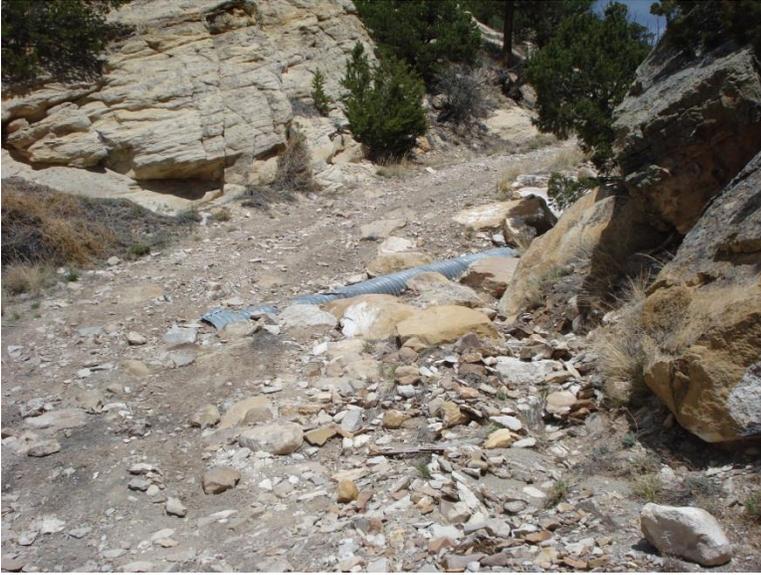
#5 culvert

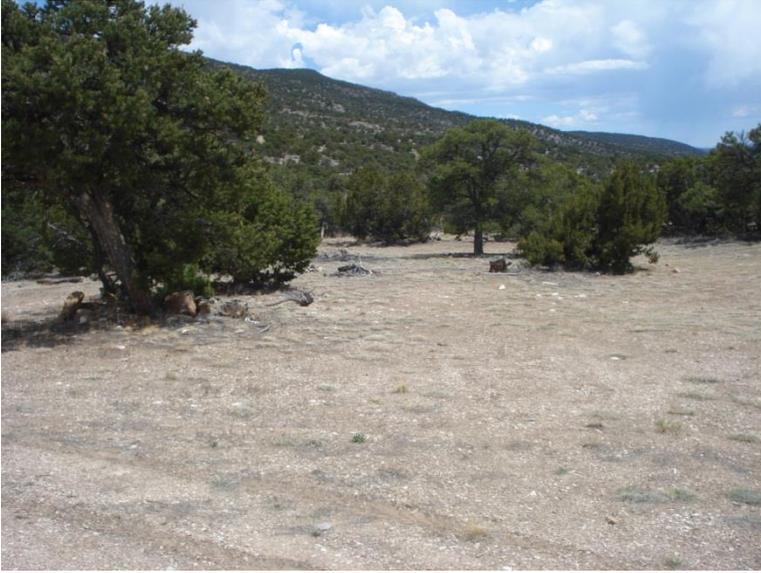
#7 fire ring

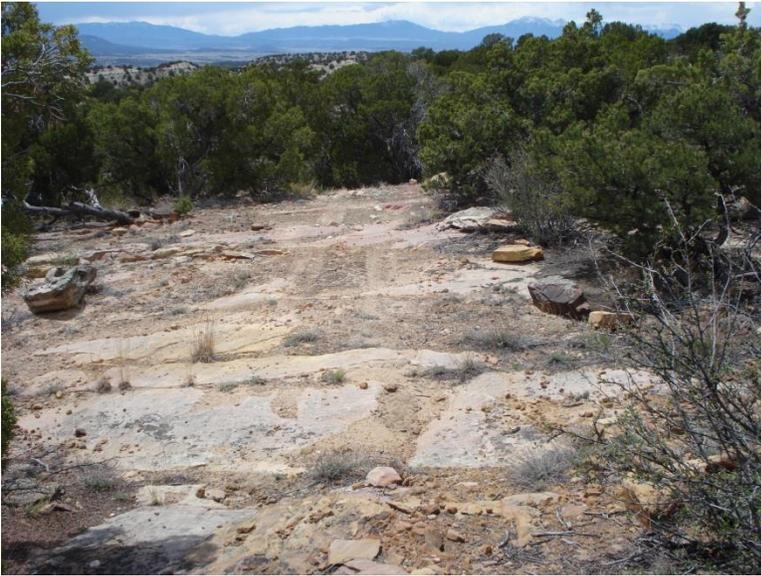
#8 User created route

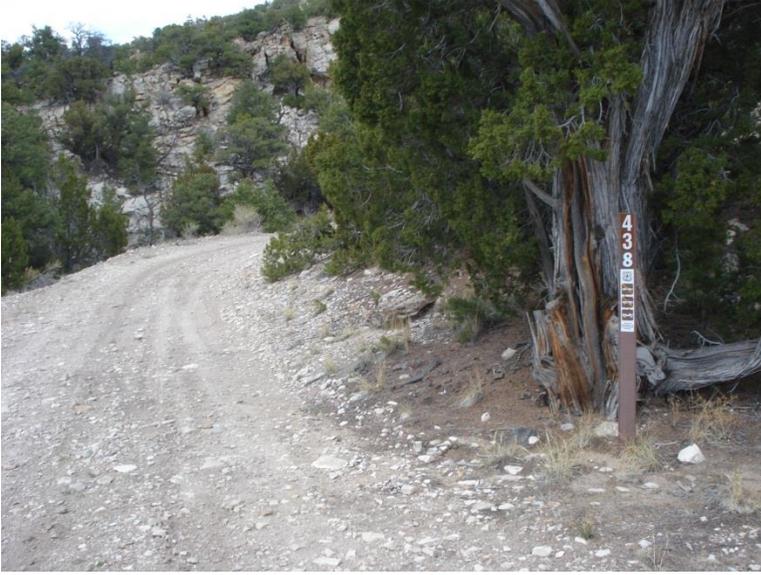
#9 USFS Rd 438

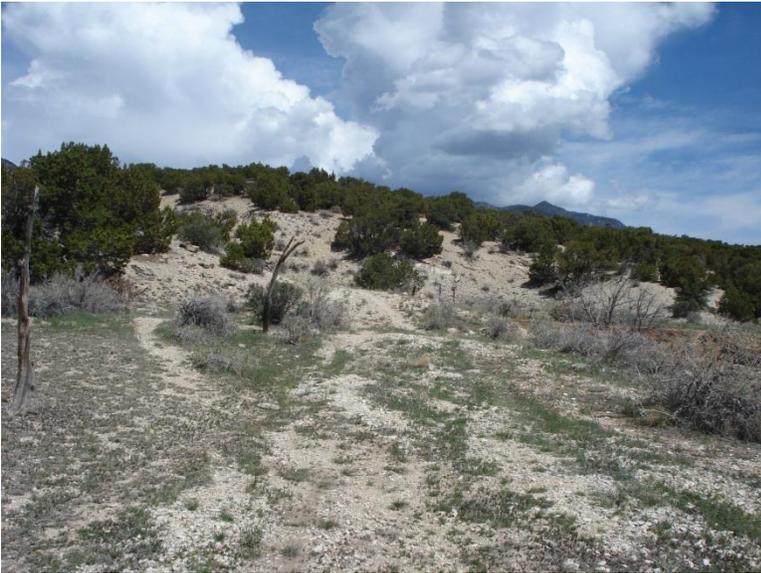
#10 User created route

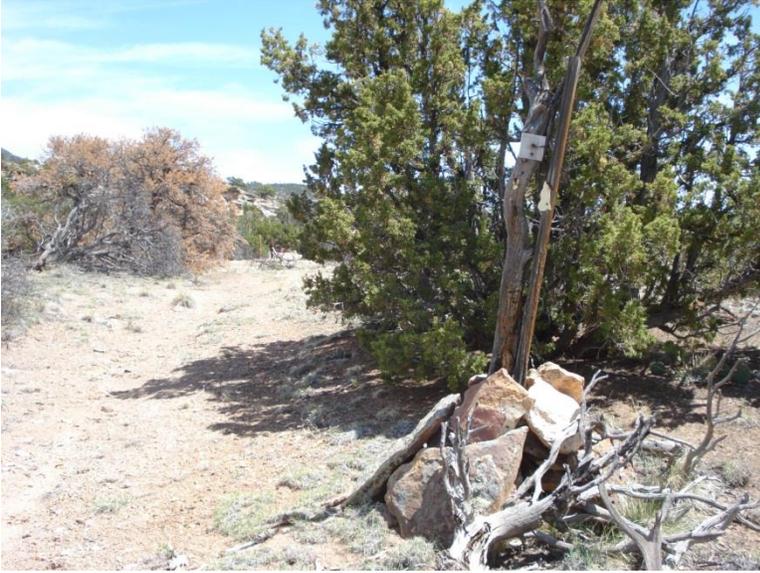
#13 mining claim

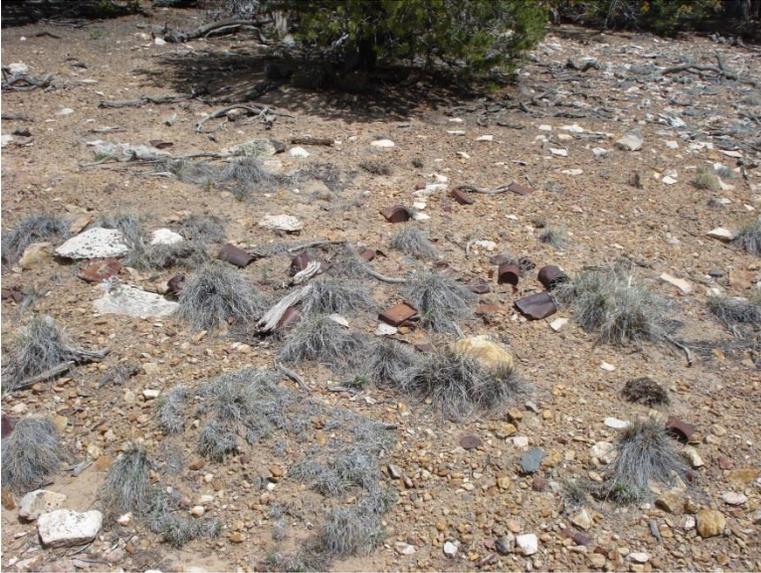
#15 trash remnants

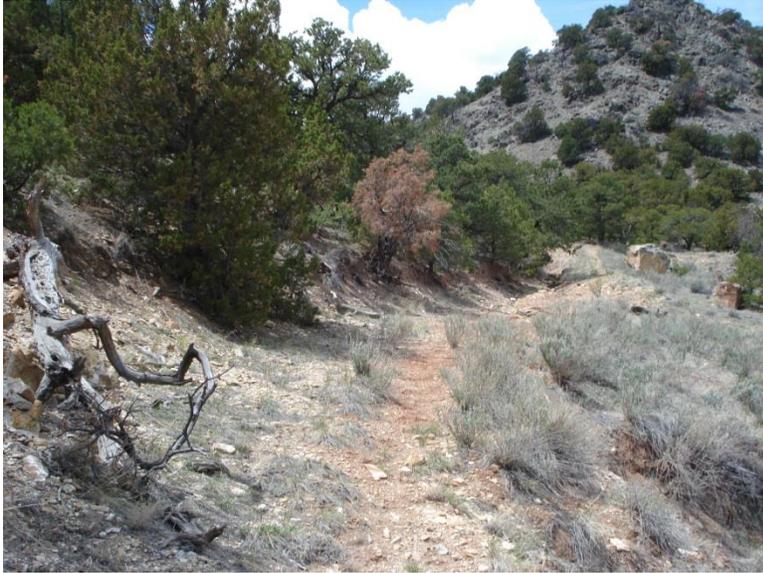
#19 Road cut

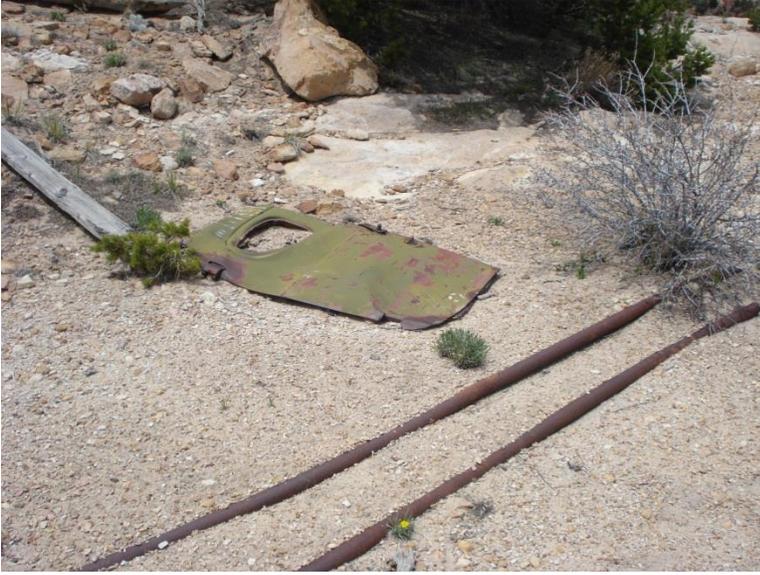
#21 piping

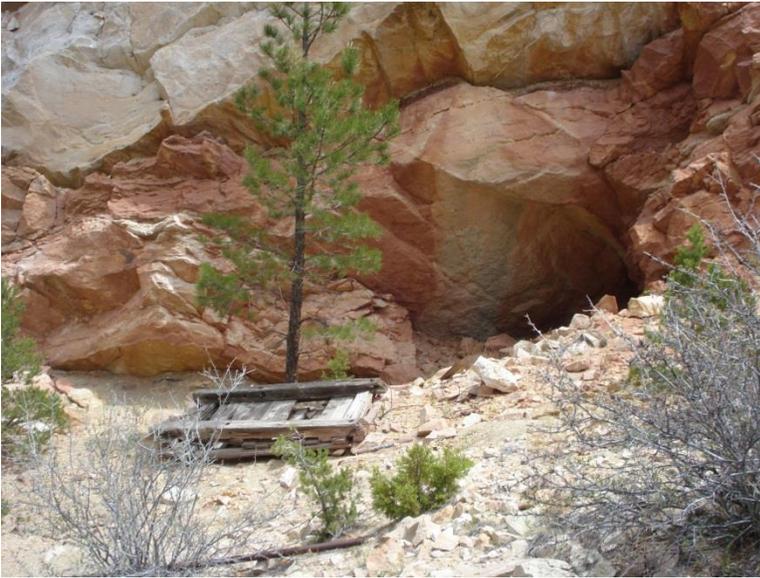
#22 mine site

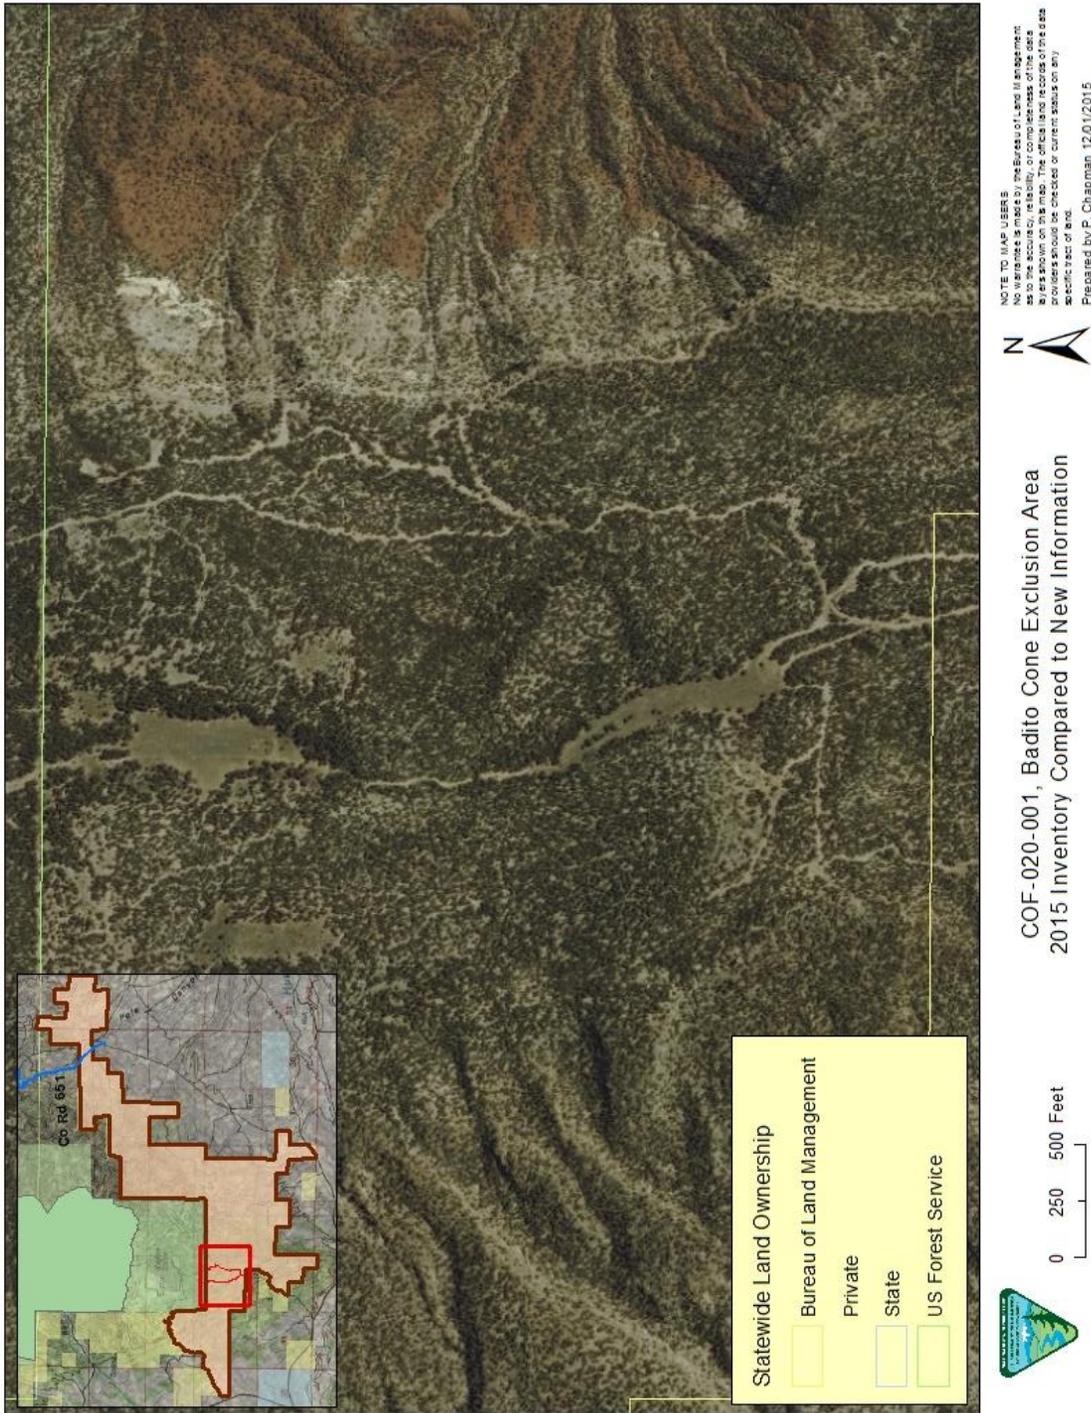
As a result of the original BLM inventory and a review of the information provided by Wild Connections, the BLM still contends that the area near BLM Road #6274 has a high

concentration of minor disturbances that cumulatively affect apparent naturalness. As a result of these findings and per BLM policy this area was excluded resulting in two units. The remaining Badito Cone East unit (COF-020-001-B) generally appears to have been affected primarily by forces of nature outside of the central part of the unit identified above. At 718.23 acres and not being contiguous with lands managed for wilderness characteristics it does not however meet the minimum size criteria. Due to its configuration and surrounding private lands its preservation would not be practicable and is not considered further.

Figure 1 Aerial view of excluded area

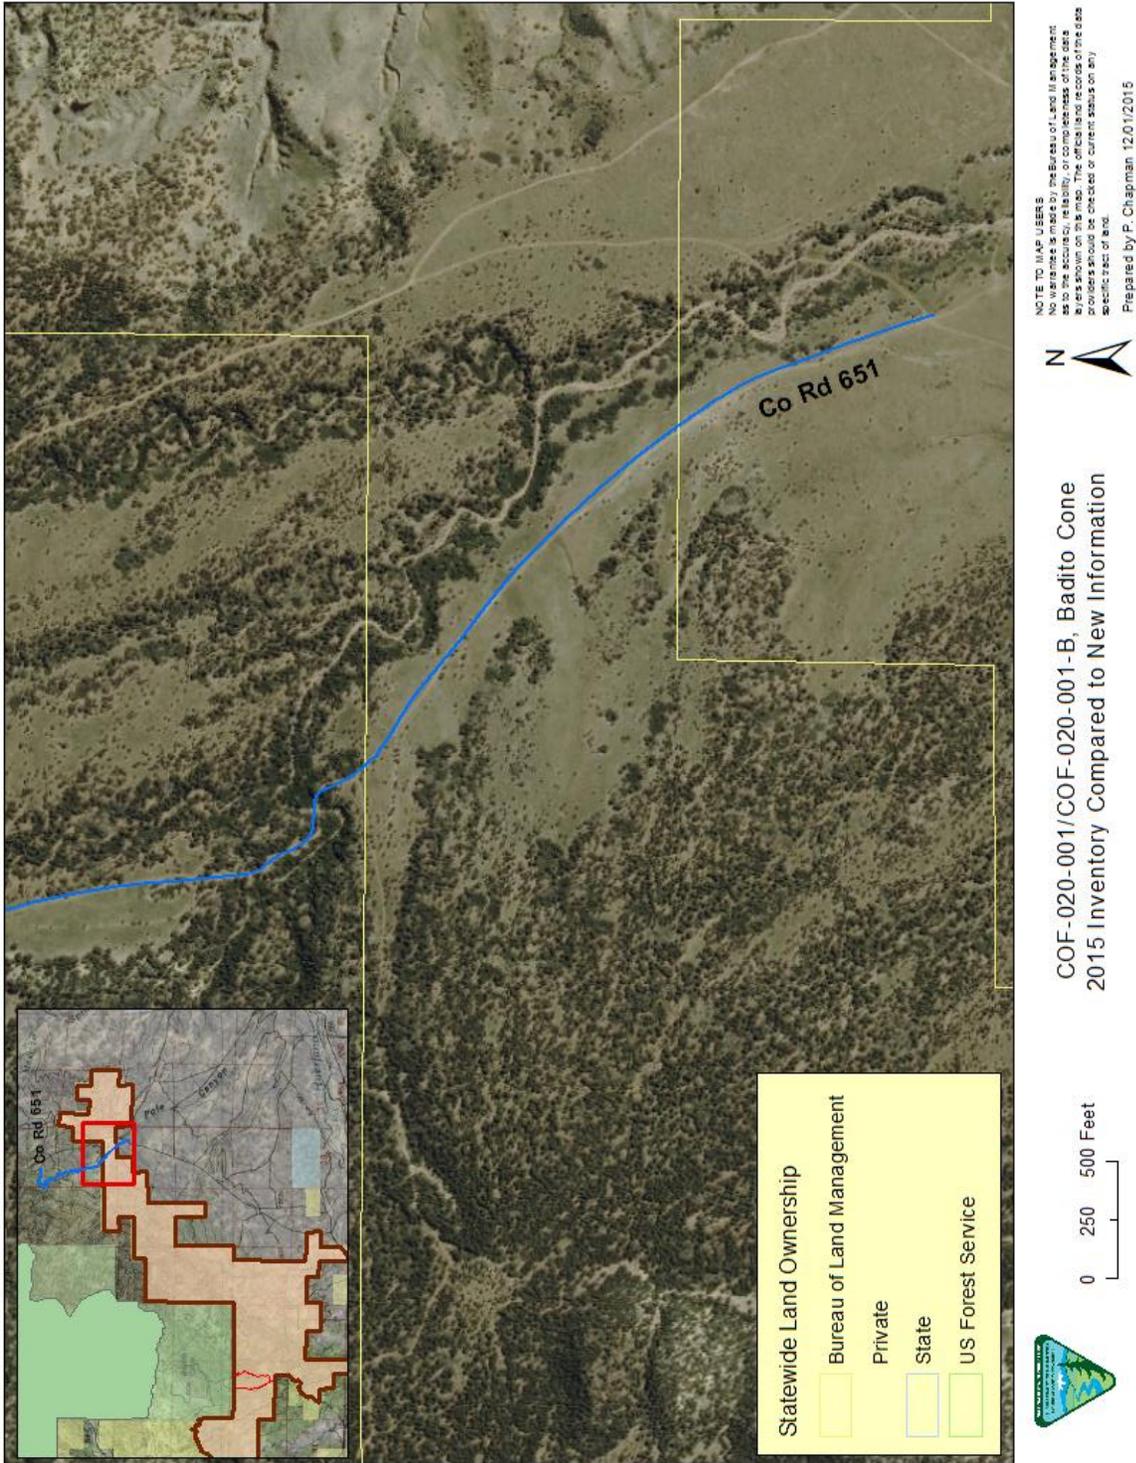
The new information submitted from Wild Connections proposed the unit COF-020-001 meets the criteria of LWC for a total of 5826.4 acres. However, County Road 651 was identified in the 2015 evaluation creating COF-020-001-B, Badito Cone East.

Figure 2 Aerial view of County road 651
