**BLM Unit Identification:** Adobe Town WY-030-401 and WY-040-408

**Description** Adobe Town is proposed by the conservation community for wilderness designation. The area proposed for wilderness includes all of the Adobe Town Wilderness Study Area, plus additional lands of wilderness quality in The Haystacks, along Willow Creek and the Willow Creek Rim, and south of the WSA to the Powder Rim and just beyond it. All of these areas possess the full complement of required characteristics for wilderness in abundance: outstanding opportunities for both solitude *and* primitive and unconfined recreation, wilderness-quality naturalness, size (at over 180,000 acres, the citizens proposed Adobe Town wilderness is well above the 5,000-acre minimum), and in addition has outstanding supplemental values such as abundant wildlife, wild horse herds, unique geology, and abundant archaeological and paleontological resources.

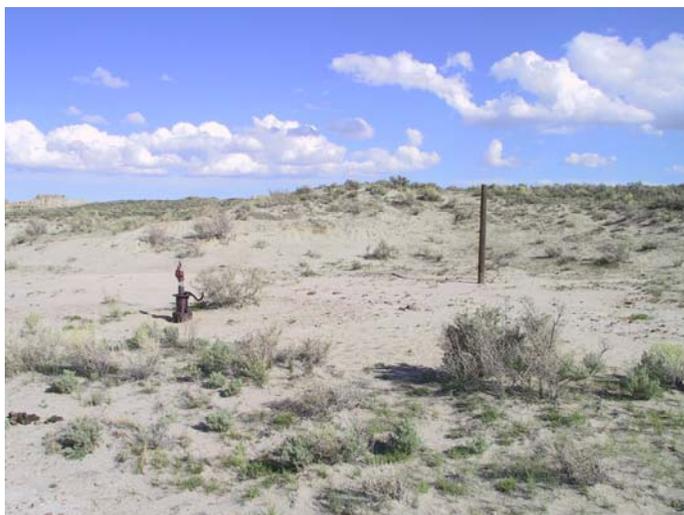
Figure 3

Trappers Trail #1 well site at the end of AT-1. This site is finally returning to a relatively natural state after several failed attempts to revegetate it.

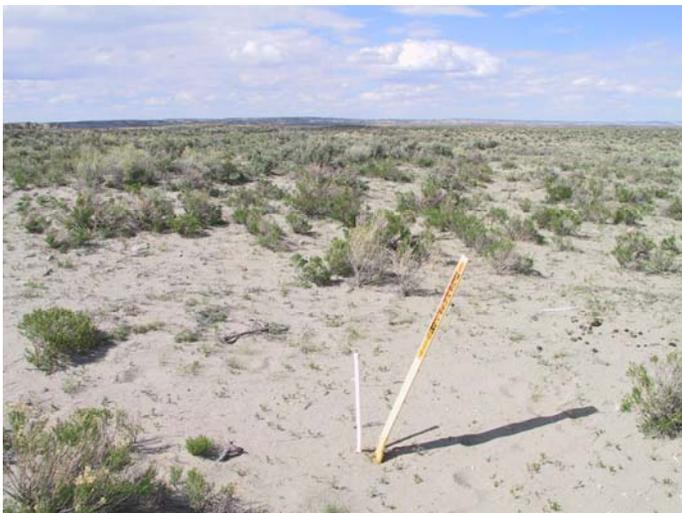
Figure 6

View north along the gas pipeline that accompanies Route AT-3. Like the road, it is a "temporary intrusion."

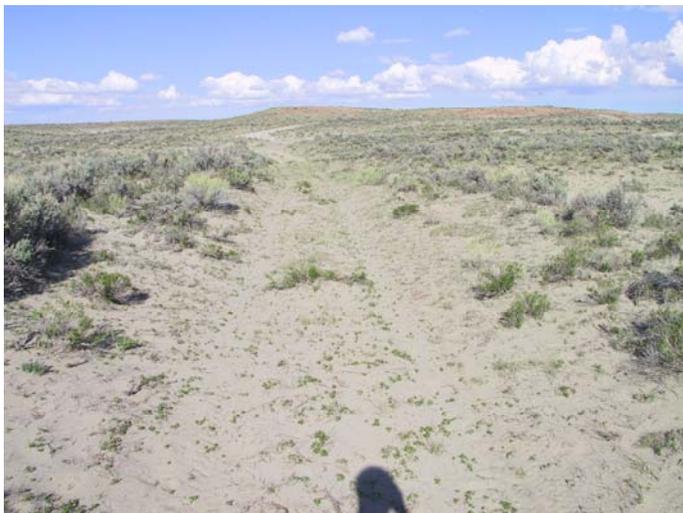
Figure 9

Typical view of Route AT-4 (part of the “Monument Valley route”) crossing sandy country. This two-track shows no evidence of construction or maintenance, being maintained solely by the passage of vehicles.

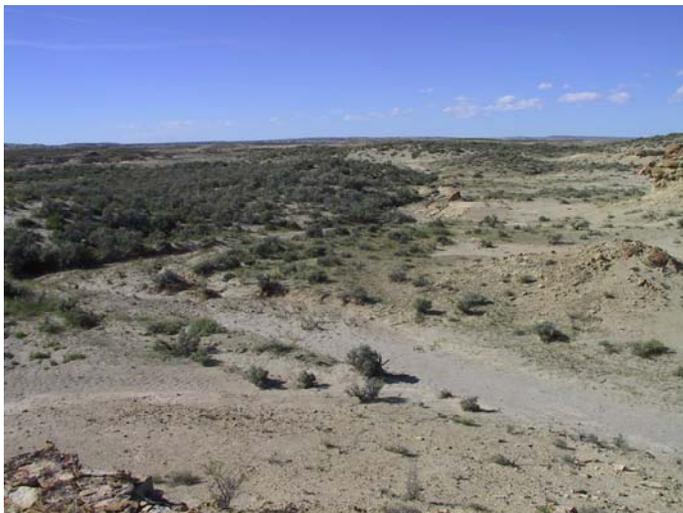
Figure 12

The central portion of AT-5 has completely disappeared and is impassable to vehicles. This part of the route no longer exists.

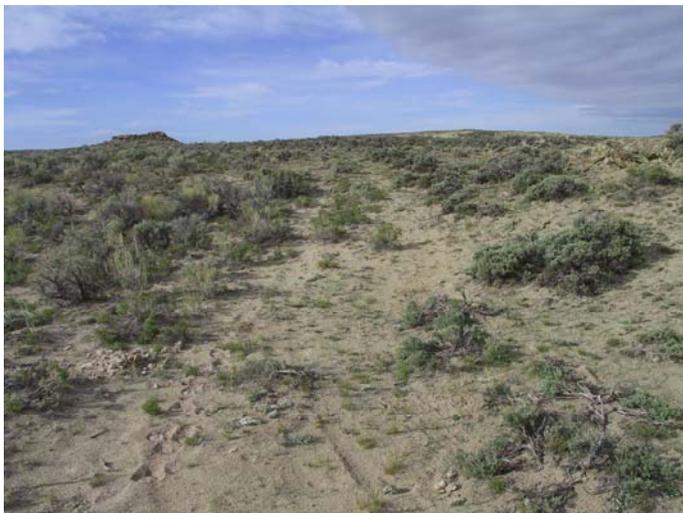
Figure 27

View of Route AT-12 in fairly faint condition. It receives very little use and is mostly reclaimed.

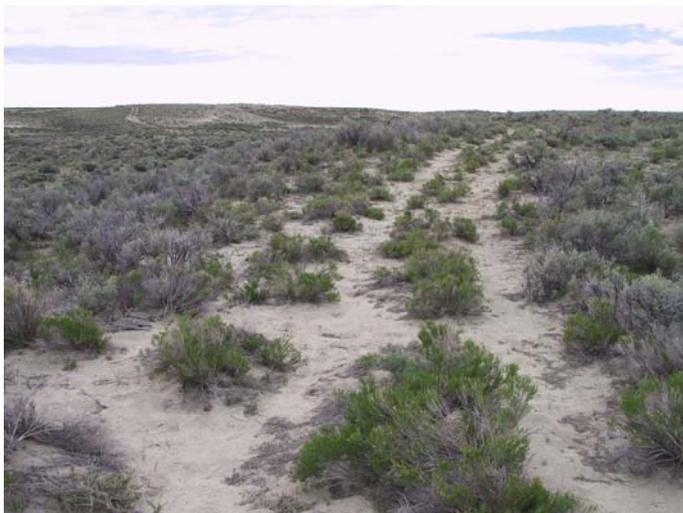
Figure 30

Typical view of AT-13, a dead-end jeep "way" entirely within Adobe Town WSA. It was not identified in BLM's Wilderness Intensive Inventory.

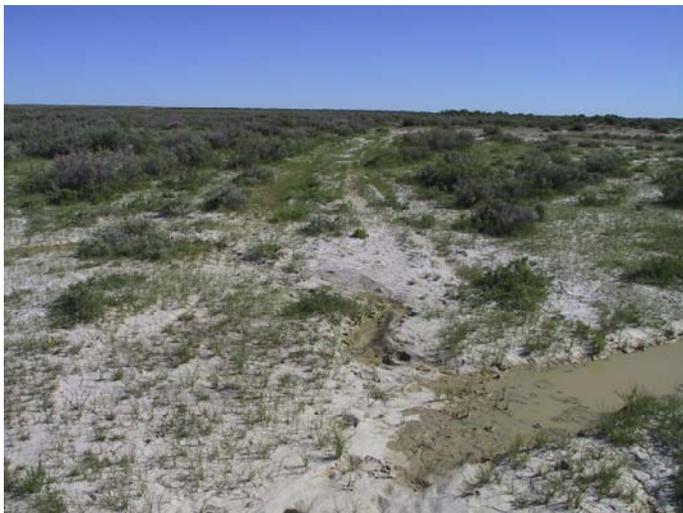
Figure 33

Impassable stretch of AT-15 as it crosses the Shell Creek bogs. There are no signs of recent vehicle use here.

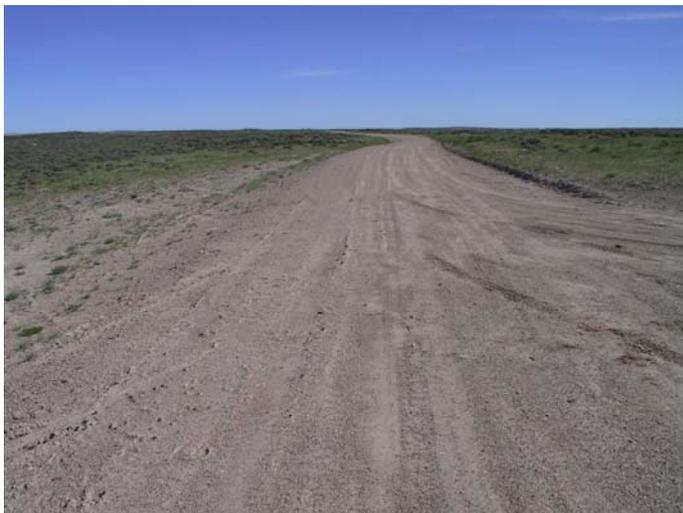
Figure 36

View of AT-16 in its best condition. This route exhibits construction and some maintenance, and receives regular use. It is excluded from the proposed Adobe Town WSA expansion.

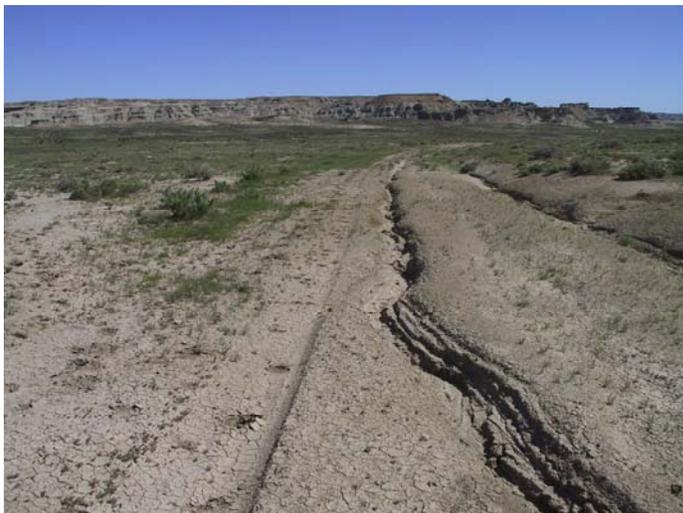
Figure 39

View of AT-17 in its typical, reclaimed condition. Although BLM used this route as a boundary for Adobe Town WSA, it is no longer even a “way” but rather a “slight intrusion.”

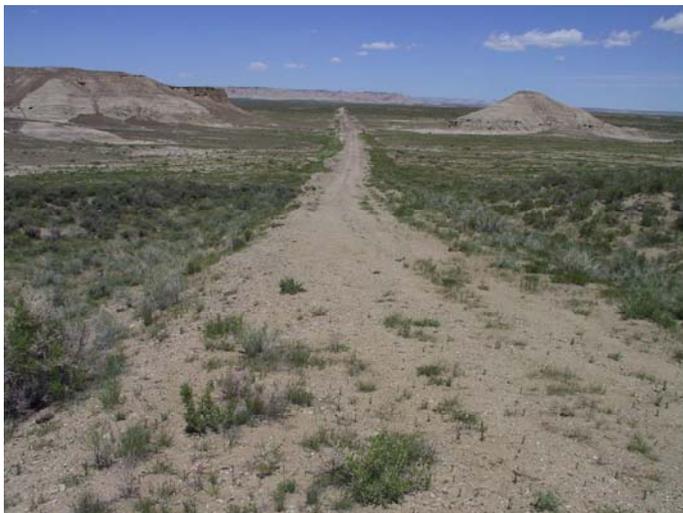
Figure 42

View of AT-18 in its best condition. This improved gravel route runs north to the abandoned Coastal Haystack #4 well. Its maintenance has been abandoned and it is deteriorating.

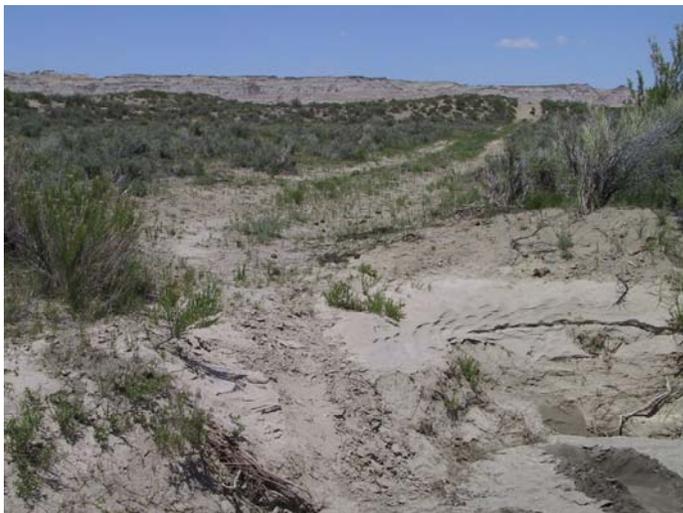
Figure 45

View of impasse on AT-19 that prevents vehicles from accessing its south end from AT-18. The wash wall is three feet high.

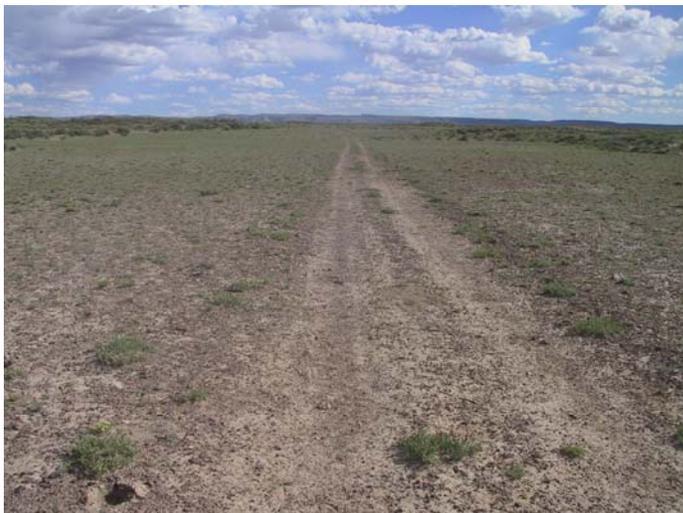
Figure 48

View of Route AT-20 in its best condition. It shows no evidence of construction or maintenance and receives no use. This dead-end way serves no purpose other than functioning as the southeast boundary of the Adobe Town WSA.

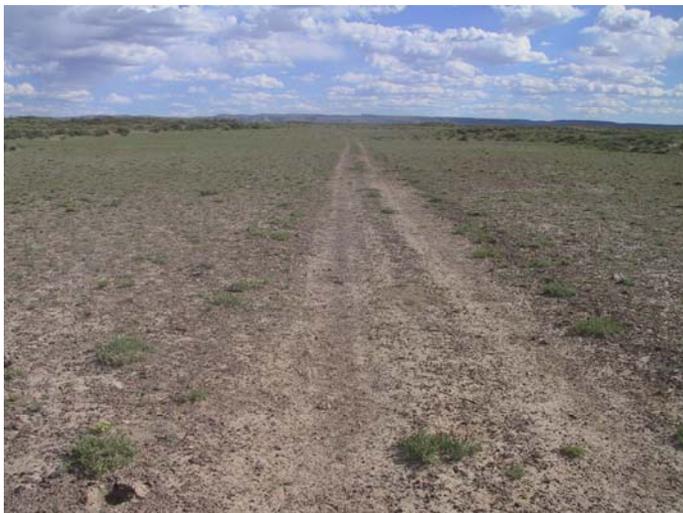
Figure 51

View of Route AT-22 in typical condition. It accesses Blank Reservoir, which is still in use. There is evidence of blading all along this route, but it receives no use and is revegetating naturally. It falls entirely within Adobe Town WSA.

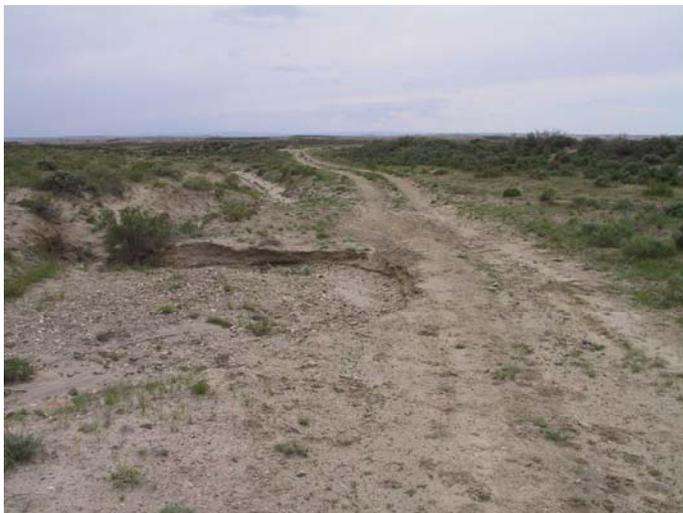
Figure 60

Unreclaimed portion of AT-27 at its most primitive. The original constructed route has washed out here, and a two-track detour carries all traffic.

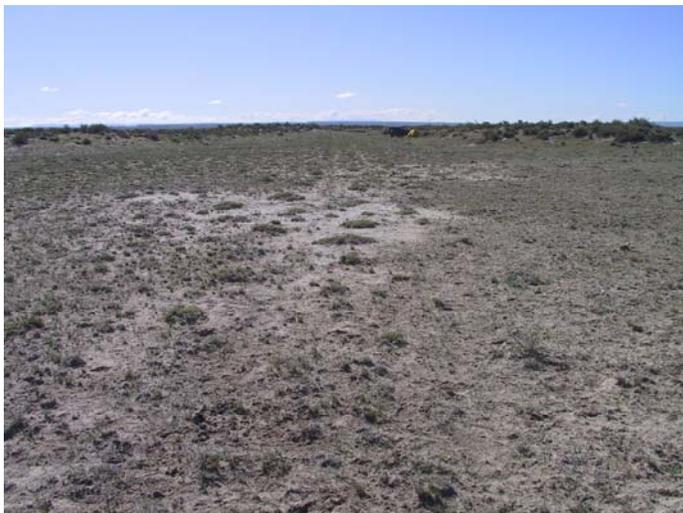
Figure 63

Route AT-28, the former access route to Sand Branch Reservoir. It has been completely obliterated by natural degradation, and now does not even qualify as a “slight intrusion.”

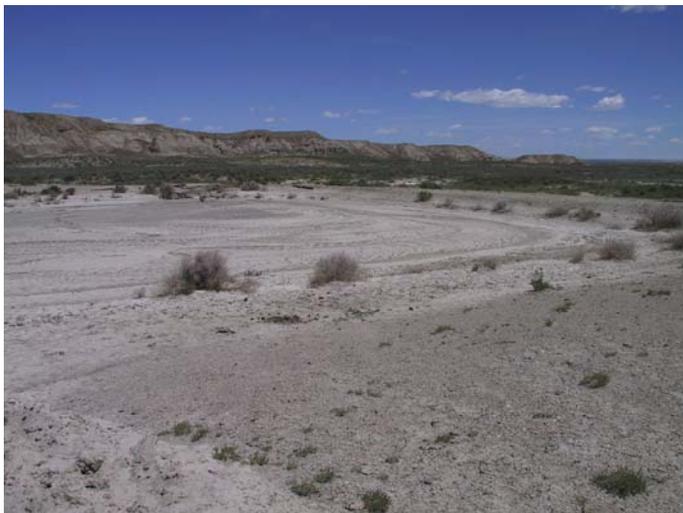
Figure 84

Last Reservoir. There is no access route that reaches it. The dam is breached in the center and it no longer holds water.

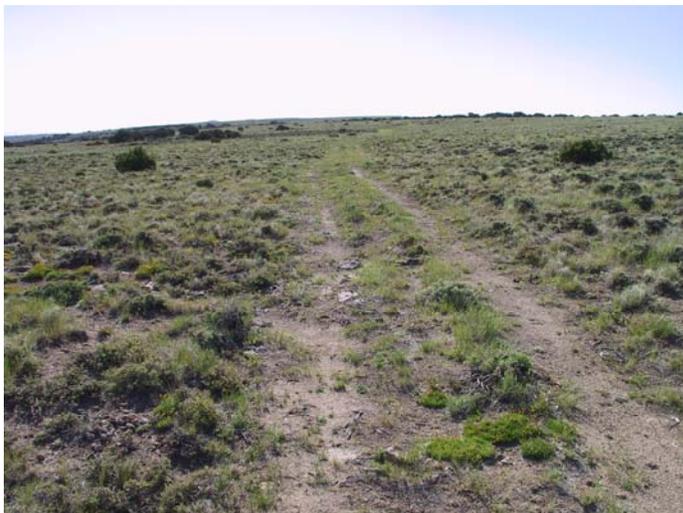
Figure 102

Typical view of AT-49. This route shows no evidence of construction, maintenance, or regular use.

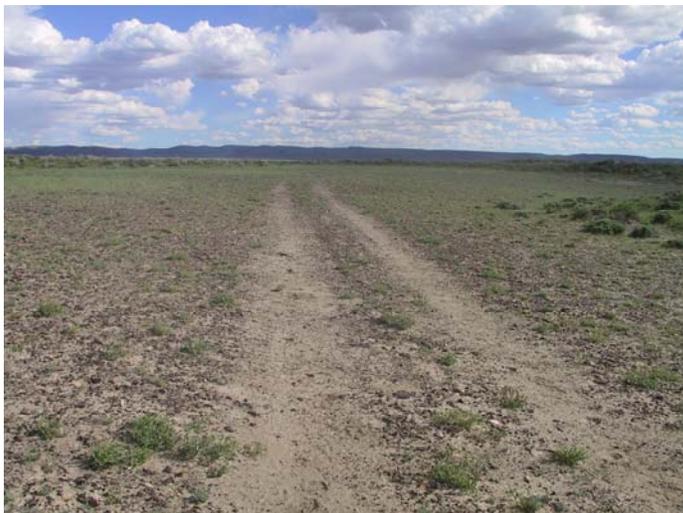
Figure 114

Route AT-57 in its best condition. This dead-end southern extension of AT-20. It was not constructed or maintained, and does not receive regular use. It is incorporated into the proposed WSA expansion.

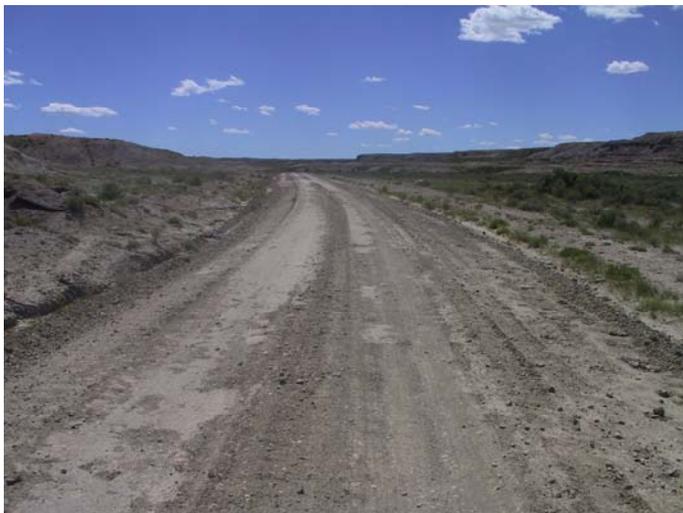
Figure 117

Route AT-60 in typical condition. This is a road that was constructed and receives regular maintenance. It is excluded from the proposed WSA expansion.

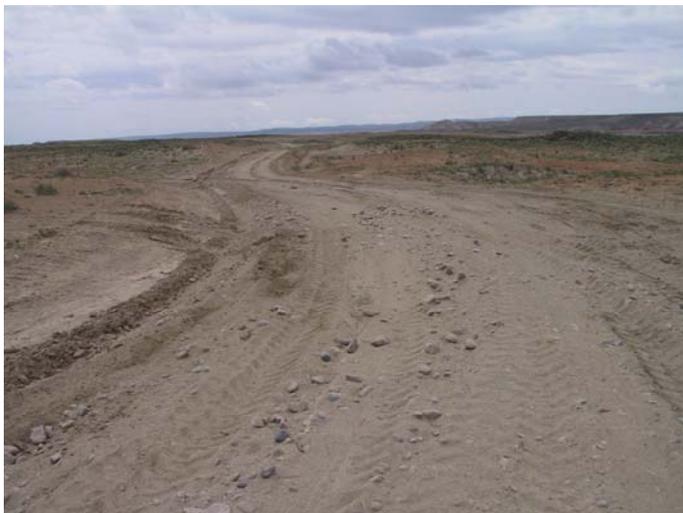
Figure 120

Route AT-63 in typical condition. This is a road that was constructed in 2001 and has yet to receive maintenance. It is a “road,” but may also qualify as a “temporary intrusion.” It has been cherry-stemmed out of the proposed WSA expansion.

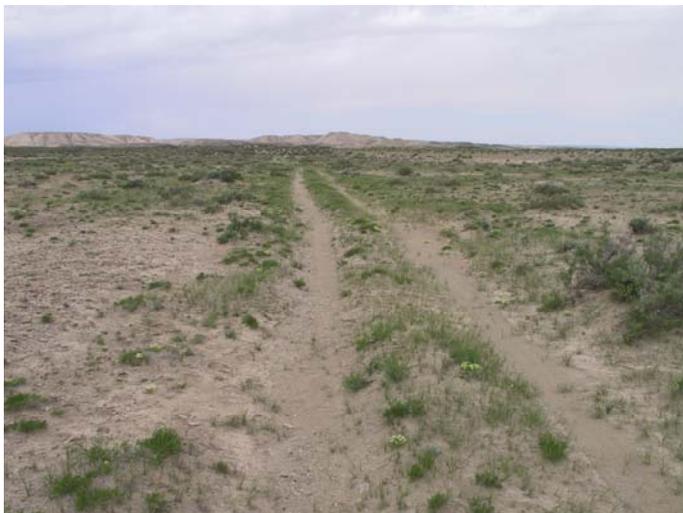
Figure 123

Route AT-63A in its most obvious condition. This way was never constructed or maintained, and is fully reclaimed along much of its length.

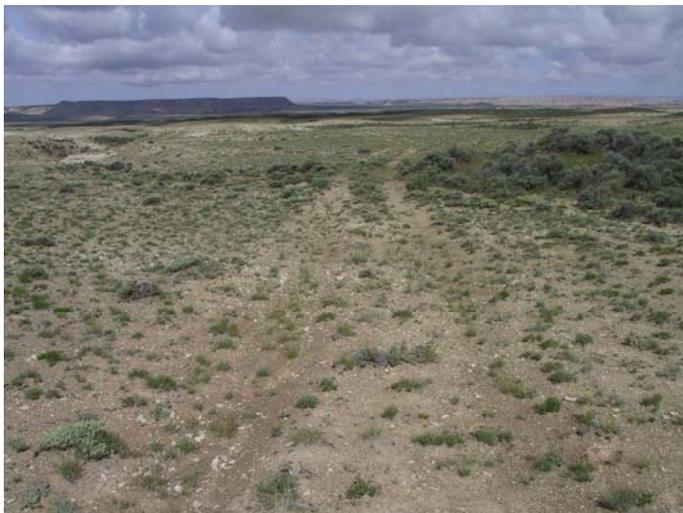
Figure 141

Abandoned jeep trail AT-72 in its most evident condition. This route is well-reclaimed and is a “slight intrusion” rather than a “way.”

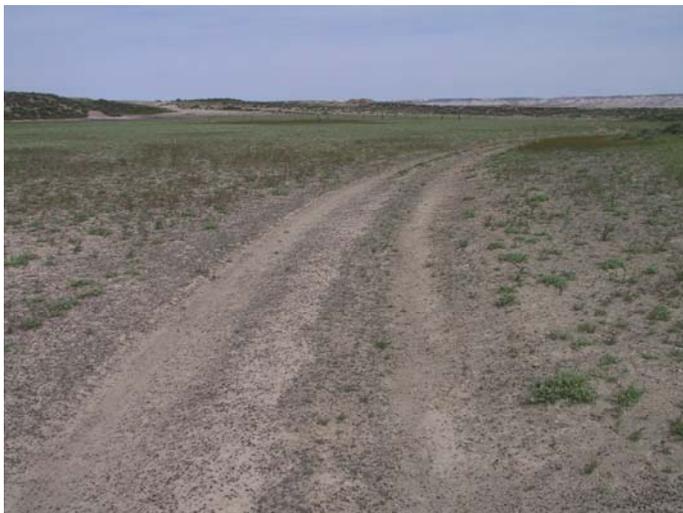
Figure 156

Route AT-84 in its best condition. This two track is clearly maintained solely by the passage of vehicles.

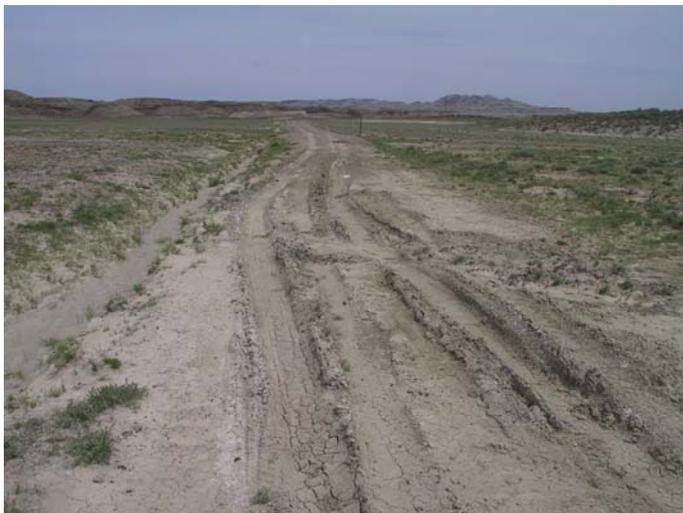
Figure 162

View of the middle reaches of AT-86, demonstrating its lack of maintenance and impassability to passenger vehicles.

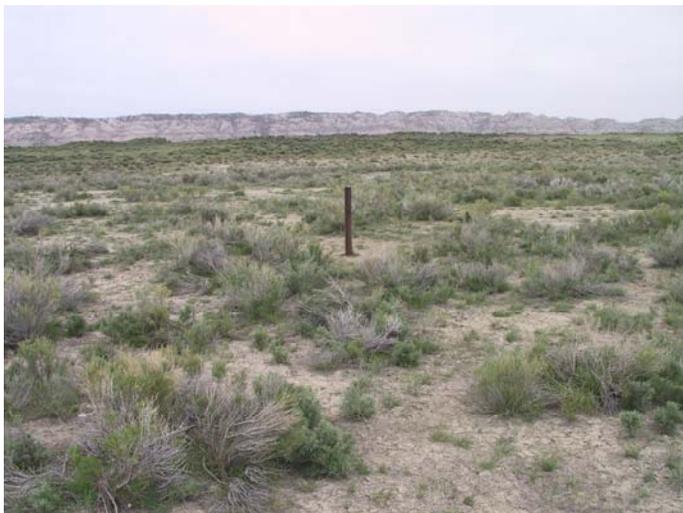
Figure 165

Abandoned Ladd Petroleum drill site beside AT-87. This site has returned to a natural state.

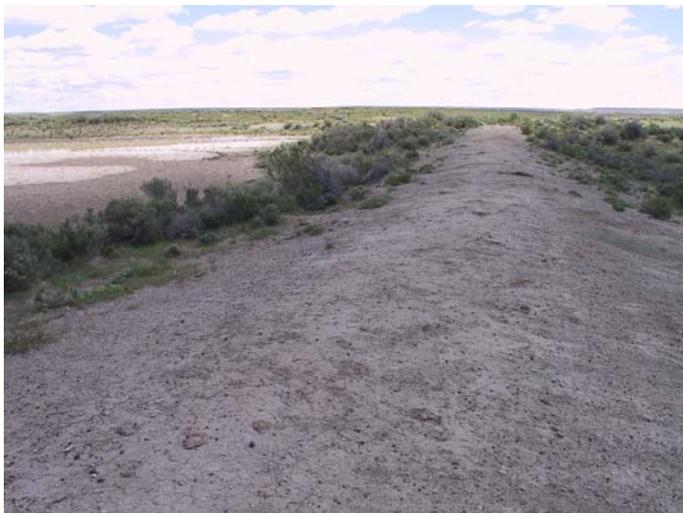
Figure 171

N-T Reservoir along AT-89B. This reservoir is sound and holds water, but its dam is camouflaged by vegetation. It is similar to reservoirs inside Adobe Town WSA.

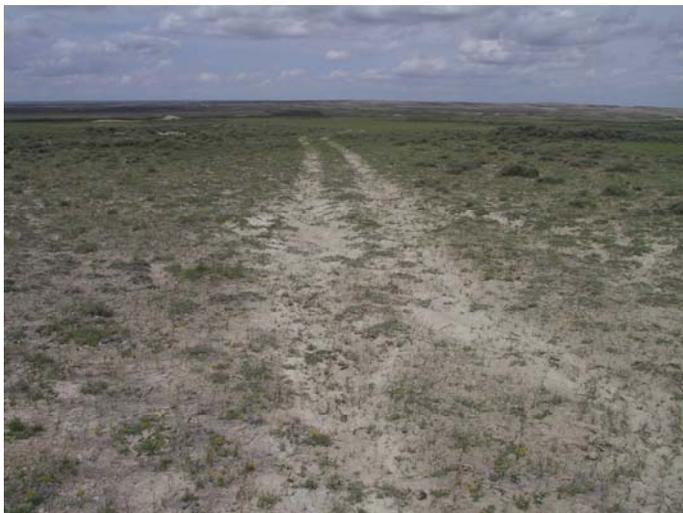
Figure 186

Route AT-98 in its typical condition. This route was never constructed or maintained, and does not receive regular use. It is a “way.”

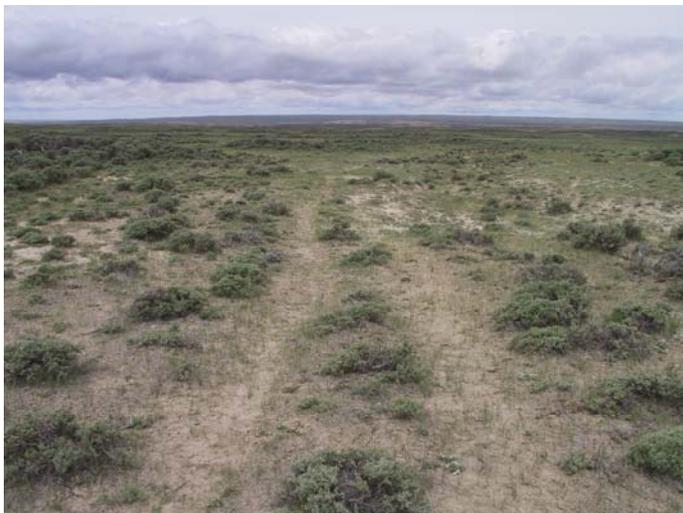
Figure 192

Typical condition of AT-103, an abandoned jeep trail that dead-ends at the base of the Haystacks. A way while in use, it now qualifies only as a “minor intrusion.”.

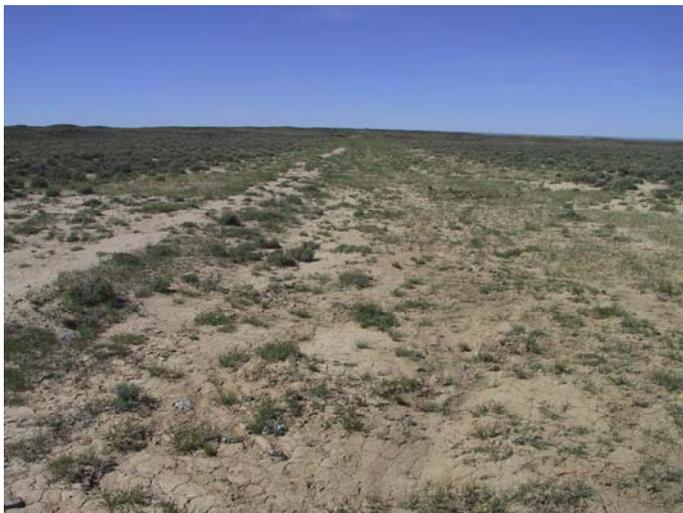
Figure 195

Pipeline AT-106, a significant human intrusion. It has been excluded from the proposed WSA expansion and serves as the north-west boundary.

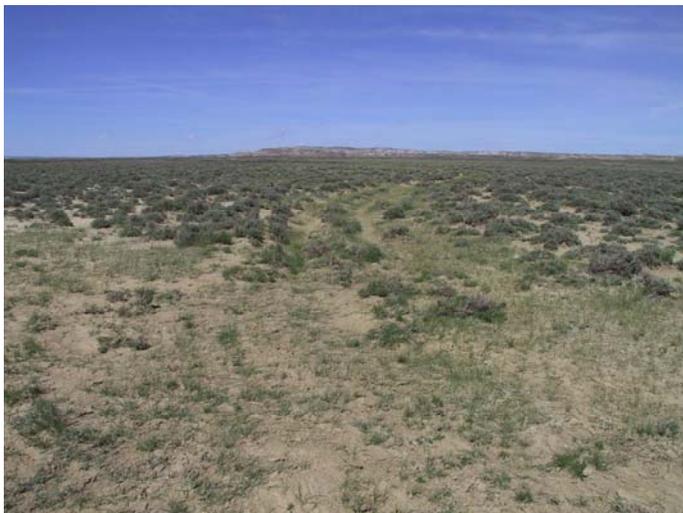
Figure 198

Route AT-109. The western portion of this route, shown here, has been abandoned and receives no use at all. It is deteriorating rapidly.

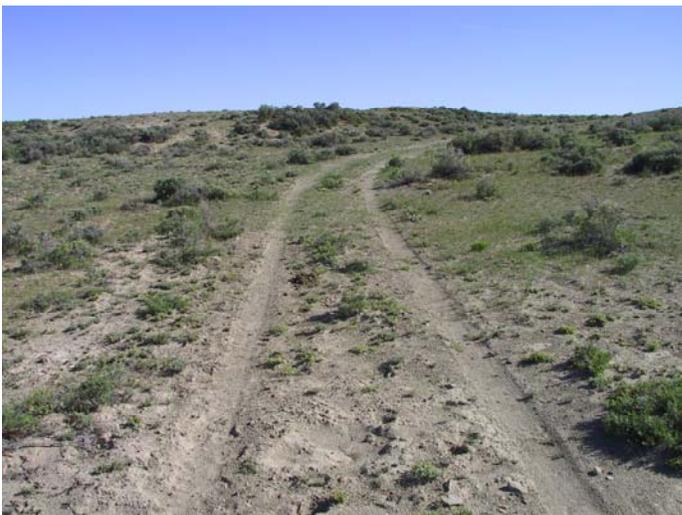
Route is very faint as it passes through the Shell Creek bogs. There are no signs of use here.

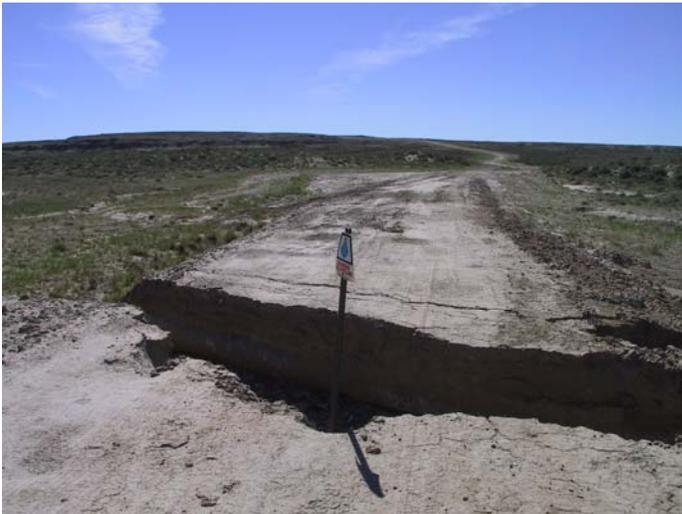
Route is in poor condition here  
due to wet-weather use.

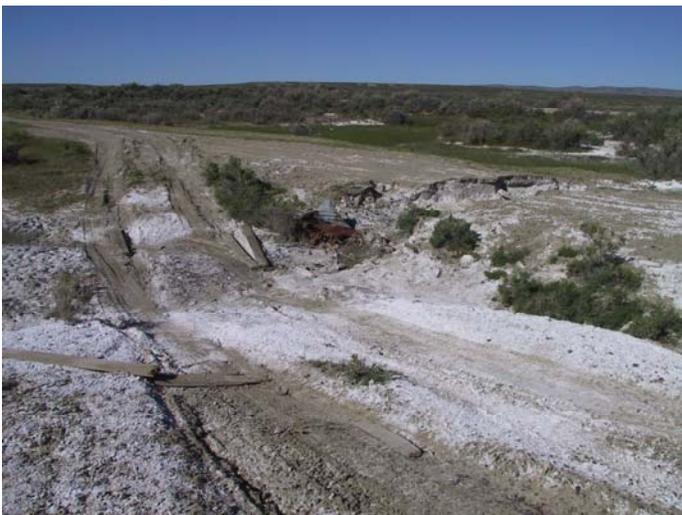
View south along AT-16 from junction with cutoff to AT-9. This portion of route crosses an alkali bog, and is in very poor condition. Note buildings of Cow Creek Ranch in background.

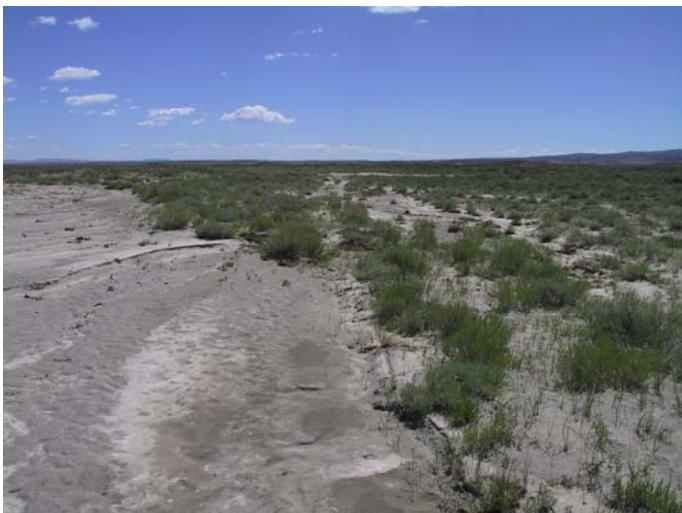
Location of boundary route AT-17, which has been entirely erased by natural degradation and no longer exists. View west.

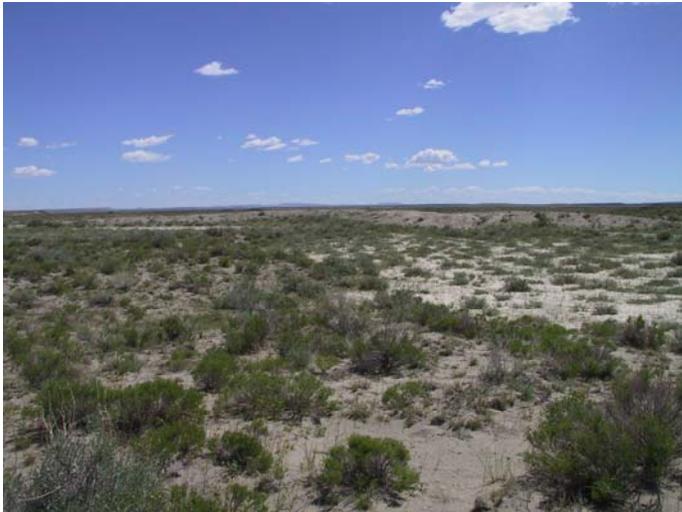
Location of boundary route AT-17, which has been entirely erased by natural degradation and no longer exists. View east.

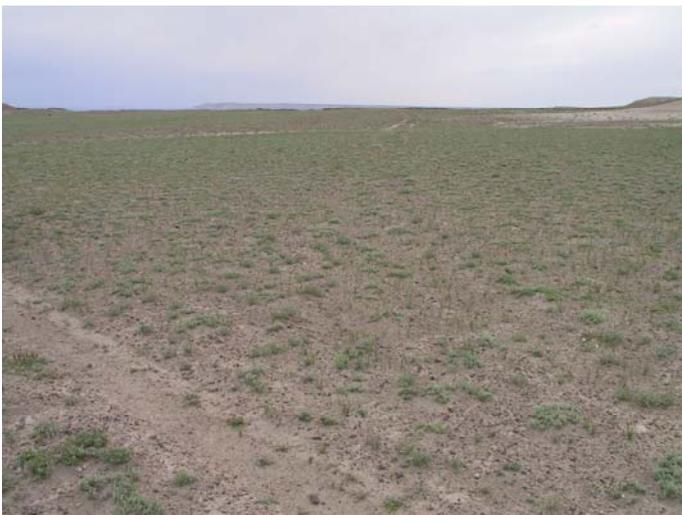
Route is in poor condition here.

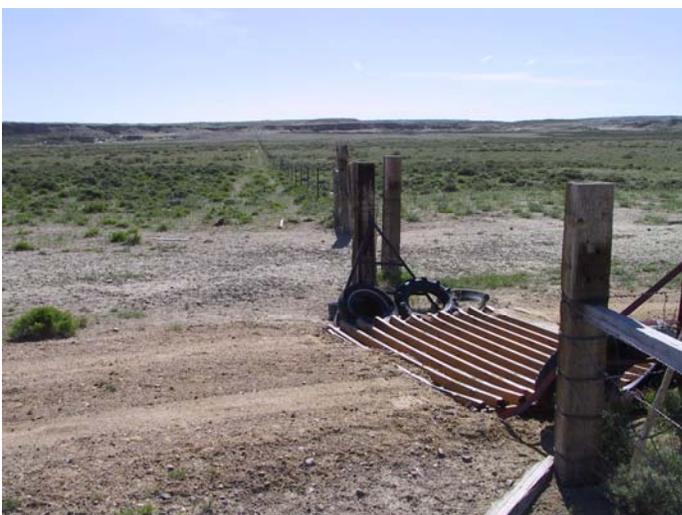
This fence appears to divide several grazing allotments. For long stretches east of Route AT-16, the fence wire is down, allowing passage of livestock and wildlife. The fence ends atop Skull Rim. The easternmost end of the fence, which is in good repair, falls within Adobe Town WSA.

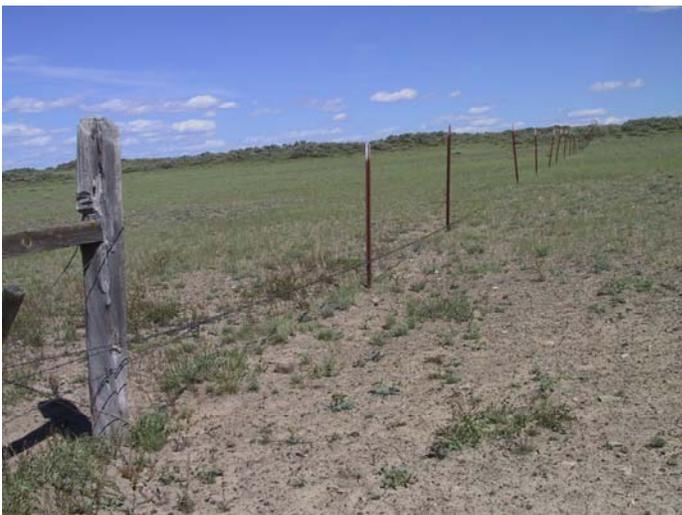
View west along fence at gate crossing of AT-7. There is no gate present. The fence is down at this locale. Note rusting barrel.

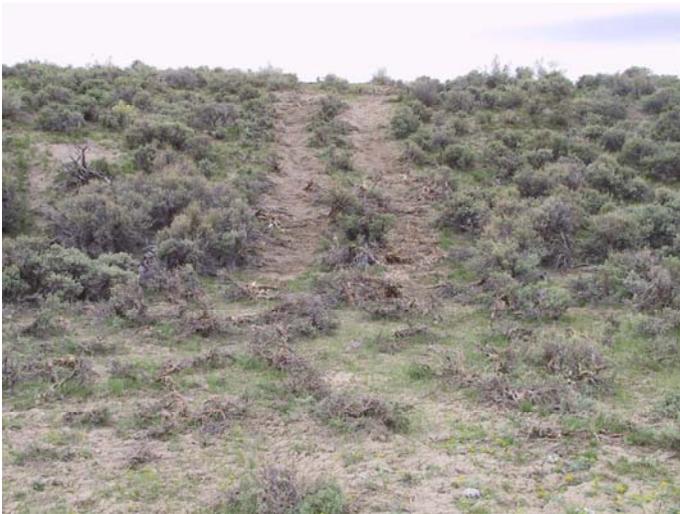
This route represents damage from off-trail driving by heavy equipment.

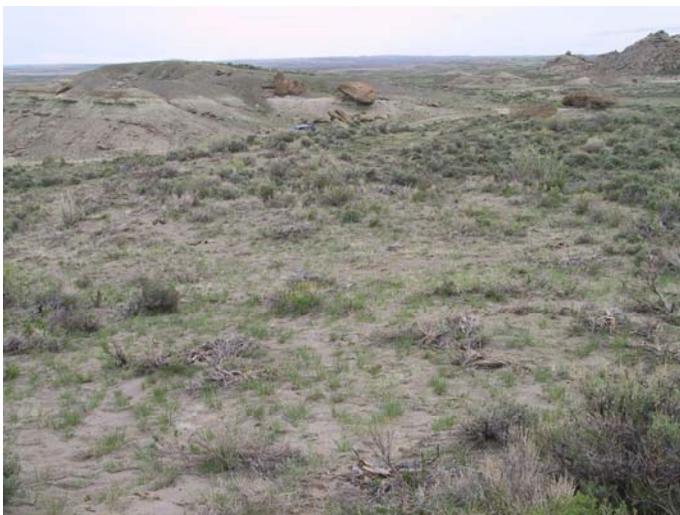
Begin off-trail heavy equipment  
damage, departing from AT-96.
