H-6300-1-WILDERNESS INVENTORY MAINTENANCE

Gardner Mountain Wilderness Inventory Unit

Year 2012 Inventory Unit Number/Name Gardner Mountain (WY-060-201)

a. Area Number/Name: Gardner Mountain Inventory Unit (WY-060-201, expanded)

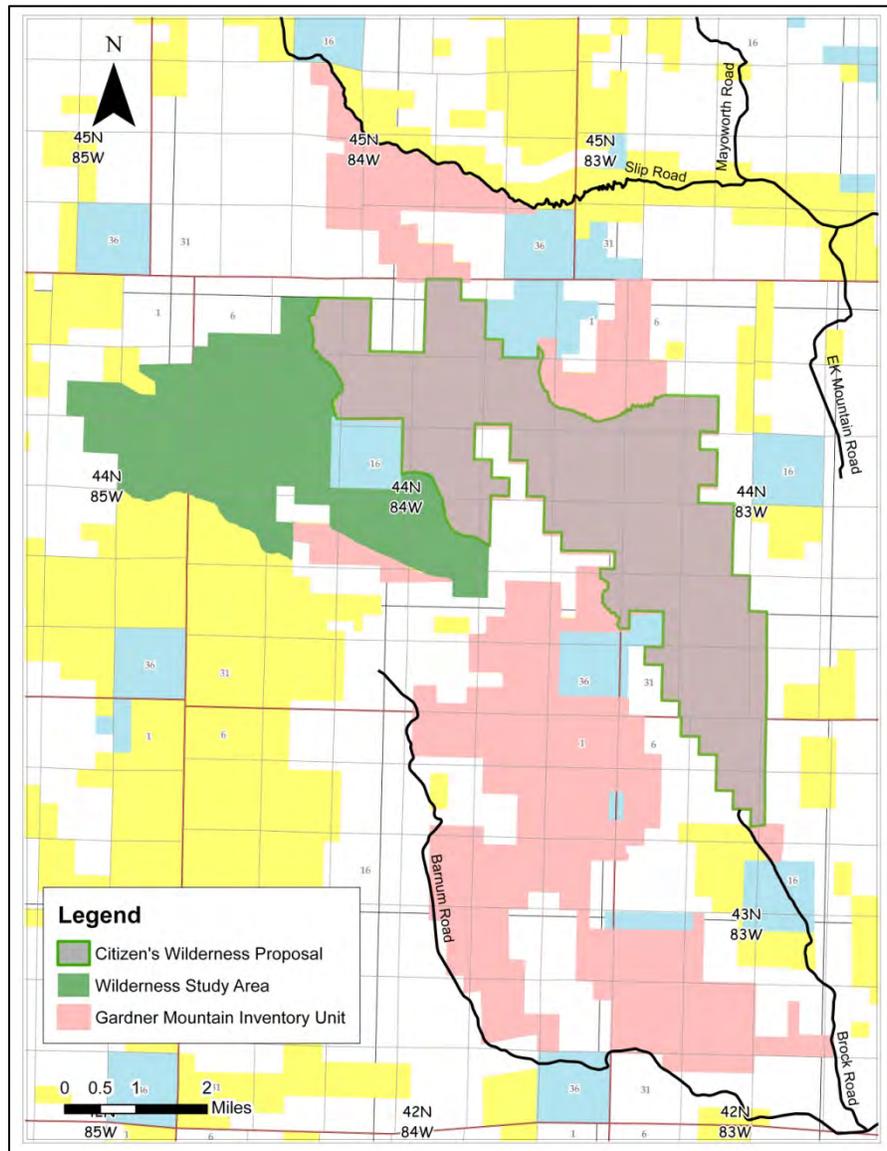
Figure 1. Gardner Mountain Inventory Unit.

The Gardner Mountain WSA and the majority of the CWP (except for the portion of the CWP in T 43 N R 83 W) were inventoried in 1979. The remainder of the inventory unit, which includes approximately 13,000 additional acres of BLM administered lands north and south of the CWP, does not have a record of previous inventory. The current inventory unit was expanded to incorporate all contiguous BLM administered public lands south of the Slip Road, North of Barnum and Brock Roads and east of the Gardner Mountain Wilderness Study Area, a total of 23,380 acres.

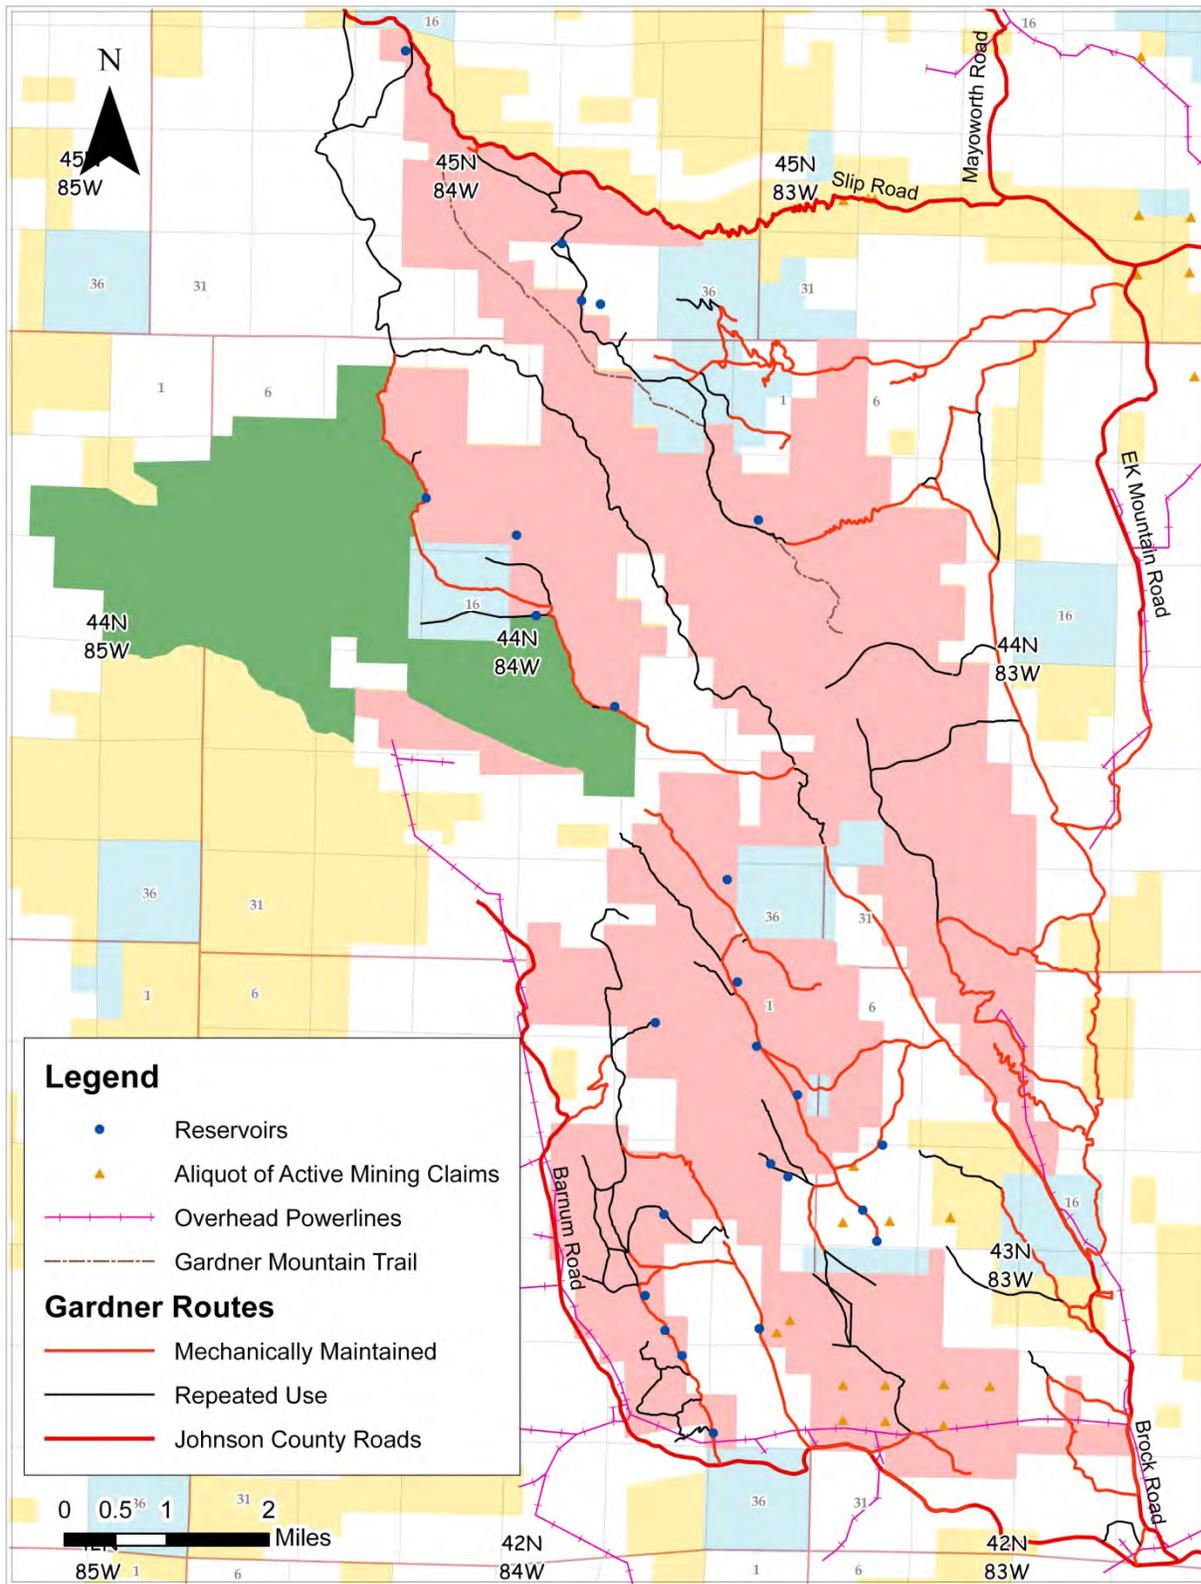
Figure 2. Mining Claims, Stock Water Improvements, and Energy Transmission in the vicinity of the Gardner Mountain Inventory Unit

Mining claim information is available to the nearest aliquot. Nine active mining claims exist within the southern portion of the inventory unit. An additional 4 claims are located within one mile of the unit along routes that require maintenance over BLM administered surface. Figure 2 illustrates documented development in the Gardner Mountain Inventory Unit.

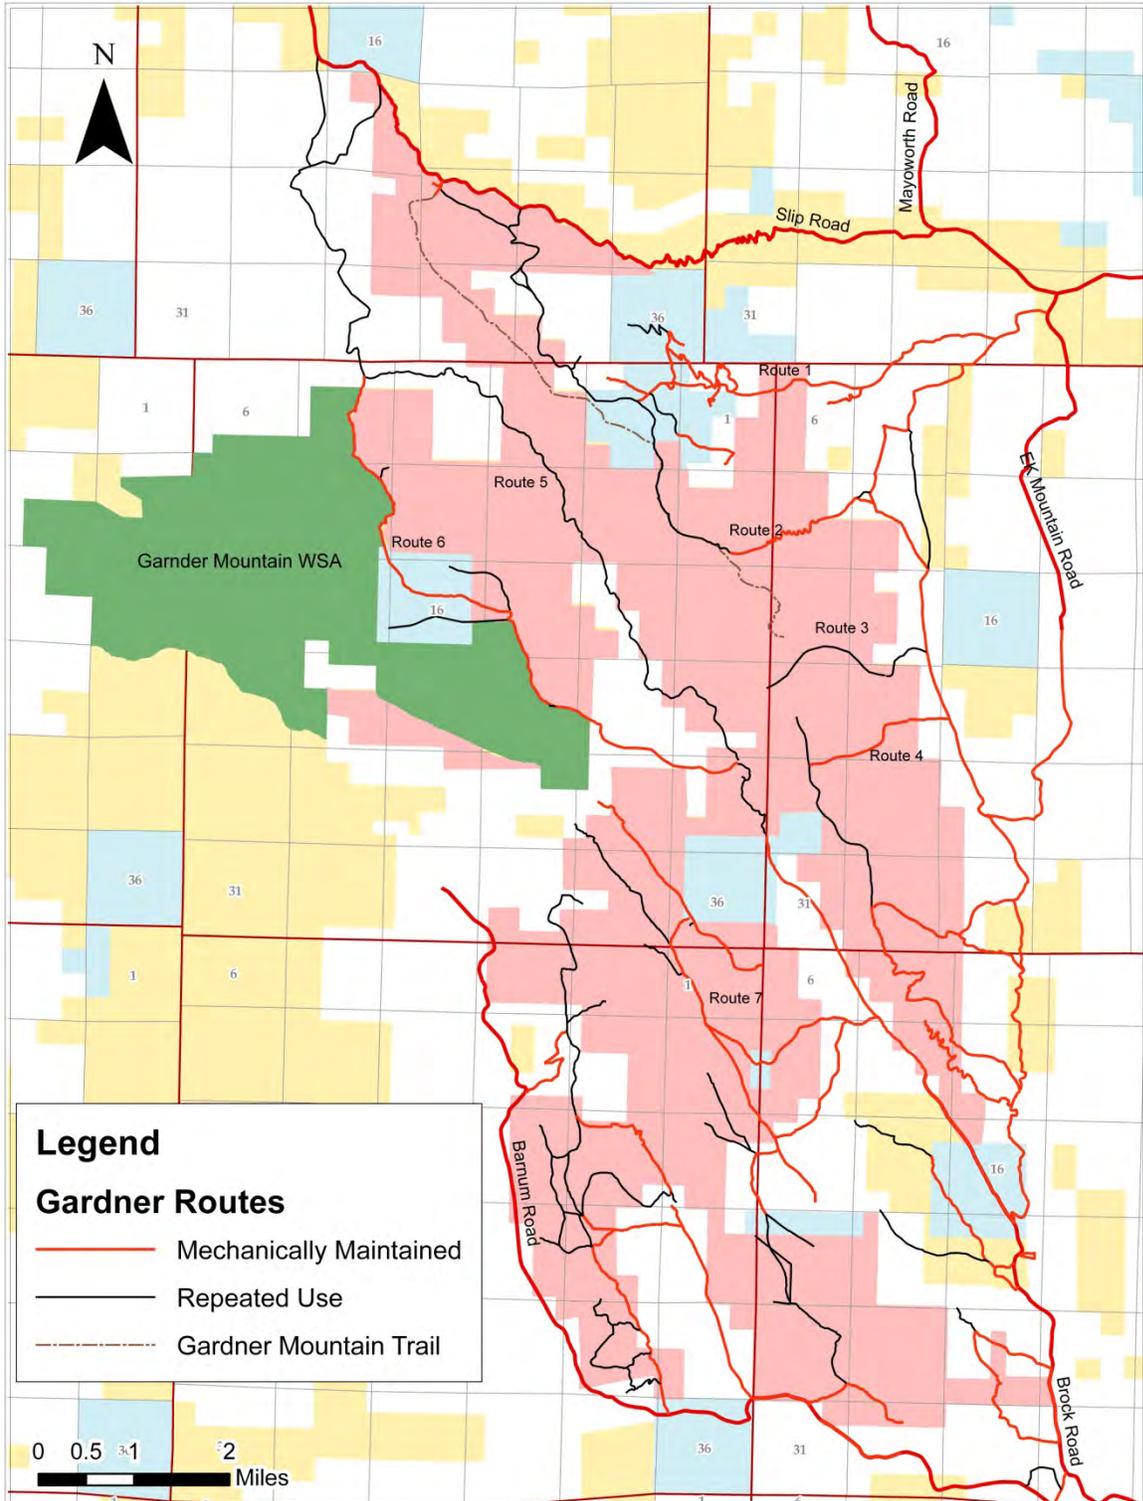
Figure 3. Route Analysis

Due to the extensive route network in the Gardner Mountain Inventory Unit, Appendix C forms were completed for selected routes only. The six original inventory routes and an additional mechanically maintained road that bisects the unit are included here. Determinations for all other linear access features were made based on a combination of helicopter and ground survey data, information from BLM specialists, and a travel management inventory completed by AECOM (available at the Buffalo Field Office).
