Fire: Red Bridge # DM93 Supplemental

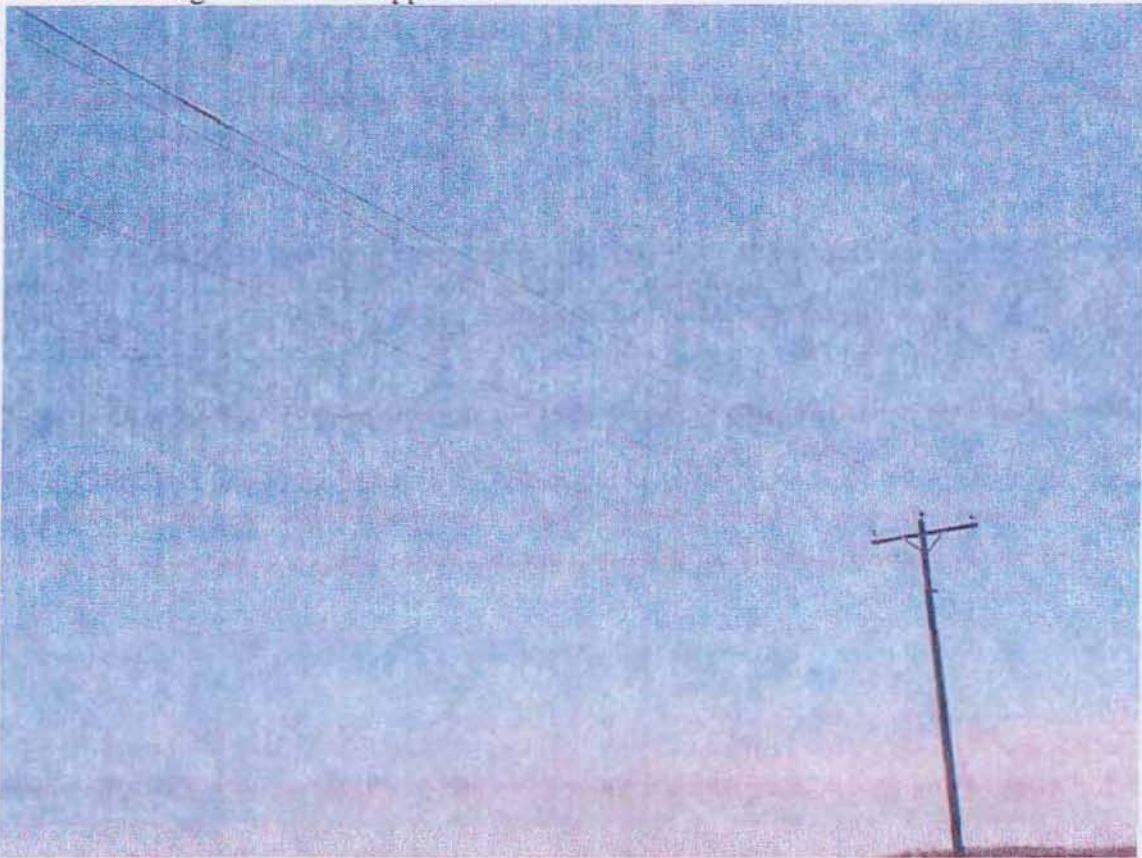
Photo # 3 East end of the span over the origin, facing east – note dark line upper left

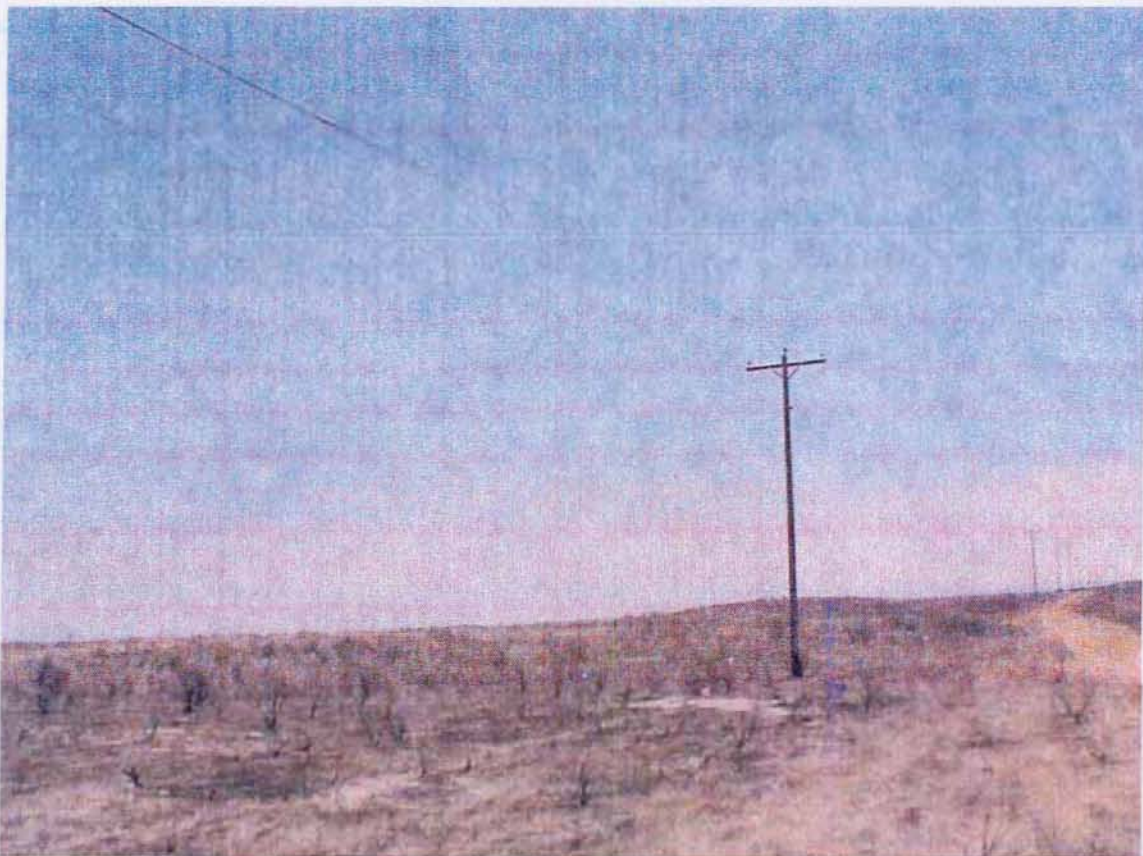
Photo # 4 Similar to photo # 3, with the origin on the ground visible as well

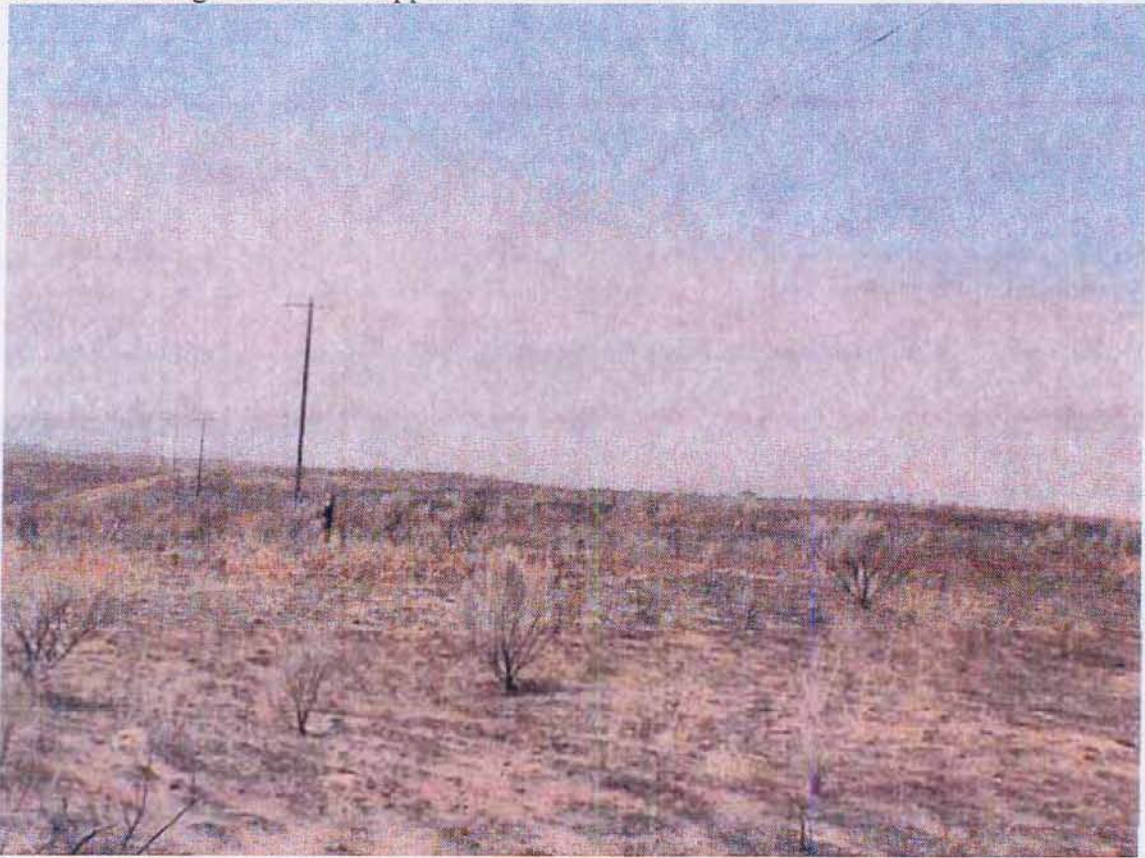
Photo # 5 West end of the span over the origin, facing west

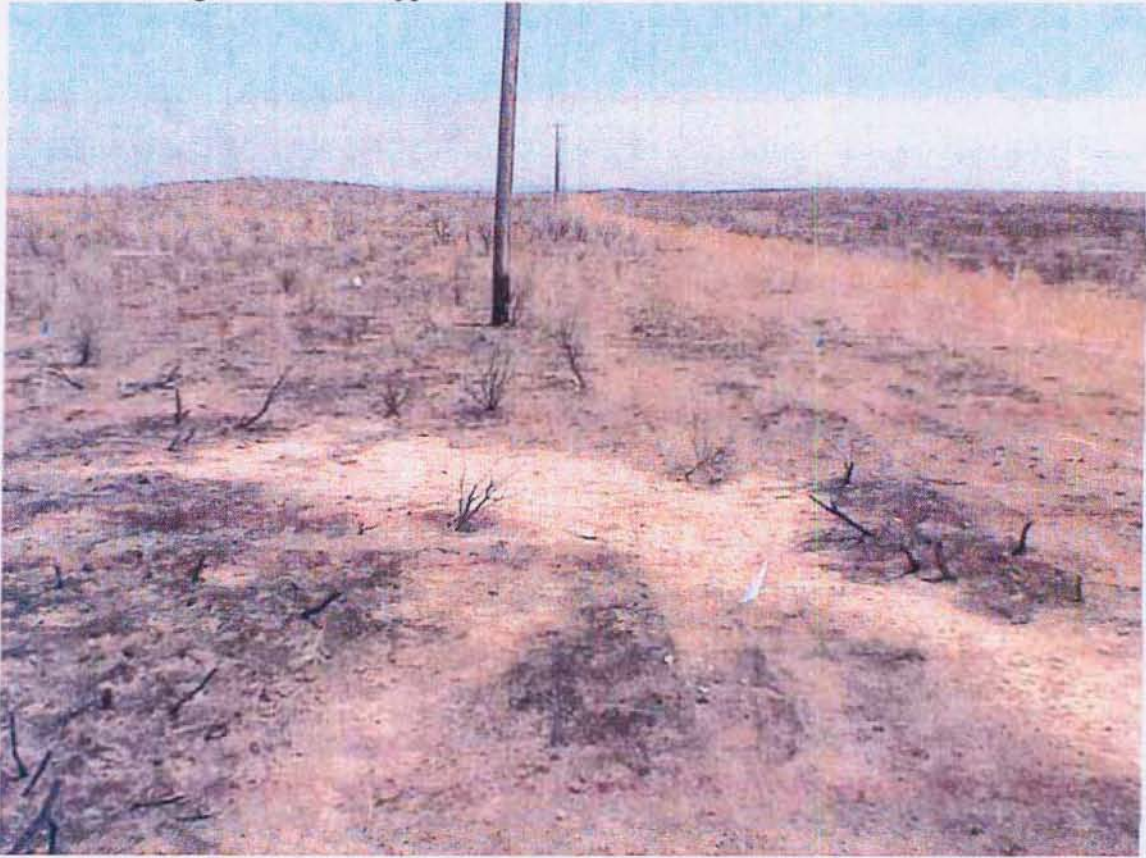
Photo # 15 View of the origin area, facing east toward pole in photo # 13

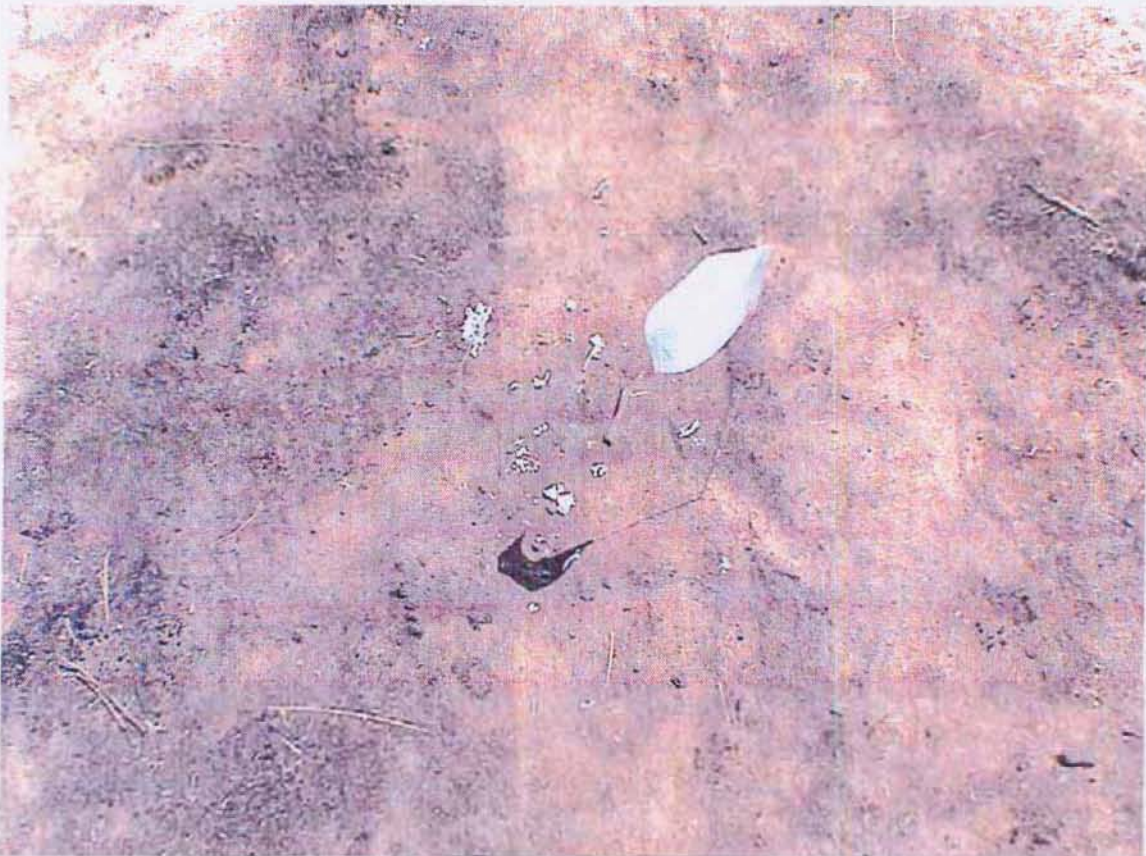
Photo # 16 Closer view of melted aluminum pieces collected, lower right of photo # 15

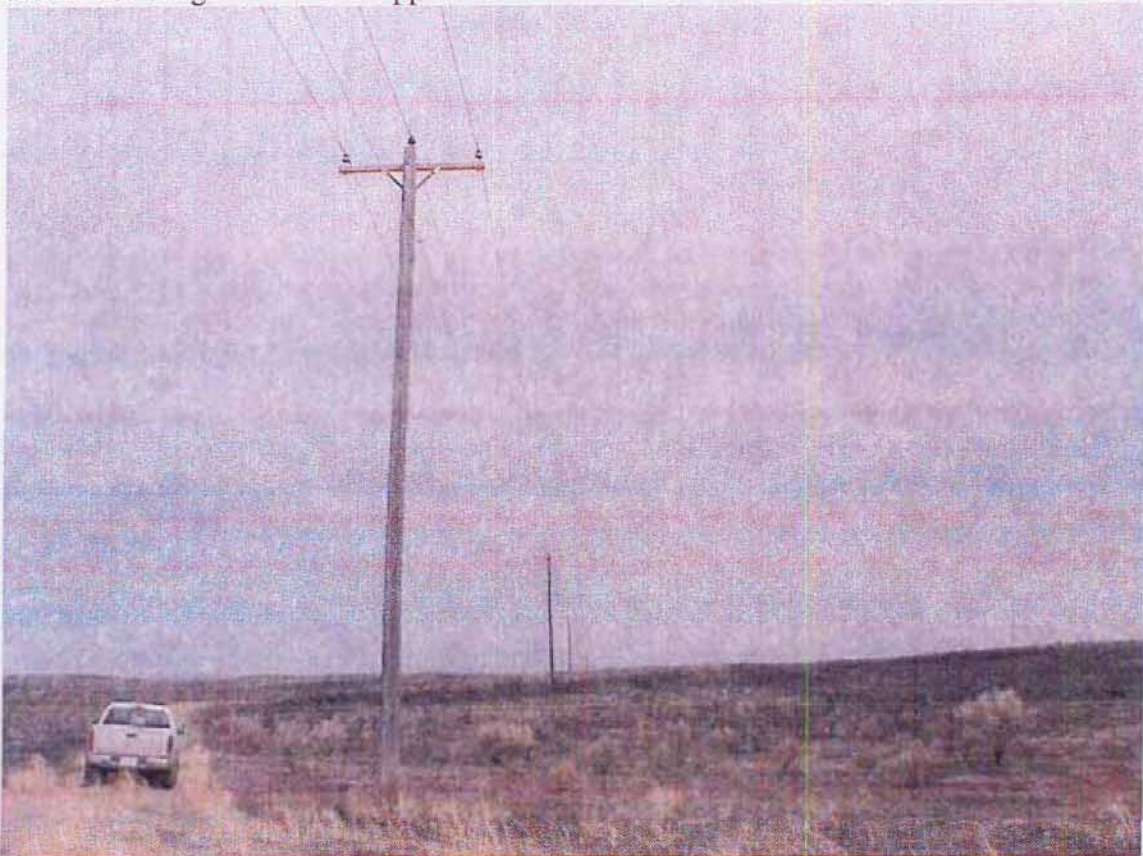
Photo # 17 Third span east of the point of origin, facing east – Photo taken 7-24-2007

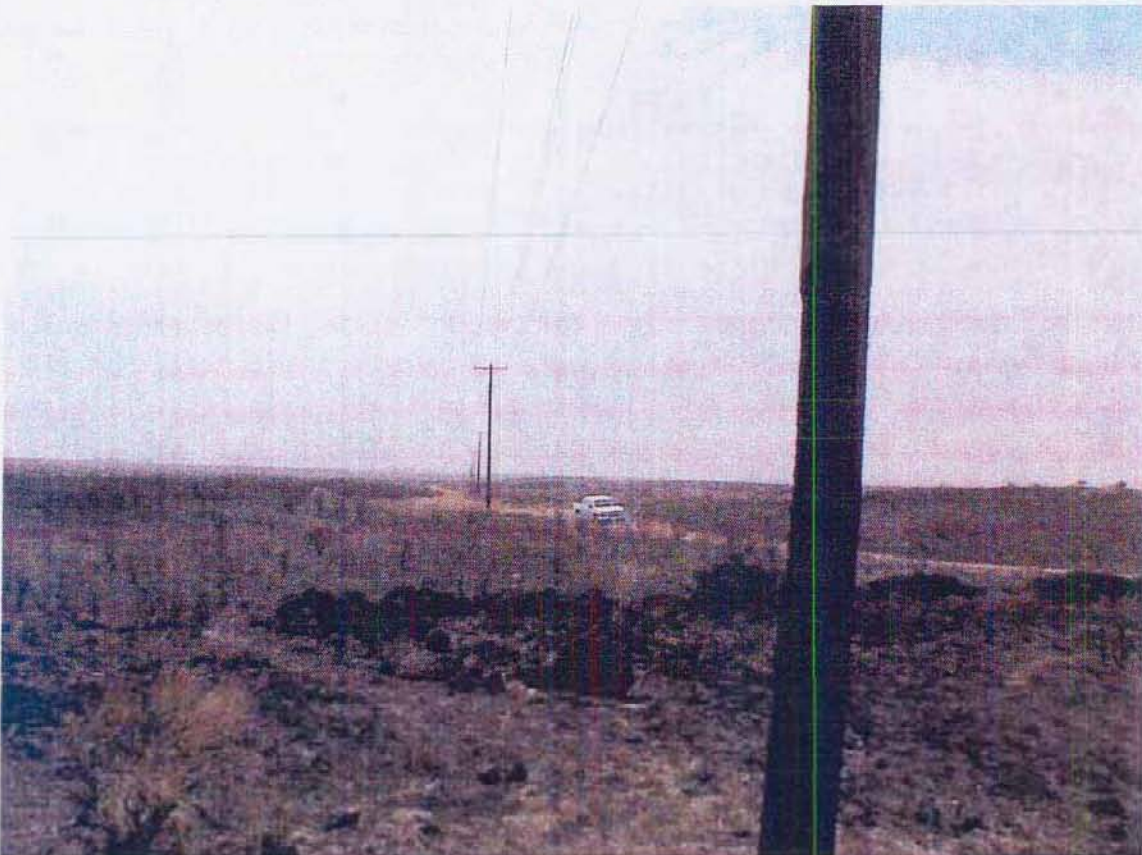
Photo # 18 Third span east of the point of origin, facing west – Photo taken 7-24-2007
