Nevada Strip Fishery Survey

Nevada Department of Wildlife

Bureau of Land Management

Technical Bulletin ID-2005-06

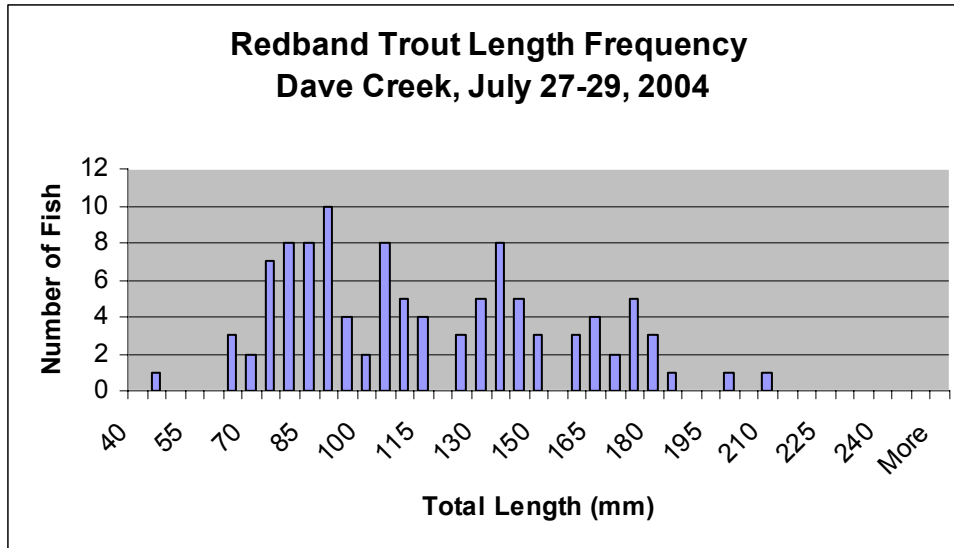
Figure 1. Dave Creek redband trout length frequency, July 27-29, 2004.

There were seven fish population sample sites completed in Dave Creek during the period of July 27-29 (Appendix II). The 6.4 mile reach of Dave Creek below the Forest Boundary had an average of 844.8 redband trout per mile. An estimated 5407 redband trout resided within the surveyed reach. Length frequency analysis of the sample of 105 redband trout revealed five age groups including a single young-of-year, a large age-I class, age-II, age-III, and two age-IV fish (Figure 1).

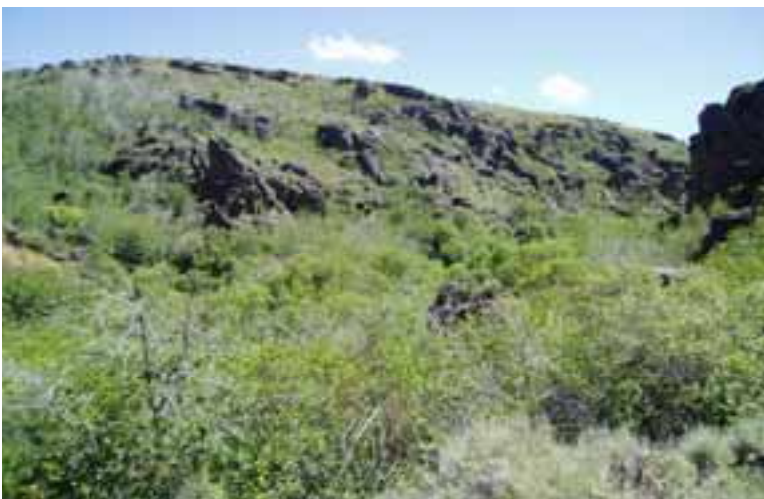
A total of six sample sites were slated for survey on Cherry Creek during July 7-8 (Appendix II). Only SS-1 was not surveyed due to the extreme density of riparian vegetation (Figure 2).

Figure 2. Cherry Creek SS-1 located near the stateline.
