## APPENDIX G—Example Greenlines

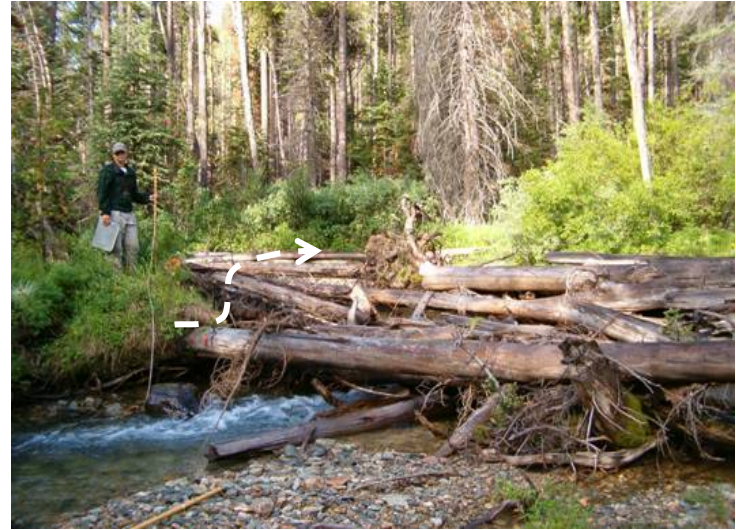
**Figure 20**—when a log jam that crosses the stream is encountered, the greenline continues over the log jam and is recorded as anchored wood. Photo - PIBO, U.S. Forest Service

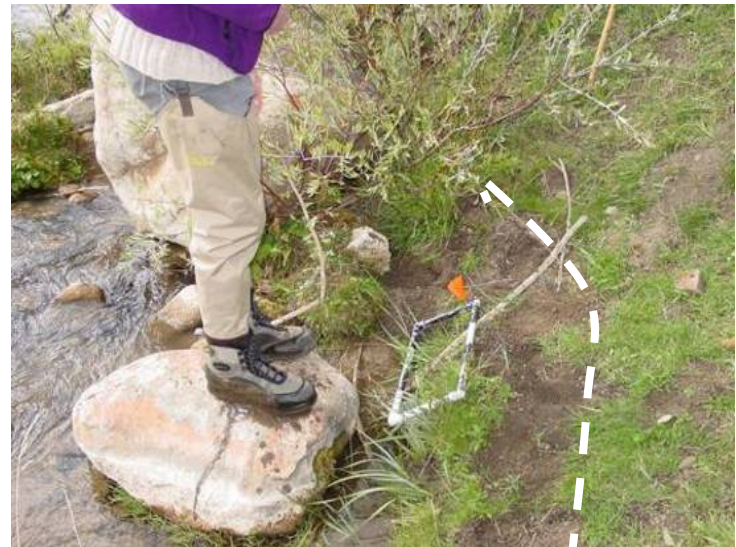
**Figure 21**—the patch of vegetation that the quadrant is on does not meet the 15 cm (6 in) by 50 cm (19.6 in) rule.

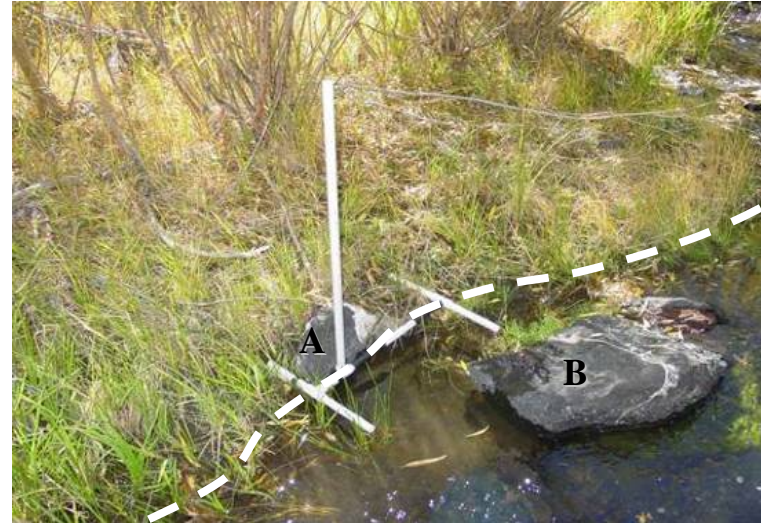
**Figure 22**—the rock “A” is anchored and part of the greenline. Active erosion exists on the streambank side of rock “B” and is not considered part of the greenline.

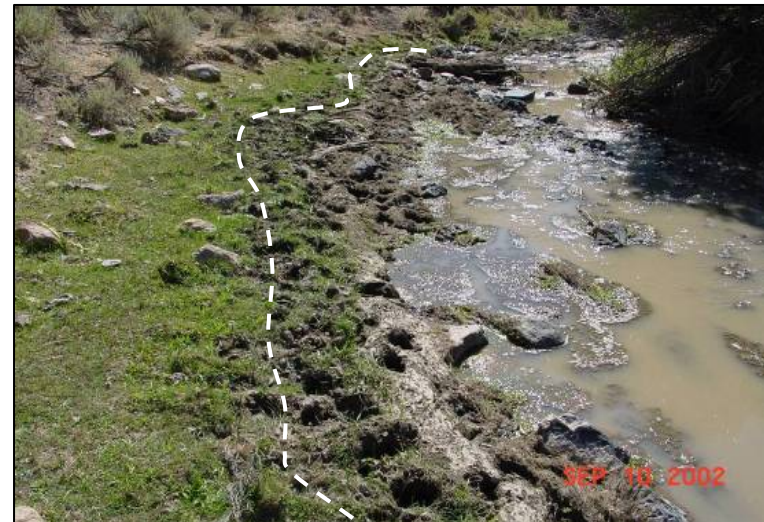
**Figure 23**— greenline follows the line of relatively continuous with lineal groupings of perennial vegetation with 25 percent foliar cover.

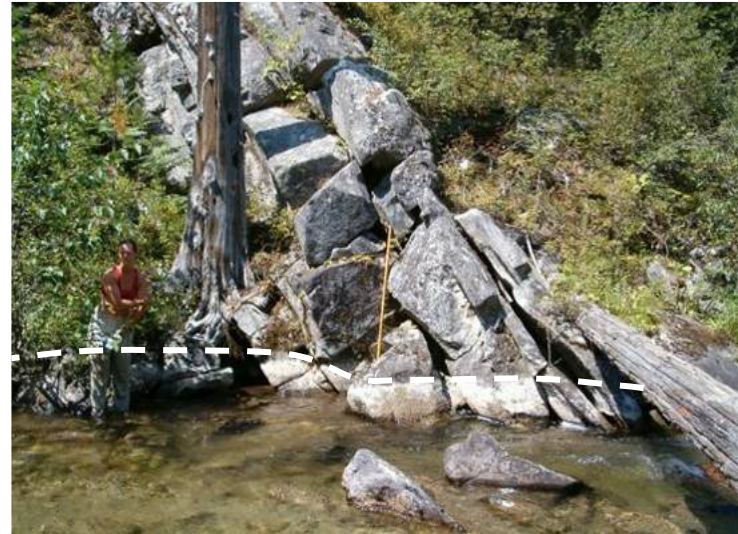
**Figure 24**—large anchored boulders and bedrock are recorded as rock. Note the color change on the rocks, indicating the bankfull stage. Photo - PIBO, U.S. Forest Service

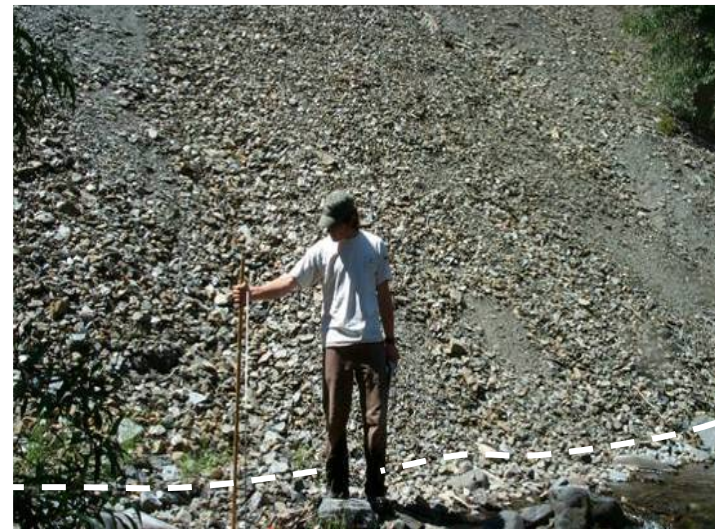
**Figure 25**—the greenline along talus slope is considered as rock and is at about the bankfull stream level. Record the data as rock. Photo - PIBO, U.S. Forest Service

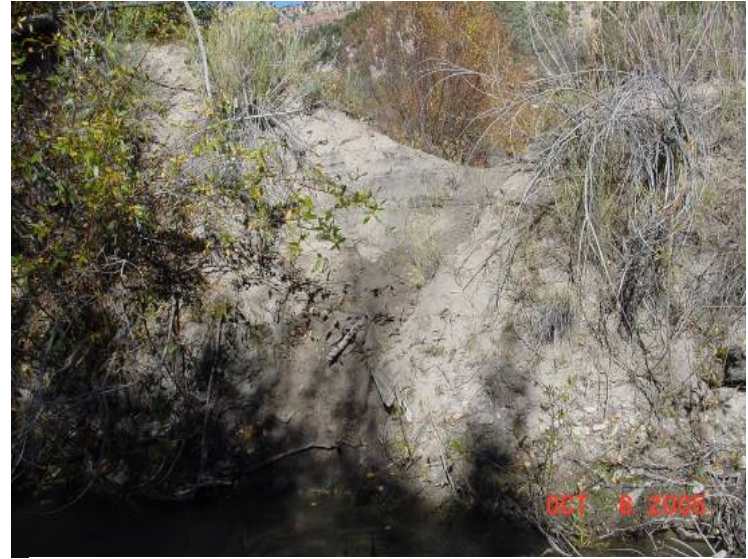
**Figure 27**—a narrow peninsula on a tight meander bend has no greenline vegetation. Place the frame with the center bar along the top of the ridge and record “NG” (no greenline vegetation). Record the non-vegetative indicators.
