DOI-BLM-OR-C030-2010-0005-EA

Spruce Reach House Environmental Assessment

March 8, 2013

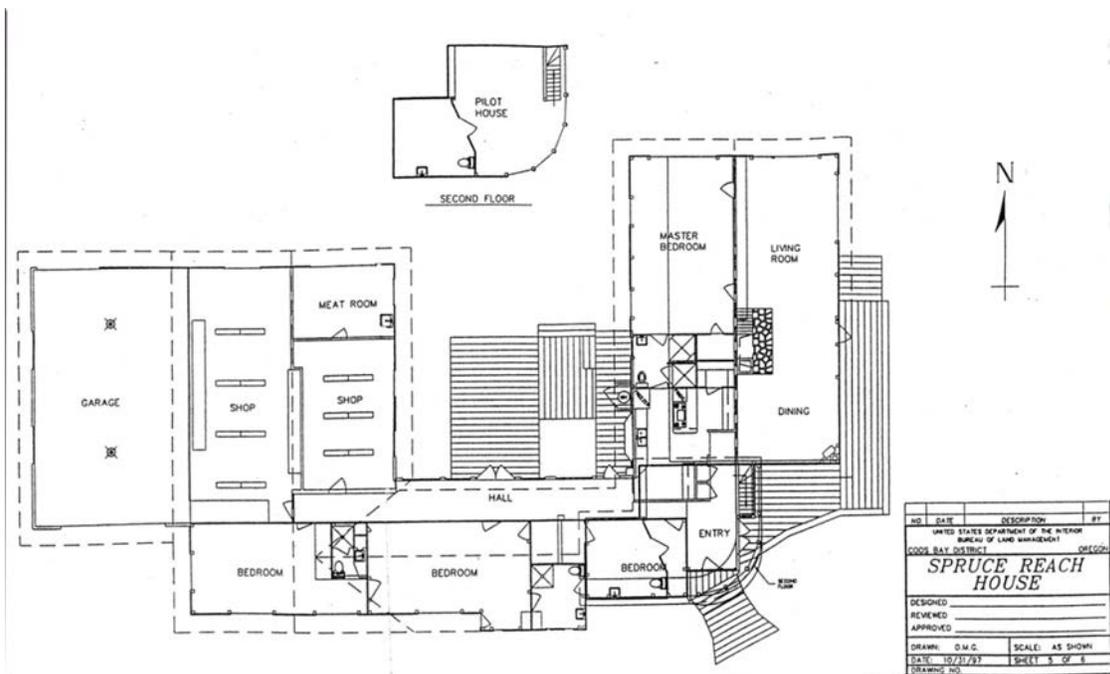
Figure A3. Floor plan of the Spruce Reach house (OTAK 1998).

The Spruce Reach house has a 4,500 square-foot main level, a 450 square-foot loft space (pilot house), and a 950 square-foot attached garage at ground level (Appendix A, Figure A3). The house has been unoccupied since at least 1994 resulting in a lack of maintenance and external and internal deterioration due to water damage, dry rot and pest infestation. The garage has a concrete slab foundation, and sill plates and wall studs in the garage show powder post beetle and water damage. Trusses in the garage are discolored with fungus and mold and they remain wet all winter due to roof leaks. The foundation of the house consists of approximately 100 rectangular pressure-treated pilings of varying dimensions (6-8 inches x 8-9 inches) that are set in the ground. Untreated cross bracing and beams support the main floor of the building. Untreated materials have been damaged by powder post beetles, carpenter ants, termites and dry rot, particularly where they are exposed along the edges of the house (Graham 1995). About half of the post and beam framing shows signs of pest infestation, and the roof is structurally inadequate (Otak 1998).

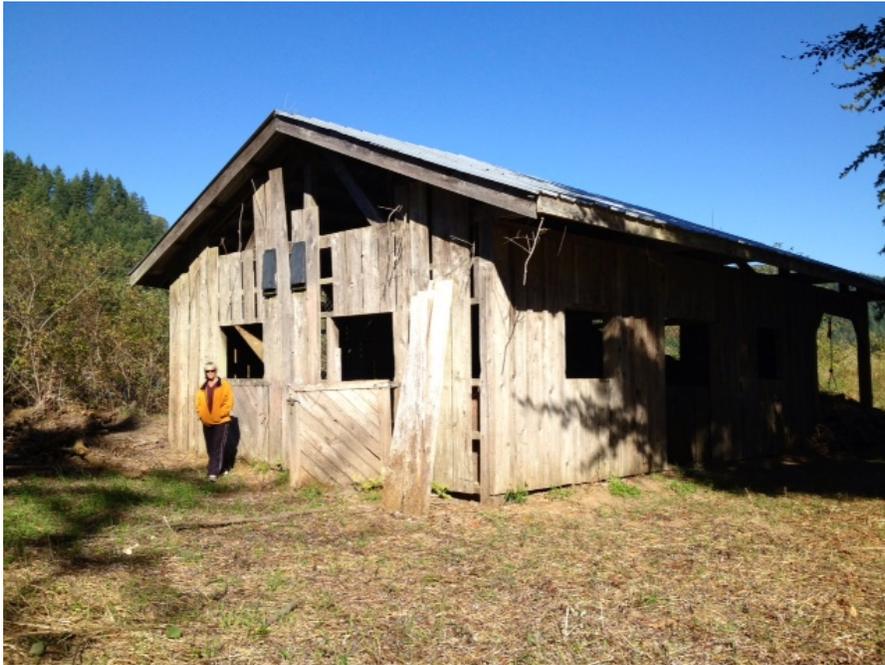
Figure A4. The 980 square foot horse barn northwest of the Spruce Reach house.

- During Year 1, the barn would be reconfigured for bat habitat and the bat condo and Oregon wedge structures would be built. The roof of the barn would be restructured to create a warmer environment for maternity roosting. The aim would be to create a building with a hot attic space; hottest at the peak and progressively cooler towards the eaves. The existing metal roof would be replaced with a darker roof to increase solar heating and attic warmth, and one gable end of the barn would be closed and the size of openings along the eaves would be reduced to discourage predatory owl roosting in the structure.

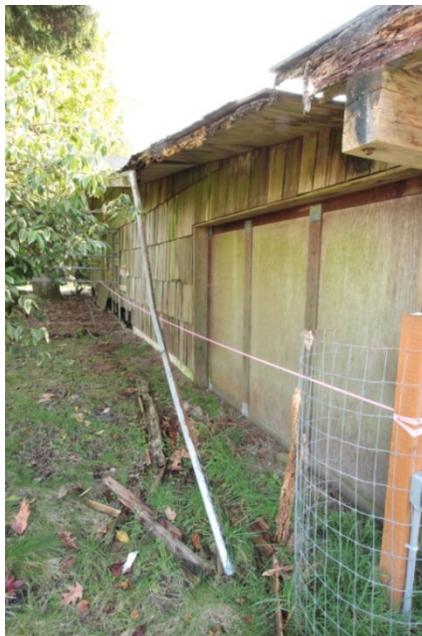
Figure A5. Fascia and soffit deterioration on the north side of the garage and shop. Photo taken February 11, 2011.

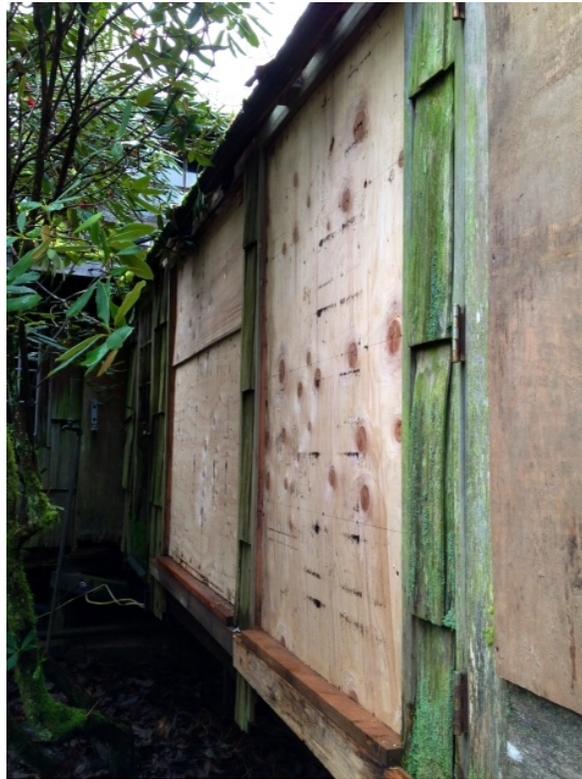
Figure A6. Large plate glass windows in the hall have been replaced with plywood to prevent injury from falling glass and limit access to the house. Photo taken February 9, 2012.

Under the No Action Alternative, the Spruce Reach house would be left to deteriorate and collapse. Bureau personnel would continue to replace damaged windows and doors with plywood or similar material as necessary to limit public contact with debris and prevent access to the interior of the structure. The house would remain locked and posted No Entry. As the house deteriorates further, it may become necessary to close Spruce Reach Island to the public and employ extra measures to secure the structure.

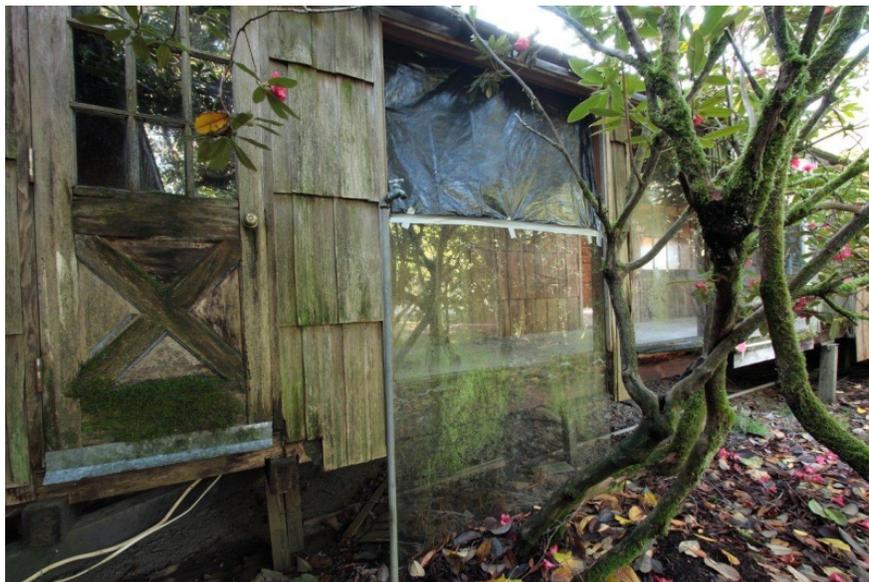
Figure A7. East side hall window that dropped from its frame during 2011 due to rot. Photo taken December 1, 2011.

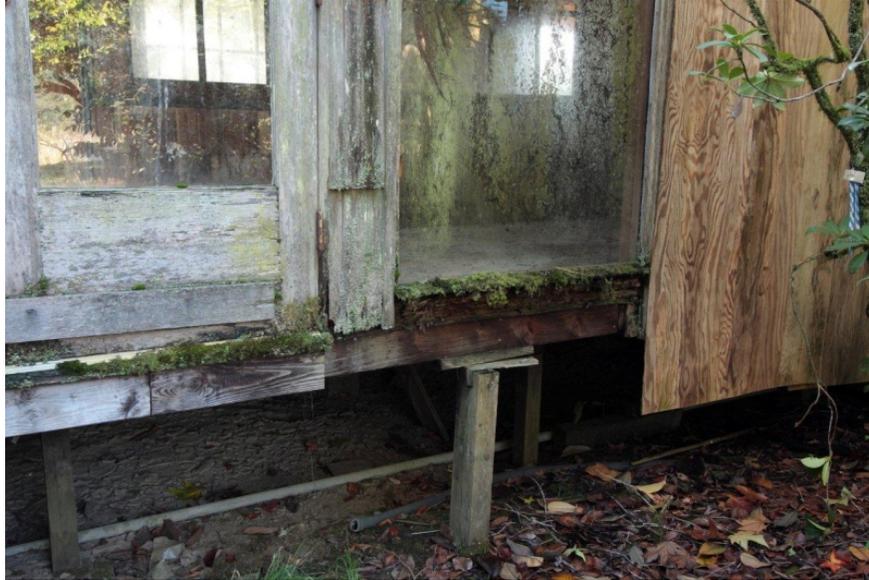
Figure A8. Window frame deterioration west of the hall doors and plywood covering an opening where a window dropped from its frame in 2009. Photo taken December 1, 2011.

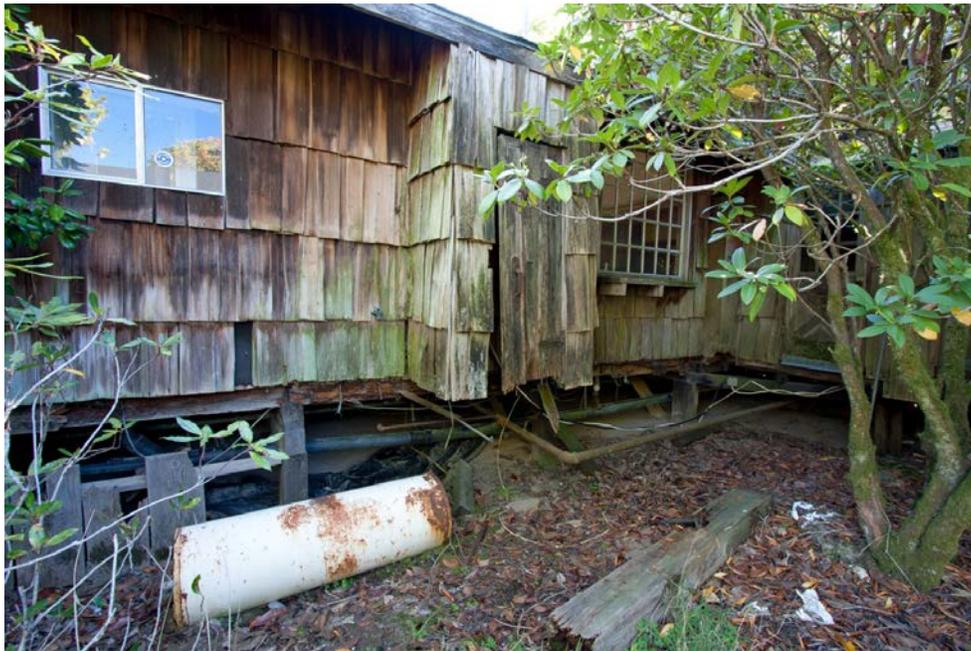
Figure A9. Condition outside of the kitchen and bathroom on the north side of the house. Photo taken October 19, 2010. The water heater has since been removed.

The Department of Interior Safety and Health Handbook (1999, Chapter 23) states that “Each bureau will establish a public safety program that minimizes the potential for injury, illness, death and/or property damage to the public while they are visiting Departmental facilities or in the proximity of Departmental operations.” As noted in Chapter 1, members of the public visit Spruce Reach Island. Currently, the public can approach and crawl under the locked and posted, but otherwise unsecured, Spruce Reach house. The remains of decks and dog kennels in the yard are potential tripping and falling hazards, and people in close proximity to the house risk being struck by material falling from the building. Wood and metal fell from the north side of the building in early 2011 (Appendix A, Figure A5). Otak, an architectural and engineering firm, reported in 1998 that the “roof is structurally inadequate and many of the rafter extensions at the overhangs have had companion pieces nailed to them due to dry rot.” In 1995, a BLM engineer conducted an evaluation of the house and found that window sills, casings and sashes had severe powder post beetle, carpenter ant and dry rot damage. To prevent potential injury to visitors and BLM staff, and limit access to the interior of the house, all four 5-foot by 6-foot plate glass windows in the hall have been replaced by plywood and the glass panes in the double doors have been covered with plywood as of February 2012 (Appendix A, Figure A6). One of these large windows fell from its frame in 2009 and another window dropped to the ground in the summer of 2011 (Appendix A, Figures A7 and A8). The house is built on pilings and the crawl space under the main floor is a confined space and potential overhead hazard. Nails, splintered wood and other debris may be present in this area. Sewer and water pipes and disconnected electrical wiring, possibly with asbestos covering, remain under the house (Appendix A, Figure A9).

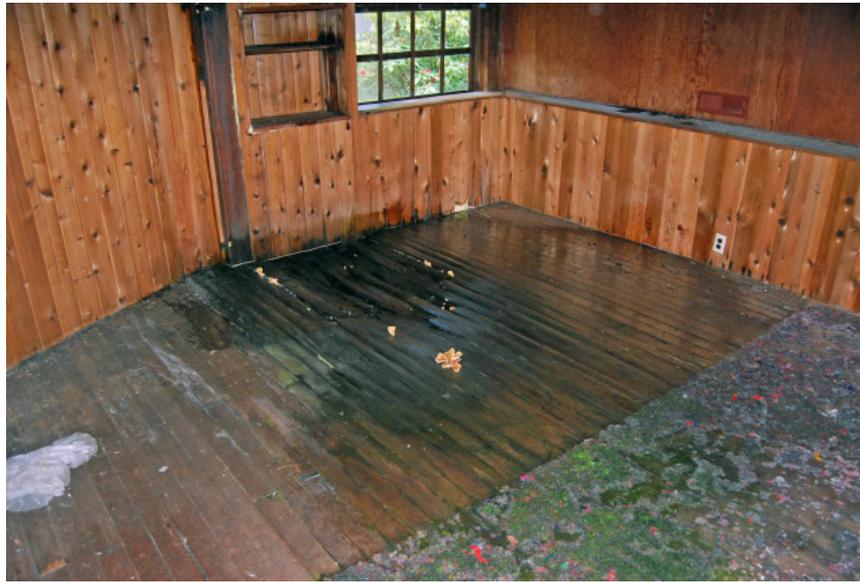
Figure A10. Fungal fruiting bodies sprouting on the water damaged and sagging floor in the pilot house. Photo taken February 13, 2012 by Jim Nieland. In July 2012, a portion of this damaged floor collapsed into the hall below (narrow passageway in Figure A11) leaving an approximately 4 square foot hole open between the first story and second story of the house.

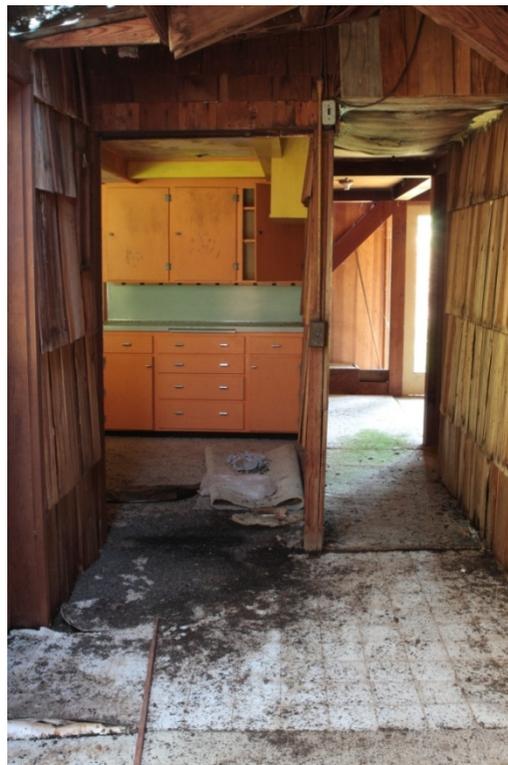
Figure A11. Water damaged flooring in the hall (separated flooring bottom left and discolored carpet in narrow passageway), and sagging ceiling (narrow passageway) below water damaged pilot house floor. A big brown bat roost site

is marked by the dark guano pile. Roosting also occurs where the shake wall meets the ceiling on the right. No bats were present when this photo was taken on June 3, 2011.

- During Year 4, late September to early October, the remaining shakes on the south side of the building would be removed and interior shakes in the hall (Figures A3 and A11) would also be removed. Windows not replaced with plywood would be opened to cool the building and discourage use as a maternity roost. Grating and mesh or something similar would be placed over the windows to allow air flow, but deny entry into the building.

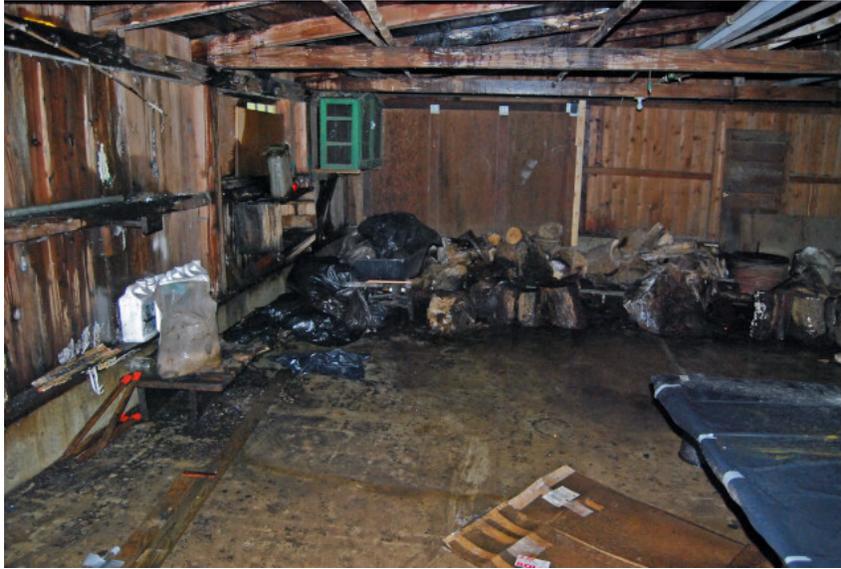
Figure A12. Water leaking into the garage has weakened the trusses and damaged the walls. Photo taken February 13, 2012 by Jim Nieland.

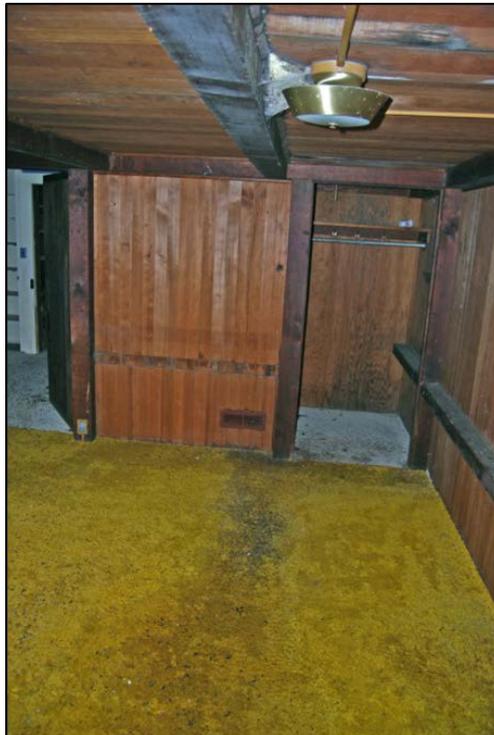
Figure A13. Bat roost in the bedroom west of the entry marked by a stripe of guano on the carpet beneath the ceiling beam. No bats were present when this photo was taken on February 13, 2012 by Jim Nieland.

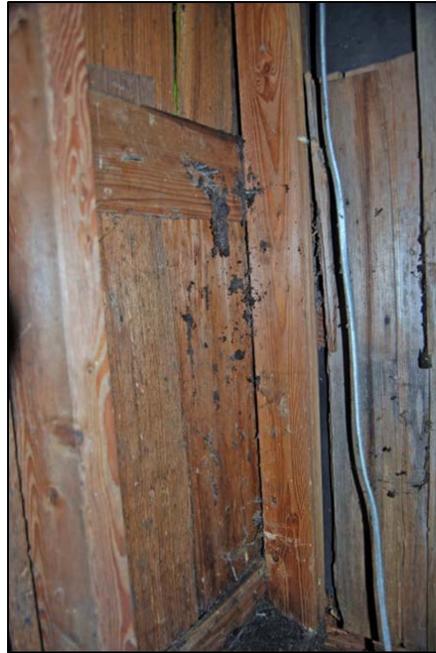
Figure A14. Interior of the water heater enclosure pictured in Figure A9 showing bat guano hanging from the walls and on ledges. No bats were present when this photo was taken on February 13, 2012 by Jim Nieland.

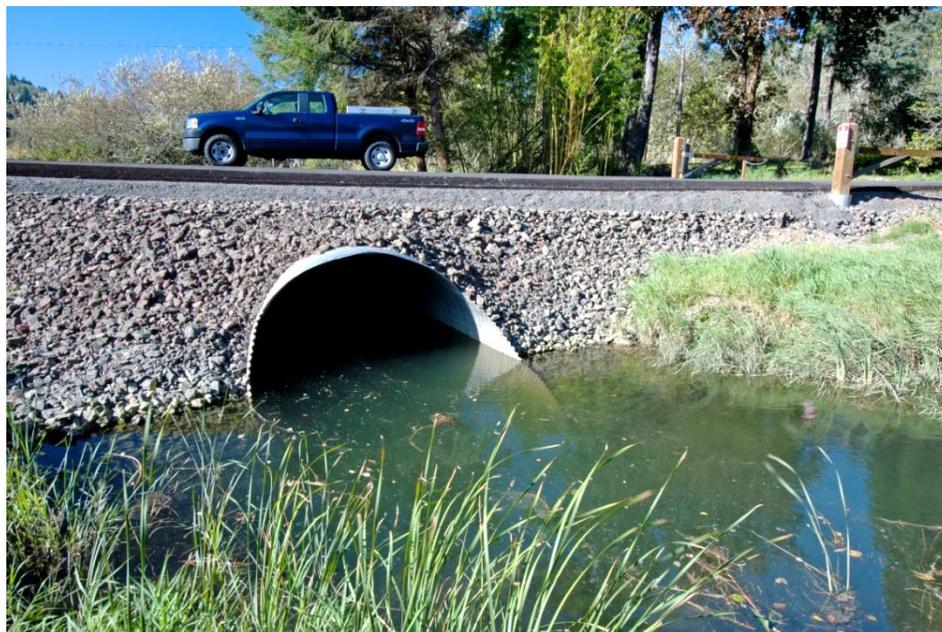
Figure A15. Tidally-influenced culvert crossing to Spruce Reach Island. Highway 38 is to the left out of the picture. Wood gate restricts vehicle access. Photo taken October 19, 2010.

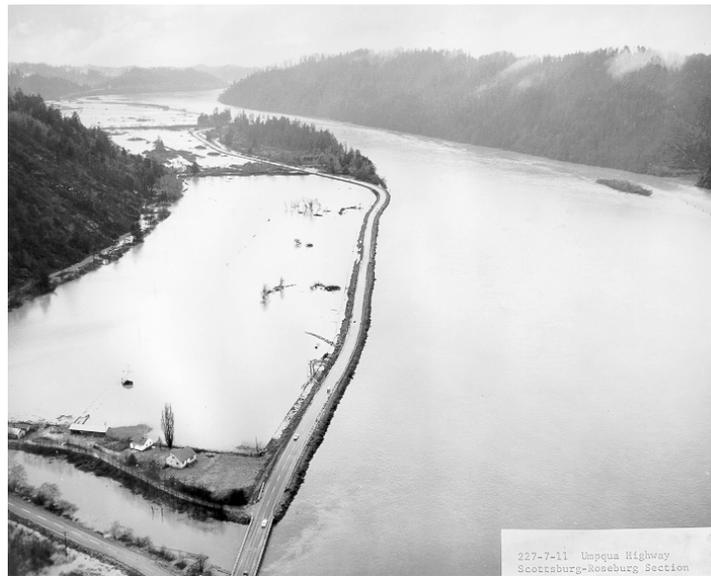
Figure A16. December 1964 flooding on the Umpqua River. Dean Creek enters the river at the bottom of the picture and Spruce Reach Island is near the top. Photo courtesy of the Oregon Department of Transportation.

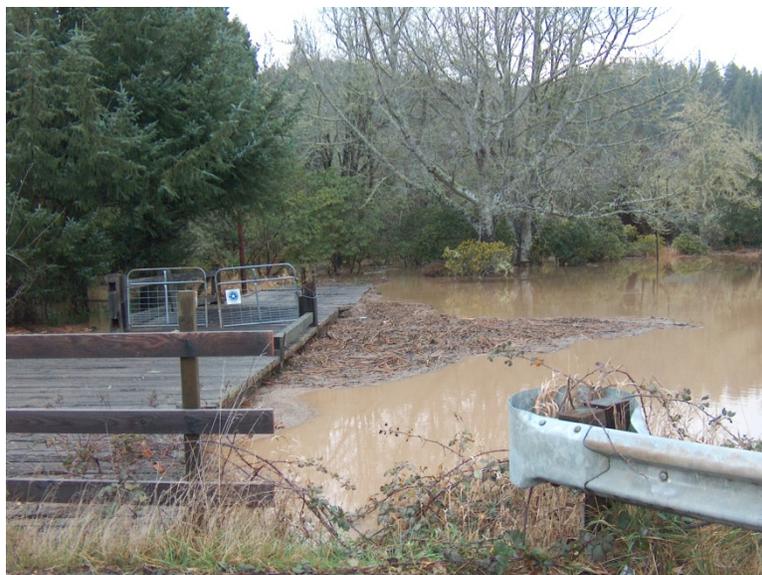
Figure A17. December 2005 flooding at the entrance to the O.H. Hinsdale Garden. The wooden bridge has been replaced with a culvert.

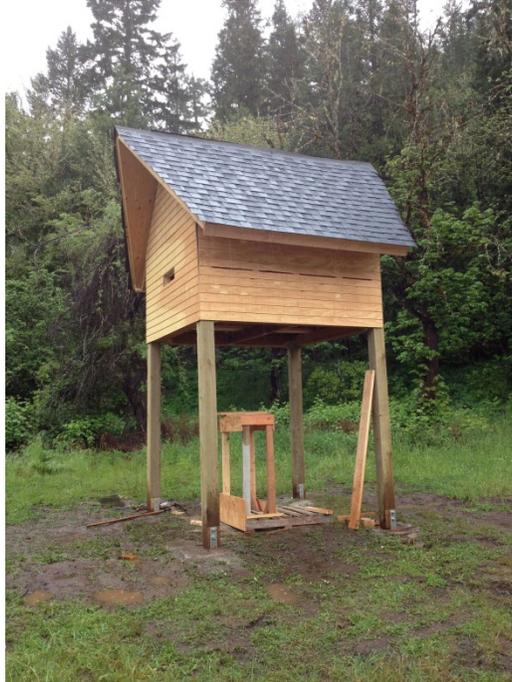
Figure A18. Pennsylvania bat condo built near Oakridge, Oregon as part of the Willamette National Forest Flat Creek Building Disposition Project (Ferland 2012a).

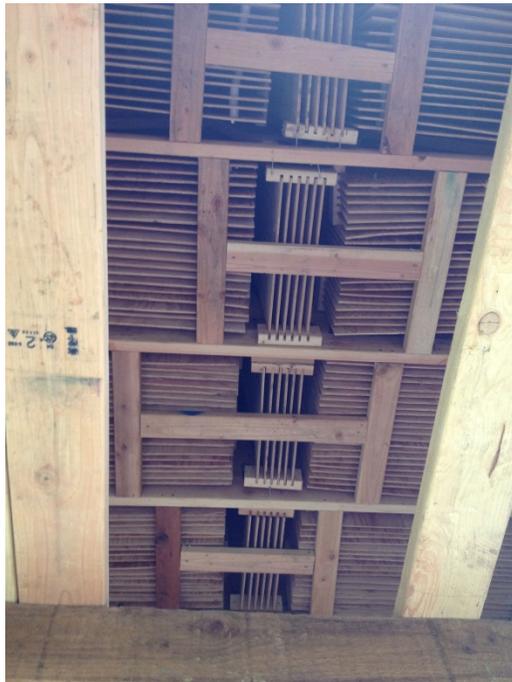
Figure A19. Inside of bat condo pictured in Figure A18.

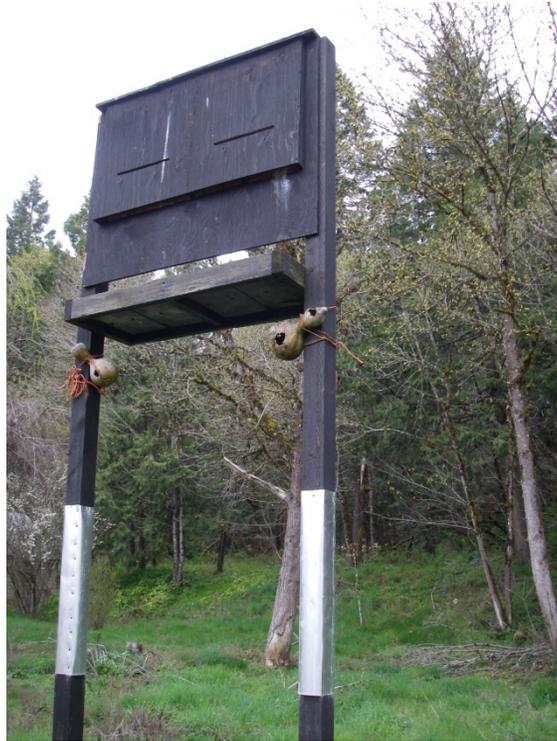
Figure A20. Oregon wedge bat box near Oakridge, Oregon (Ormsbee 2012b).
