BUREAU OF LAND MANAGEMENT

To: Edward W. Shepard, State Director, Oregon/Washington
From: Review Team, Burns District Road Maintenance Review
Subject: Report of Fact-Finding

1. Overview of Actions

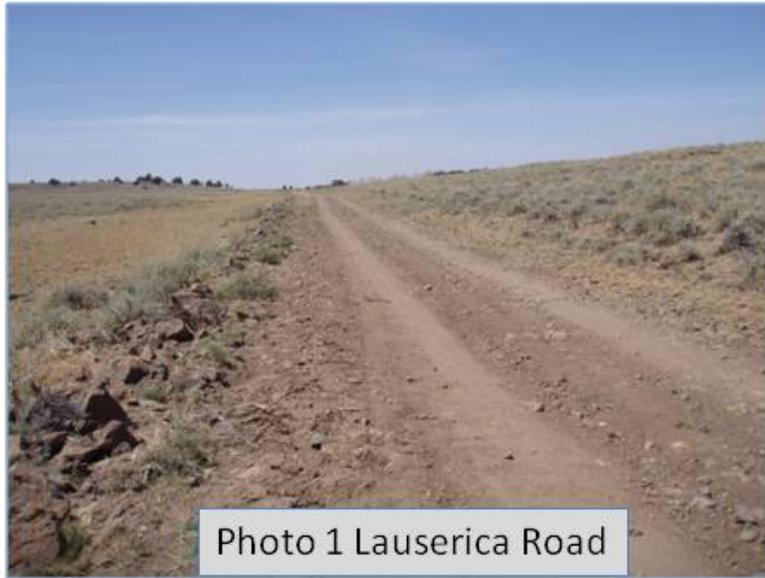
Photo 1 Lauserica Road

- 2) The road in this area appeared to have an average width of disturbance (side cast to side cast) of 20 to 30 feet prior to this year's maintenance. Road work entailed mostly "flatblading" the existing road prism with side cast material being deposited on both the Wilderness side and the WSA side (See Photo 1 – Lauserica Road). Side cast material was kept typically within what appeared to be the previous edges of disturbance (20 to 30 feet width); although in a few areas it appeared that material may have been moved as much as 1 to 2 feet outside those limits (either towards the Wilderness or the WSA designation depending on cross slope). We were told that lower down on the Lauserica Road it was necessary to do cat work (using a bulldozer typically to move rocks and trees), although due to time constraints, the team did not see these areas.

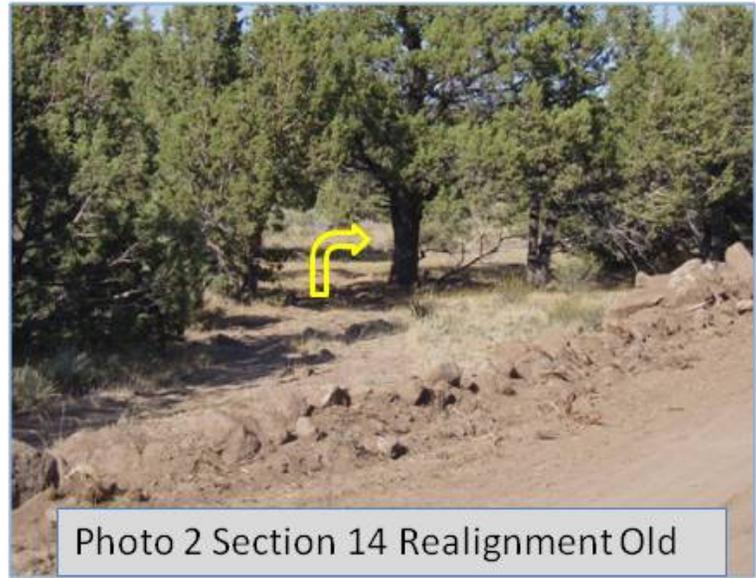
Photo 2 Section 14 Realignment Old

- 8) This portion of the road crossed a tributary drainage to Kueny Canyon in Section 14. To construct a proper right-angled crossing and prevent future capturing of creek water and having it run down the road surface, the road was realigned slightly. This realigned section was within the PD land. (See Map 3 – Sec. 14 Realignment and Photo 2 Section 14 Realignment Old, and Photo 3 Section 14 Realignment New).

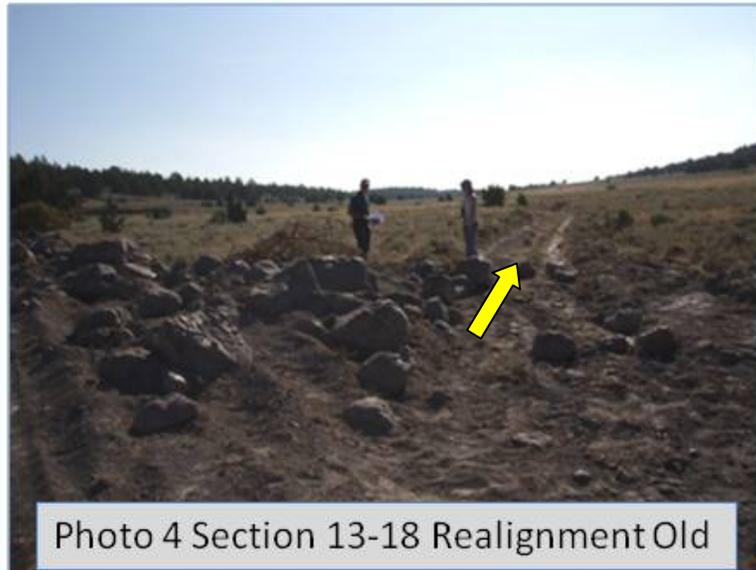
Photo 4 Section 13-18 Realignment Old

- 9) Flatter areas often had poor drainage and the road had to be realigned. In Sections 13 and 18 about 3000 feet of the road was realigned as far as 250 feet upslope. This realigned section was within PD lands. (See Map 4 – Sec. 13-18 Realignment and Photo 4 Section 13-18 Realignment Old).

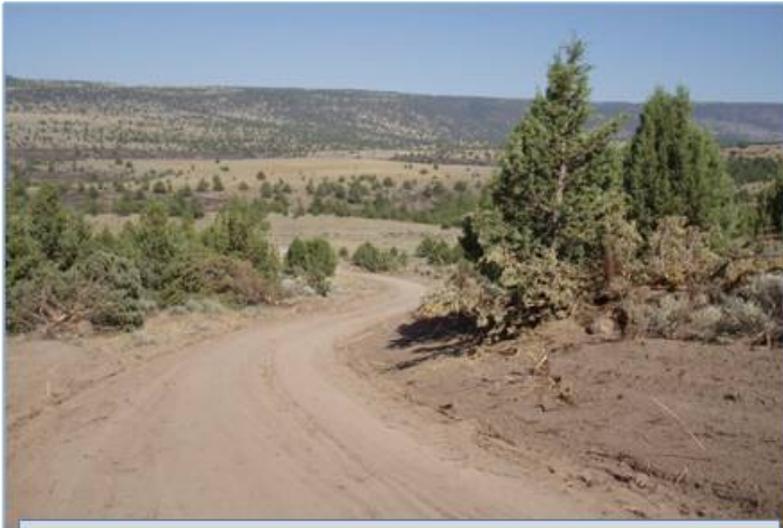
Photo 5 Burnt Car Road WSA Both Sides

- 11) The next 2 ½ miles from the intersection with the Tombstone-Burnt Car Road to the Wilderness Boundary is on rolling to steep terrain with slopes ranging approximately from 5 to 35 percent. There is a WSA designation on both sides of the road with sparse to dense juniper and low shrub vegetation. Much of this area had very high percentages of rocks and boulders in the soil profile. Road work entailed widening to provide a crowned running surface and drainage on one or both sides. Trees with branches that could reach the eventual disturbance area (cut slope to outer edge of side cast) were pushed over with the cats. Trees, rocks and other soil side cast material were deposited in the WSA on both sides. The width of this section after maintenance ranged from about 25 to 35 feet wide. (Photo 5 Burnt Car Road WSA Both Sides).

- F. Section 603 (Interim Management Policy) of FLPMA was not adequately considered because trees, rocks and bladed side cast material were deposited outside existing disturbance limits into a WSA in numerous places.

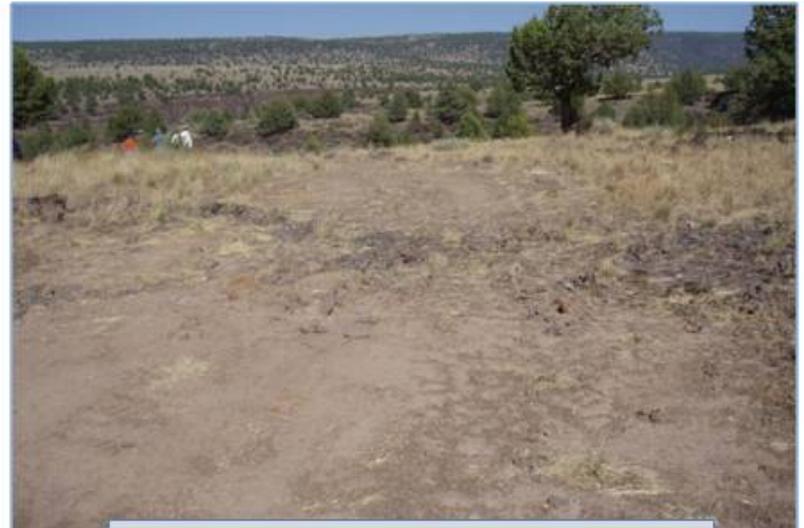
Photo 6 Two Track in Wilderness

- 13) The entry into the Wilderness was on July 7 and was accidental. Apparently the equipment operators were shown a map depicting where the Wilderness Boundary was, but the Review Team did not know what scale of map was used. To the Team’s knowledge nobody took any of the equipment operators down to the boundary location. According to at least one of the operators, he thought the boundary was at the canyon rim (of the Donner und Blitzen River). The boundary was apparently not posted or flagged before road work, but has subsequently been posted (See Photo 6 Two Track in Wilderness, and Photo 7 Wilderness-Road Maintained)

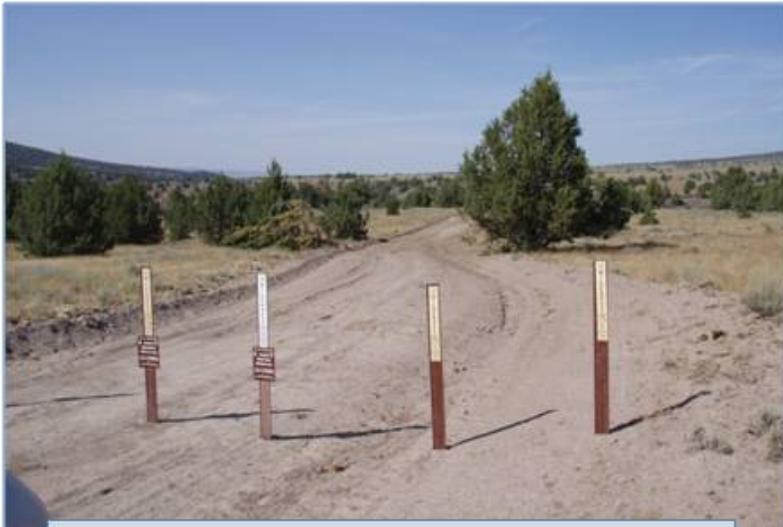
Photo 7 Wilderness-Road Maintained

- 12) The next approximately 530 feet of the road is inside the Steens Mountain Wilderness boundary and ends at location known as Burnt Car. This short section is relatively open with low shrub vegetation on slopes ranging approximately from 0 to 5 percent. Road work entailed widening to provide a crowned running surface and drainage on both sides. Side cast material was deposited on both sides. The width of this section after maintenance ranged from about 20 to 25 feet wide. (See Map 2 – Maintained Wilderness).

- E. Some requirements of the Wilderness Act and the Steens Act were not met because mechanical equipment was used to reconstruct approximately 530 feet of closed road in the Steens Mountain Wilderness.

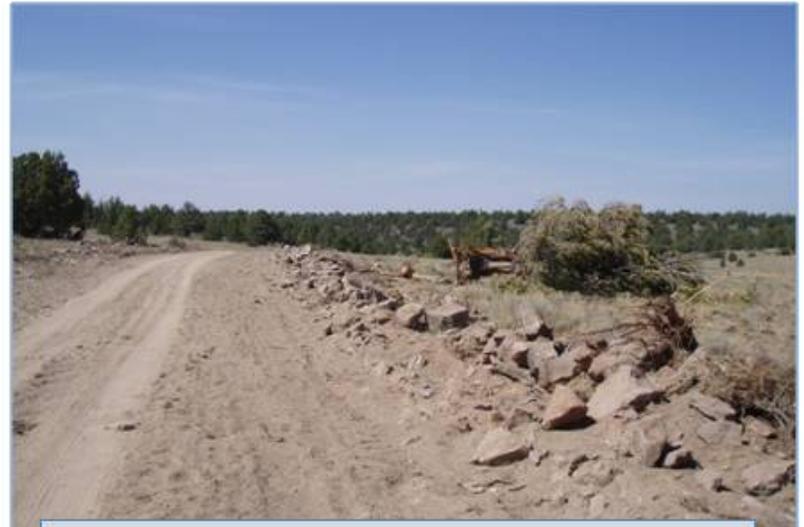
Photo 8 Tombstone Clearing-Widening

- 2) Both roads are mostly on flat to rolling terrain with slopes ranging approximately from 5 to 10 percent. It is estimated that the pre-maintenance width of the roads was about 12 to 15 feet. There is sparse to dense juniper along about 30 percent of the route and low shrub vegetation along about 70 percent. PD land is on the west side and WSA on the east side. Road work entailed widening to provide a crowned running surface and drainage on one or both sides. Trees with branches that could reach the eventual disturbance area (cut slope to outer edge of side cast) were pushed over with the cats (See Photo 8 Tombstone Clearing-Widening). Some of this area had very high percentages of rocks in the soil profile that required moving large amounts of rocks to the side. Trees, rocks, and other side cast material were deposited on both the PD side and the WSA side. The width of this section after maintenance ranges from about 20 to 30 feet wide.
