Louse Canyon Wilderness Inventory Unit Index of Documents  
**Black Butte OR-036-008, 49 total pages**

**H-6300-1-WILDERNESS INVENTORY MAINTENANCE  
IN BLM OREGON/WASHINGTON**

**Inventory Unit Name/Number: Black Butte OR-036-008**

**Wilderness Inventory Area Name and Number (Unit ID):** Black Butte OR-036-008

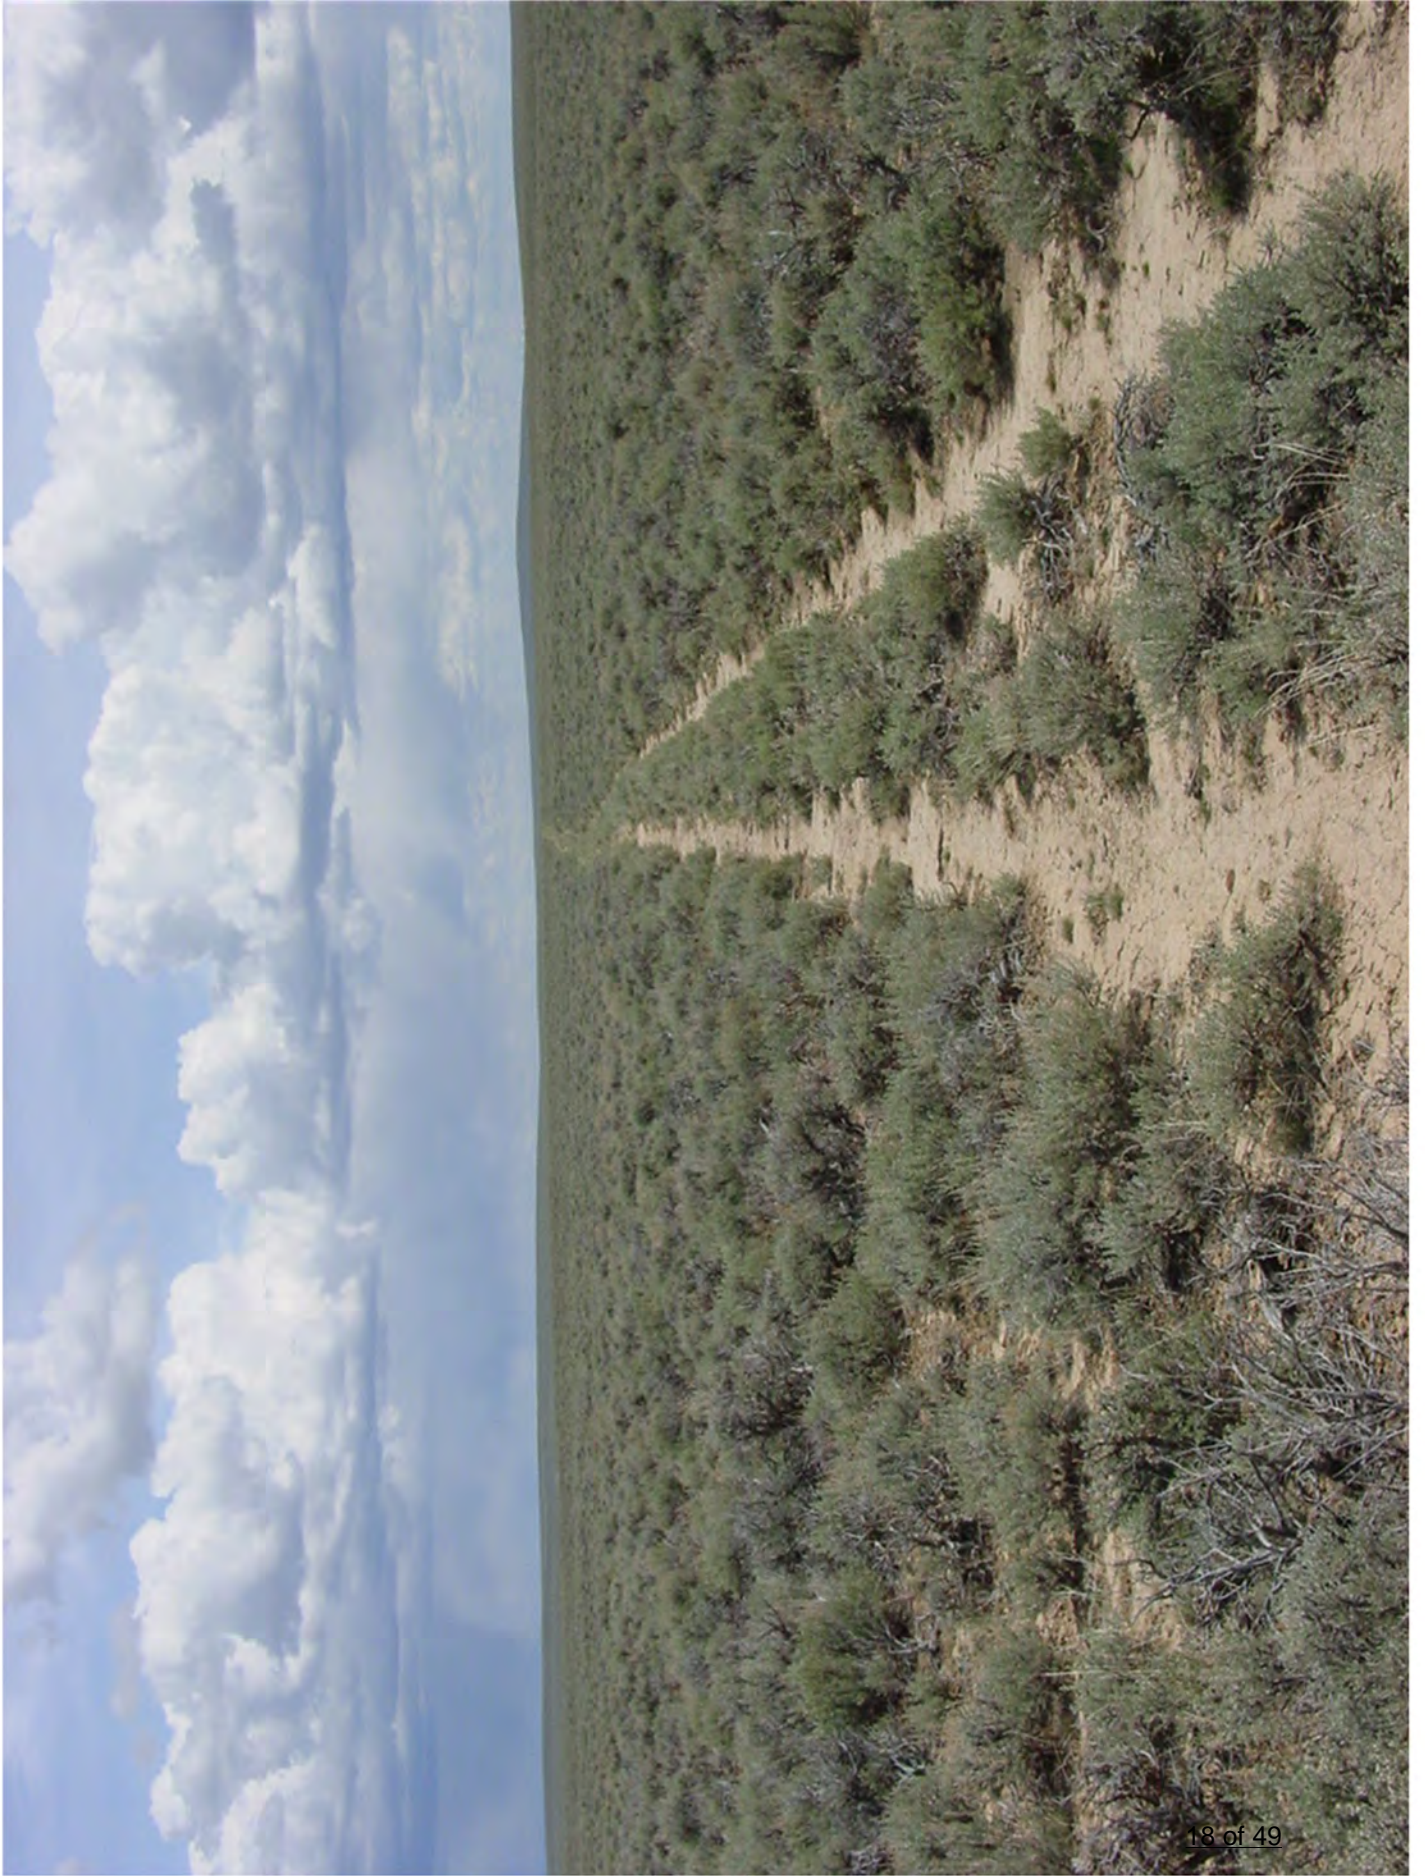
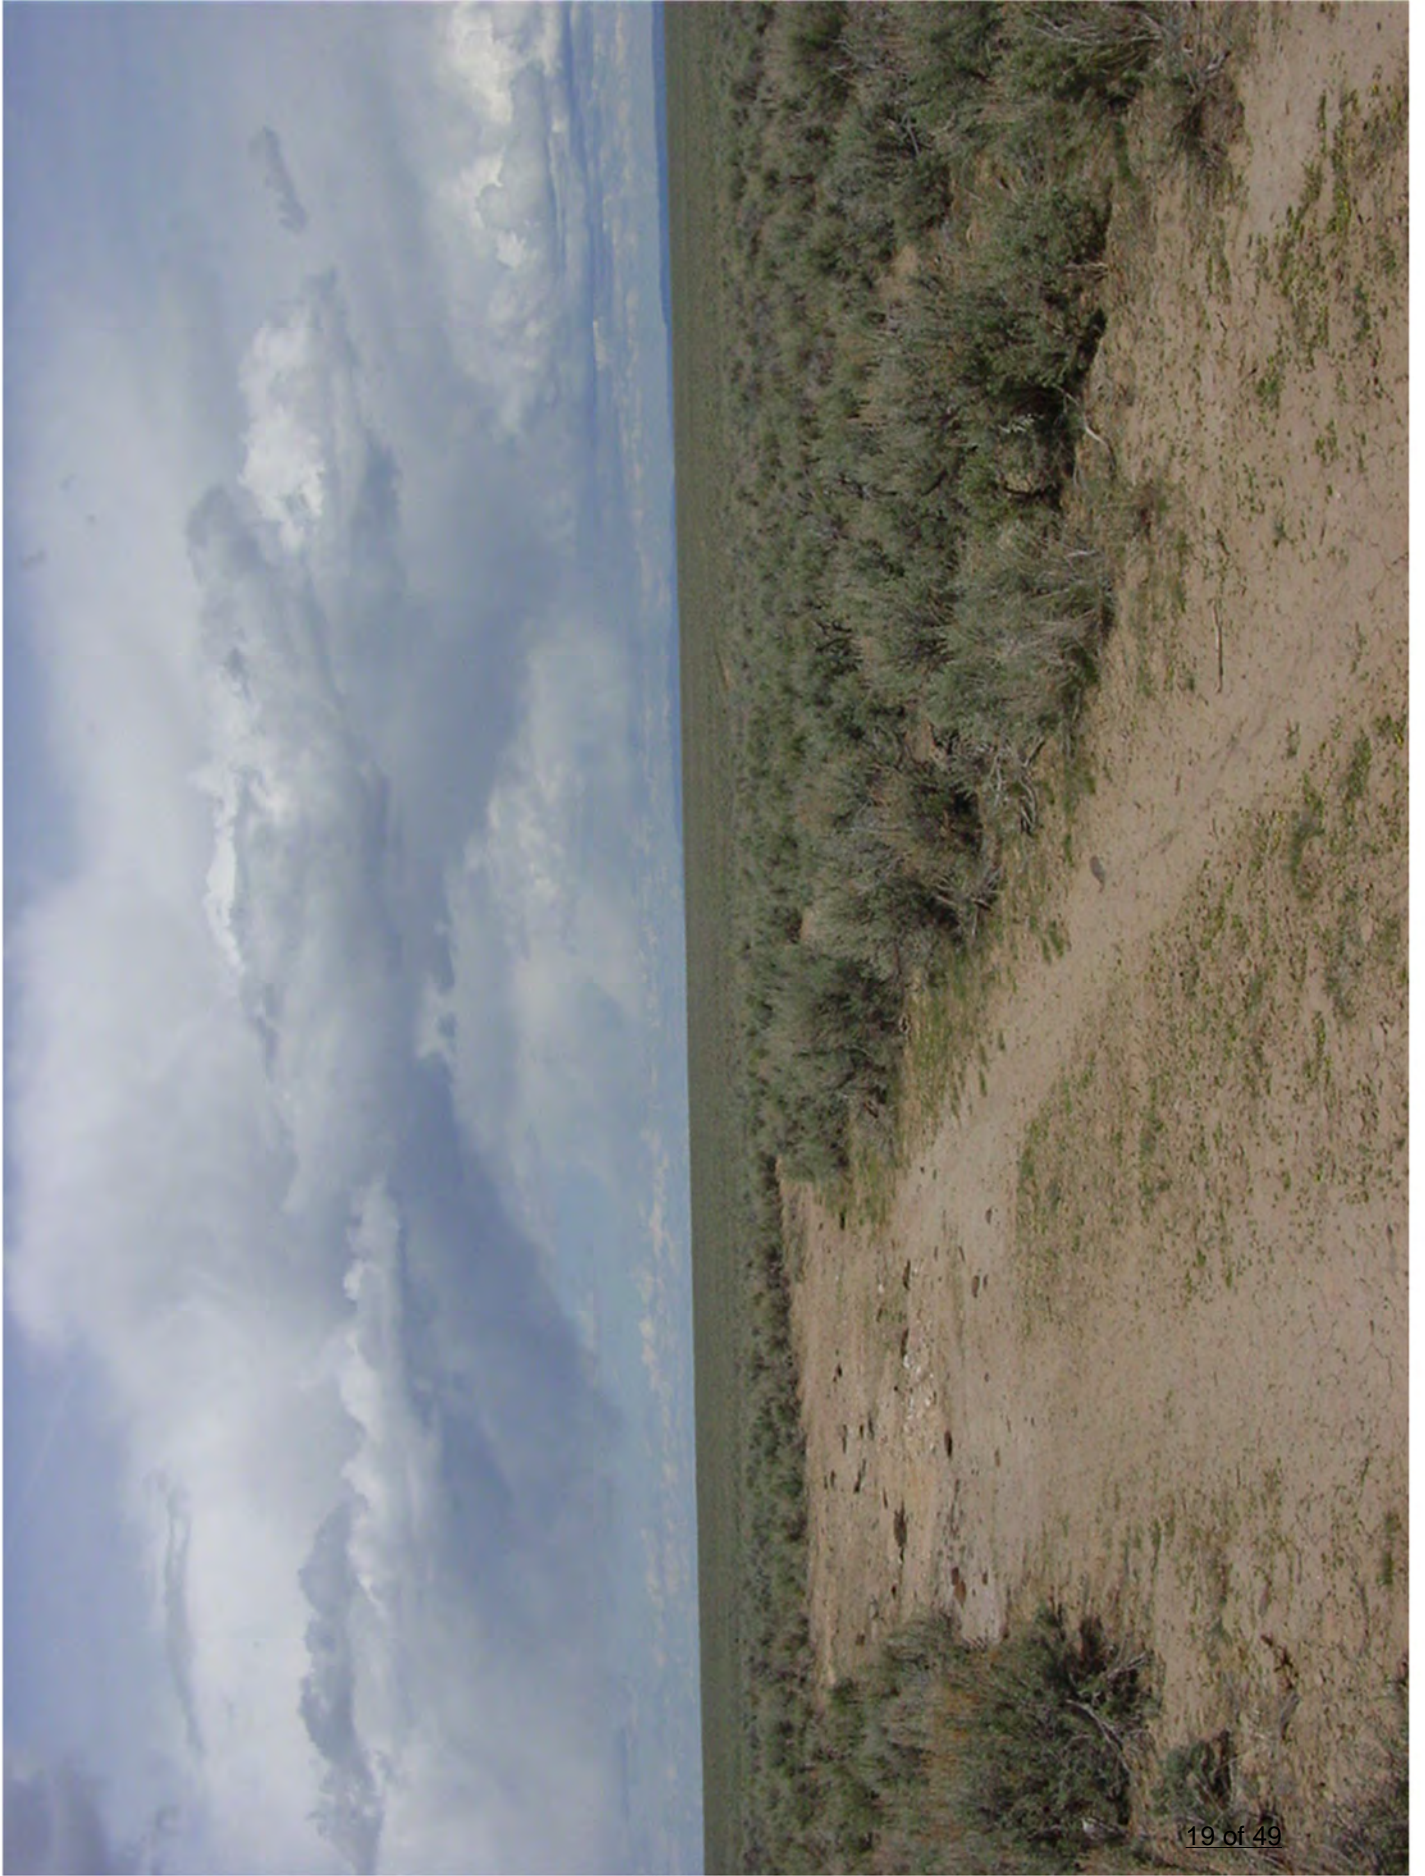
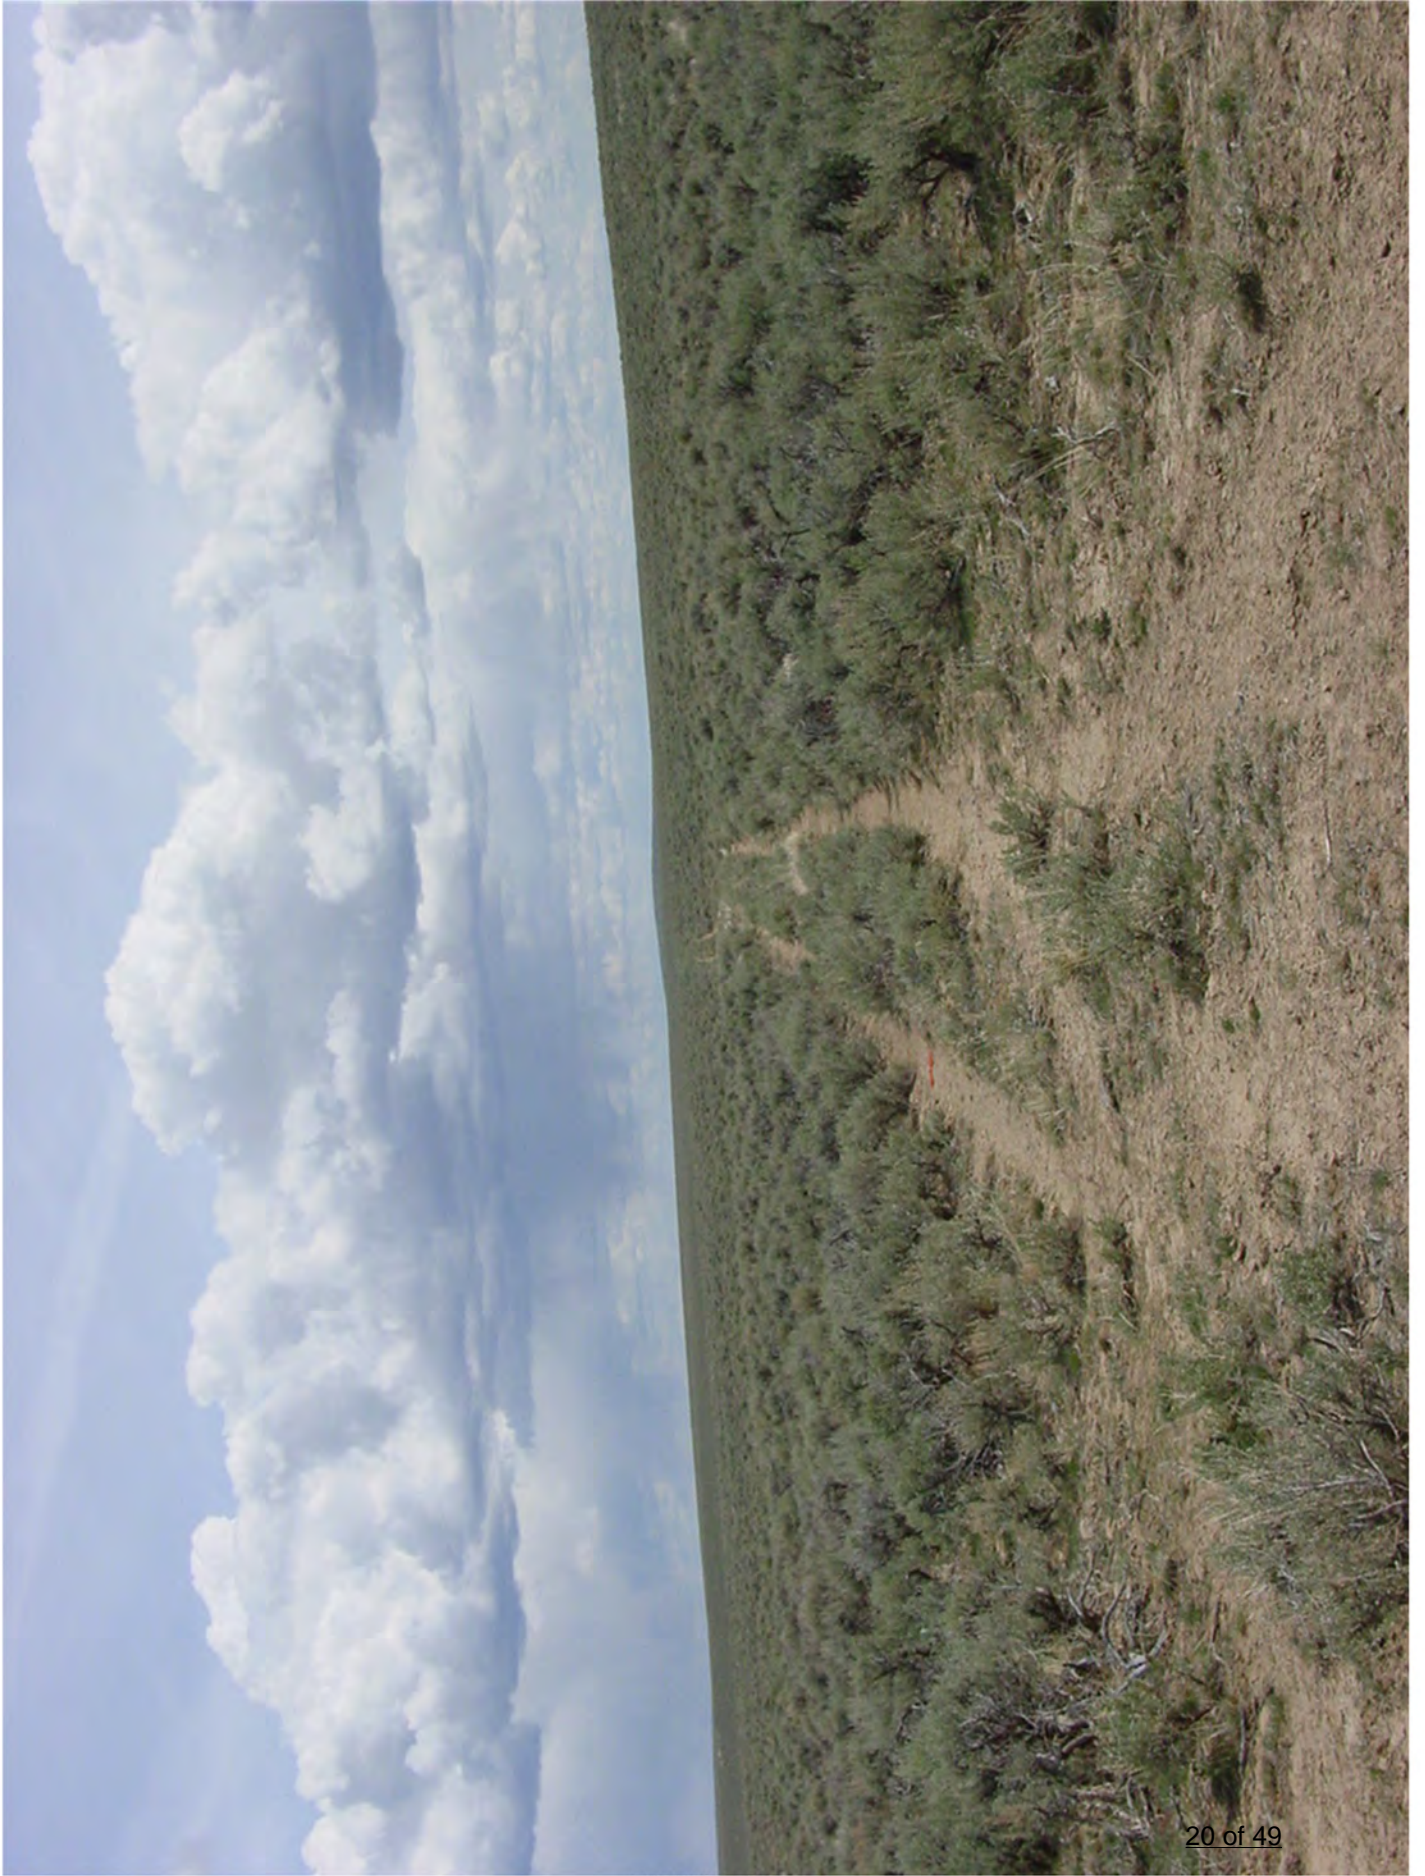
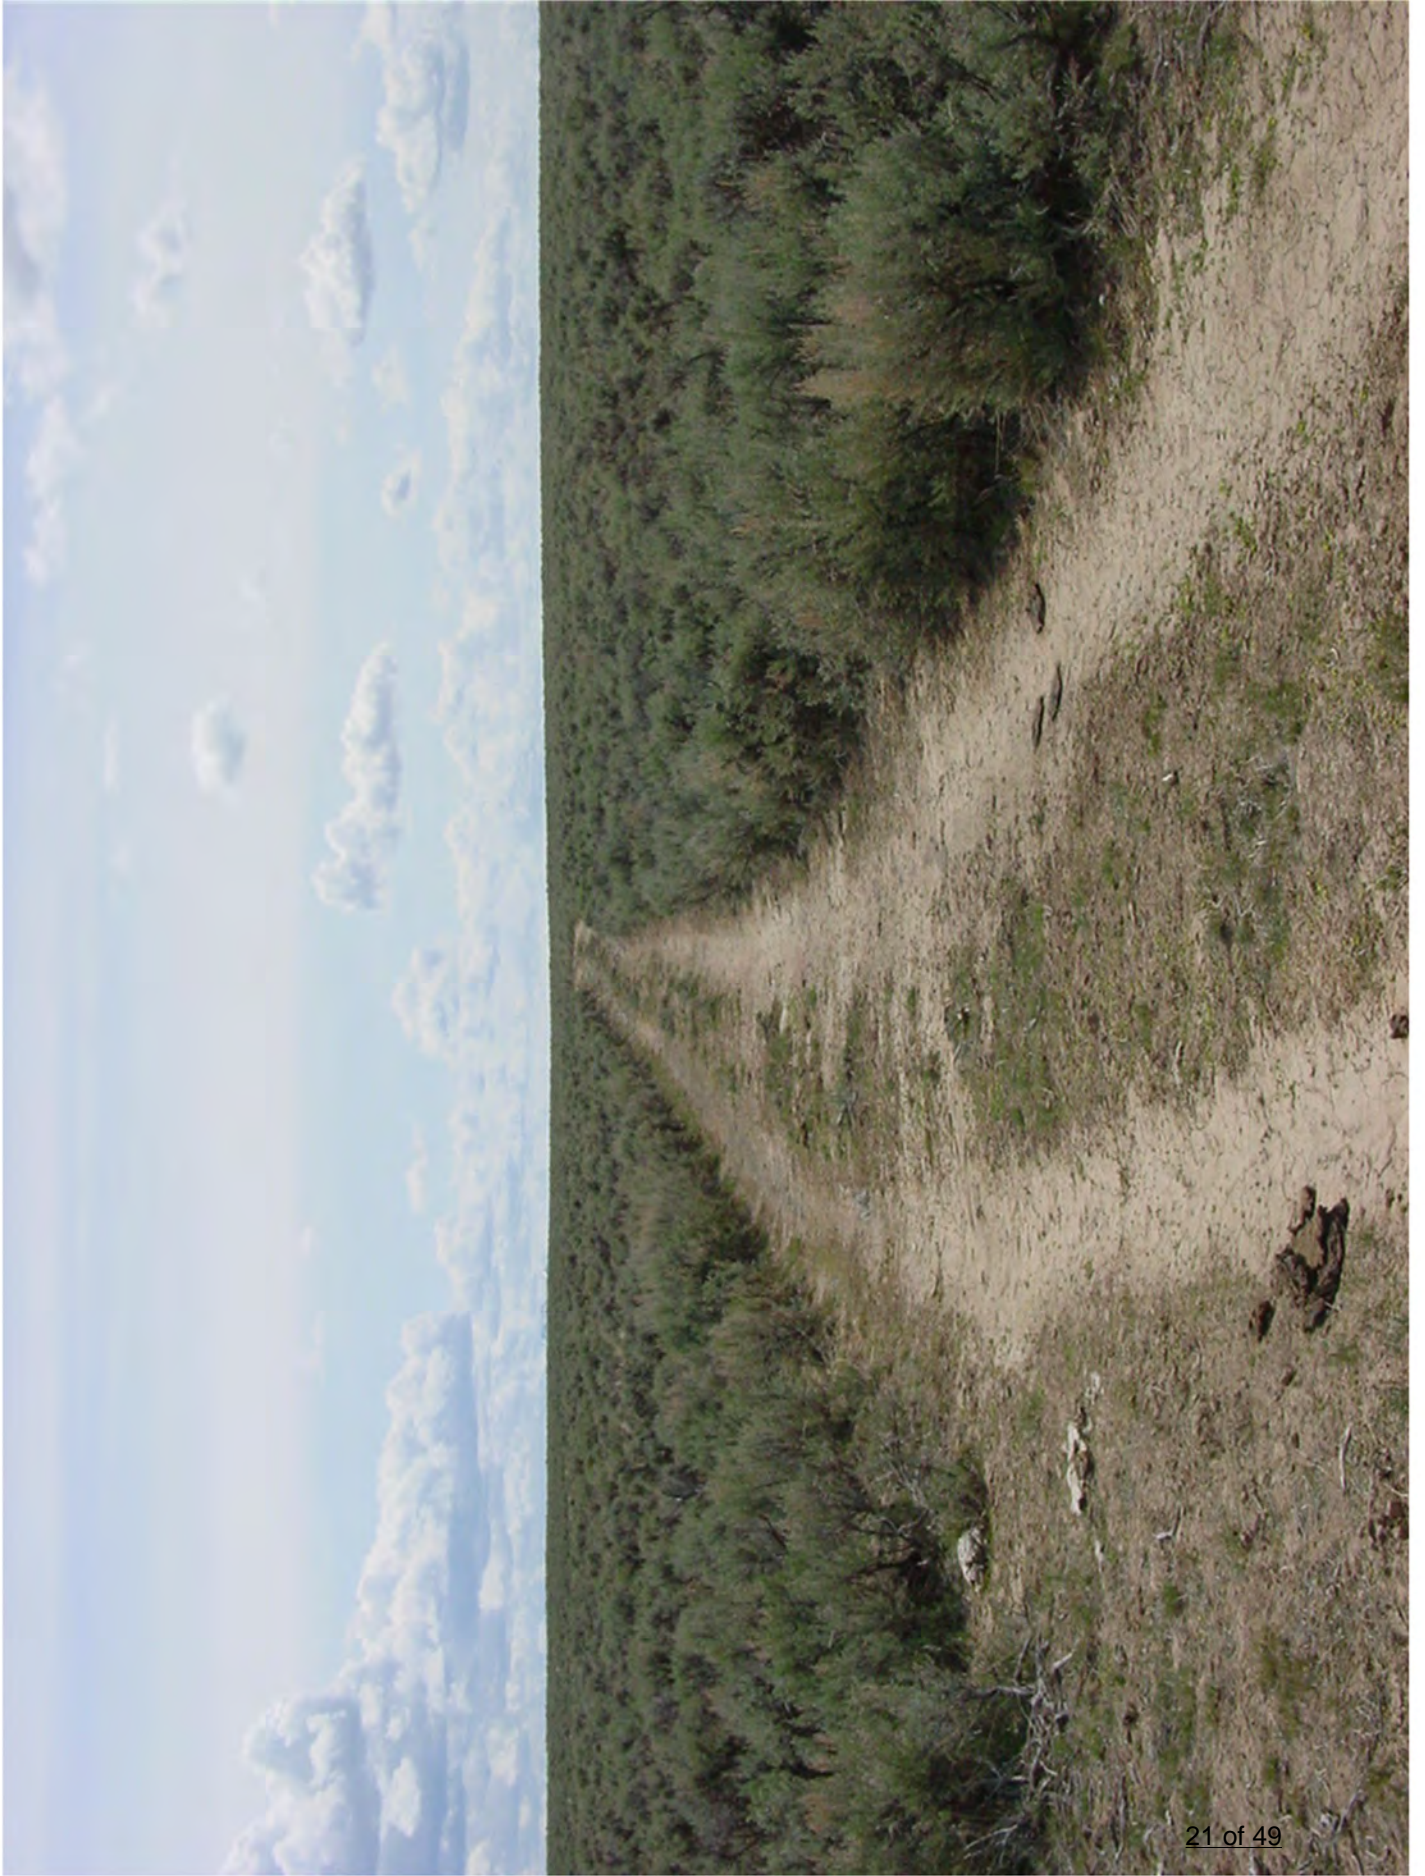
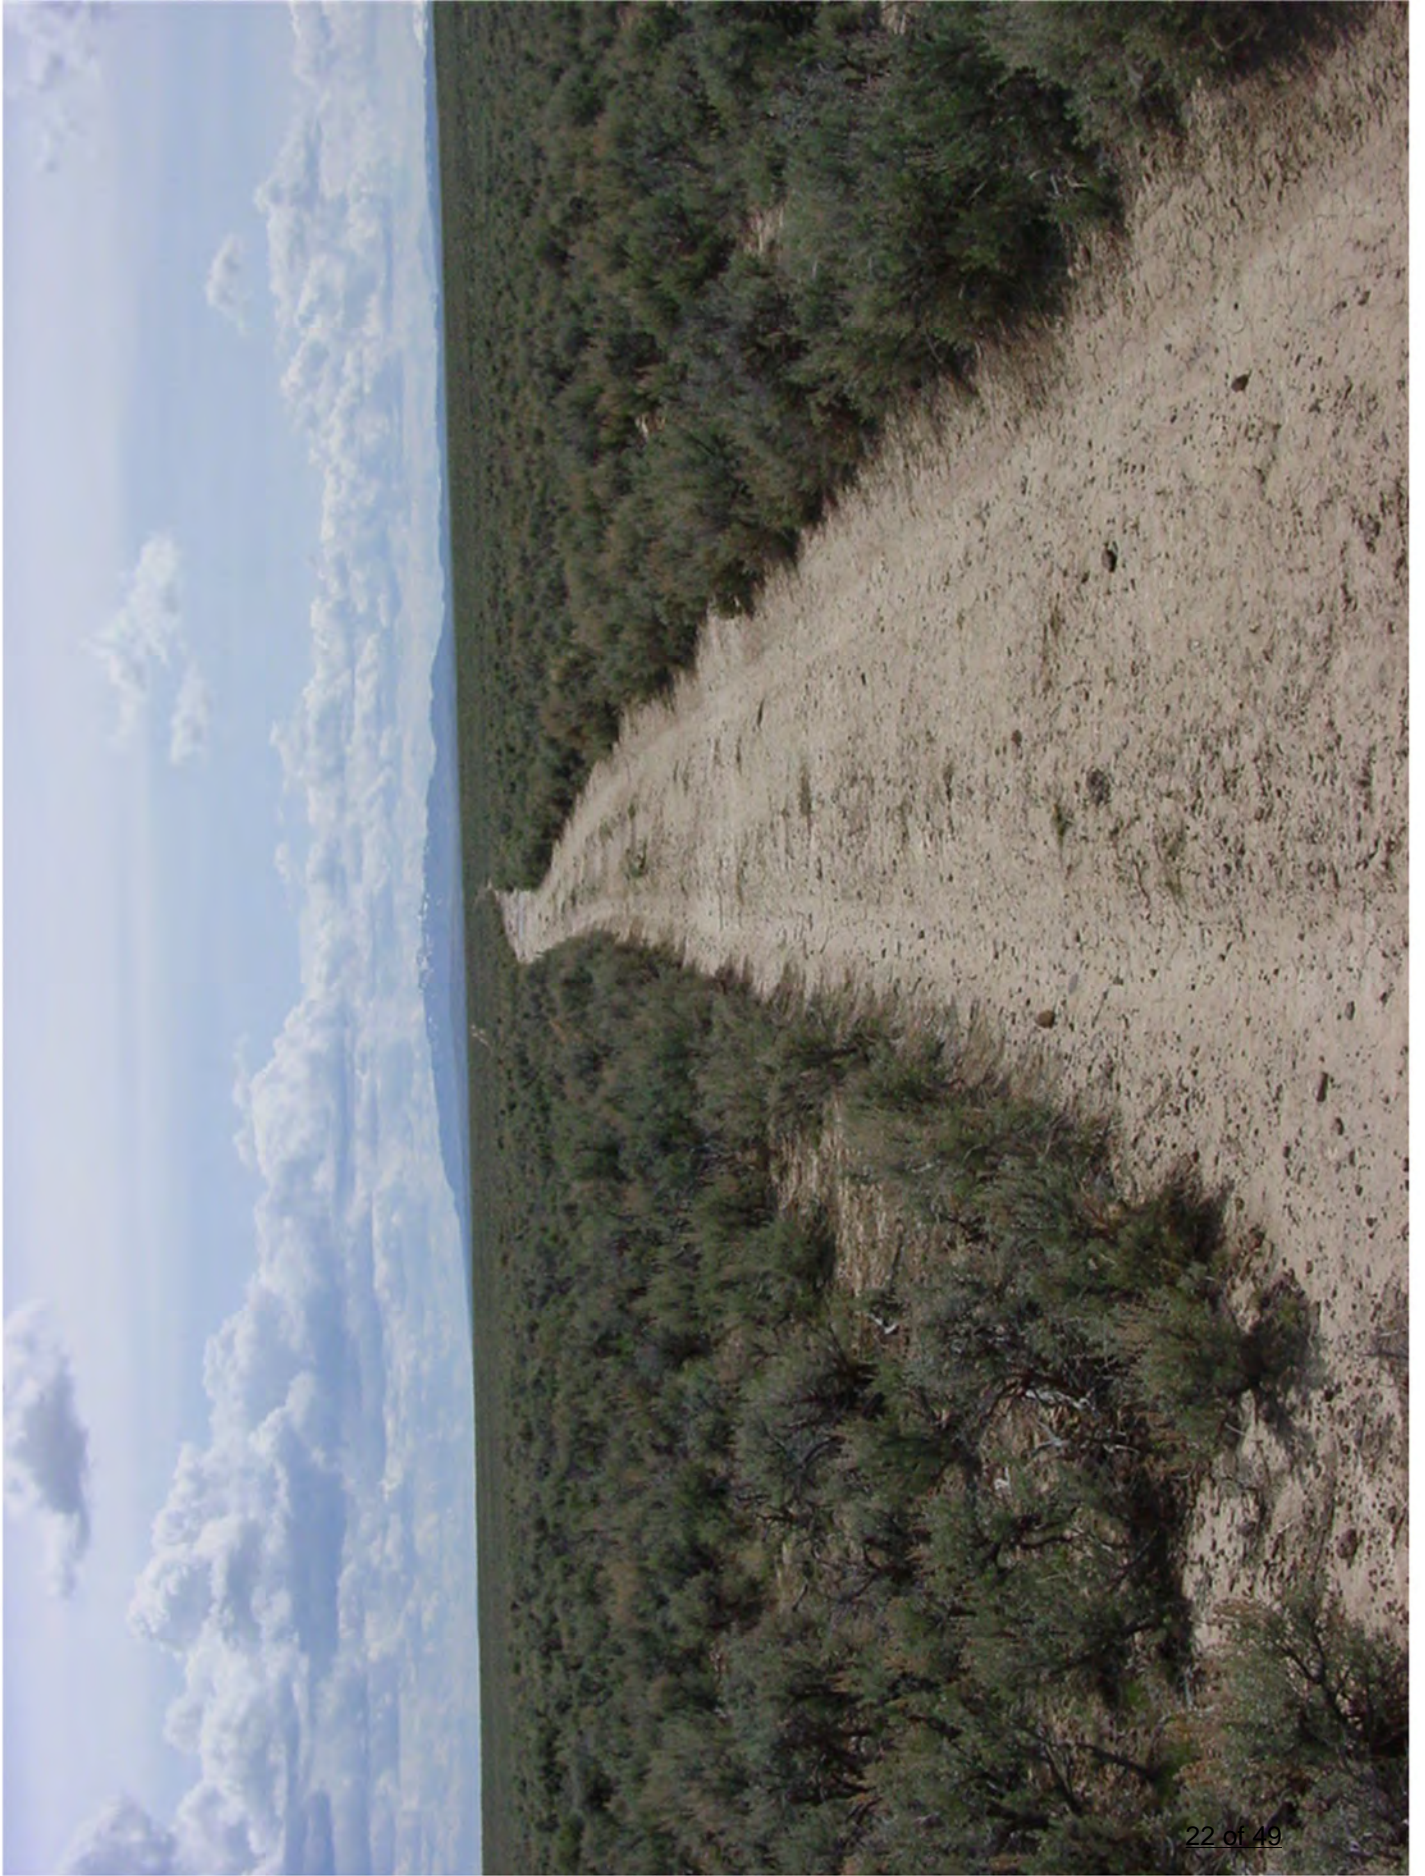
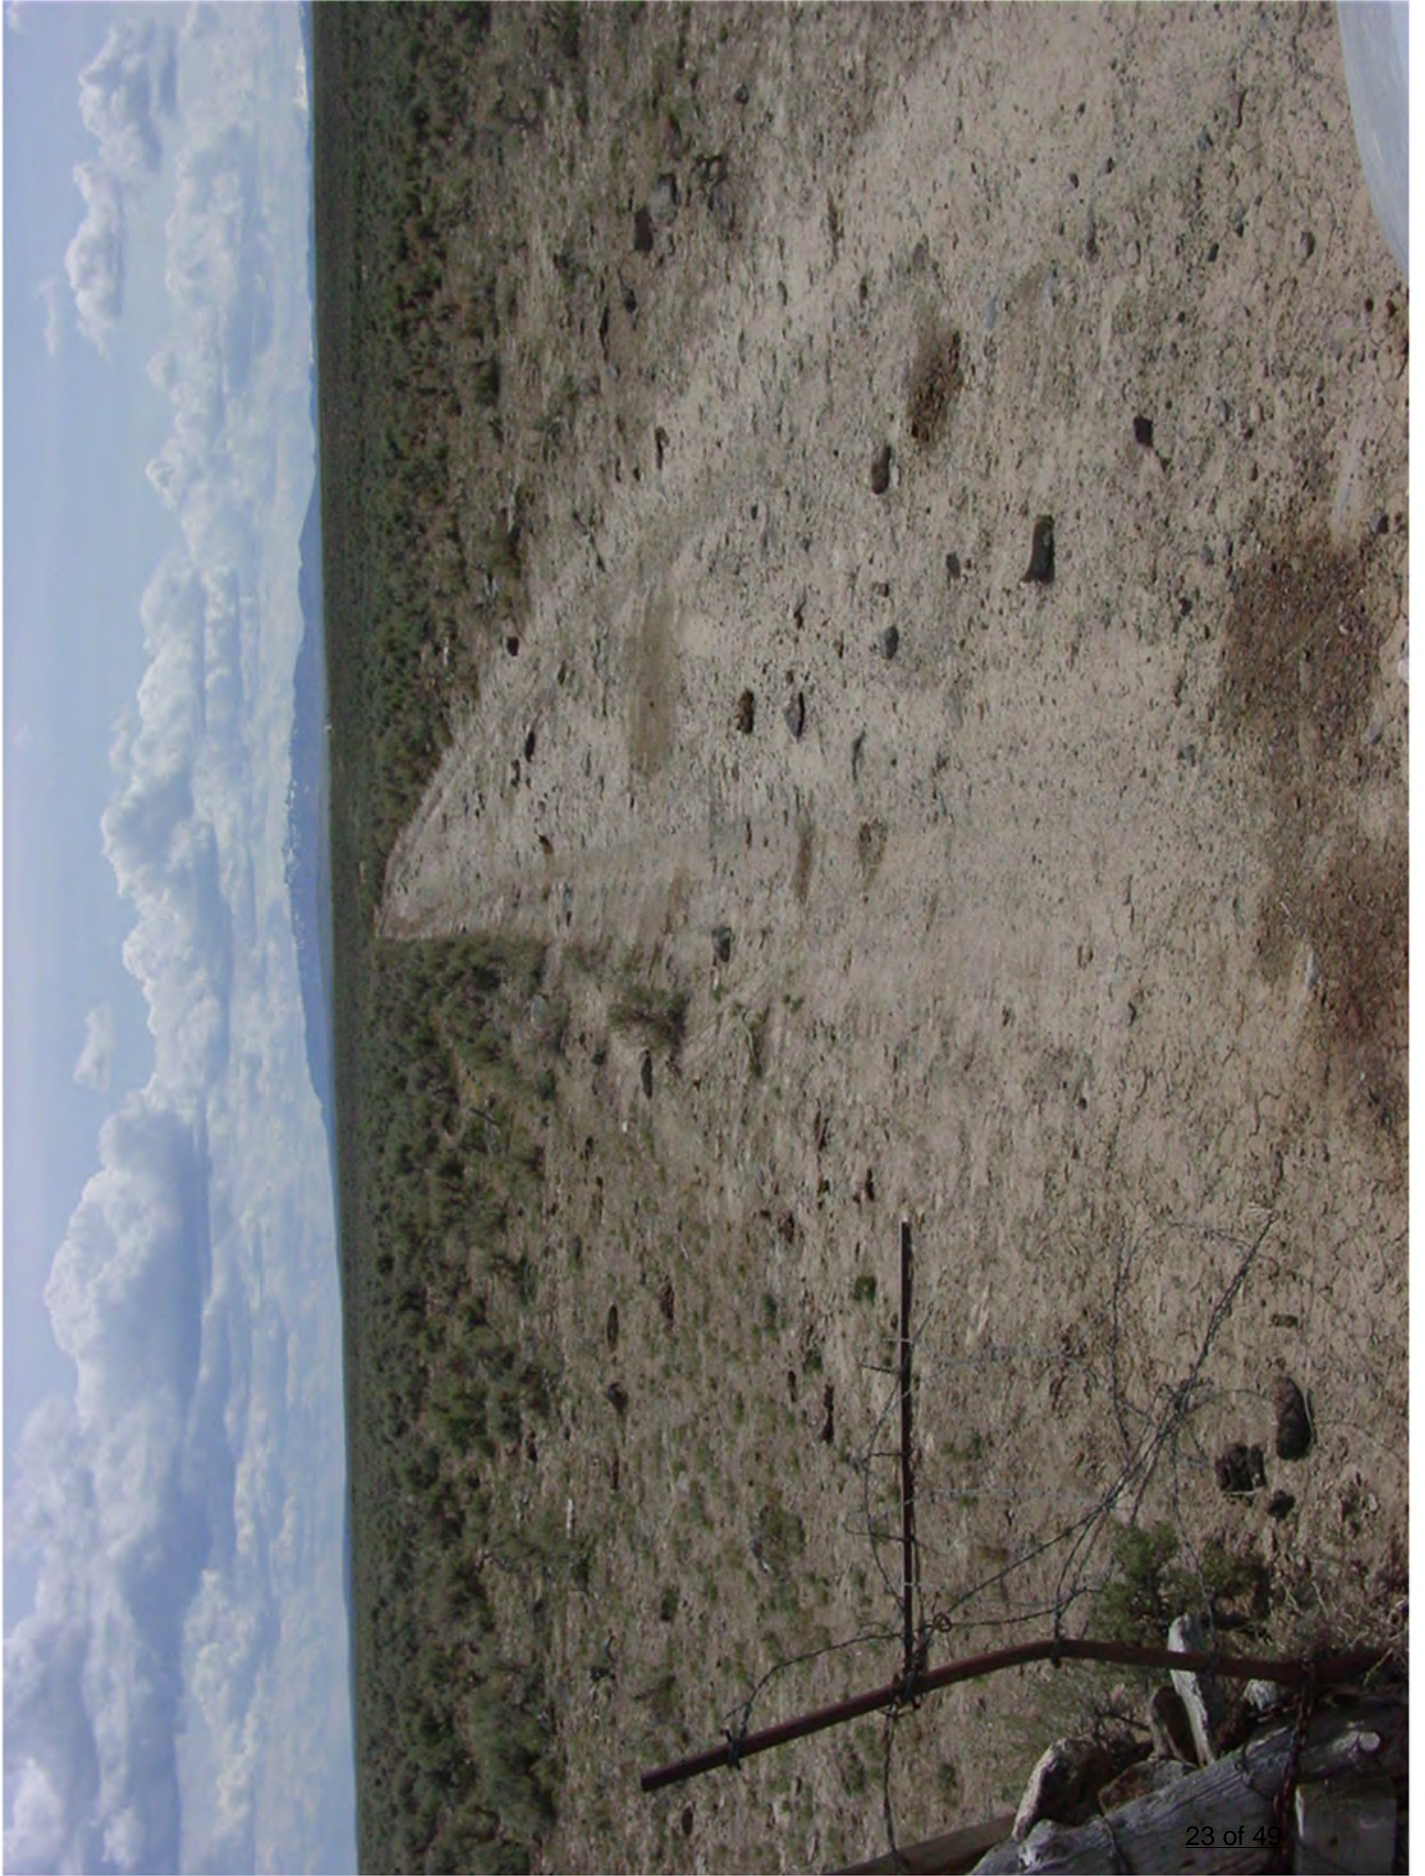
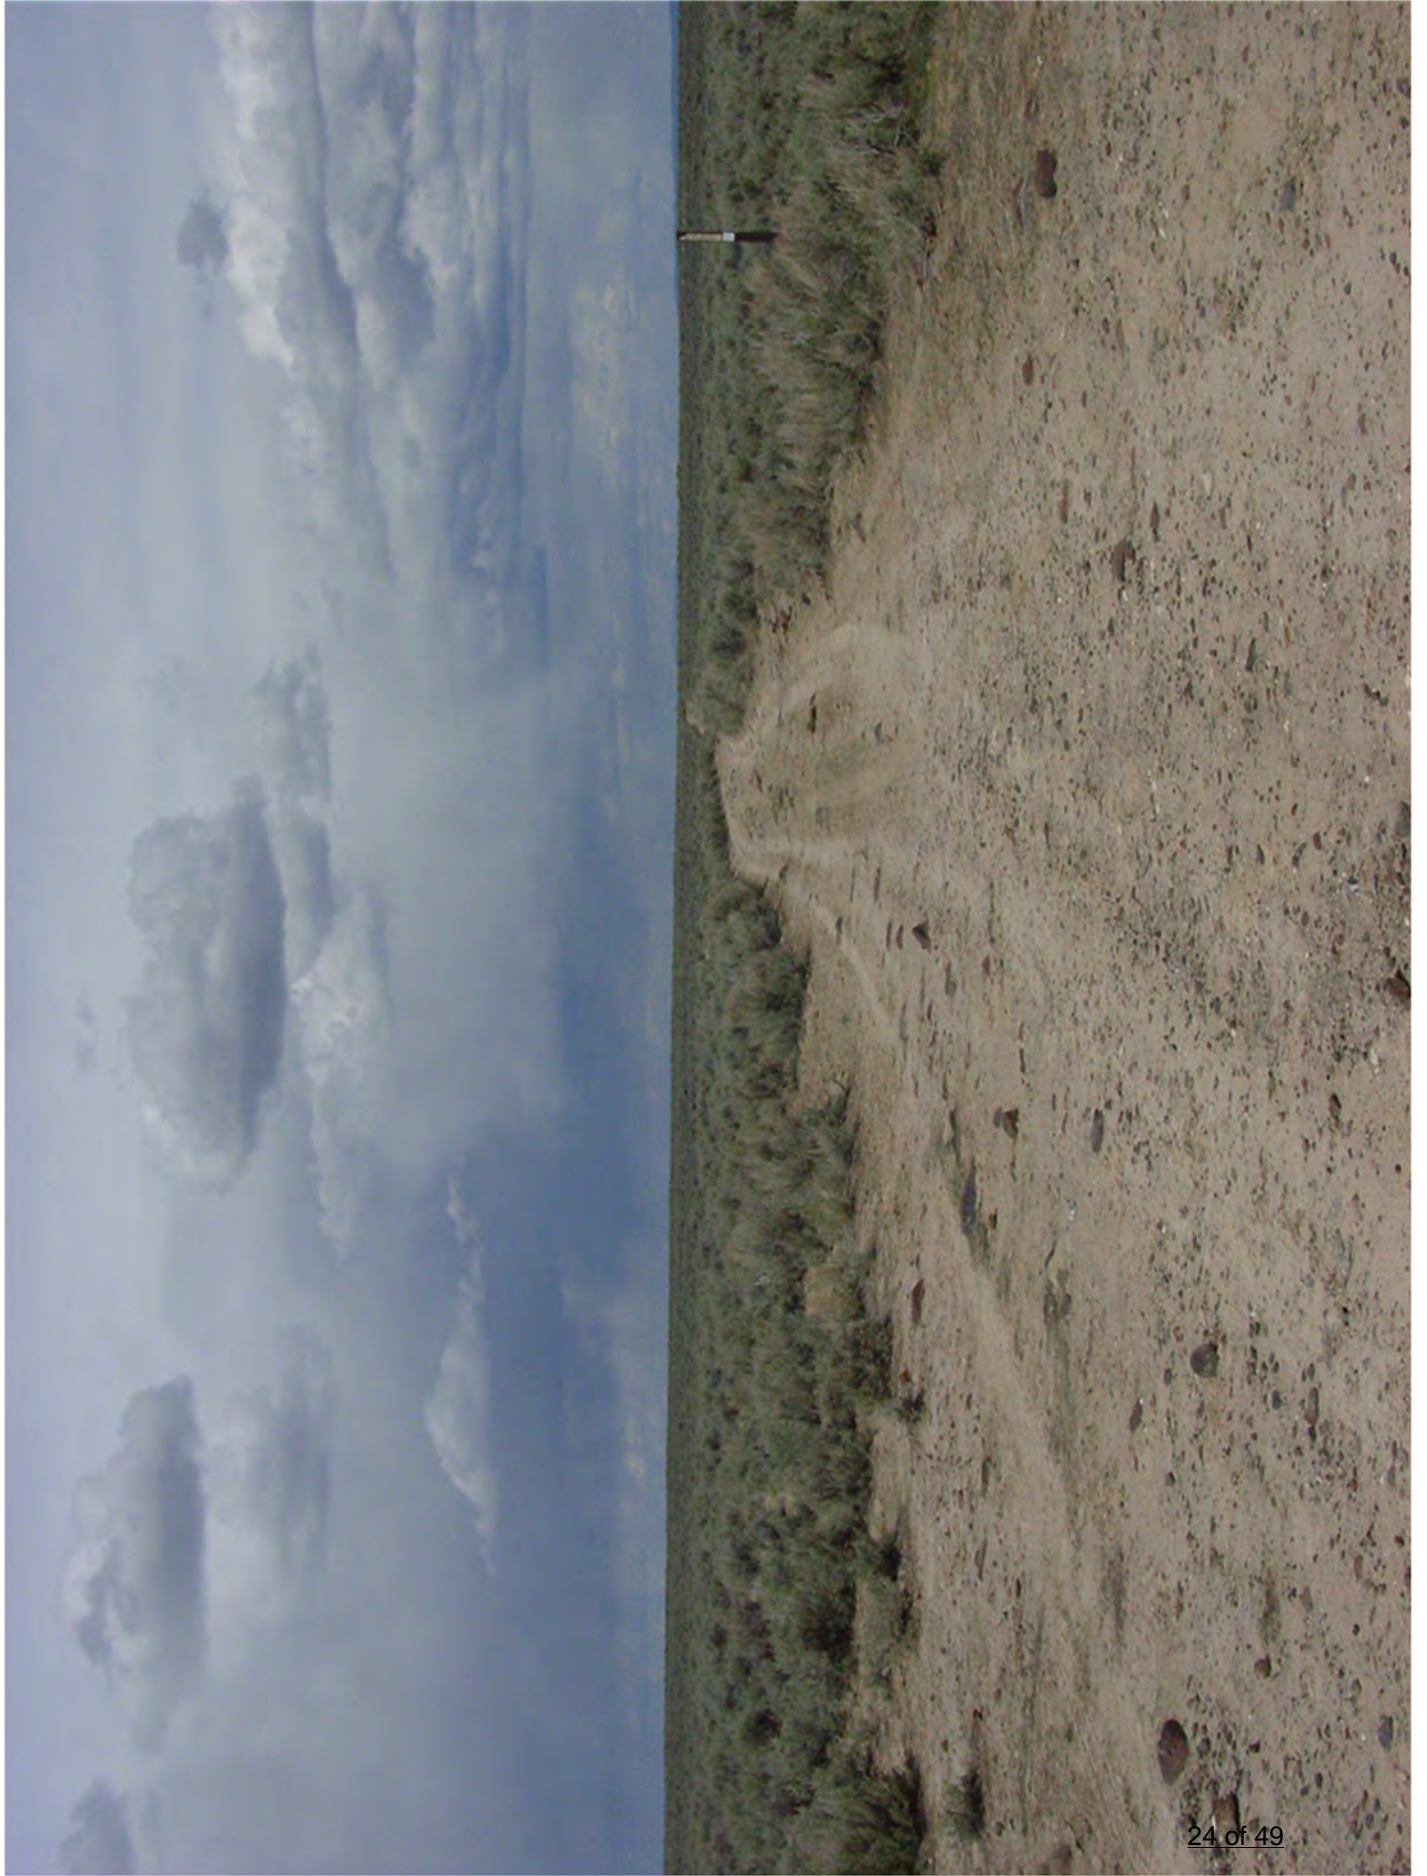
Black Butte OR-036-008 Five Bar Road 6350-0-A0

DATE	Frame #	Camera Direction	Description	GPS/UTM Location	Township	Range	Section
4/25/2007	DSC02345	E	Visible tracks	482780 4668991	T39S	R46E	Sec21
4/25/2007	DSC02346	E	Onto 5 Bar road	484124 4668801	T39S	R46E	Sec22
4/25/2007	DSC02347	N	Visible use	482780 4663386	T39S	R46E	Sec 22
4/25/2007	DSC02348	S	Visible Road	484110 4668870	T39S	R46E	Sec 22
4/25/2007	DSC02349	S	Visible road	48413 4668757	T39S	R46E	Sec 22
4/25/2007	DSC02350	S	At gate	483311 4665002	T39S	R46E	Sec33
4/25/2007	DSC02351	N	Looking back	482347 4661968	T40s	R46E	Sec 9
4/25/2007	DSC02352	W	Main Road	482347 4661968	T40s	R46E	Sec 9
7/27/2007	DSC02469	N	Visible road	484395 4669455	T39S	R46E	Sec 34
7/27/2007	DSC02470	N	Salt location	484732 4669867	T39S	R47E	Sec 27
7/27/2007	DSC02471	N	Visible tracks	484957 4670992	T39S	R47E	Sec 11
7/27/2007	DSC02472	N	Into WSA	484395 4669455	T39S	R47E	Sec 11

Explain: Comparing BLM photo DSC02472 taken at the northeast boundary of the Black Butte unit with any other BLM picture of road 6350-0-A0 clearly shows the difference in the roadbase of each section. Within the Black Butte unit, road 6350-0-A0 has a defined width and contains minimal vegetation within the road. Photograph DSC02472 shows road 6350-0-A0 leaving the Black Butte unit traveling northward between the Owyhee Canyon and Lookout Butte WSAs. This section of road 6350-0-A0 has not been maintained by a blade for a considerable time and much longer than any portion of the road within the Black Butte unit.

BLM road 6350-0-A0 has annual use as evidenced by the lack of brush in the road and by well-used bare ground where vehicle tires track (DSC02344-DSC02352, DSC02469-DSC02472). The road is well traveled, wide along much of its length, maintenance has been performed on the roadbed periodically, and it is clearly defined on the landscape.
