Louse Canyon Wilderness Inventory Unit Index of Documents  
**Black Butte OR-036-008, 49 total pages**

**H-6300-1-WILDERNESS INVENTORY MAINTENANCE  
IN BLM OREGON/WASHINGTON**

**Inventory Unit Name/Number: Black Butte OR-036-008**

**Wilderness Inventory Area Name and Number (Unit ID):** Black Butte OR-036-008

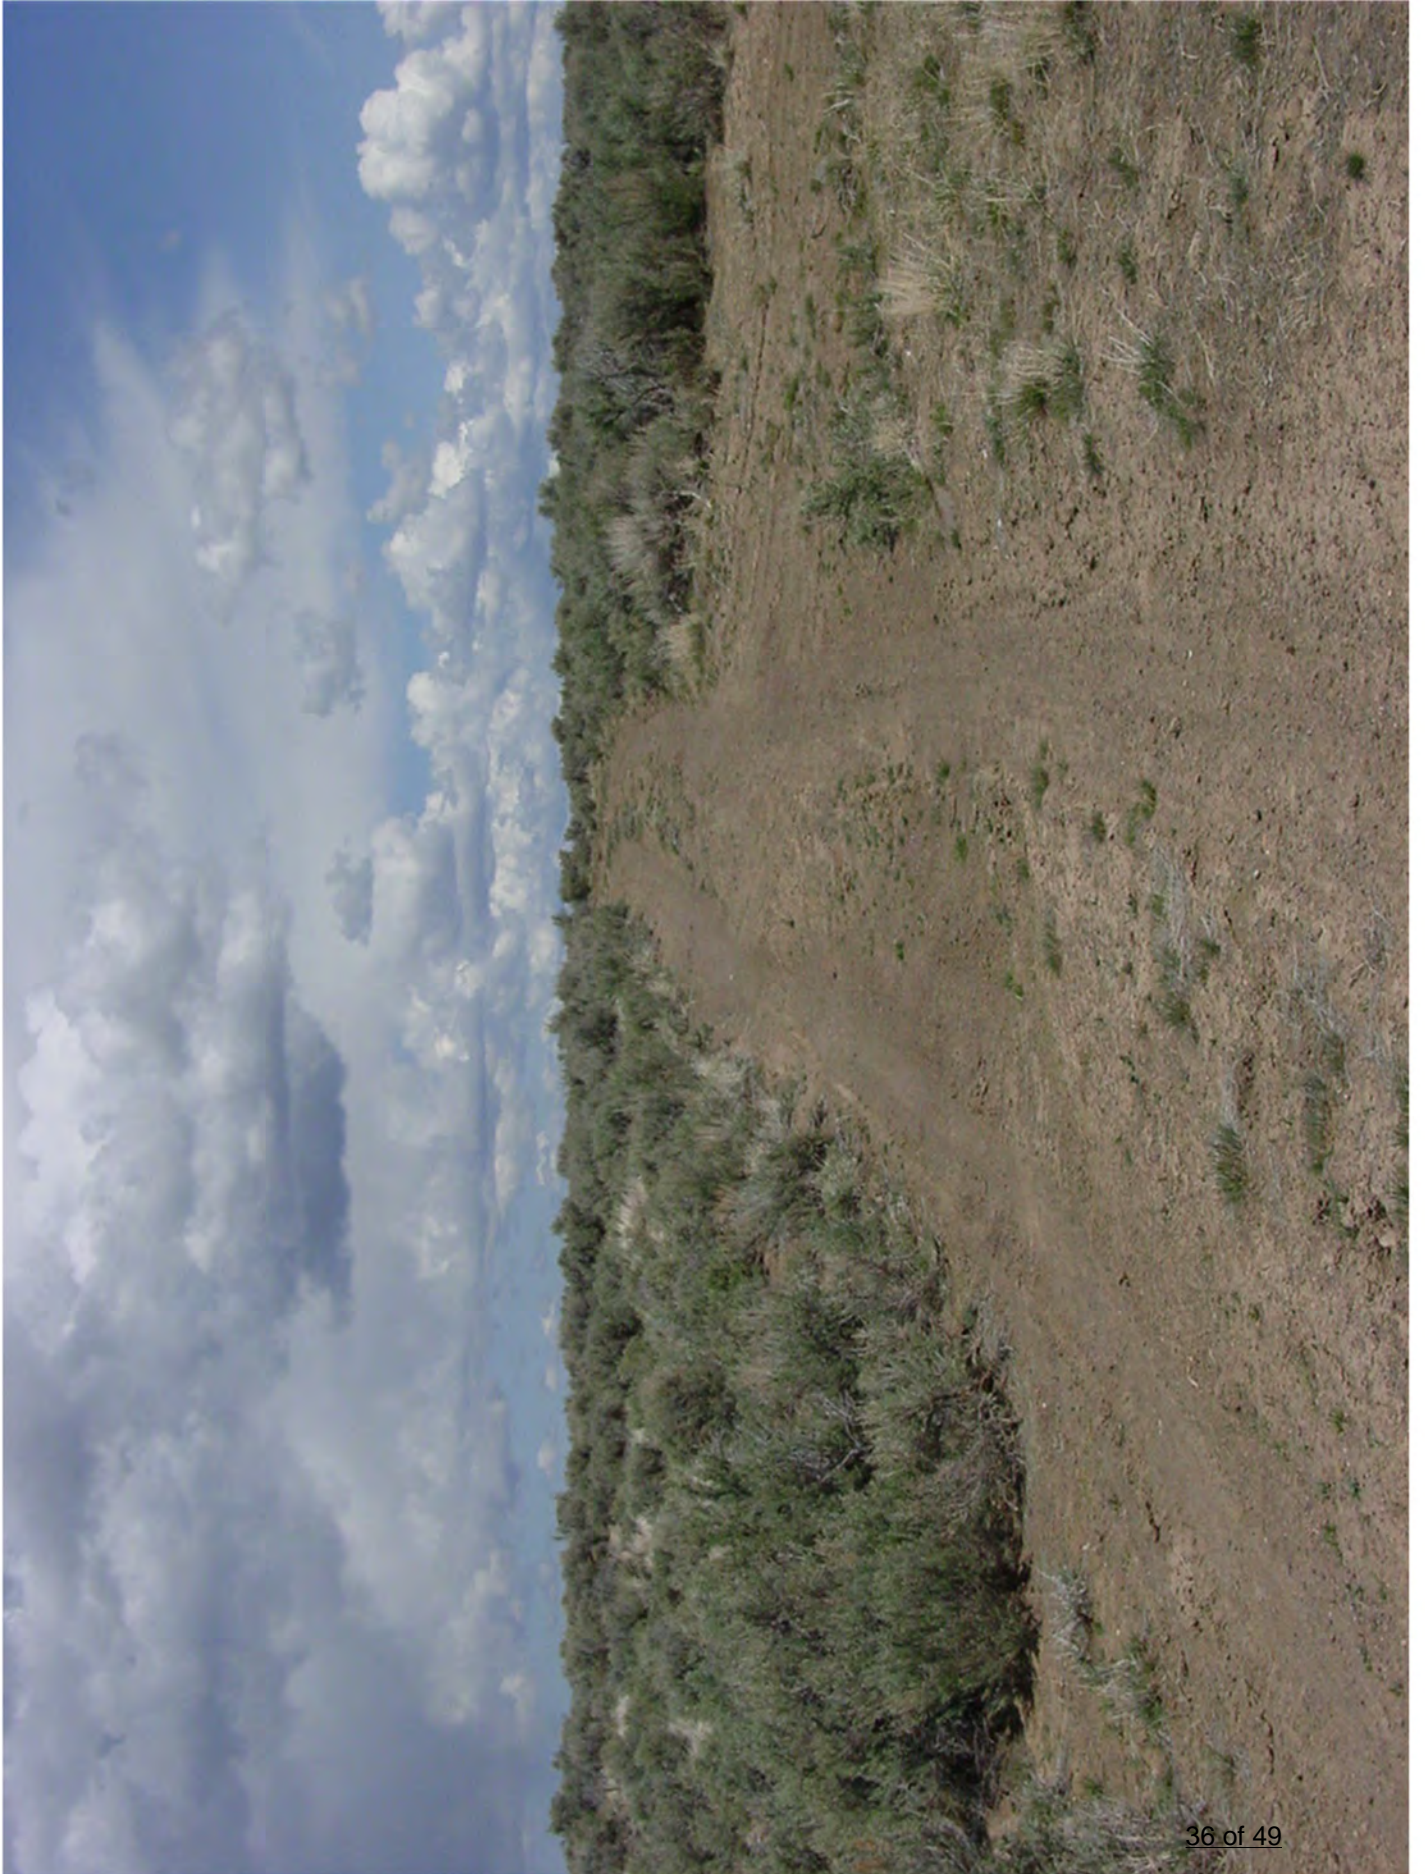
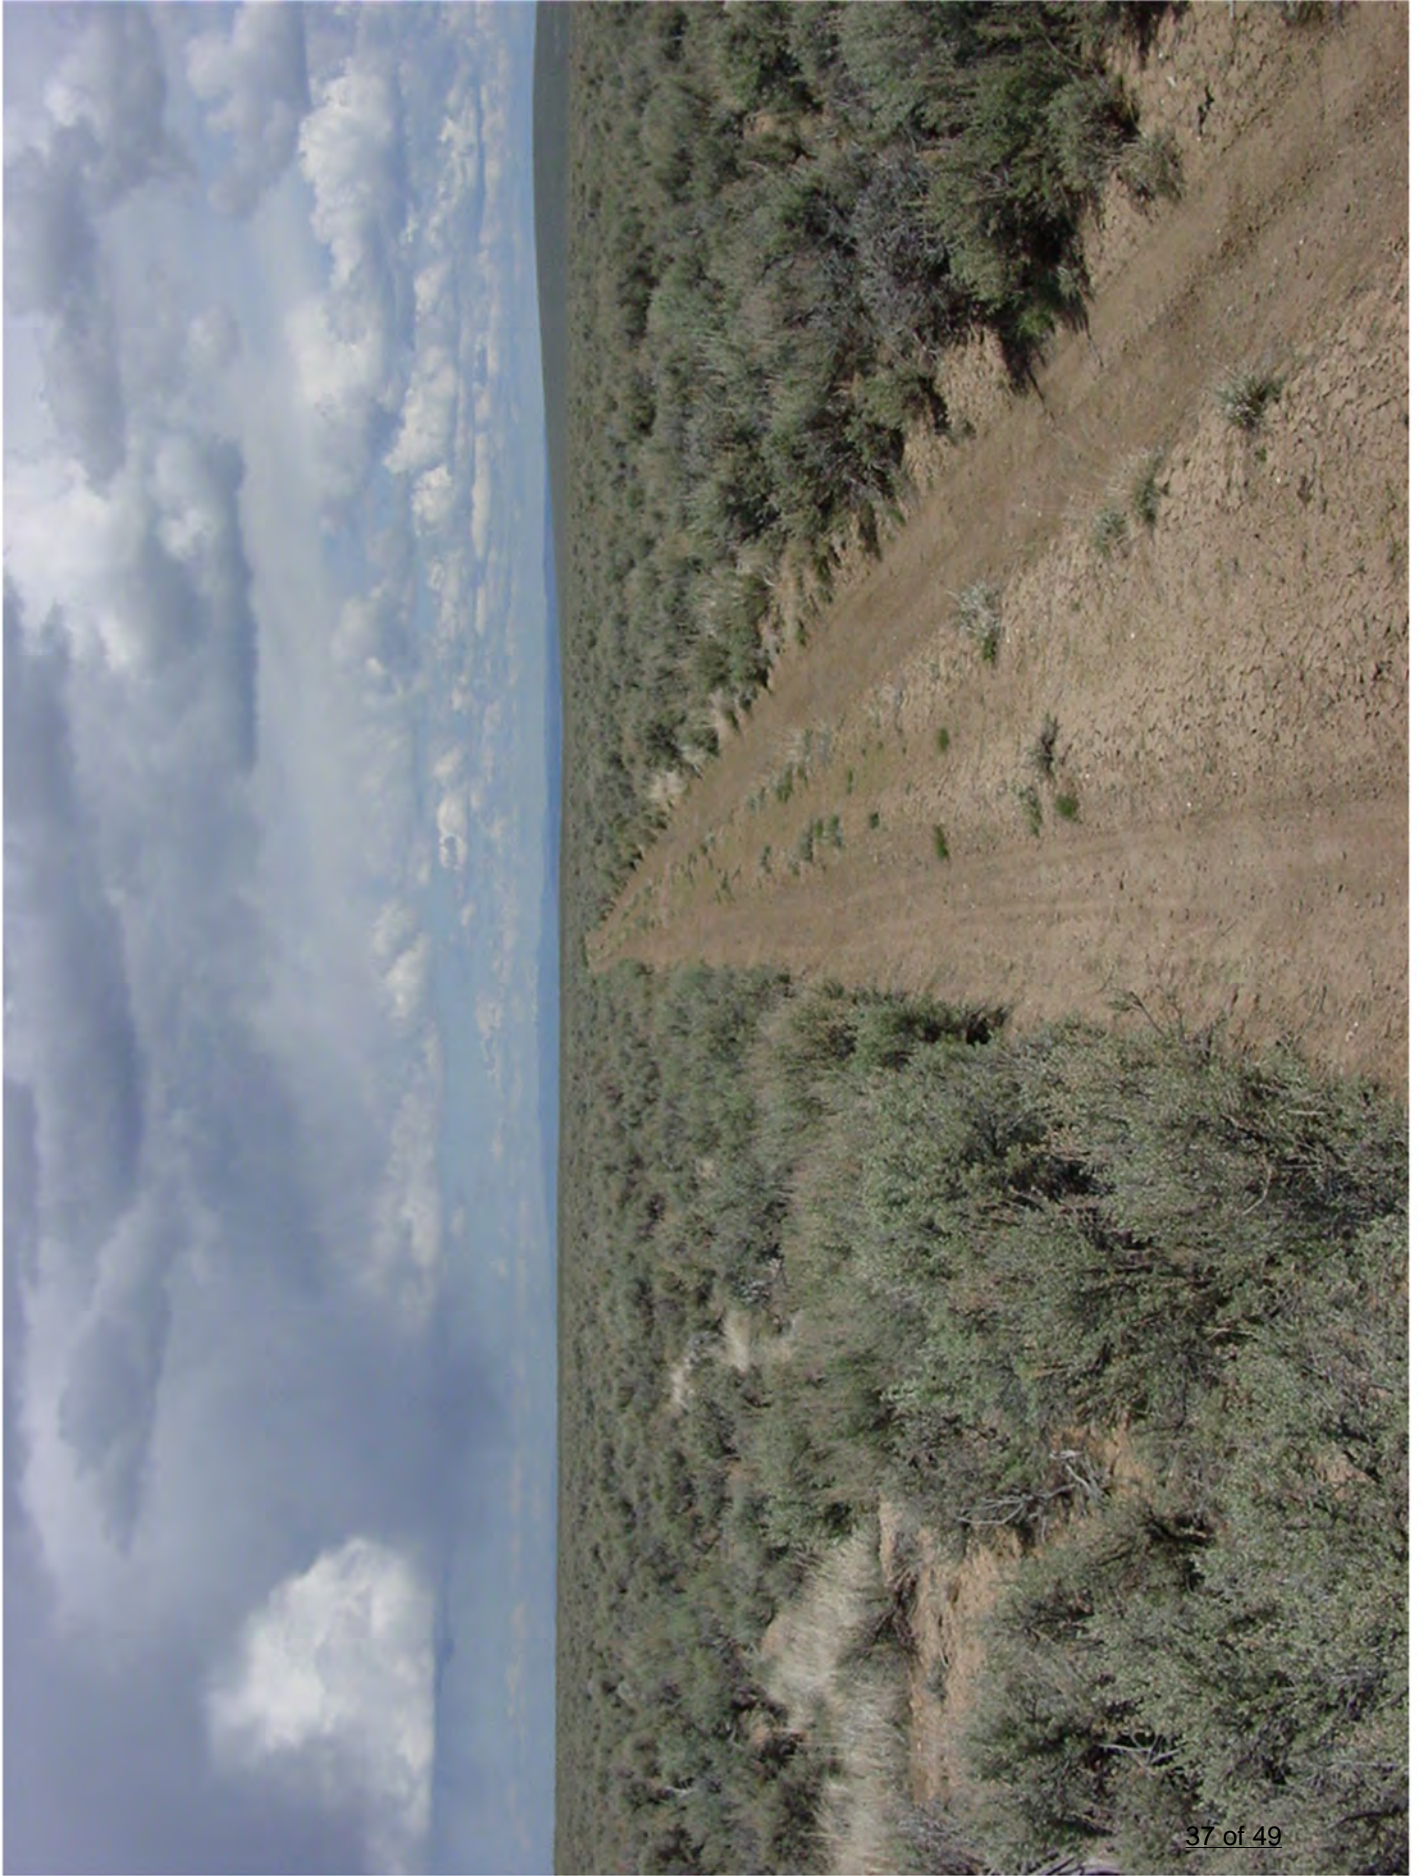
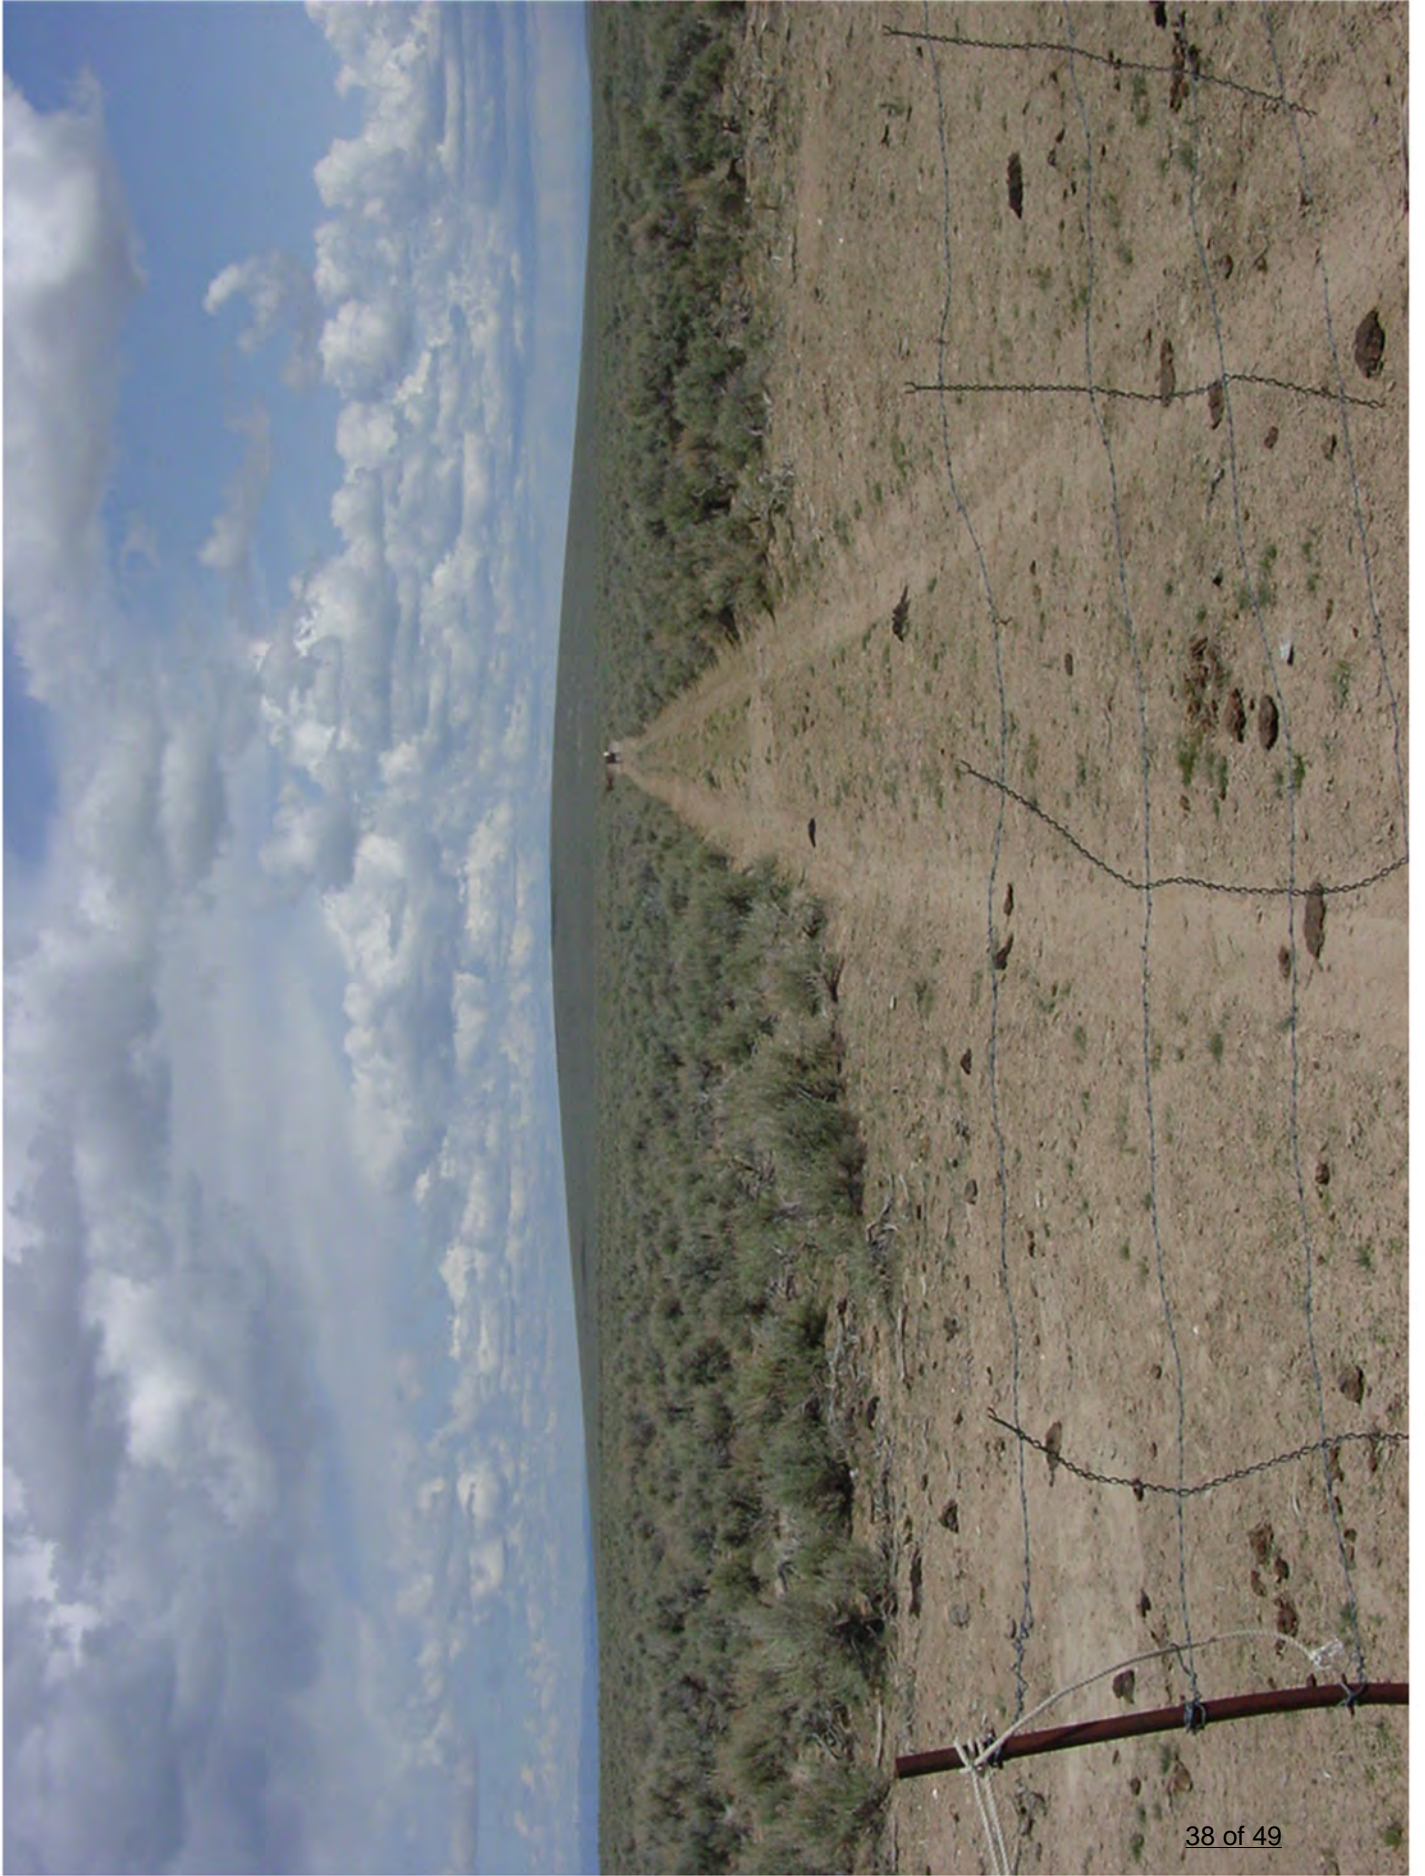
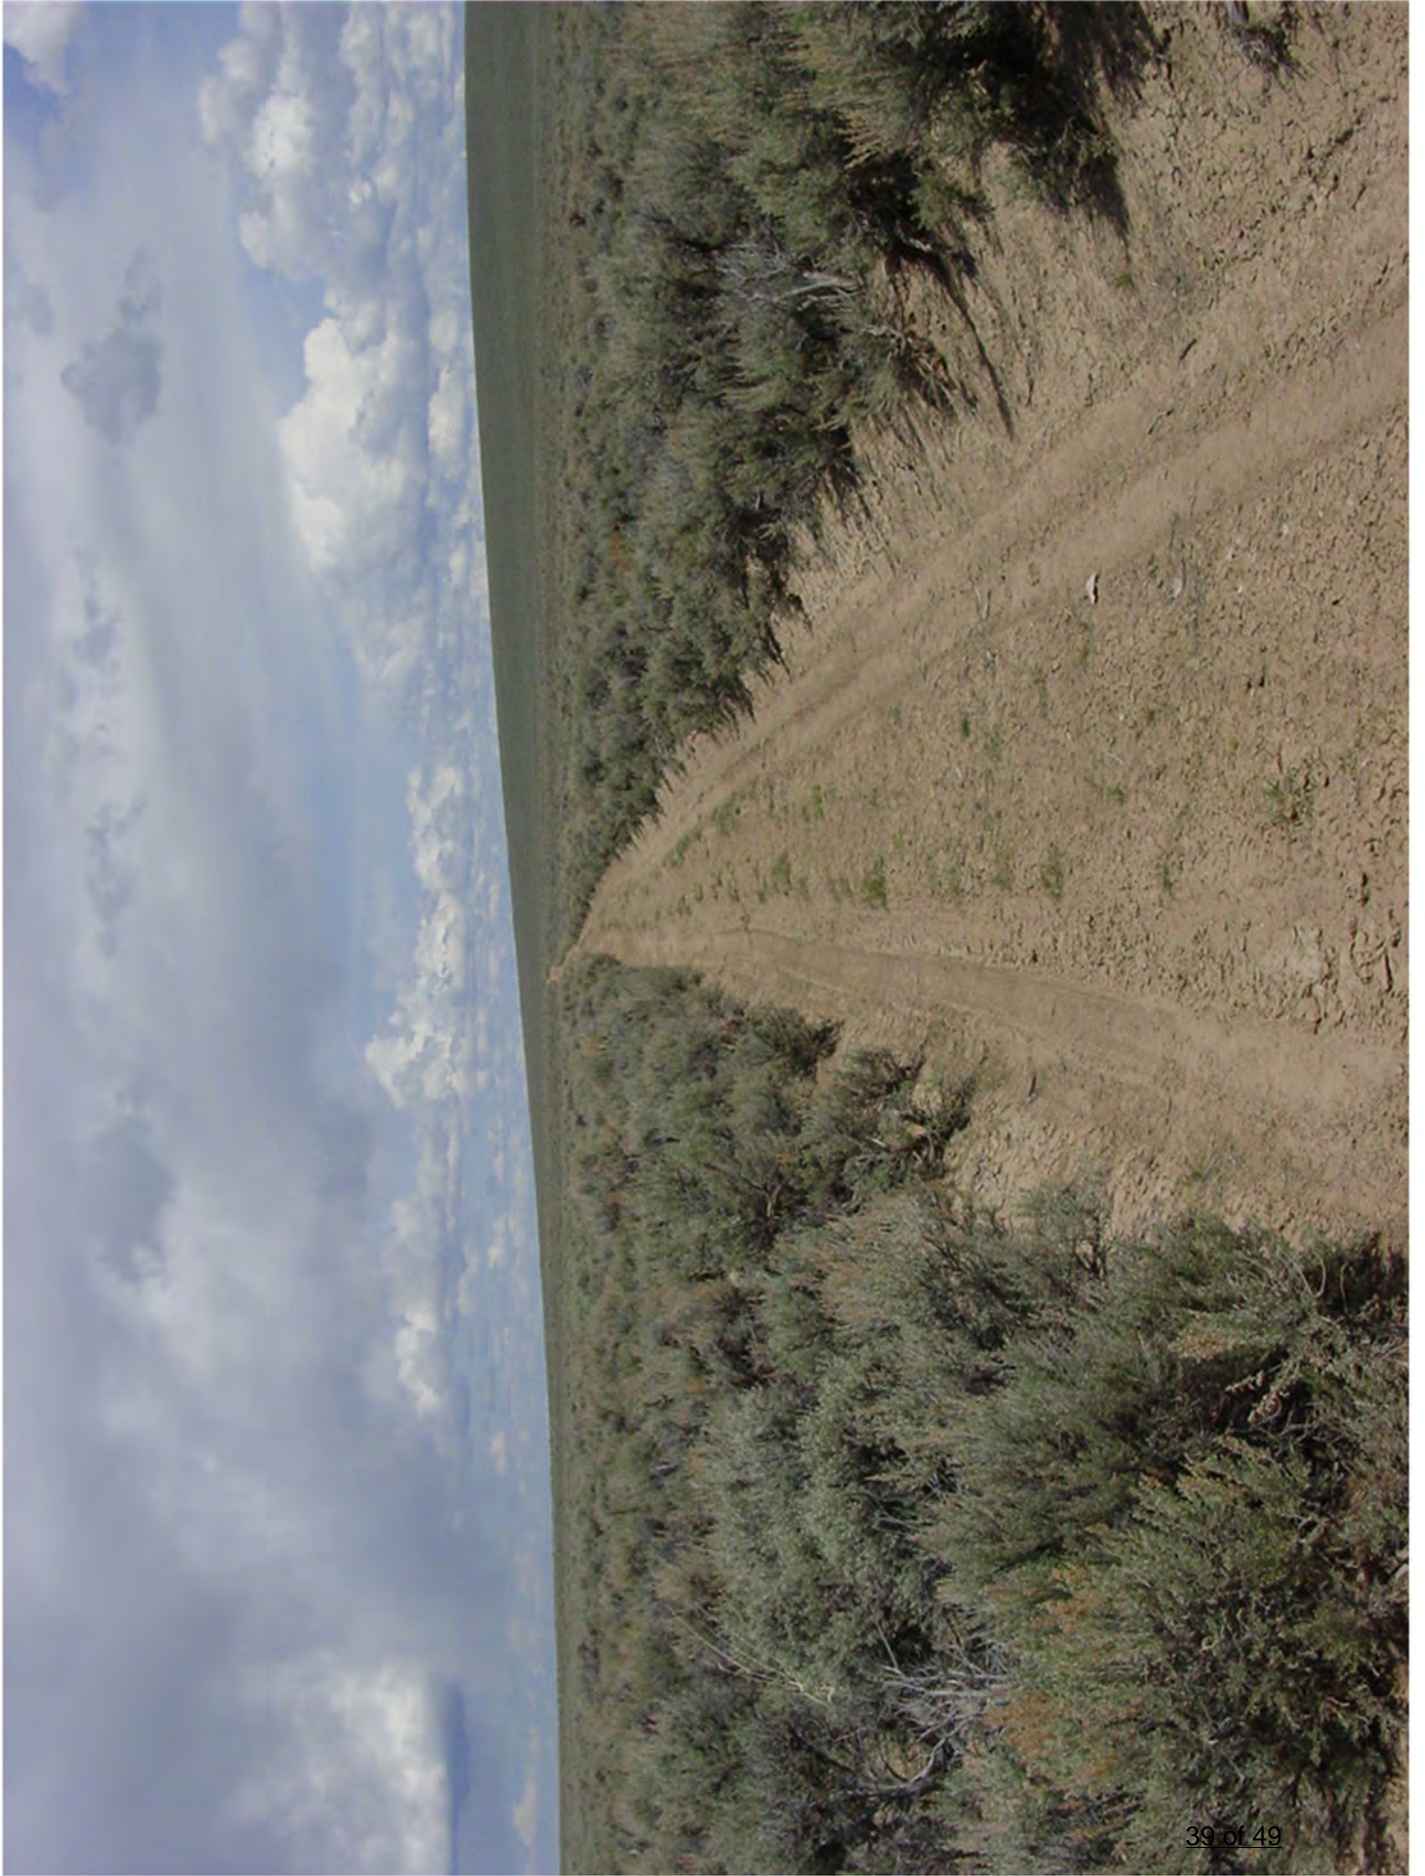
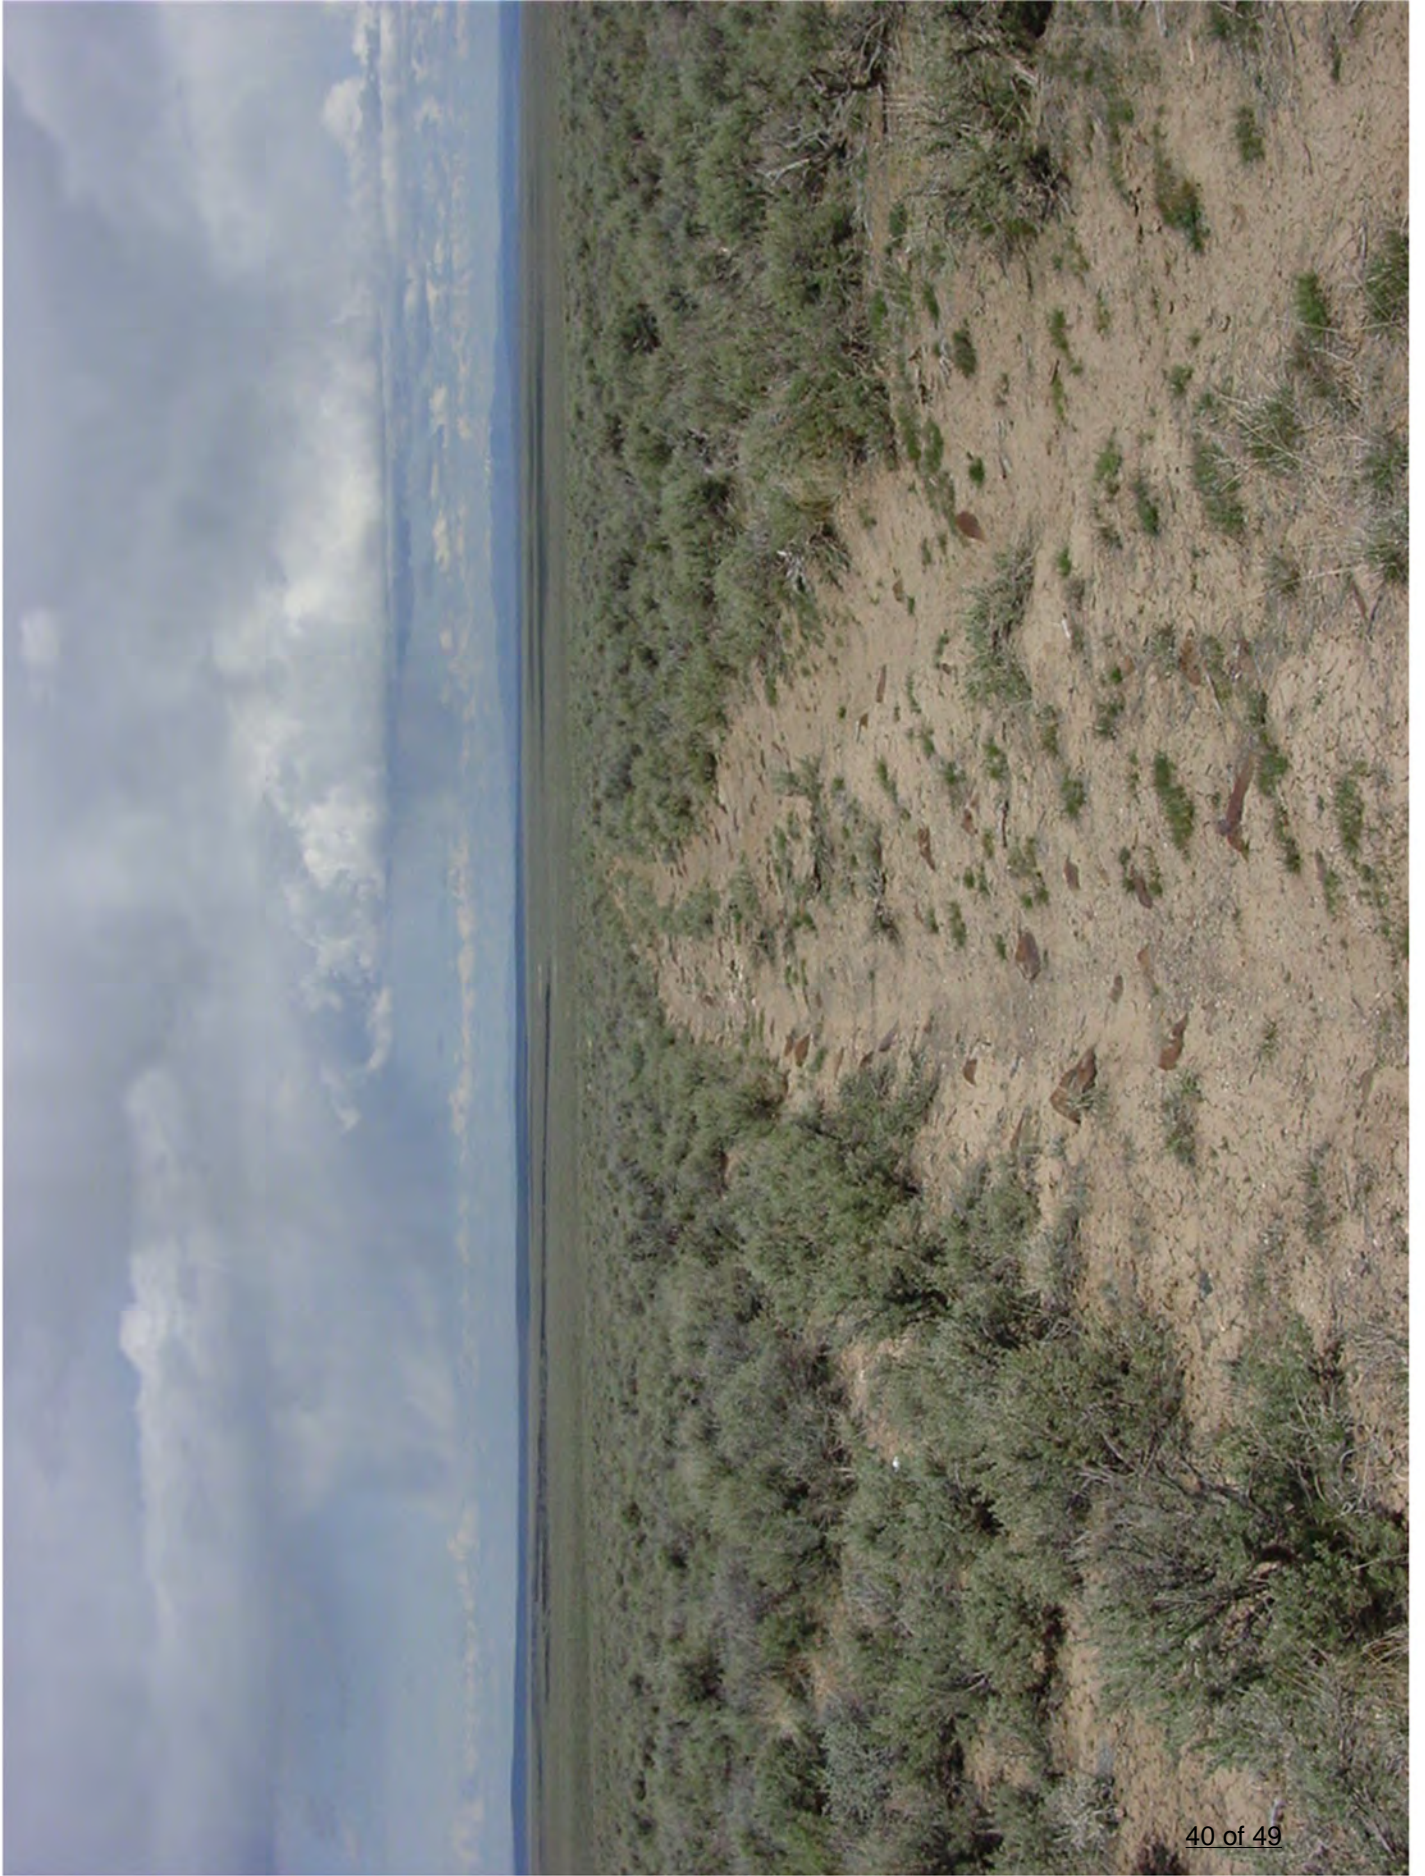
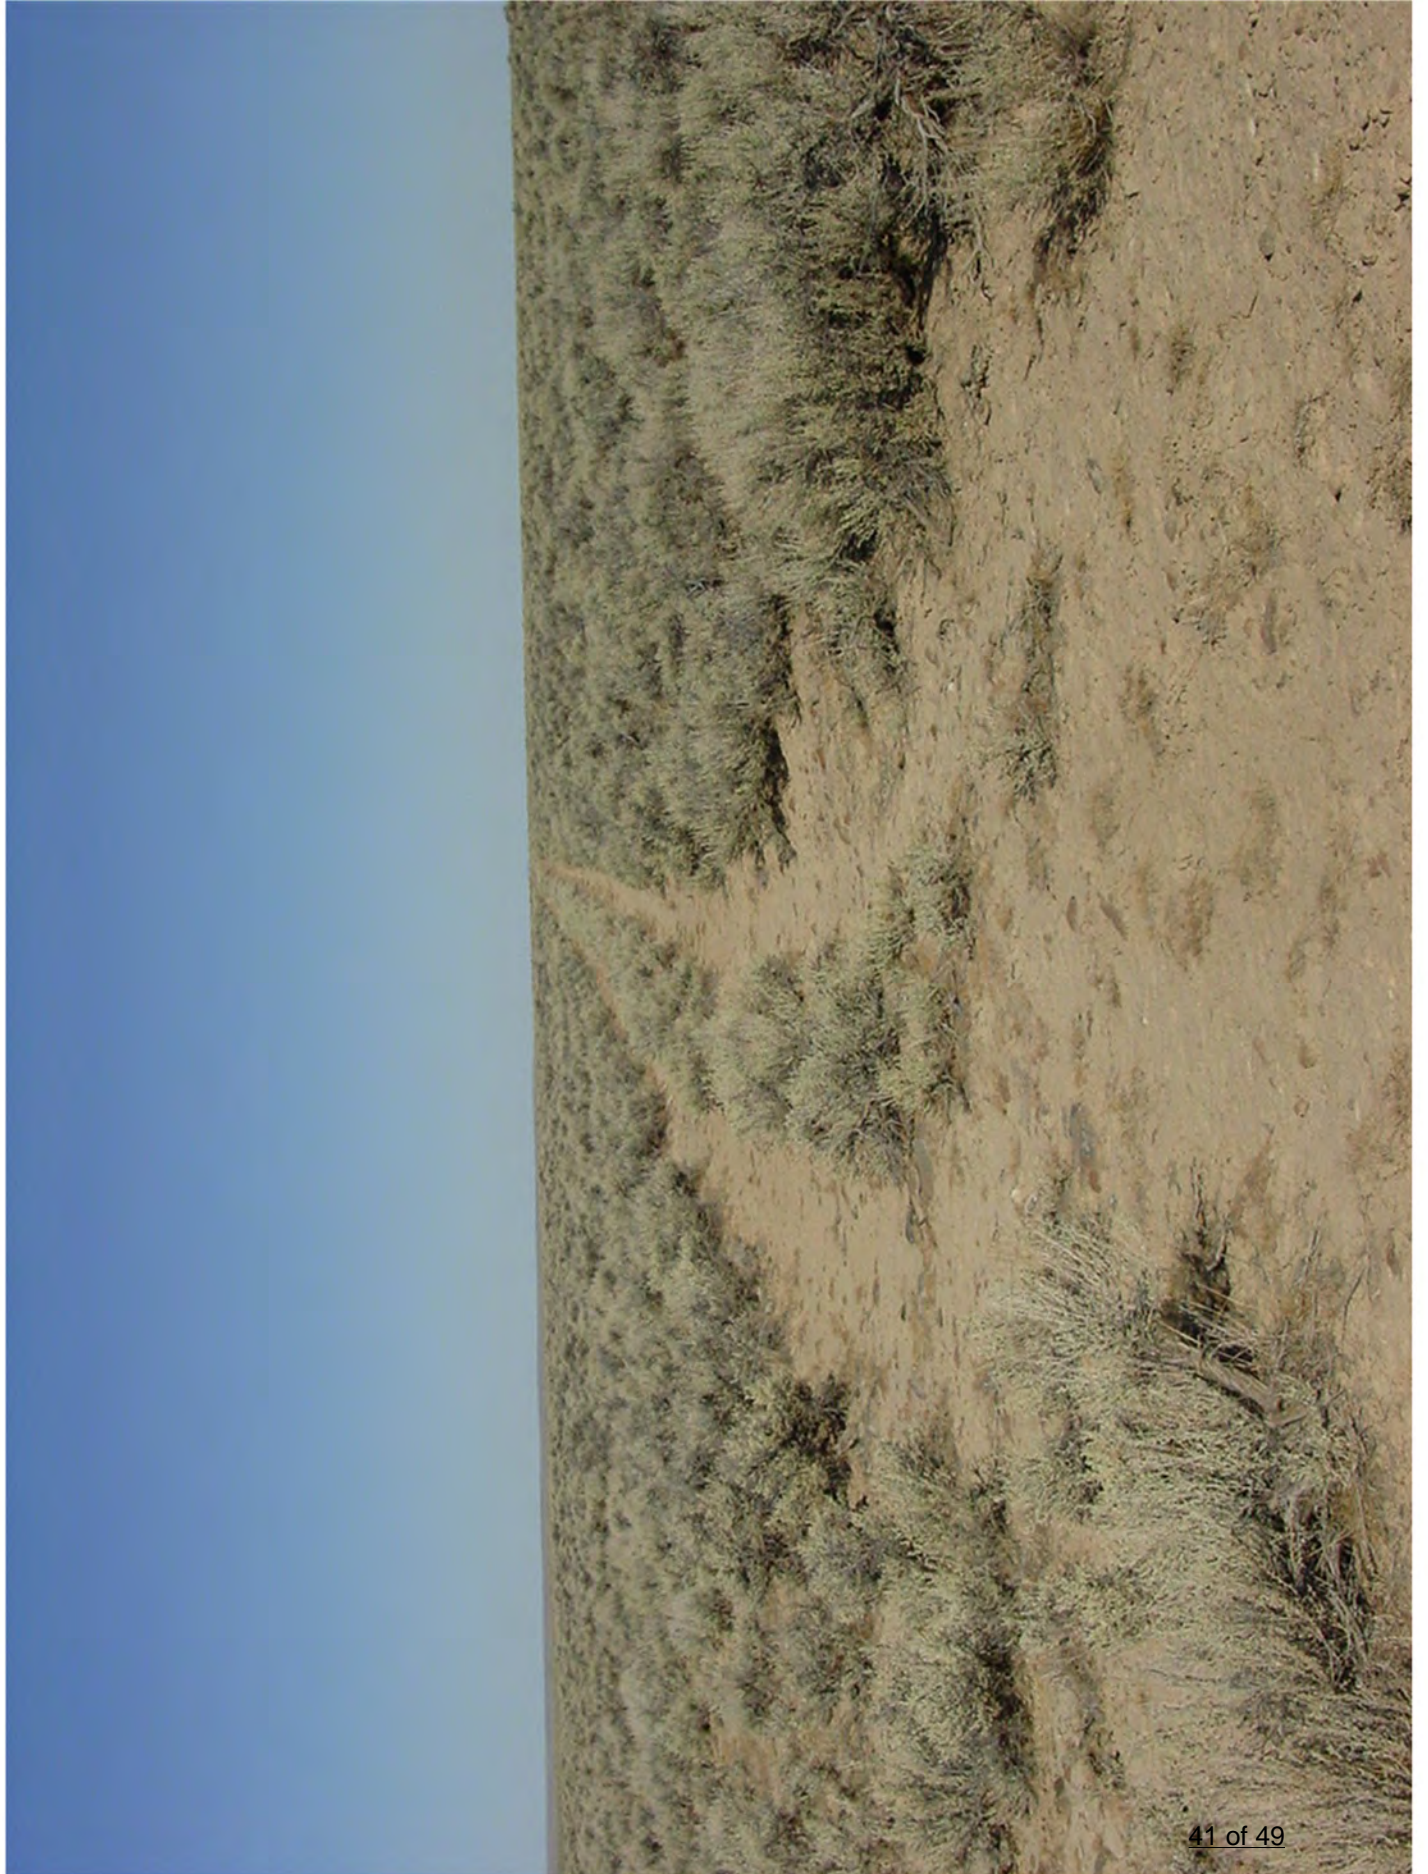
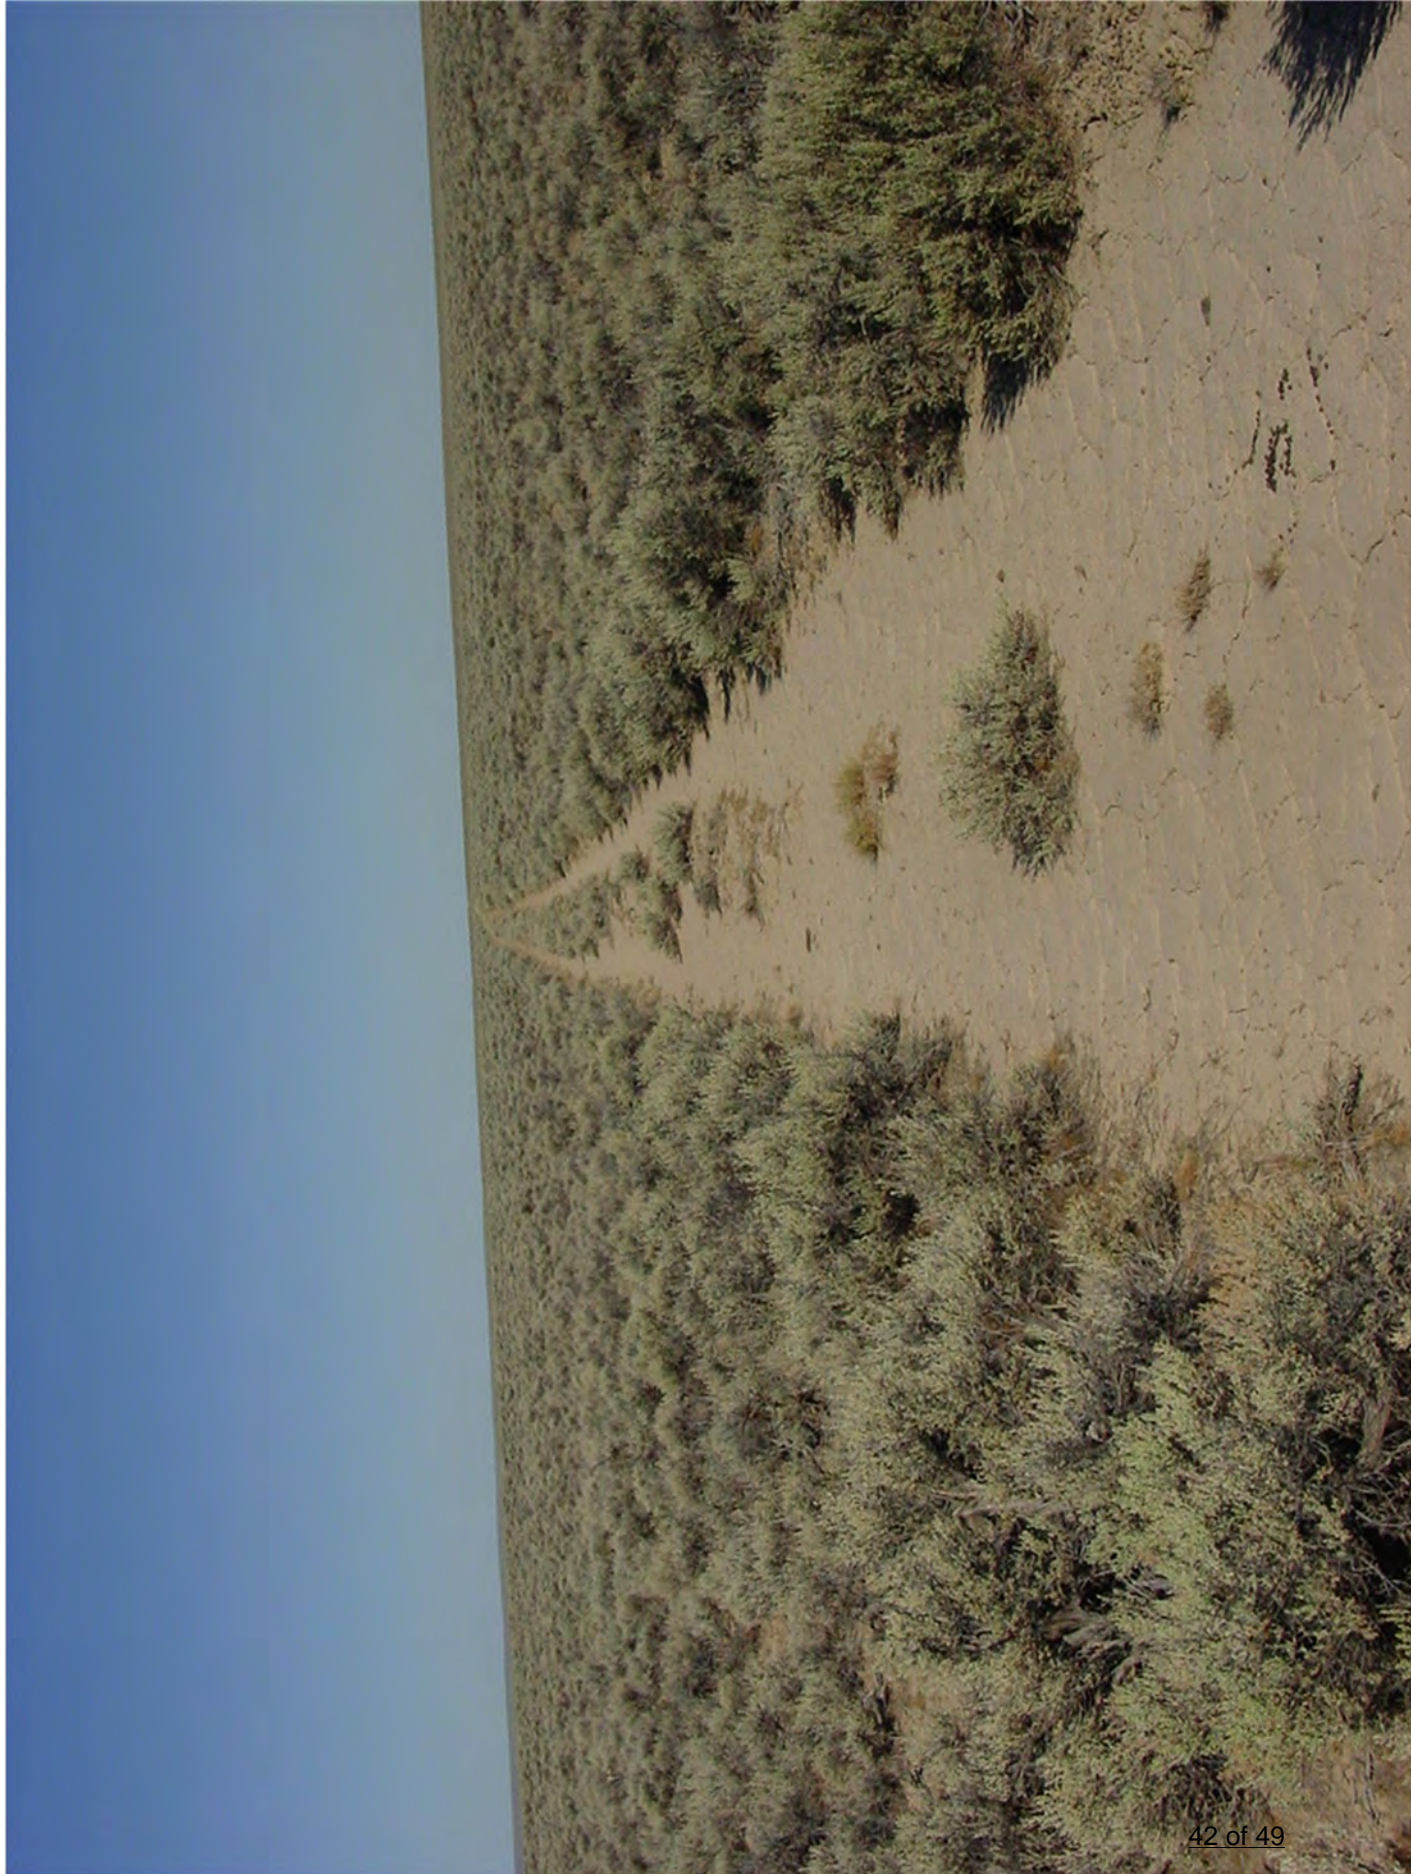
DATE	Frame #	Camera Direction	Description	GPS/UTM Location	Township	Range	Section
4/25/2007	DSC02336	N	From Star Valley Rd	475818 4662993	T40S	R46E	Sec 2
4/25/2007	DSC02338	N	Good road	476158 4663739	T40S	R46E	Sec 2
4/25/2007	DSC02339	N	Gate into N Tent Creek	477297 4664920	T39S	R46E	Sec 36
4/25/2007	DSC02340	N	Good road	476302 4666223	T39S	R46E	Sec 25
4/25/2007	DSC02341	NW	Visible tracks	470130 4668313	T39S	R46E	Sec 25
7/27/2007	DSC02473	W	Visible road	484979 4671095	T39S	R46E	Sec11
7/27/2007	DSC02474	N	Visible Road	484979 4671095	T39S	R46E	Sec 11
7/27/2007	DSC02475	W	Visible road	483689 4671461	T39S	R46E	Sec 10
7/27/2007	DSC02476	W	Visible road	483052 4671678	T39S	R46E	Sec 9
7/27/2007	DSC02477	W	Visible road	481409 4671678	T39S	R46E	Sec 8
7/27/2007	DSC02478	W	At reservoir	480175 4672072	T39S	R46E	Sec 7
7/27/2007	DSC02479	S	Visible Road	479957 4671353	T39S	R46E	Sec 7
7/27/2007	DSC02480	S	Visible tracks	479795 4670728	T39S	R46E	Sec 18

7/27/2007	DSC02481	N	Road splits	479157 4668353	T39S	R46E	Sec 19

Explain: Recent maintenance to BLM road 6350-0-B0 is not evident. Earthen berms and ditches left on the edge of the road shown in photos DSC02336, DSC02338-DSC02341, and DSC02473-81 presently contain brush encroaching from the undisturbed areas outside of the roadbed. As well, some of the pictures show brush in the center of the roadbed between wheel tracks. Although it has been many years since maintenance has been performed on this road it is evident that little to no maintenance is needed to keep the roadbed in good operational condition. This is consistent with Best Management Practices BLM has incorporated into the Southeastern Oregon Resource Management Plan for Vale District.

Comments: The southwest 3.5 miles of road 6350-0-B0 receives annual use as evidenced by the lack of brush in long sections of the road and by well-used bare ground where vehicles travel. The remaining length of road 6350-0-B0 has become an isolated loop that is no longer utilized as a main access route into the surrounding area, and has been reclassified by the current inventory team as a motorized primitive trail. Although this reclassified route 6350-0-B0 would be approved to be maintained by management as needed if the road base became impassable, it would remain a low priority to be repaired because of its limited annual use. To reduce the potential for erosion and the establishment of invasive plant and weed species, BLM emphasizes minimal ground disturbance for road construction and maintenance through Best Management Practices (BMPs) as defined in the SEORMP, Appendix O. BMPs are designed to assist in achieving land use objectives for maintaining or improving water quality, soil productivity, and the protection of watershed resources from ground disturbing activities. Therefore, BLM does not grade many roads unless obstruction to vehicle passage is evident. To further reduce ground disturbance and to minimize disruption of natural drainage patterns, roads are kept to the minimal width necessary. Additional precautions are taken to reduce vegetation removal by retention of vegetation on cut slopes unless it poses a safety hazard or restricts maintenance activities, and by conducting roadside brushing of vegetation in a way that prevents disturbance to plant root systems and does not create visual intrusions.
