Louse Canyon Wilderness Inventory Unit Index of Documents
Cairn C OR-036-003, 60 total pages

Inventory Unit Name/Number: Cairn C OR-036-003

Wilderness Inventory Area Name and Number (Unit ID): Boundary road between BLM Twin Butte OR-036-002 and Cairn C OR-036-003

Cairn C OR-036-003 Andy Fife Road 6354-0-00

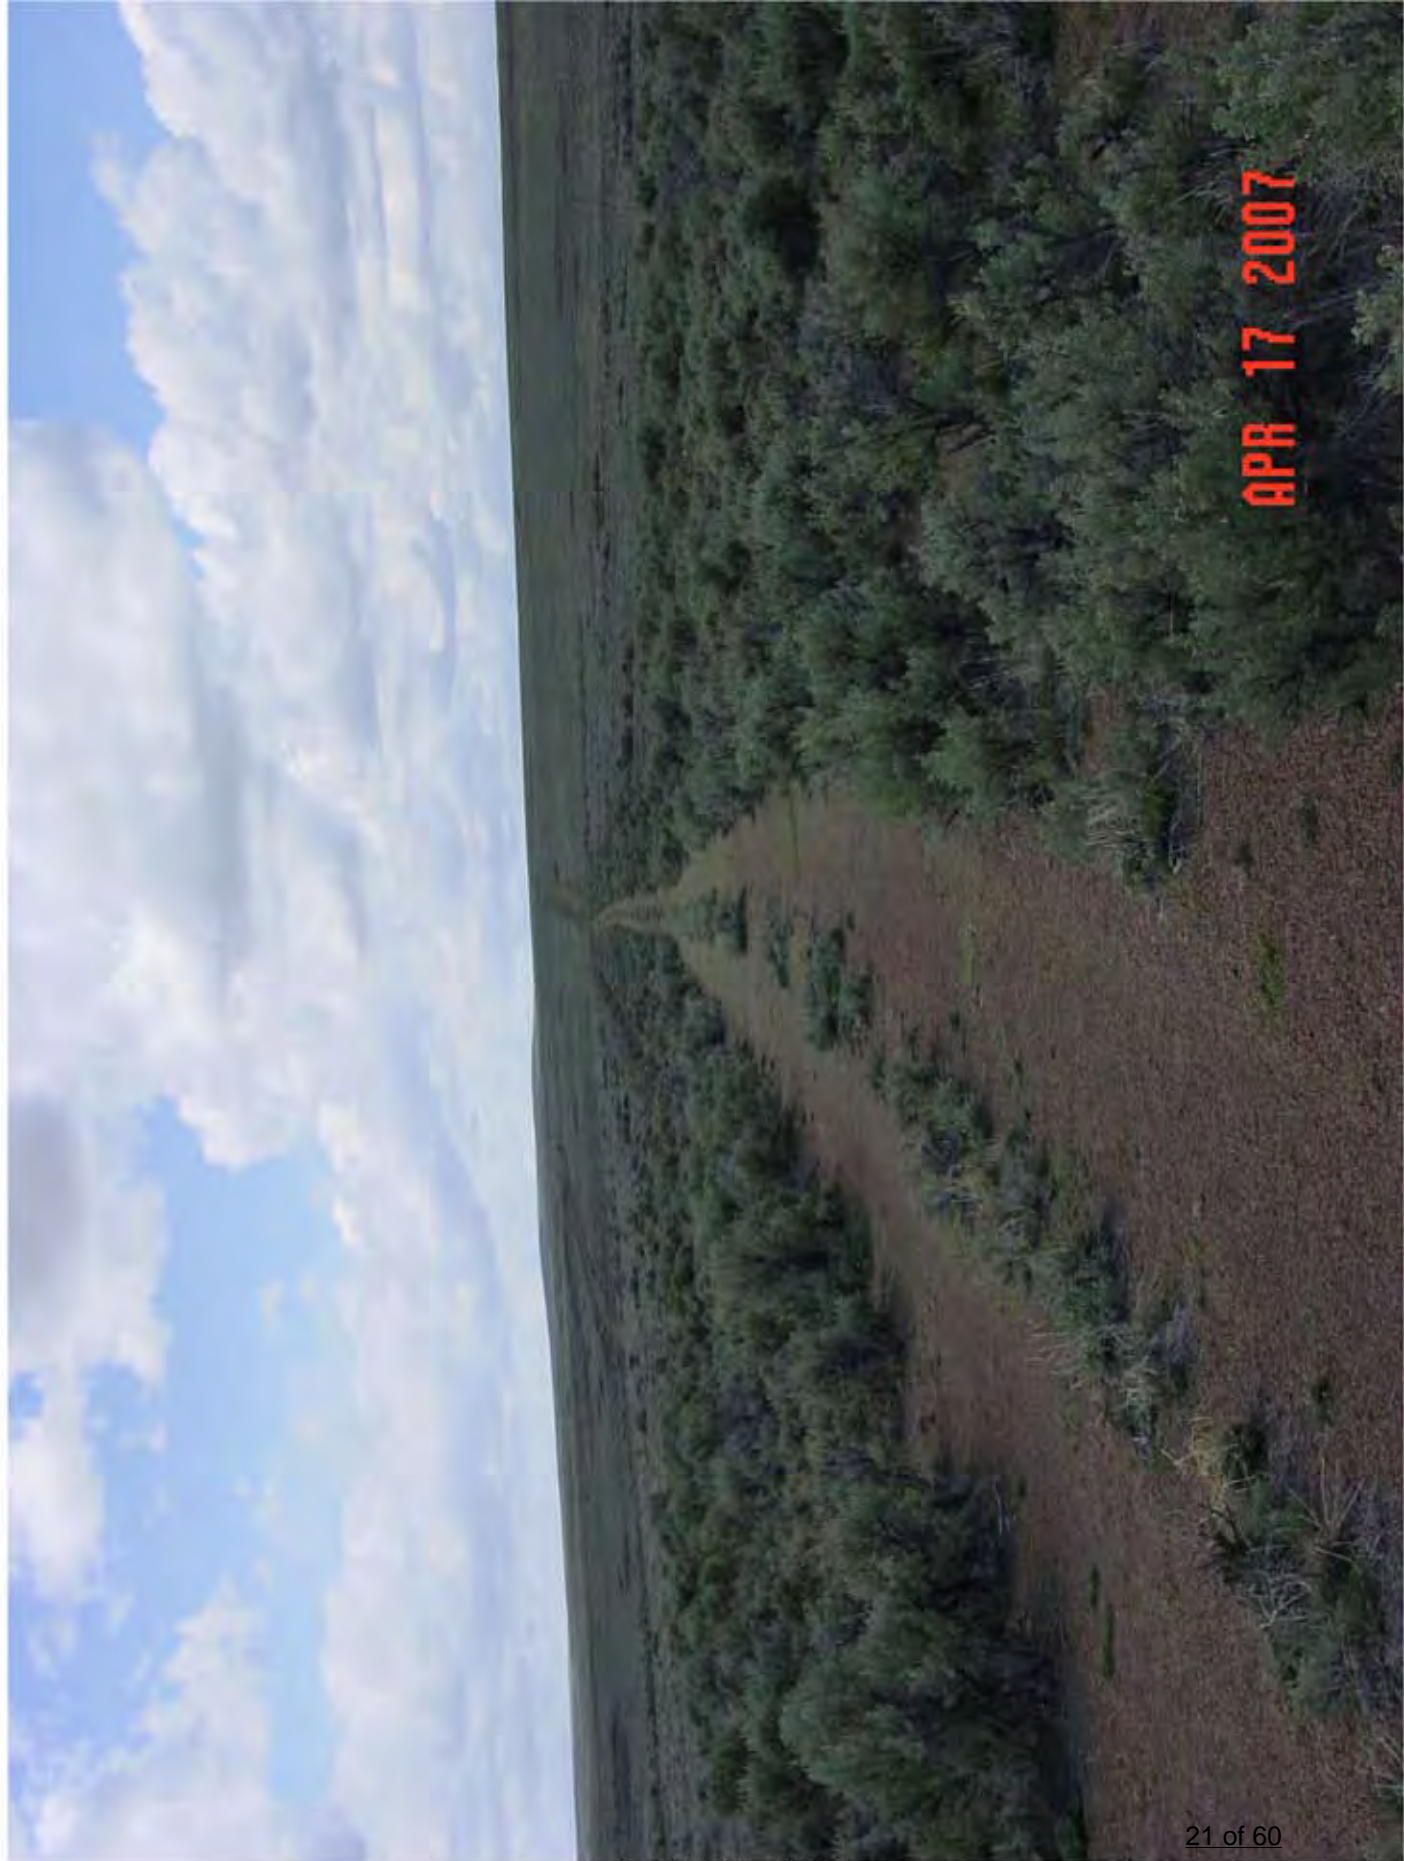
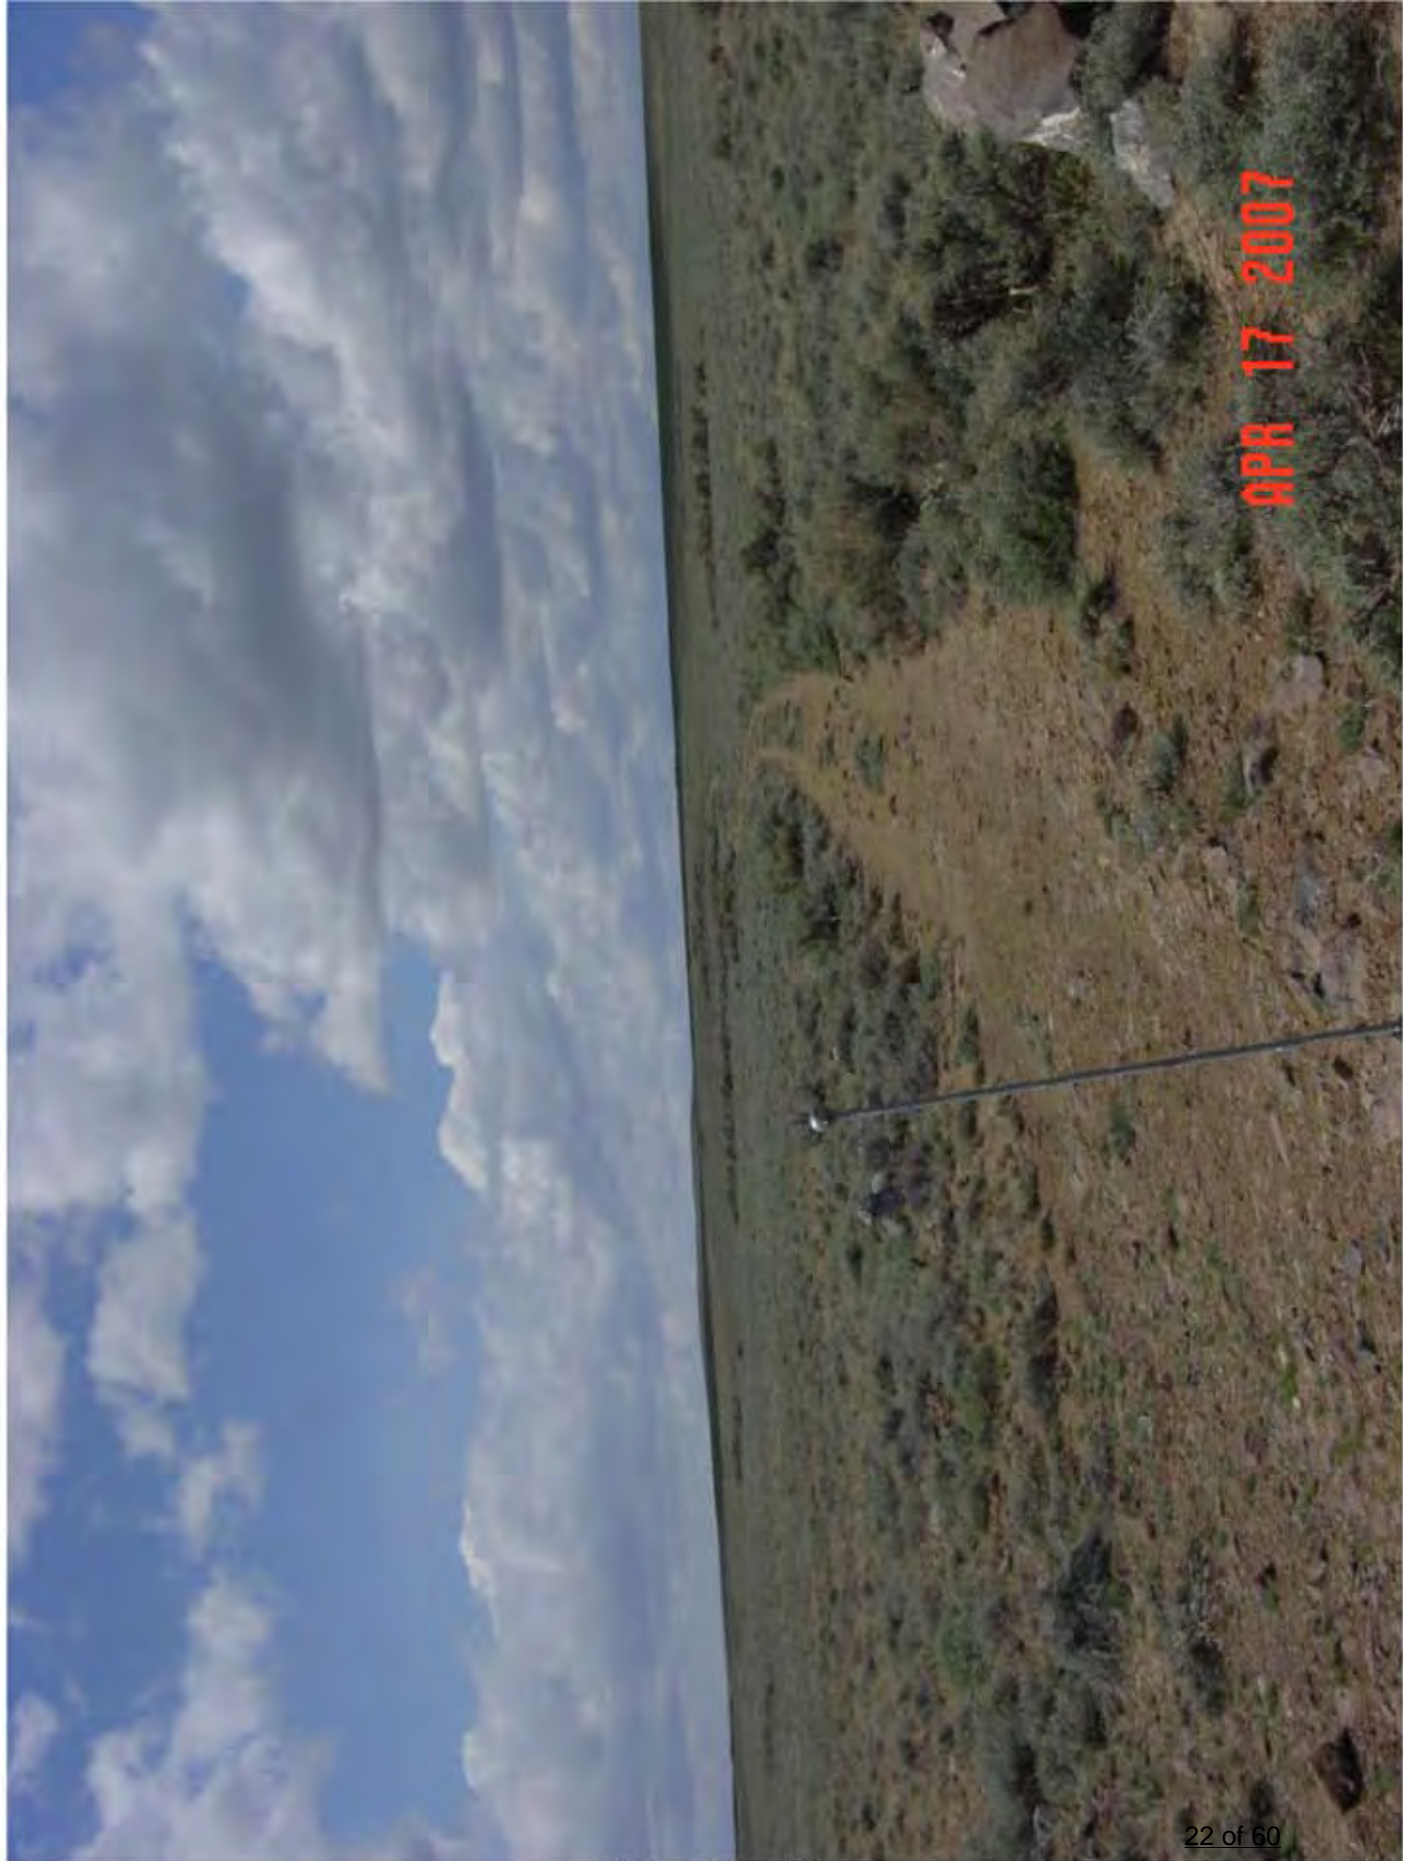
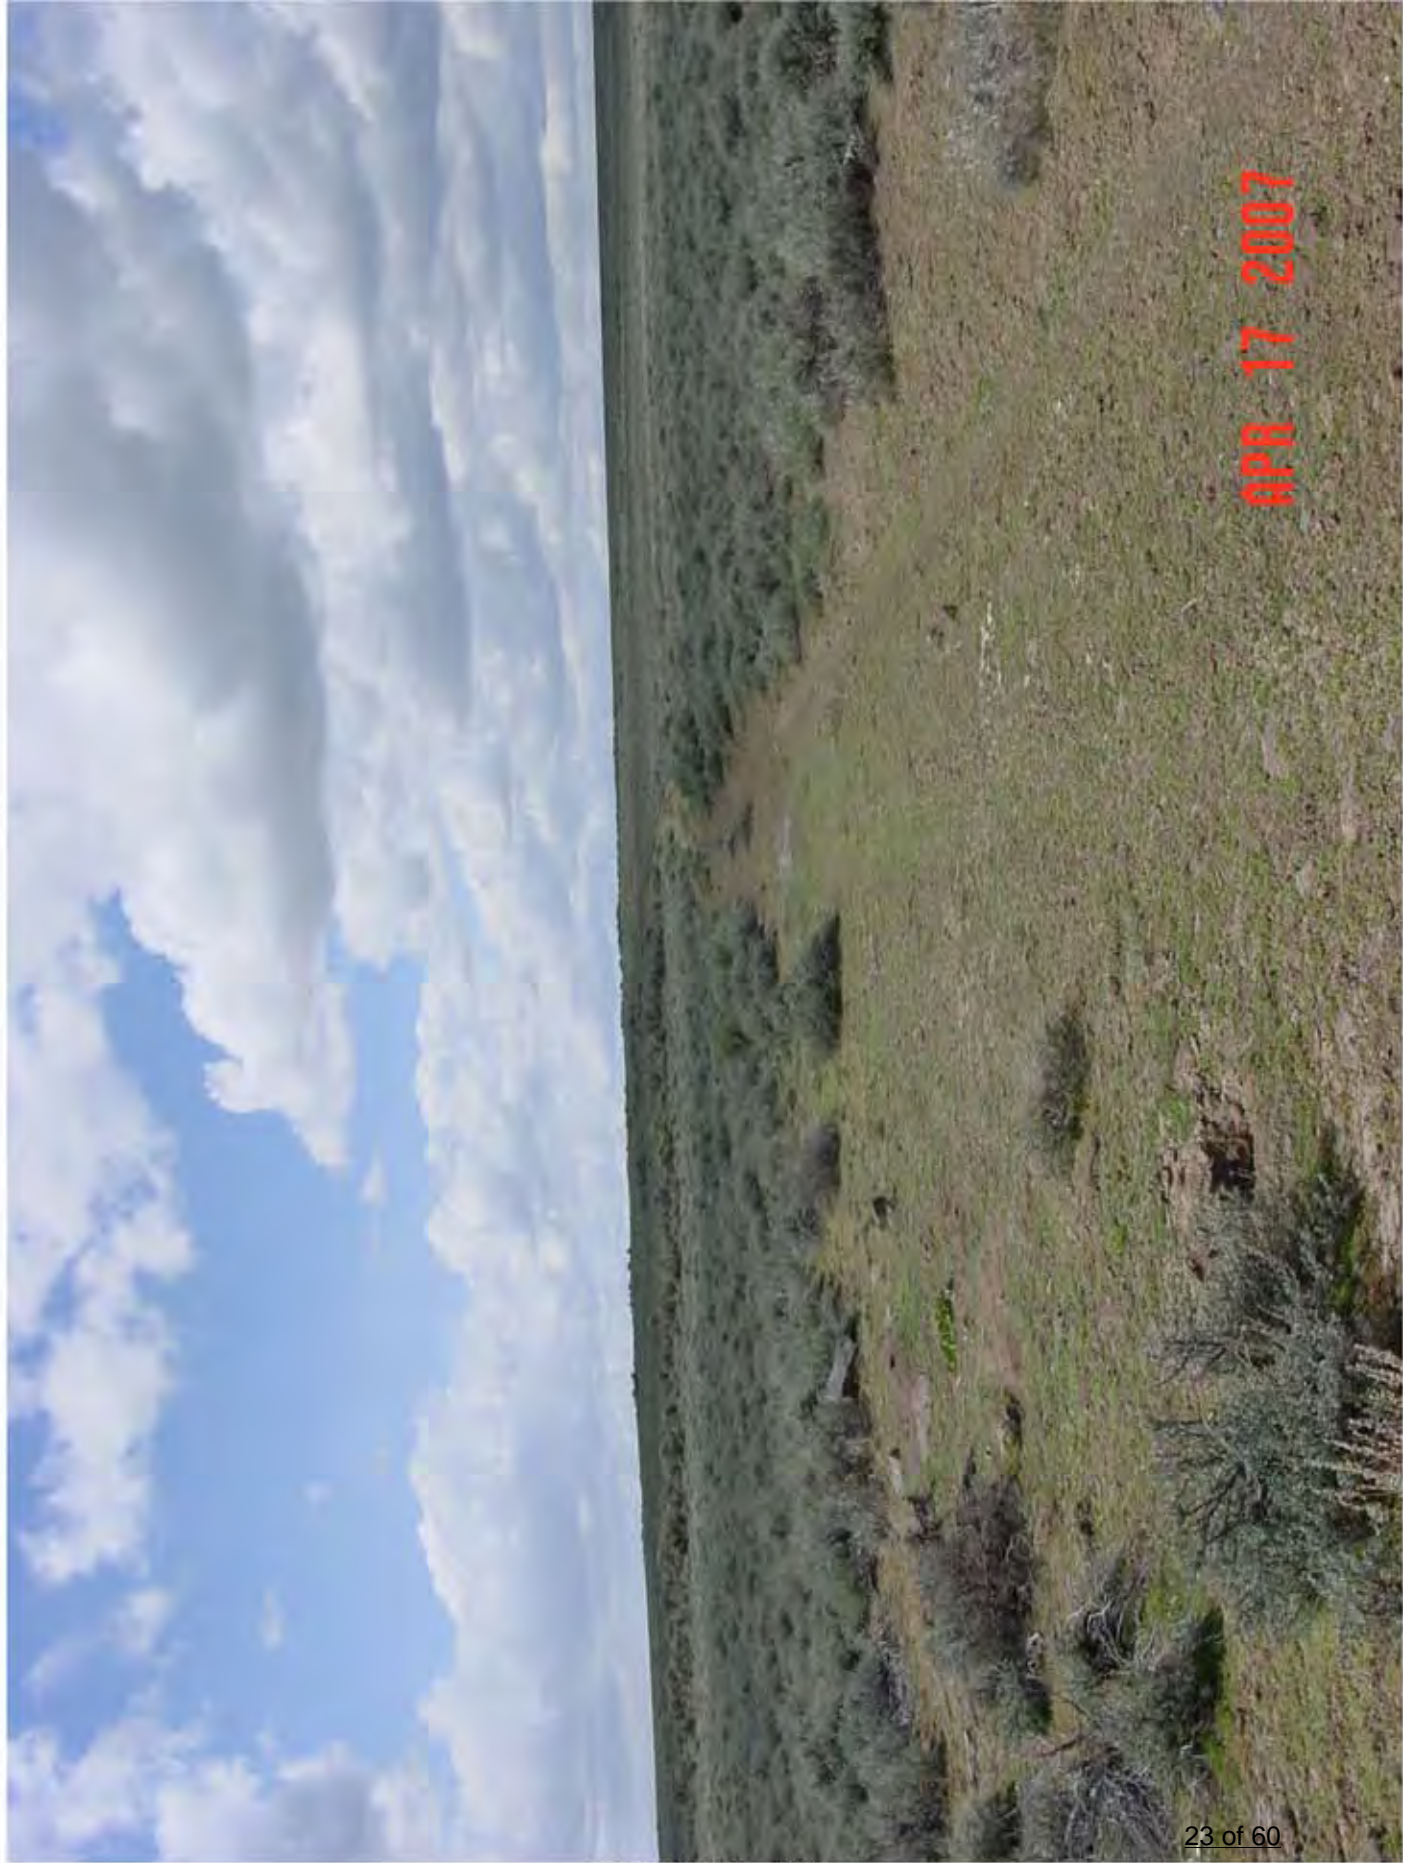
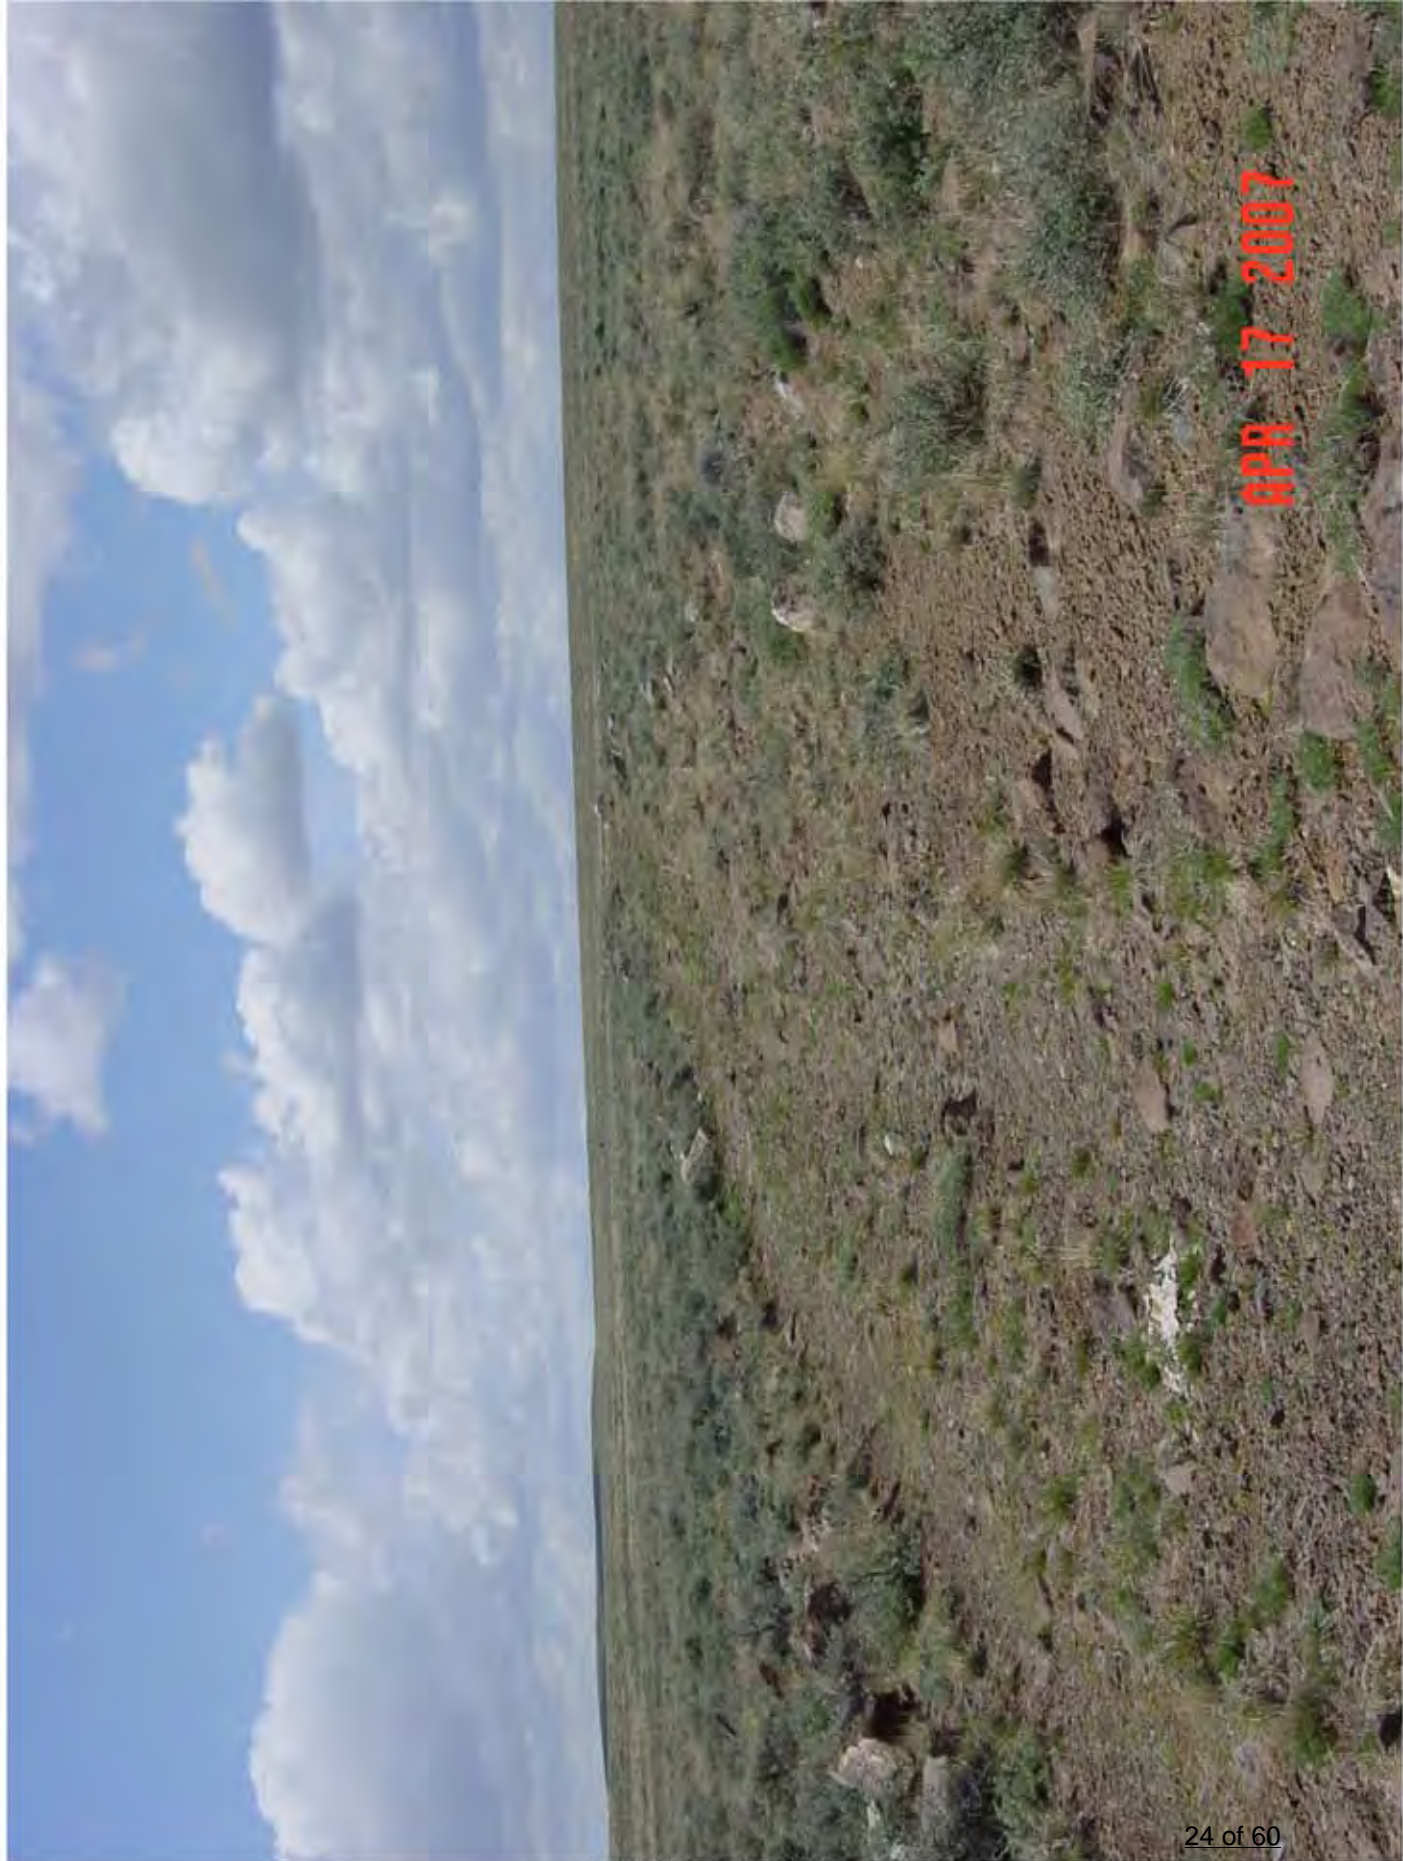
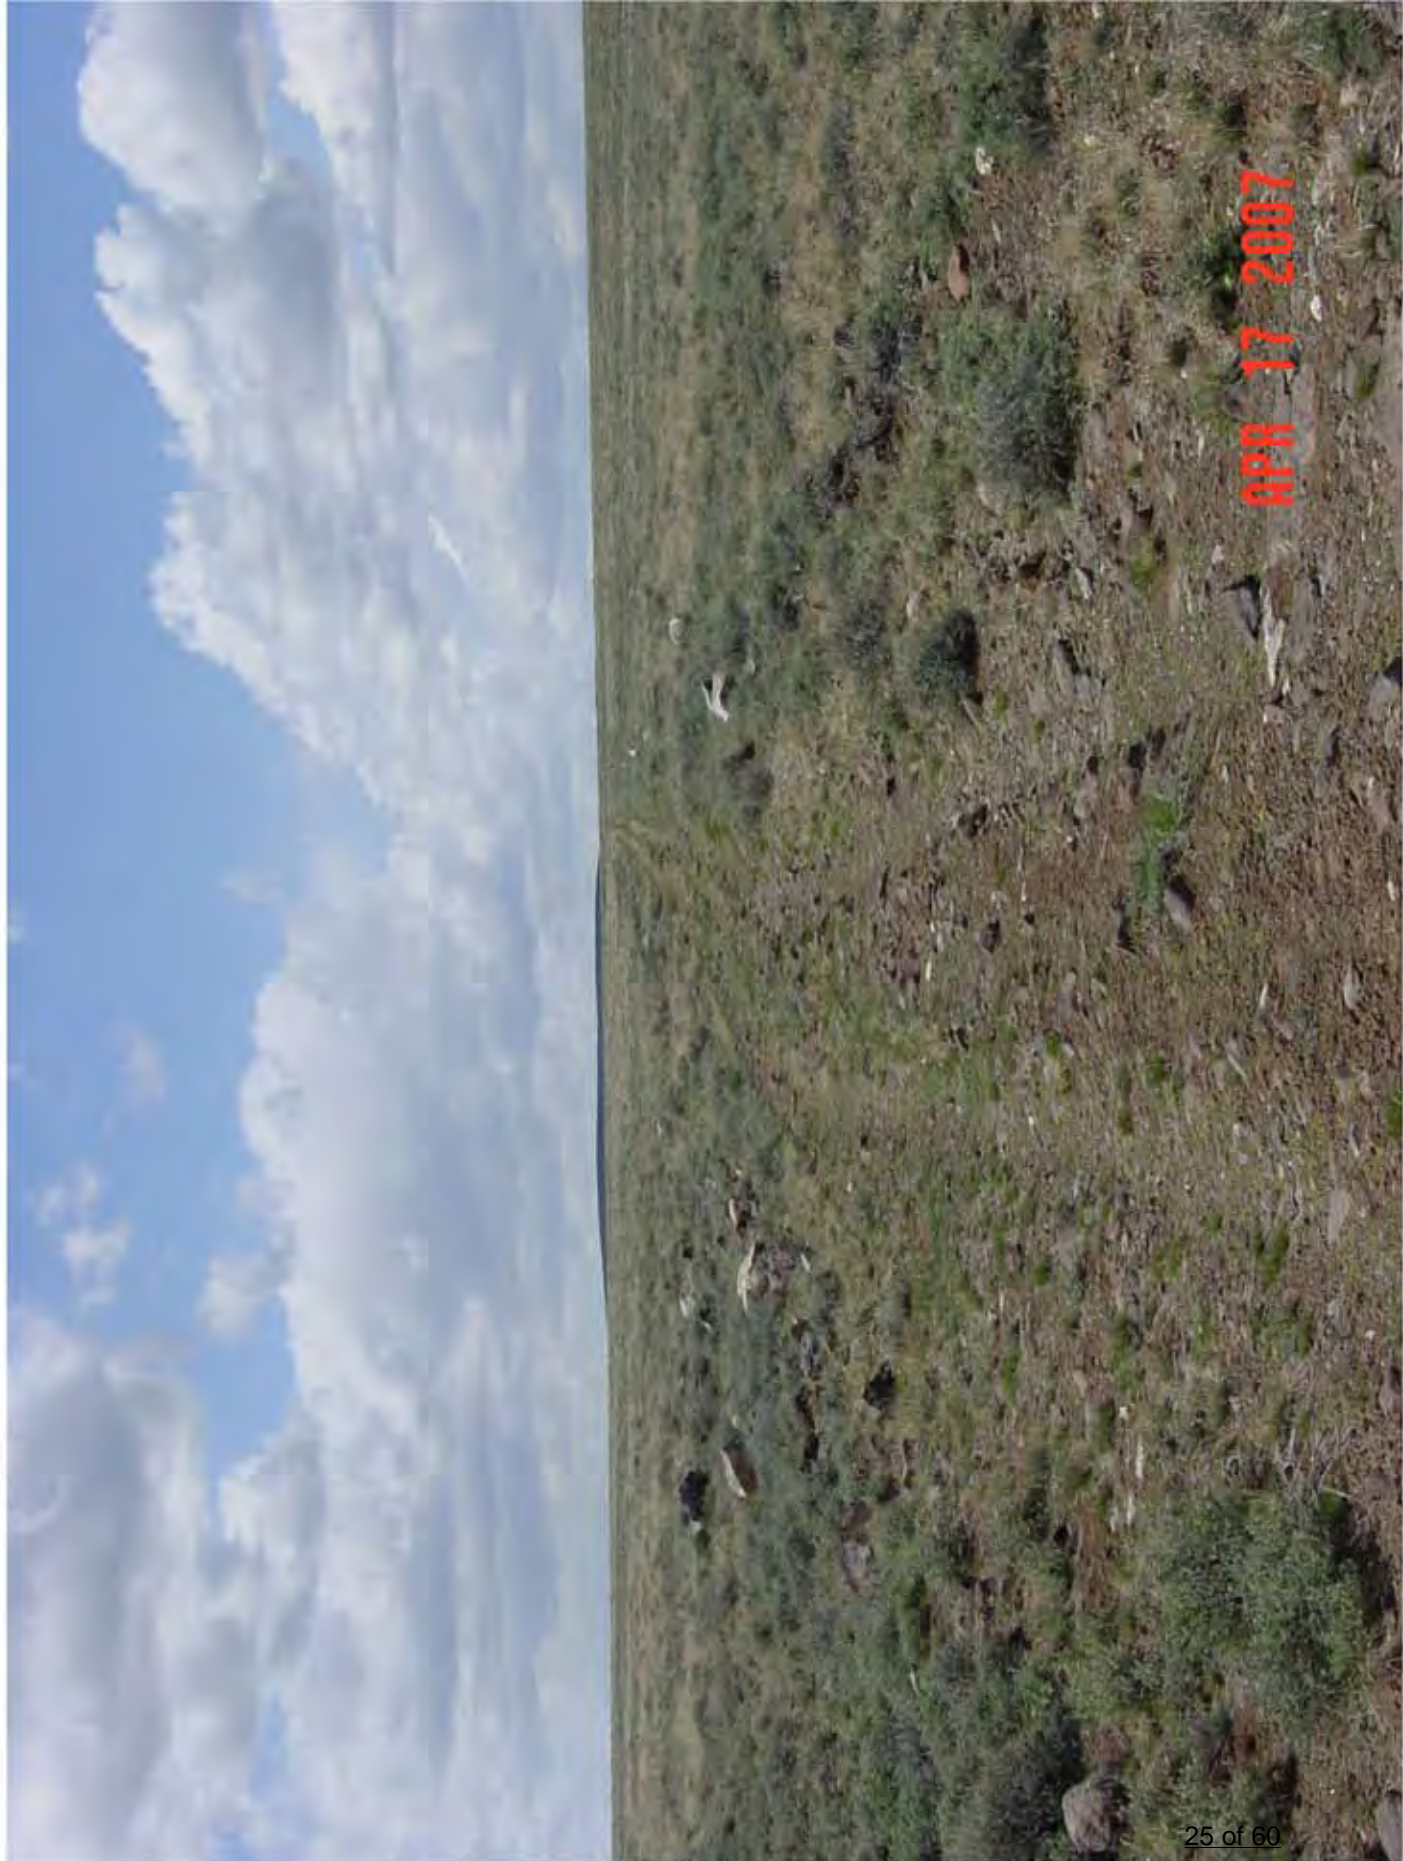
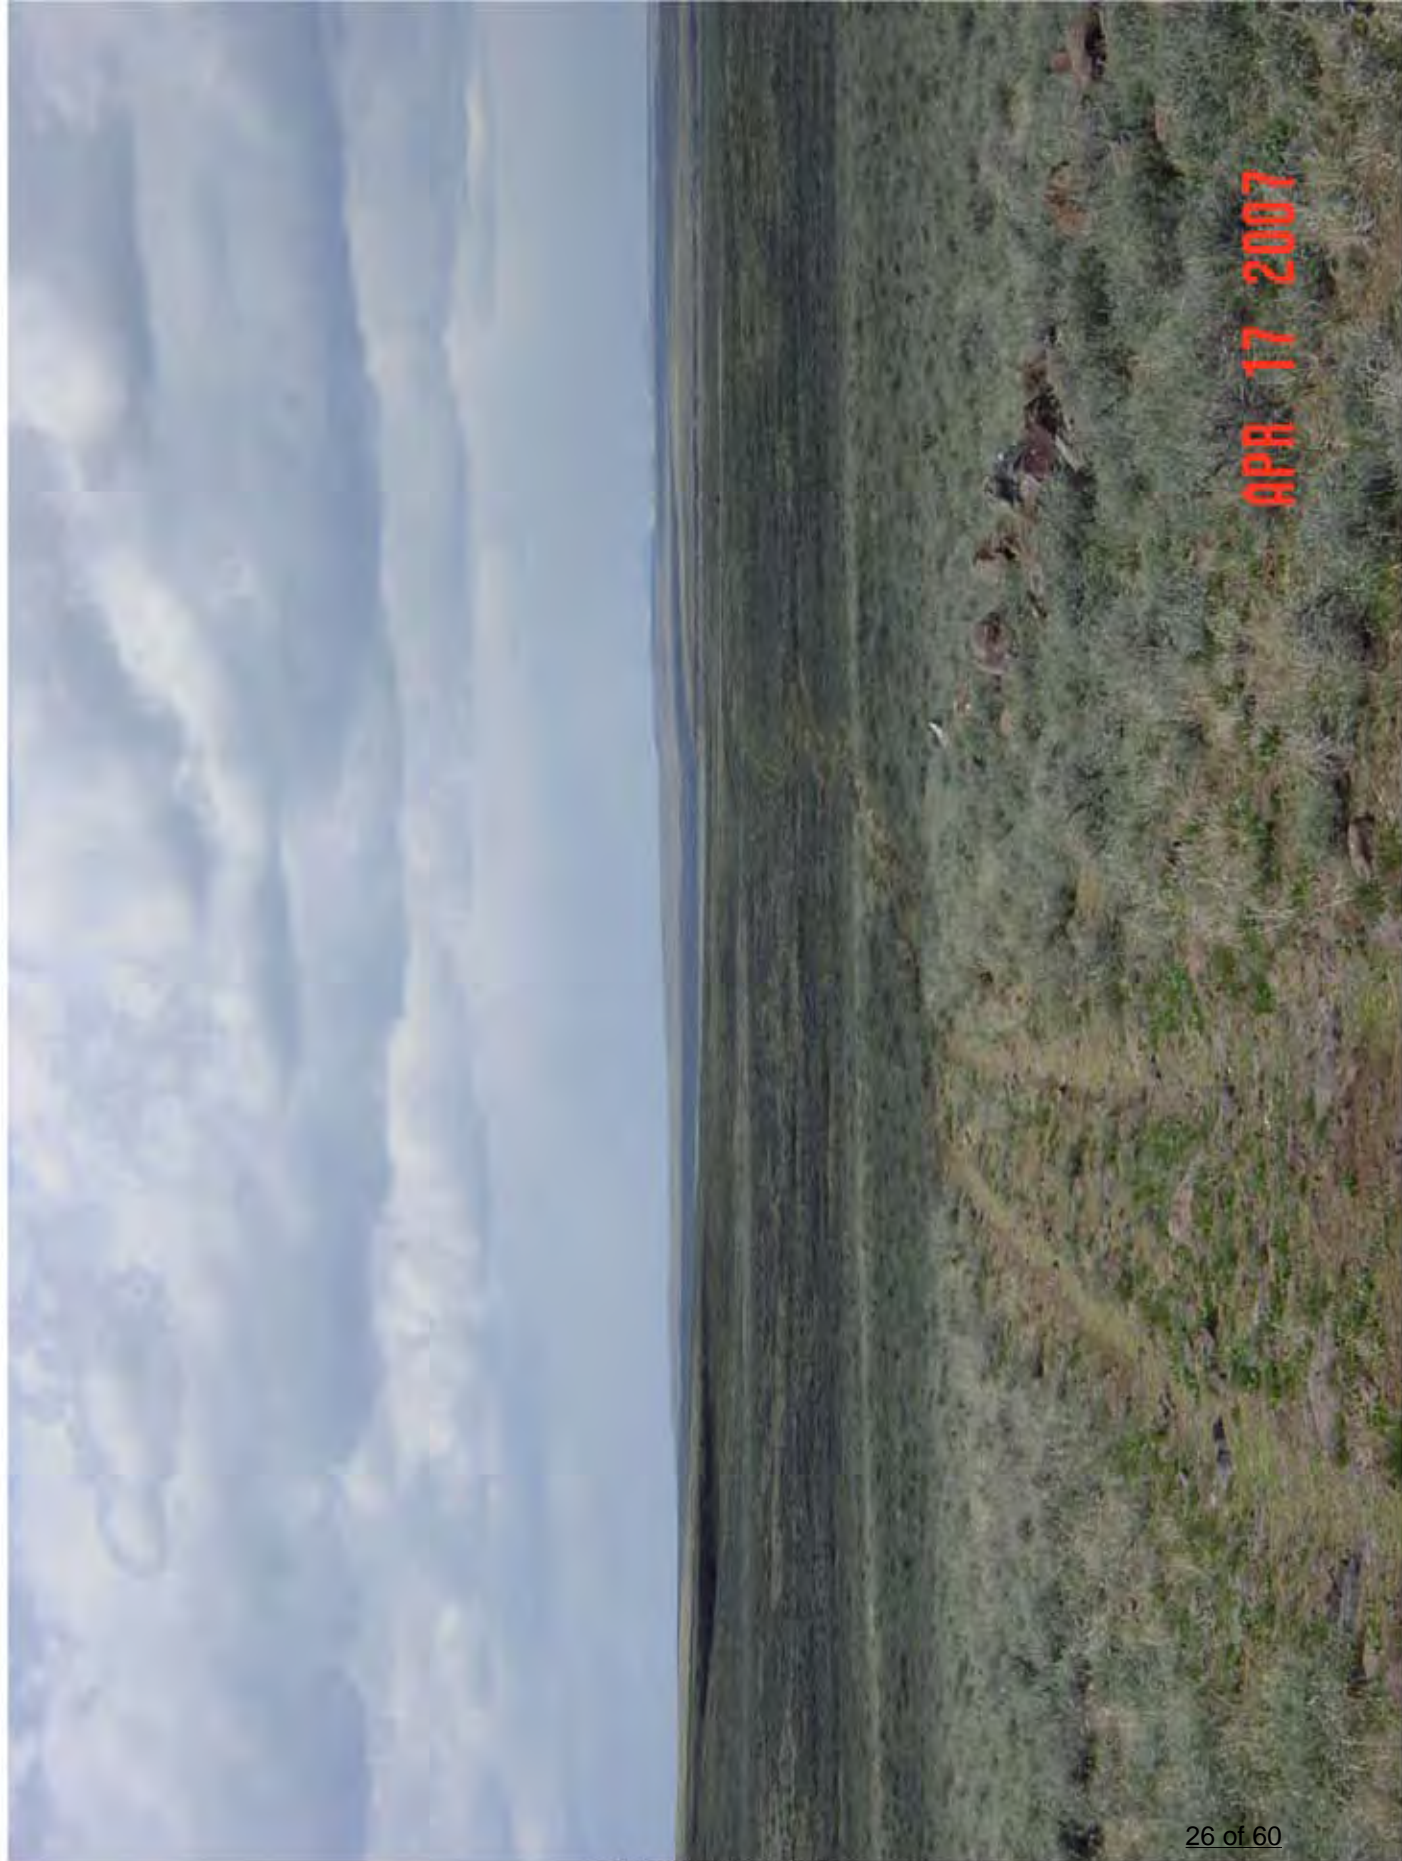
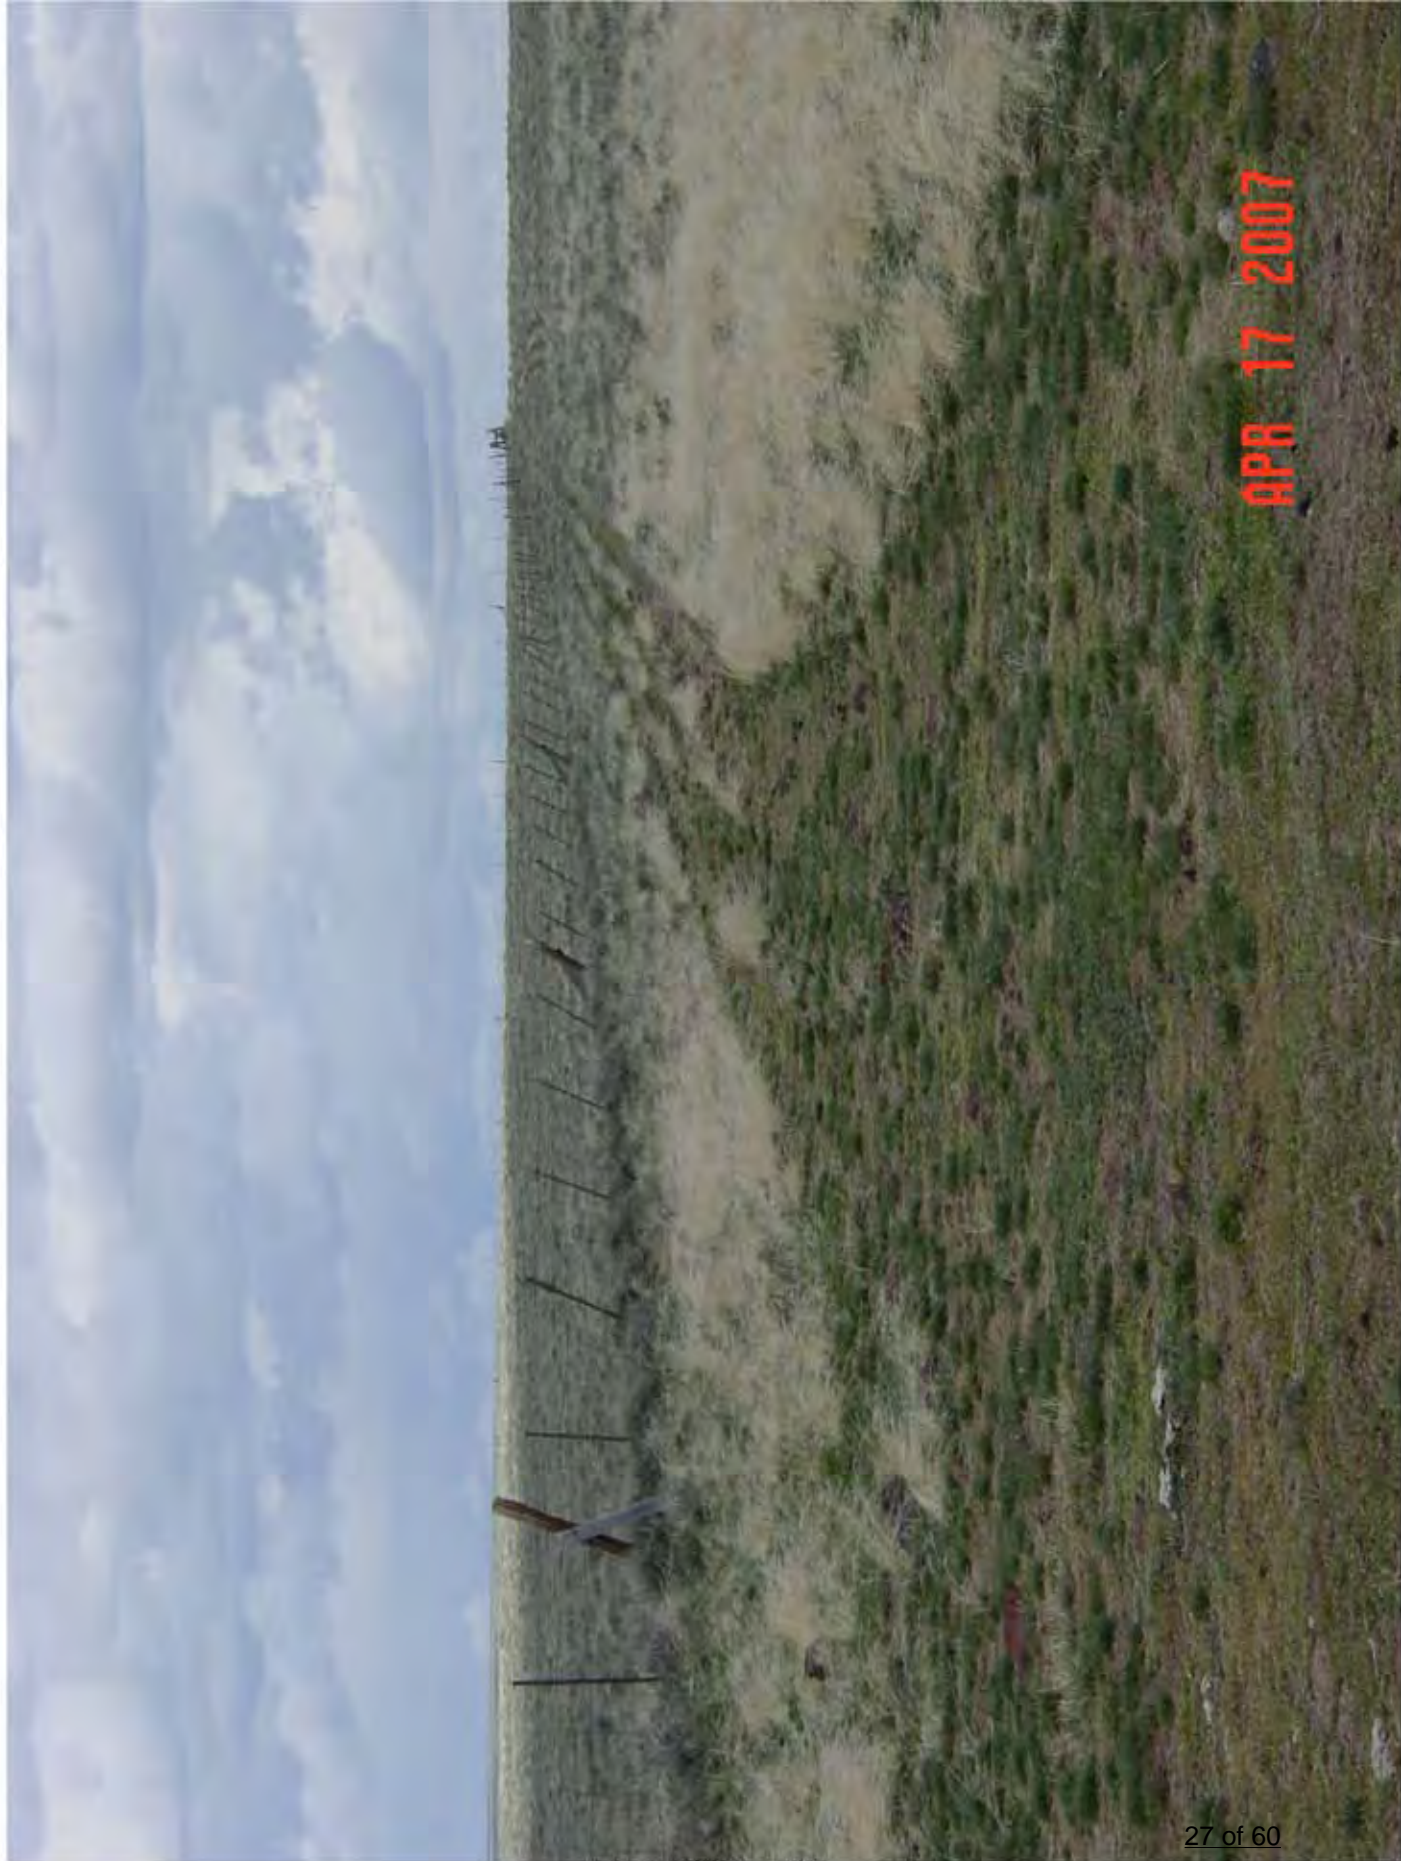
Photographs WA089-WA090 from ONDA, and photo DSC02294 from BLM, show the eastern entrance to BLM road 6354-0-00. The eastern entrance contains a small aircraft landing strip that was developed in the 1960s for flying in personnel and materials to construct rangeland grazing projects as part of the Vale Project. BLM road 6354-0-00 is the northern boundary of this now relic air field. ONDA photograph WA114 and BLM photograph DSC02295 show road 6354-0-00 as it leaves the airstrip to the west. In both photographs the road width and berms can be seen, although vegetation has taken over all but the roadbed itself.

The next set of photographs, ONDA WA116-WA117 and BLM DSC02296, occur about one-half mile to the west of the airstrip. ONDA's WA116 shows a close-up of a small rut about 15 feet in length extending into a low area where water has run onto the road. Information from ONDA's photo log for photograph WA117 indicates that the road has been bladed but not used or maintained. BLM's road 6354-0-00 contains many intermittent areas of rocky soils as shown in ONDA photo WA117, and areas that are essentially void of any rock material as shown in BLM photo DSC02296, taken about 150 yards to the west of photo WA117. Photo WA117 shows a compacted and well-traveled roadbed, whereas photo DSC02296 shows a well compacted mineral roadbed. Requiring maintenance on compacted natural rock or a natural soil roadbed that is passable to virtually all types of vehicles, simply for the sake of appearance does nothing for the road except create new disturbance. As stated previously, over time vegetation has become established within the berms along each side of the roadbed but does nothing to restrict travel on this road. Low-growing vegetation is also present in rocky areas of the road and gives the appearance that the road is not often traveled. A large percentage of this vegetation can be attributed to annual species that flourish in the spring and die off or

are beaten down by traffic over the active use period during late spring, throughout the year into late fall. Most of the remaining series of photographs along BLM road 6354-0-00, both for ONDA and BLM, show variations of rocky and natural soil roadbed with various states of vegetated road berms and lines of boulders on the outer edges of the original bladed berms.

The extreme western extent of road 6354-0-00 in this inventory unit travels across Deer Creek (BLM DSC02304-305, ONDA WA125) which contains sedges and rushes in the drainage. The Deer Creek crossing pictures show that the road is not bladed to mineral soil and contains vegetation. Blading the road across Deer Creek would only disturb the natural growth established in the drainage and would tend to dewater the associated wet meadow species that now persist year-round. This road and roads in the surrounding area are used seasonally after high-water runoff has occurred. Therefore, most low-water crossings, although vegetated, are used when they are drier and less susceptible to damage. Establishing a rocked low-water crossing through the Deer Creek drainage is not needed in most years. Exceptionally wet years extend the time period when these crossings can become damaged.

Explain: Recent maintenance to BLM Road 6354-0-00 is not evident. All photographs show that earthen berms on the edge of the road presently contain some brush encroaching from undisturbed areas outside of the roadbed. Some pictures also show small discontinuous quantities of brush in the center of the roadbed between wheel tracks. Although it has been many years since maintenance was performed on this road, it is evident by the condition of the roadbed in BLM and ONDA photographs that little, if any, maintenance is needed to keep the roadbed in good operational condition. This is

BLM road 6354-0-00 has annual use as evidenced by the lack of brush in most sections of the road and by well-used bare ground where vehicle tires track (BLM photos DSC02294-DSC02300, DSC02302-DSC02305). ONDA's 2004 document (photos WA089-WA090, WA114, WA116-117, WA119-120, WA125) refers to BLM road 6354-0-00 as a way and as not meeting the definition of a road. BLM does not support their decision. The road is well traveled, wide along most of its length, and is clearly defined on the landscape.

DATE	Frame #	Camera Direction	Description	GPS/UTM Location	Township	Range	Section
4/17/2007	DSC02294	SW	Parallel to Tent Creek	477978 4654401	T41S	R46E	Sec 1
4/17/2007	DSC02295	SW	Good Road	477193 4654113	T41S	R46E	Sec 2
4/17/2007	DSC02296	W	Berms	475720 465394	T41S	R46E	Sec 2
4/17/2007	DSC02297	W	Berms	473446 465394	T41S	R46E	Sec 3
4/17/2007	DSC02298	W	Visible tracks	472504 4653311	T41S	R46E	Sec 4
4/17/2007	DSC02300	W	Visible road	472191 4653355	T41S	R46E	Sec 5
4/17/2007	DSC02301	N	Up fenceline	471546 4653529	T41S	R46E	Sec 5
4/17/2007	DSC02302	W	Into next pasture	471546 4653529	T41S	R46E	Sec 5
4/17/2007	DSC02303	W	Visible road	471066 4653721	T41S	R46E	Sec 6
4/17/2007	DSC02304	S	Into Deer Creek	466105 4653799	T41S	R45E	Sec 1
