Louse Canyon Wilderness Inventory Unit Index of Documents
Cairn C OR-036-003, 60 total pages

Inventory Unit Name/Number: Cairn C OR-036-003

Wilderness Inventory Area Name and Number (Unit ID): Boundary road between BLM Twin Butte OR-036-002 and Cairn C OR-036-003

Cairn C OR-036-003 Andy Fife Road 6354-0-00

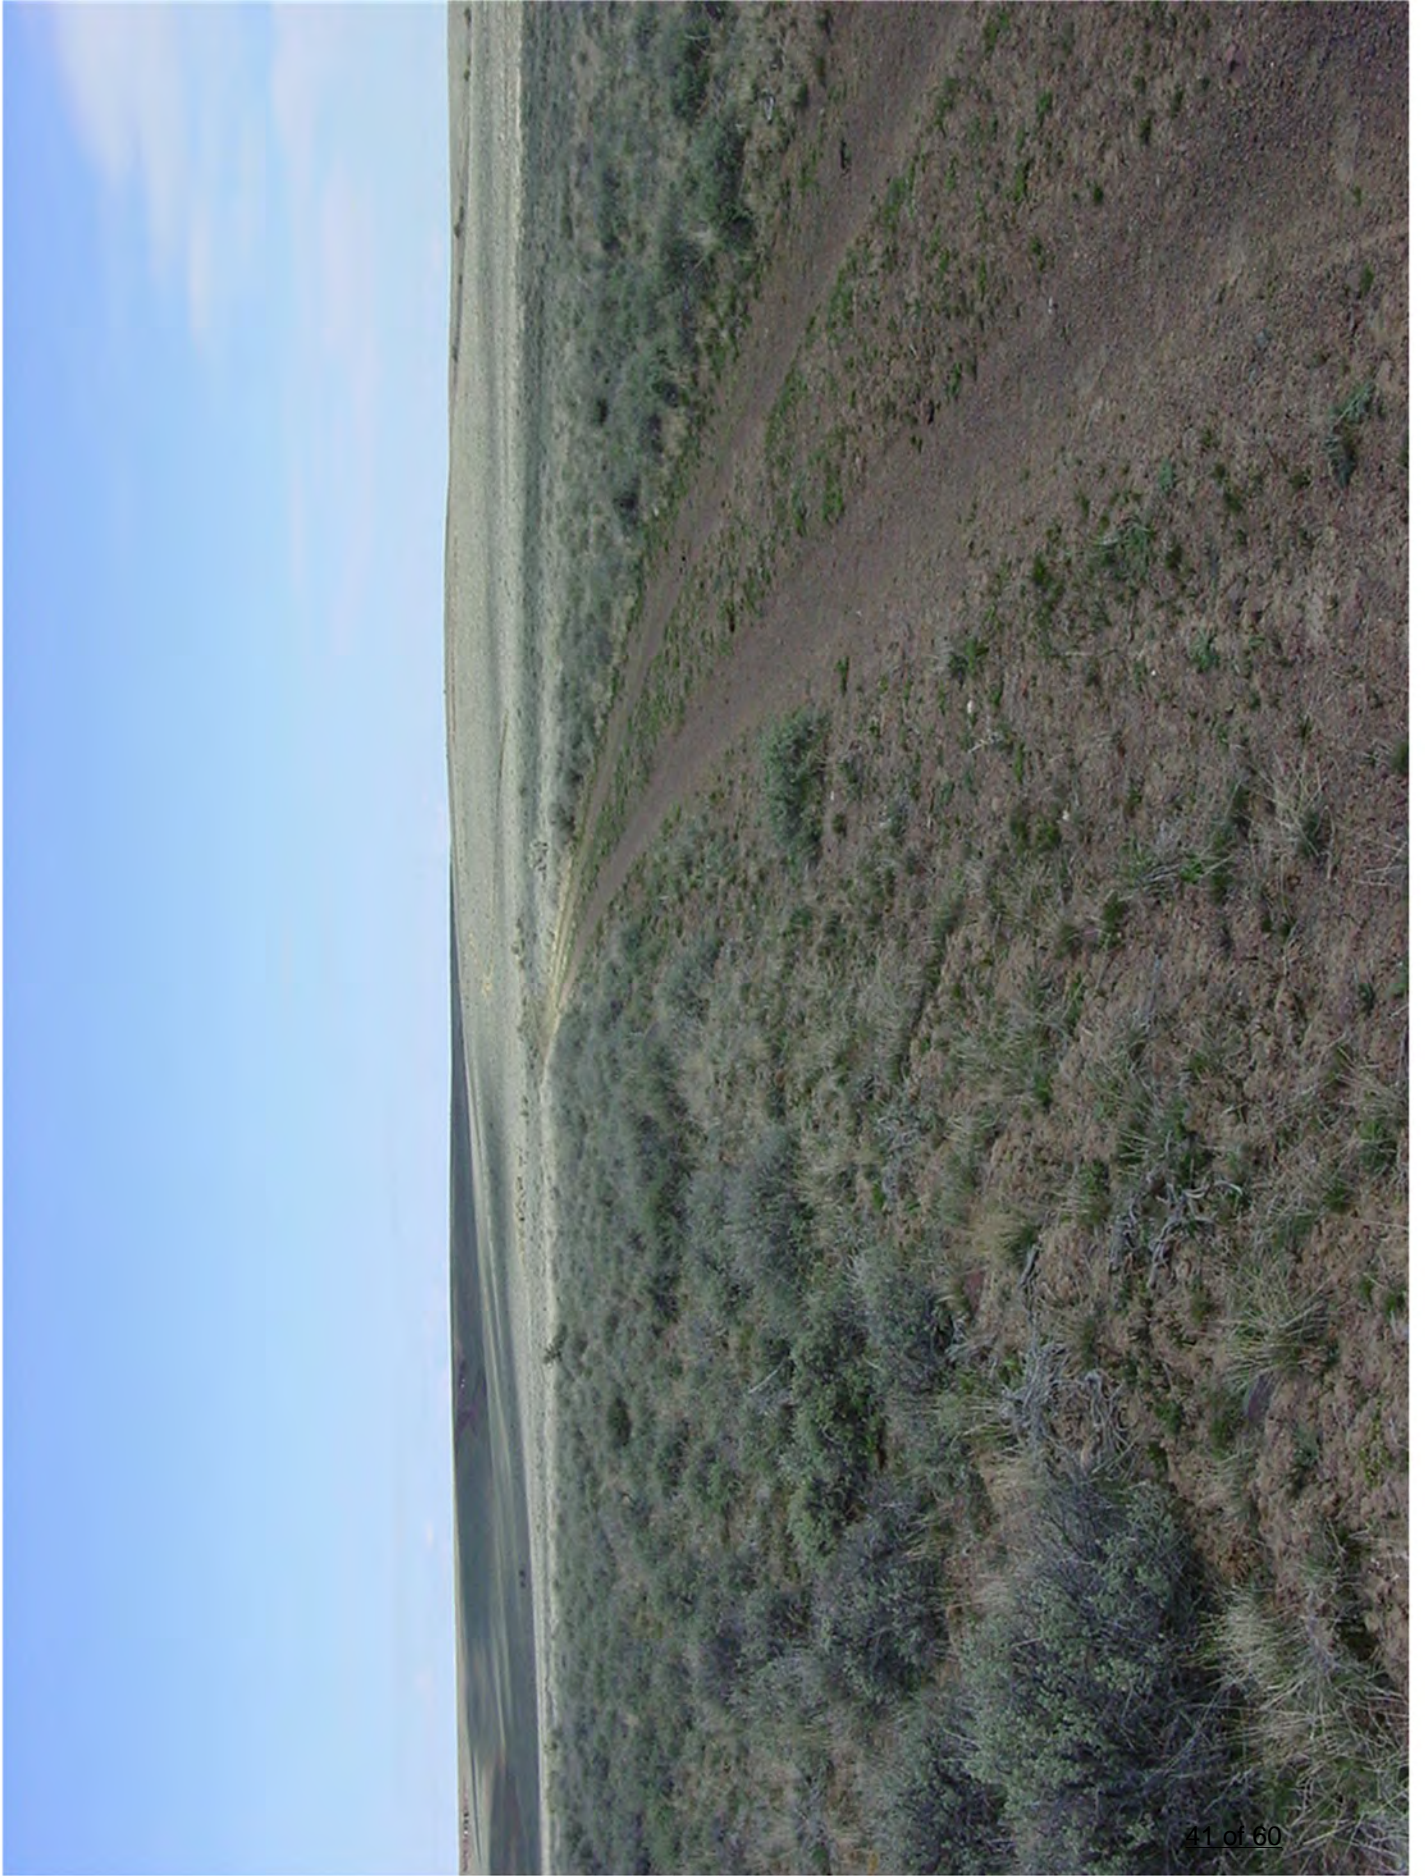
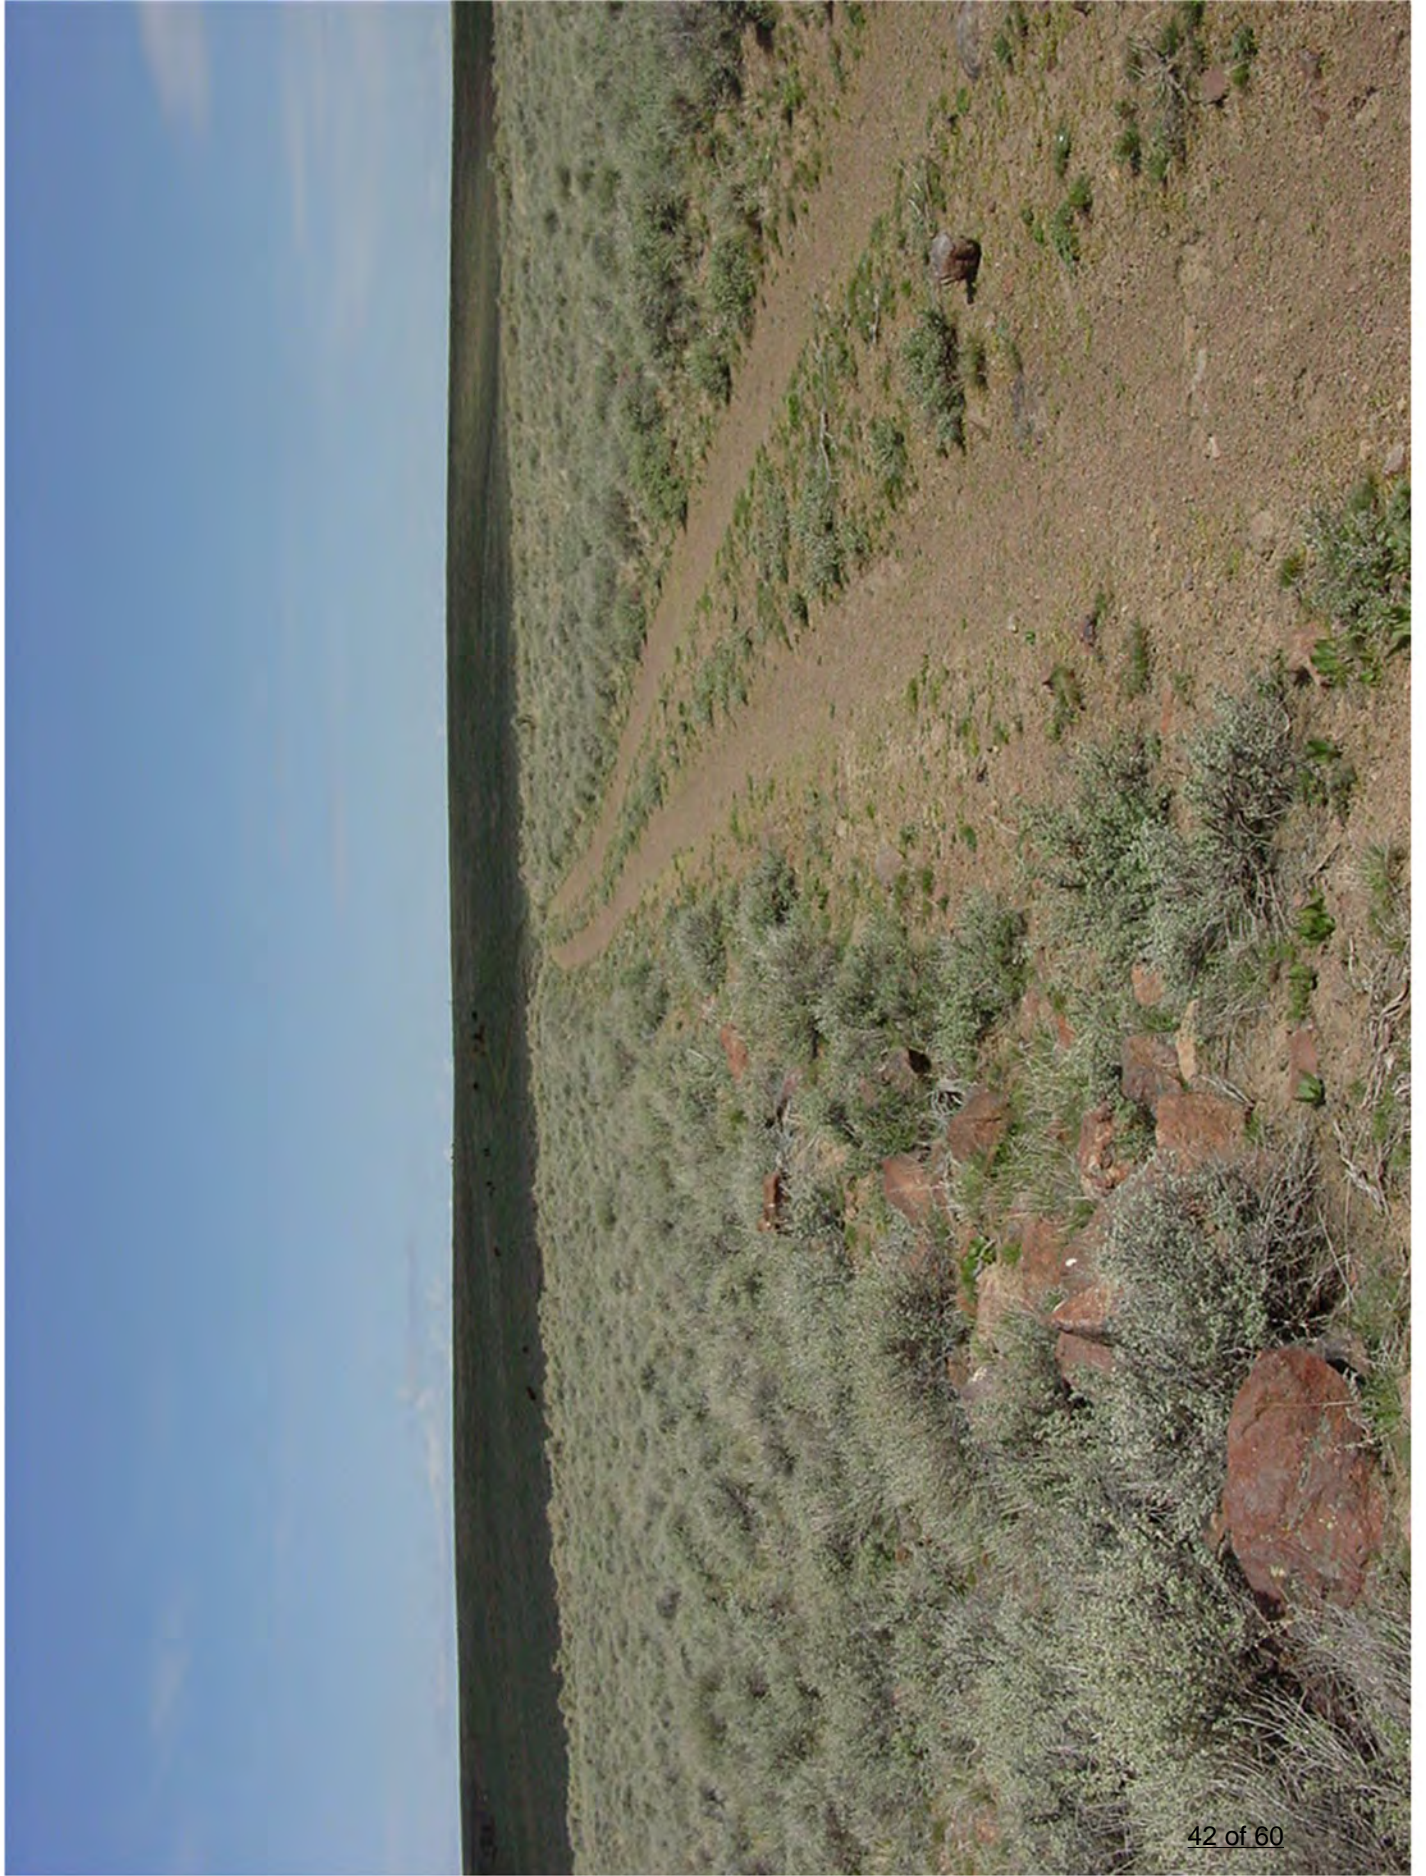
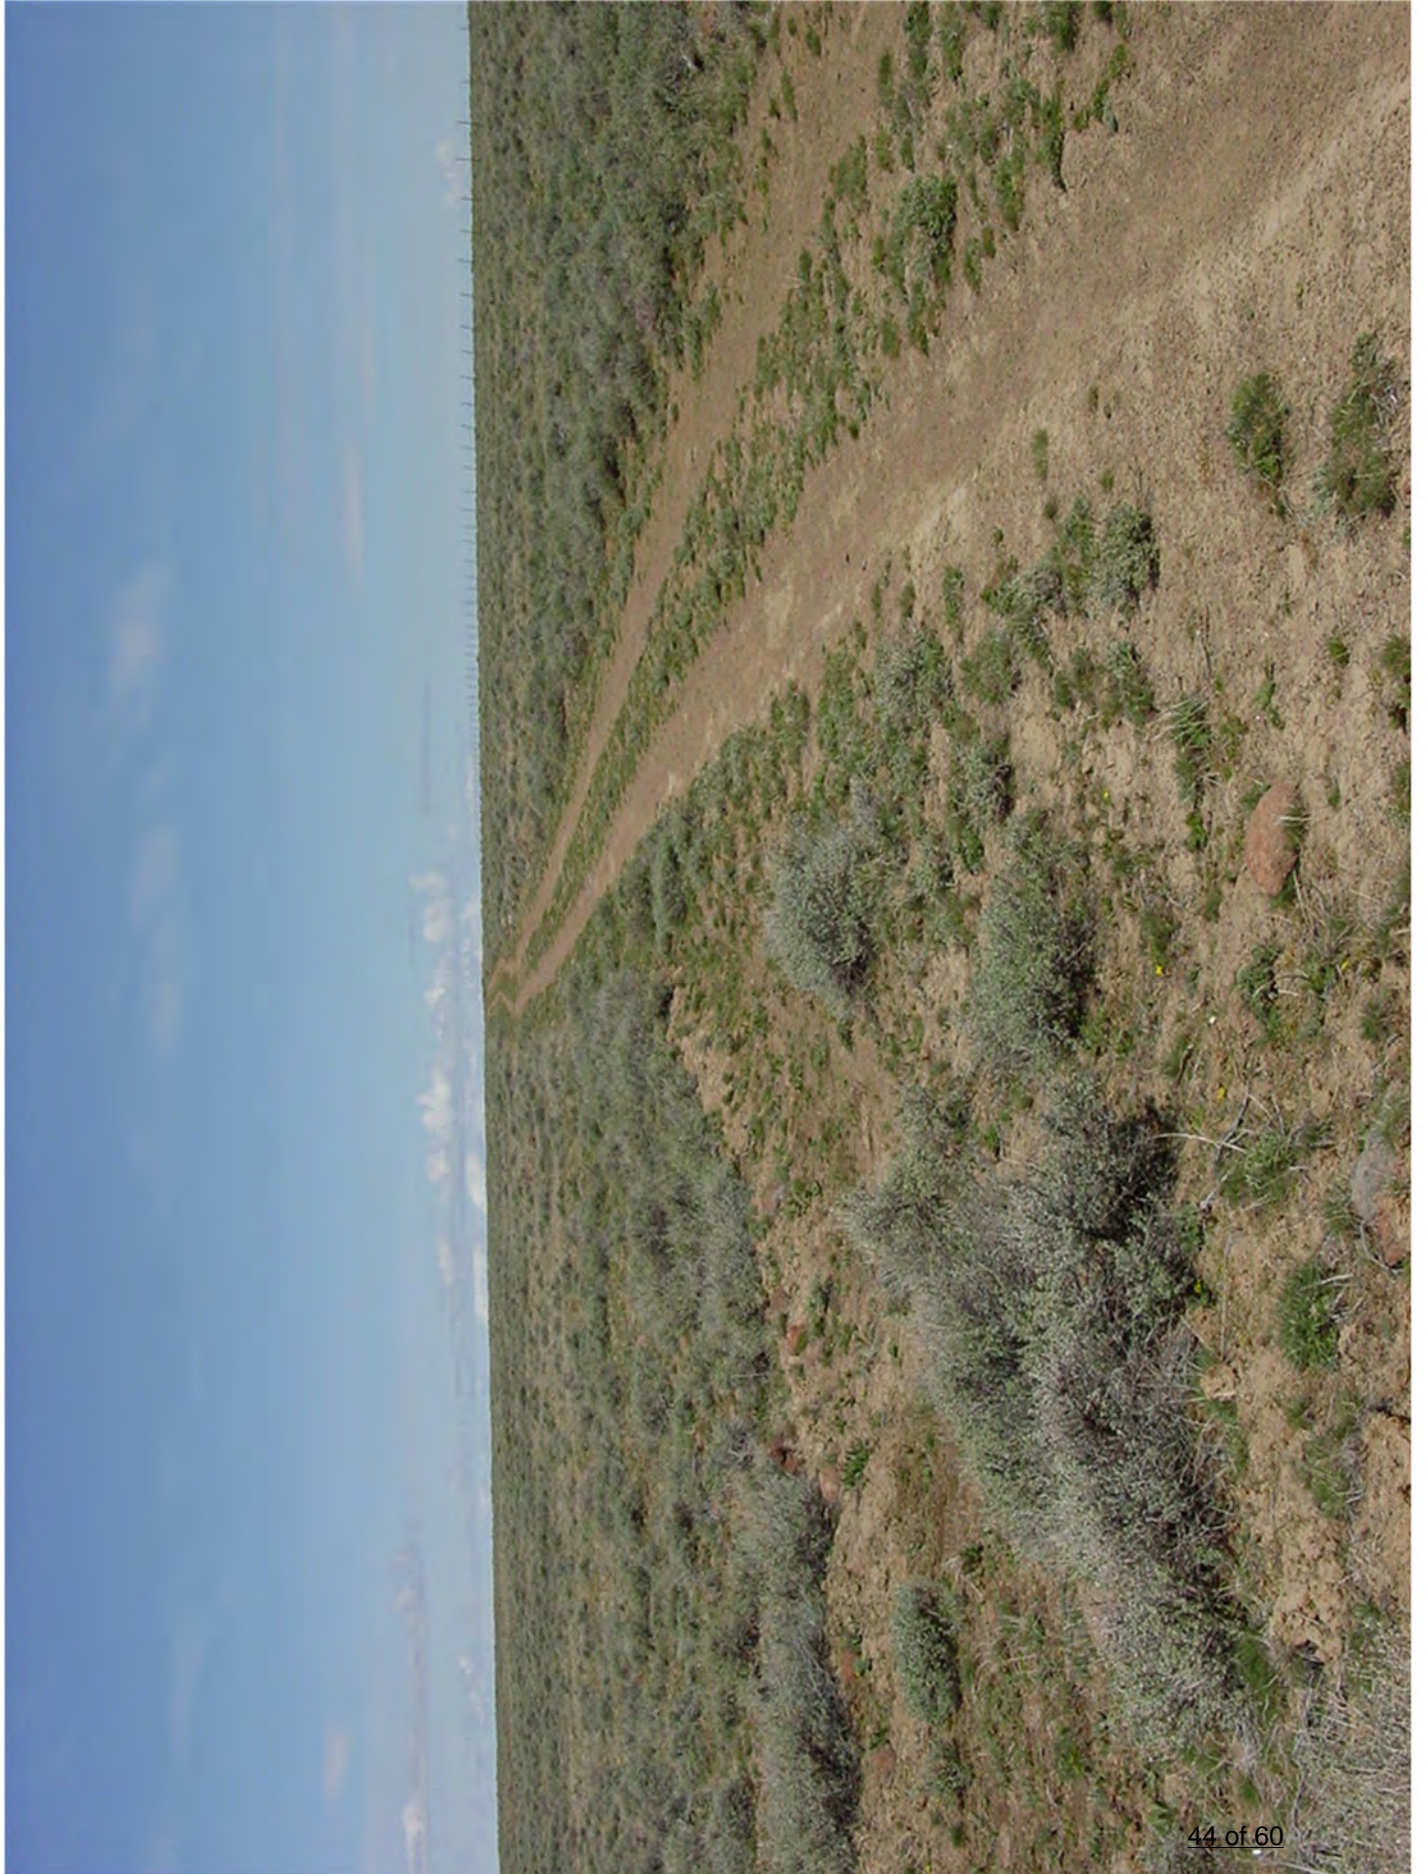
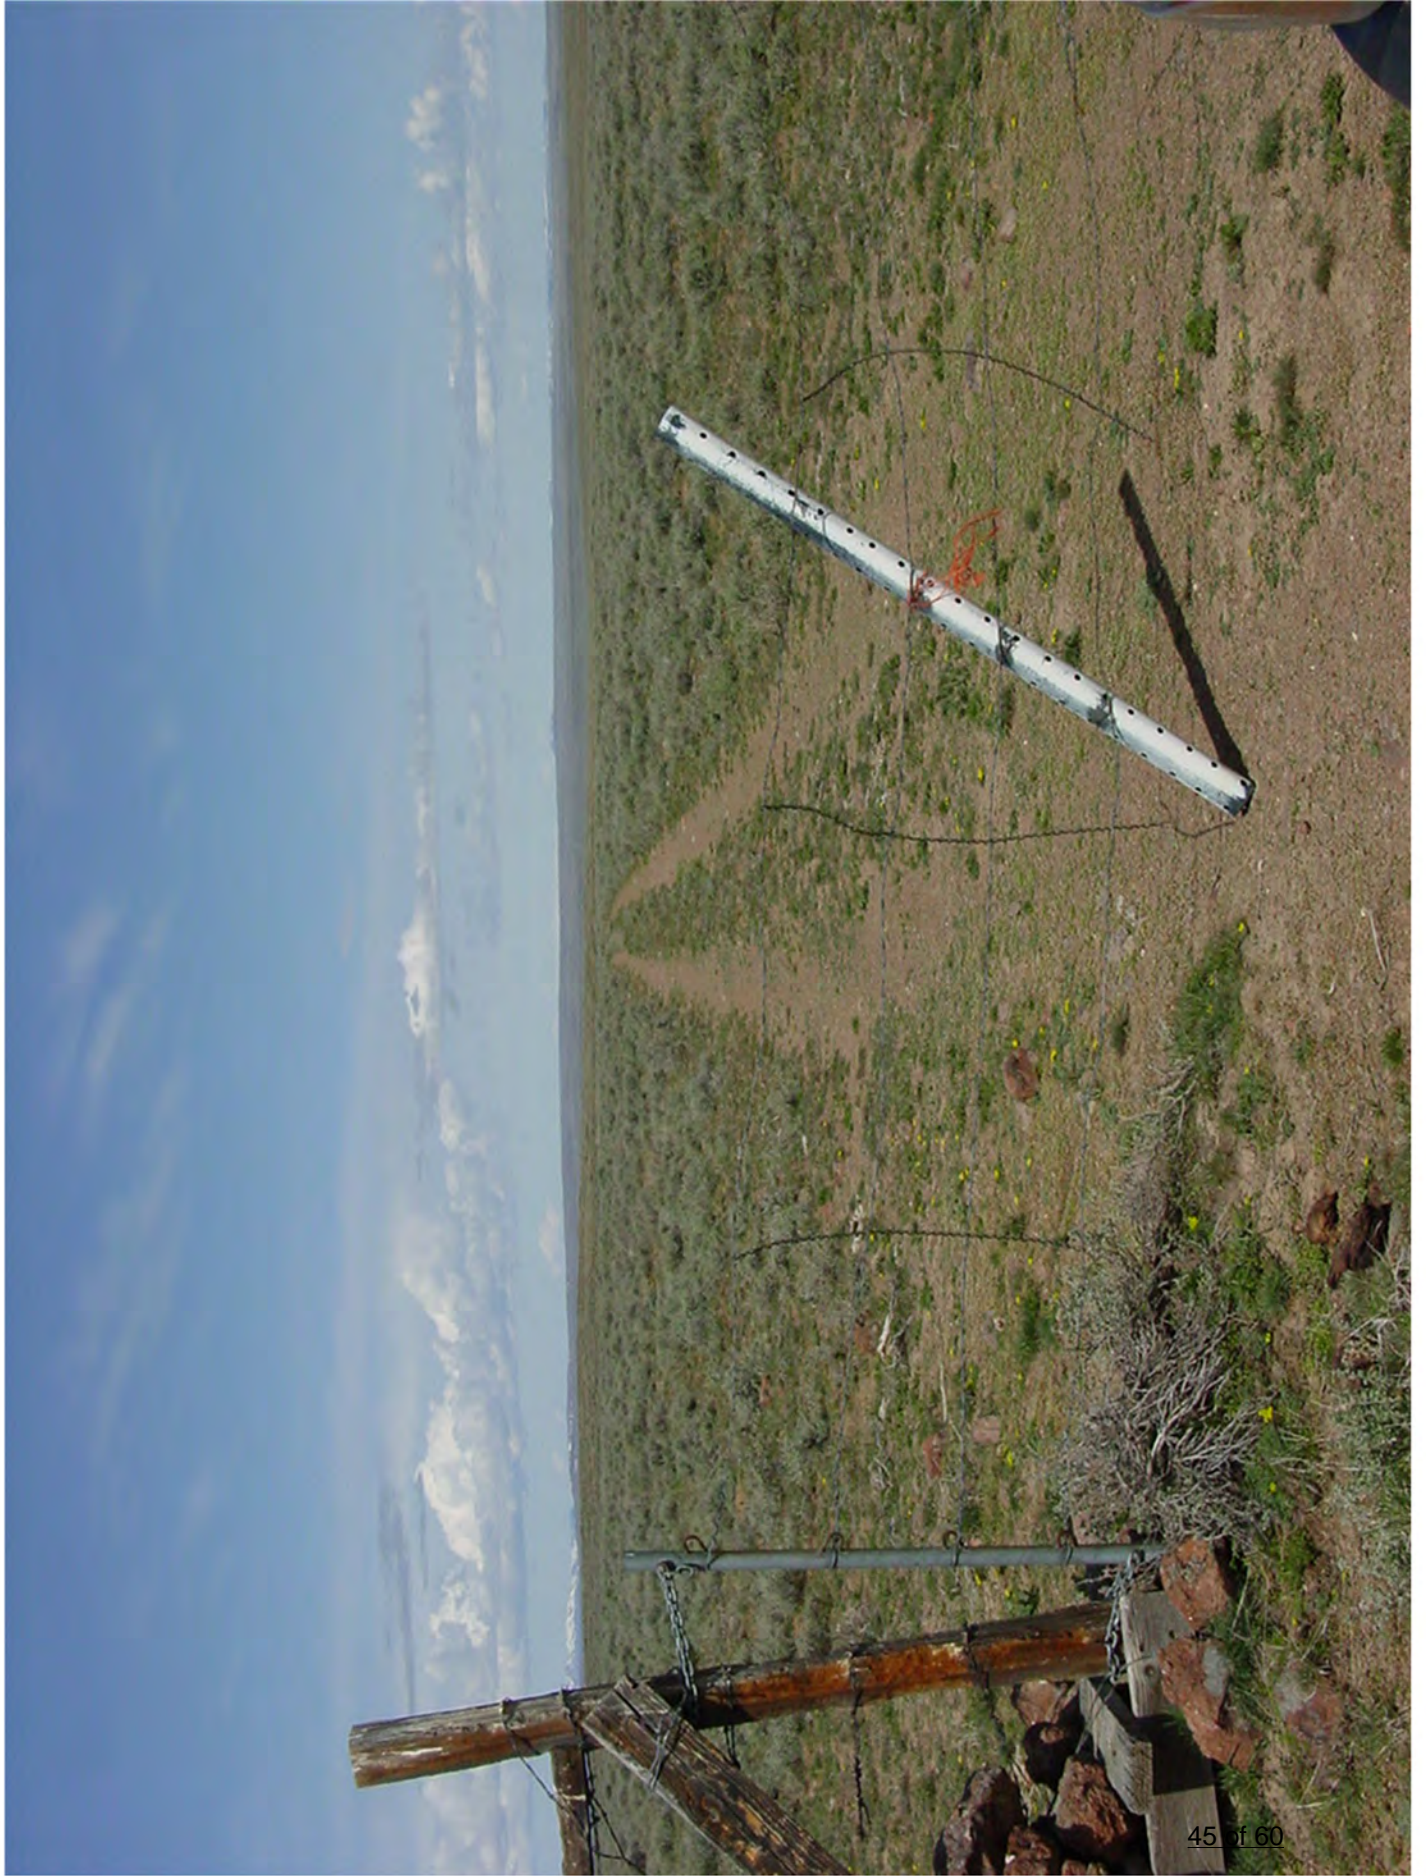
Explain: Maintenance to BLM road 8300-6-01 has been conducted over time as needed to keep this route passable. Earthen berms, water bars, and drainage turnouts on the edge of the road in photographs DSC02308, DSC02310-312, DSC02316-DSC02324, DSC02537-DSC02545, and DSC02547-DSC02549 show maintenance work that has been performed on this road. Although it has been many years since maintenance has been performed on the entire road it is evident from photographs BLM has taken, that little to no maintenance is needed to keep the roadbed in good operational condition.

Comments: BLM road 8300-6-01 receives annual use, as evidence by the lack of brush in the road and by well-used bare ground where vehicles travel. It should be noted that small amounts of low brush occur sporadically throughout the length of the road. To reduce the potential for erosion and the establishment of invasive plant and weed species, BLM emphasizes minimal ground disturbance for road construction and maintenance, through

9/11/2007	DSC02539	N	Visible	467422	T41S	R46E	Sec 12

Road	4651238			
9/11/2007	DSC02540	N	In Creek bottom	467368 4651453	T41S	R46E	Sec 13
9/11/2007	DSC02541	N	In Bottom	467422 4651363	T41S	R46E	Sec 13
9/11/2007	DSC02542	N	Visible road	467297 4651453	T41S	R46E	Sec 13
9/11/2007	DSC02543	N	Along bottom	467137 4652167	T41S	R46E	Sec13
9/11/2007	DSC02544	N	Along bottom	467154 4652327	T41S	R46E	Sec 13
9/11/2007	DSC02545	N	Road continues	467065 4652506	T41S	R46E	Sec 13
9/11/2007	DSC02547	N	Road continues	467137 4652505	T41S	R46E	Sec 13
9/11/2007	DSC02548	N	Crossing	466922 4652791	T41S	R46E	Sec 13
9/11/2007	DSC02549	N	Junction	466940 4652827	T41S	R46E	Sec 13
