Louse Canyon Wilderness Inventory Unit Index of Documents
Coyote Wells OR-036-015, 31 total pages

Pages 20-31: H-6300-1-Wilderness Inventory Maintenance in BLM Oregon/Washington Appendix D – Photo Log and Photos for Inventory Areas: Coyote Wells OR-036-015 and Twin Springs Road 6357-0-C0

Wilderness Inventory Area Name and Number (Unit ID): Boundary road between BLM Coyote Wells OR-036-015, Hanson Canyon OR-036-016, and Owyhee Canyon WSA

Route Name and/or Identifier: Twin Springs Road/6357-0-C0; Mouse Trap Butte proposed WSA Addition TF17c,TF21a,TF21d,TF24

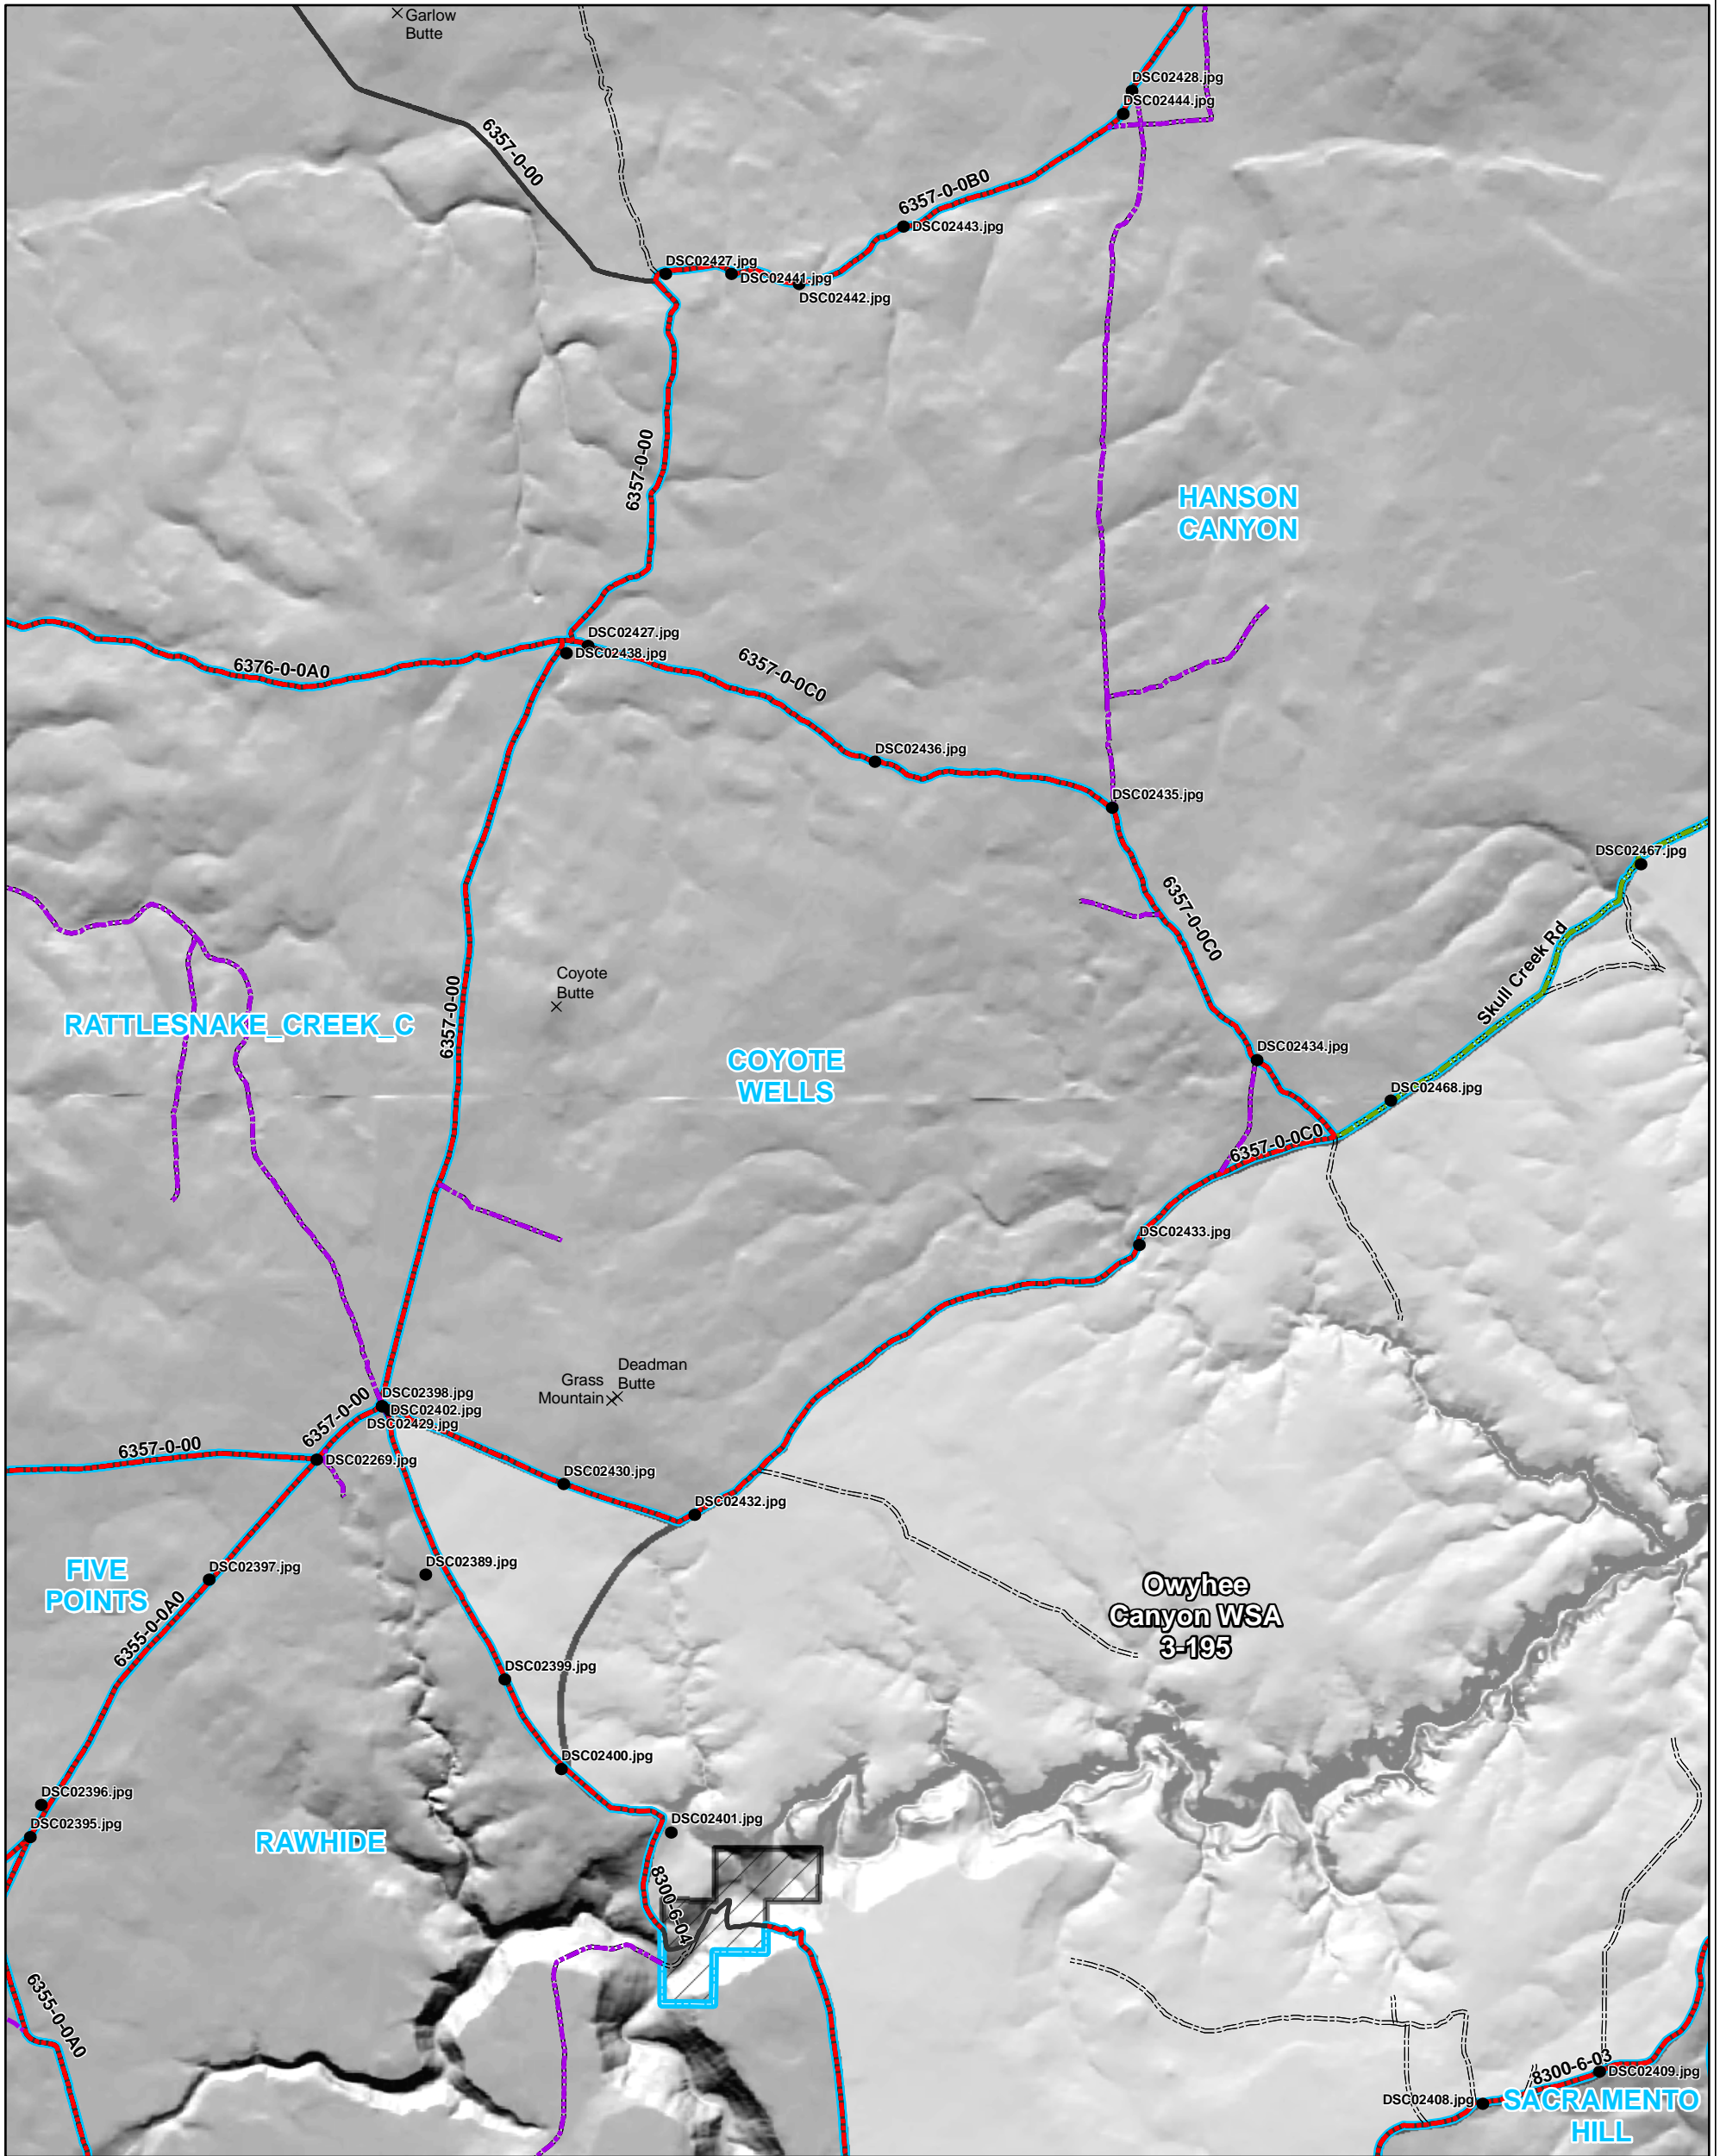
COYOTE WELLS
OR-036-015
ACRES: 7147

The boundaries of unit OR-036-015 are identified as BLM road 6357-0-00 on the west, and BLM road 6357-0-C0 on the north, east, and south. The unit is surrounded by 13.9 miles of boundary roads. Periodic maintenance of the boundary roads has occurred in the past (no confirmed dates available) and they are used regularly by ranchers (as observed by current BLM staff) and BLM employees for livestock management. Refer to map 2007_Coyote_Wells_OR_036_015.pdf for the unit boundary.

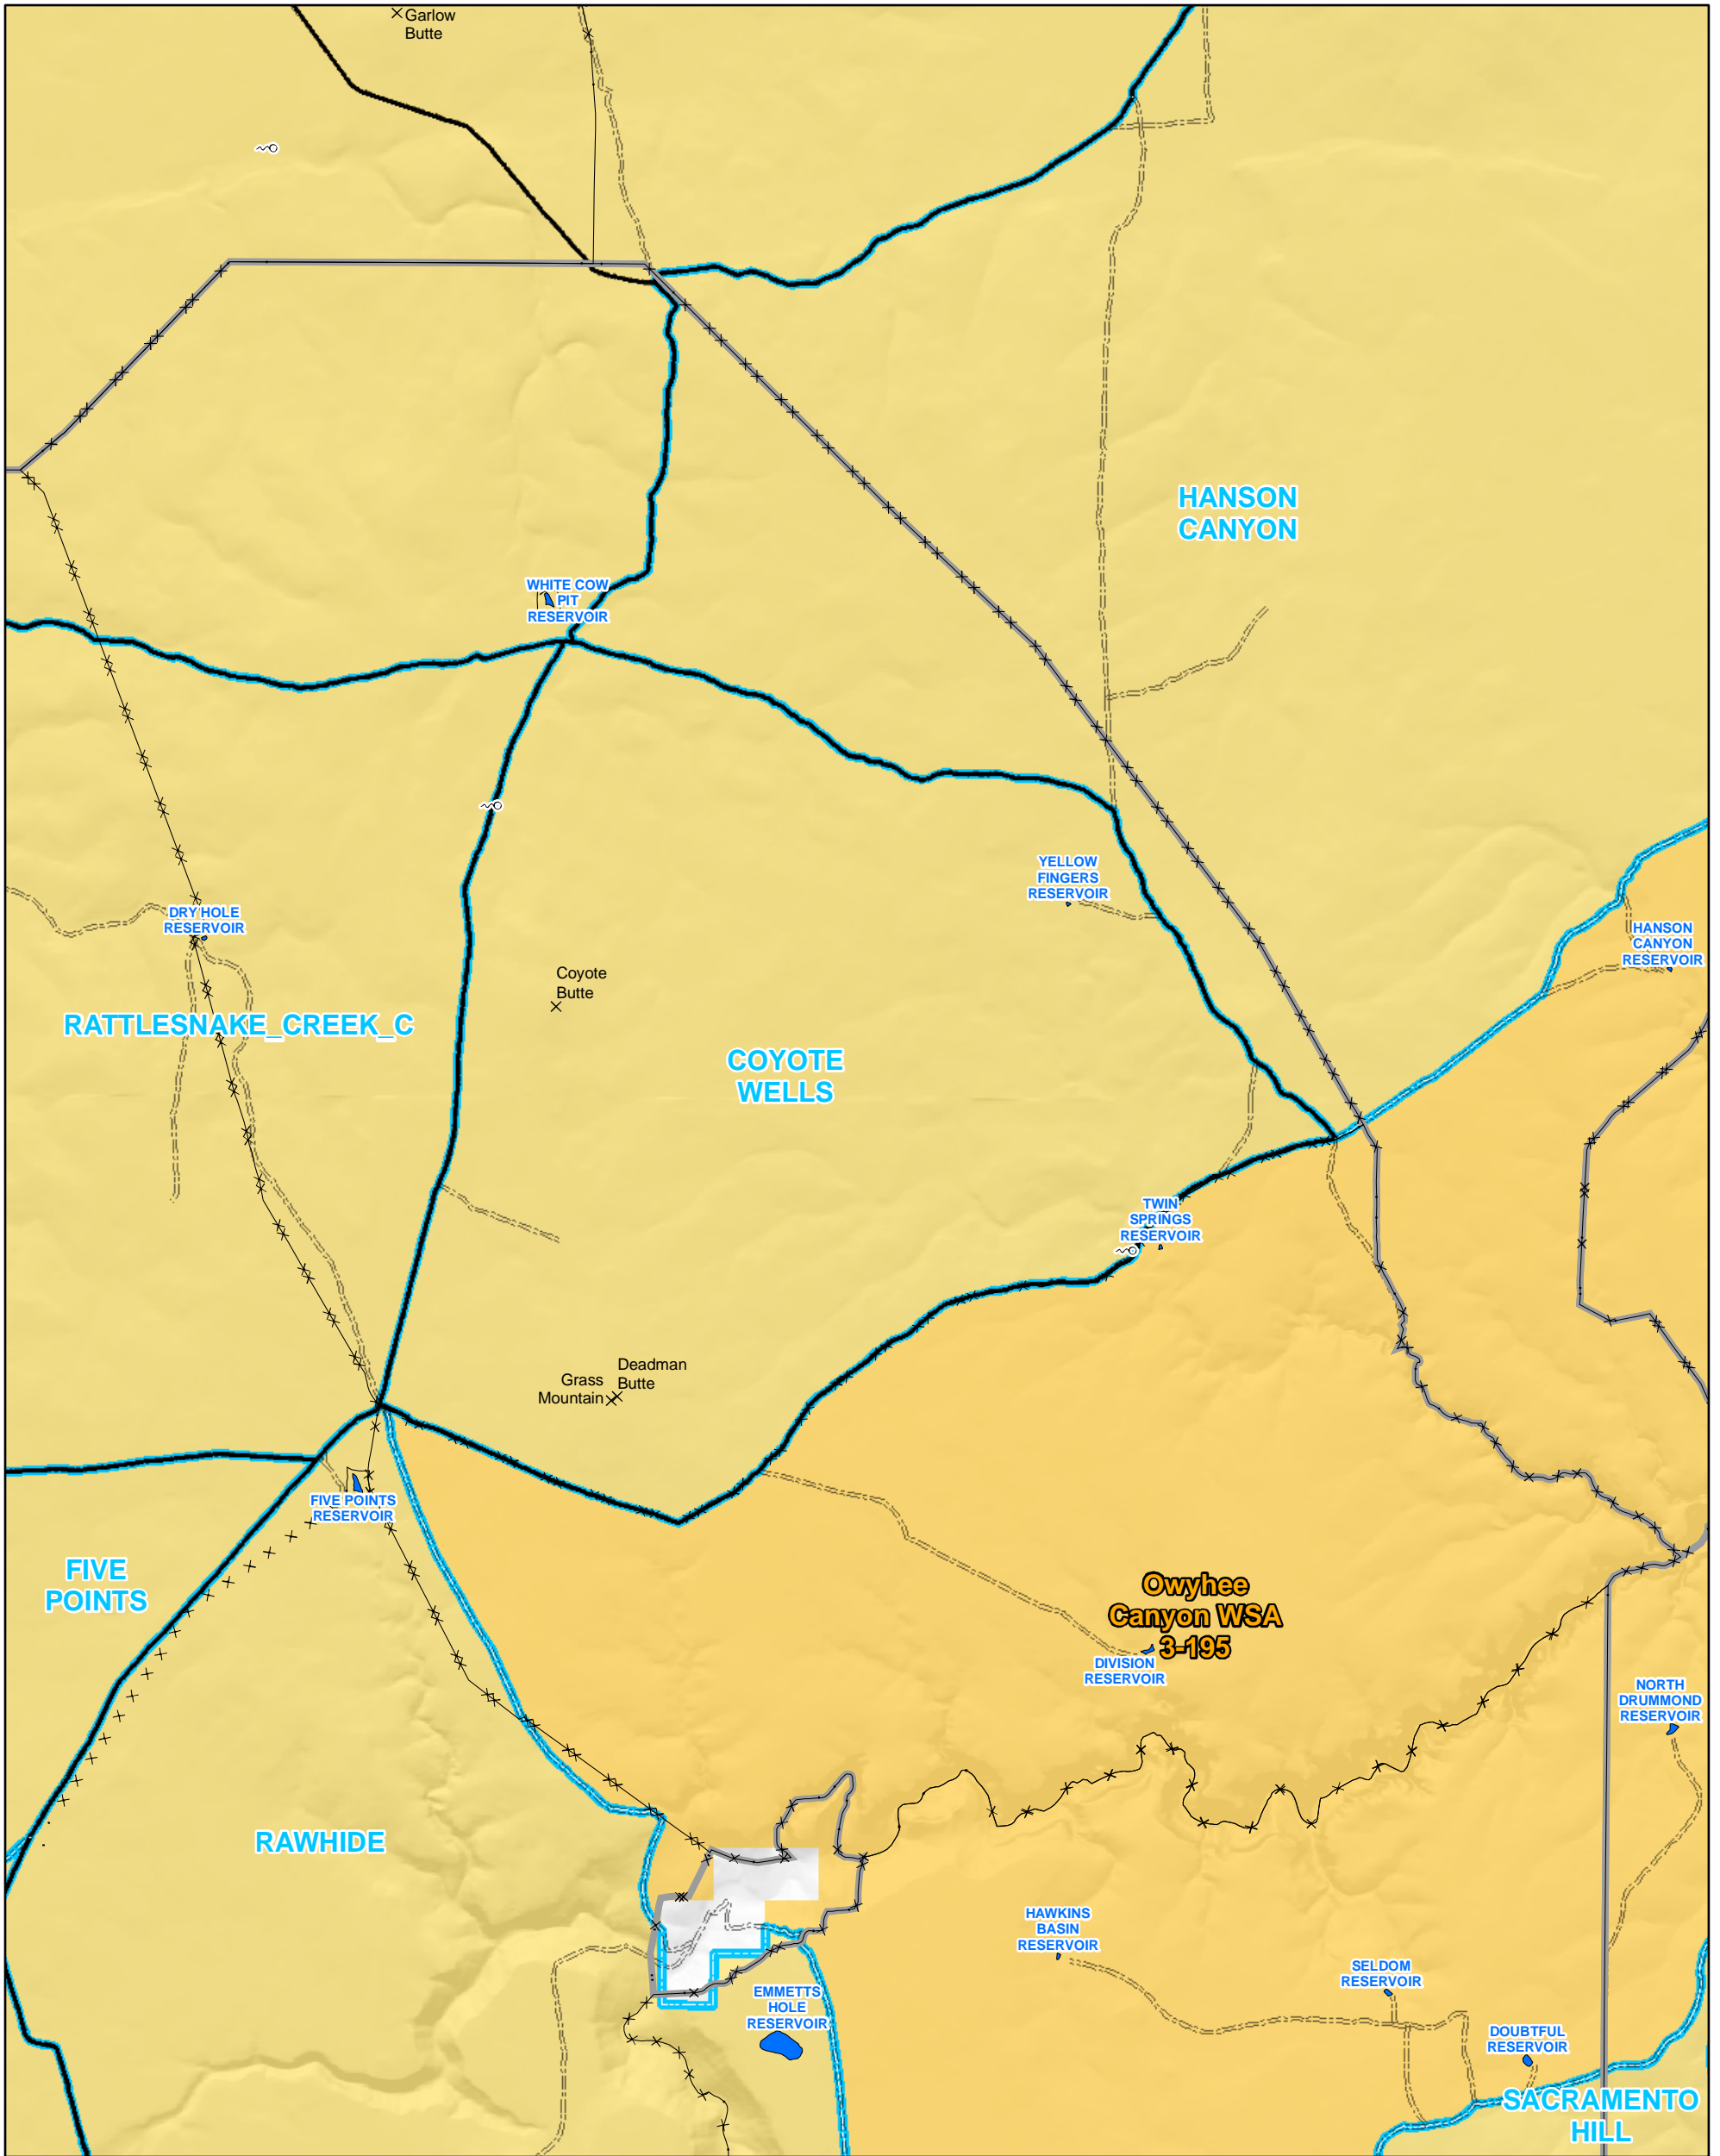
COYOTE WELLS
 OR-036-015
 ACRES: 7147

Human imprints within the Coyote Wells OR-036-015 unit include one earthen reservoir, and 1.65 miles of motorized primitive trails. The reservoir and interior motorized primitive trails are substantially unnoticeable because of the vegetative screening provided by sagebrush on the relatively flat terrain. Overall, the area appears to be primarily affected by the forces of nature with the imprint of human activity substantially unnoticeable. Refer to map 2007_Coyote_Wells_OR_036_015A.pdf for human imprints.
