Louse Canyon Wilderness Inventory Unit Index of Documents
Hanson Canyon OR-036-016, 55 total pages

**H-6300-1-WILDERNESS INVENTORY MAINTENANCE
IN BLM OREGON/WASHINGTON**

Wilderness Inventory Area Name and Number (Unit ID): Hanson Canyon OR-036-016

Route Name and/or Identifier: BLM, Deadman Pass/6372-0-00; Mouse Trap Butte proposed
WSA Addition TF17 d

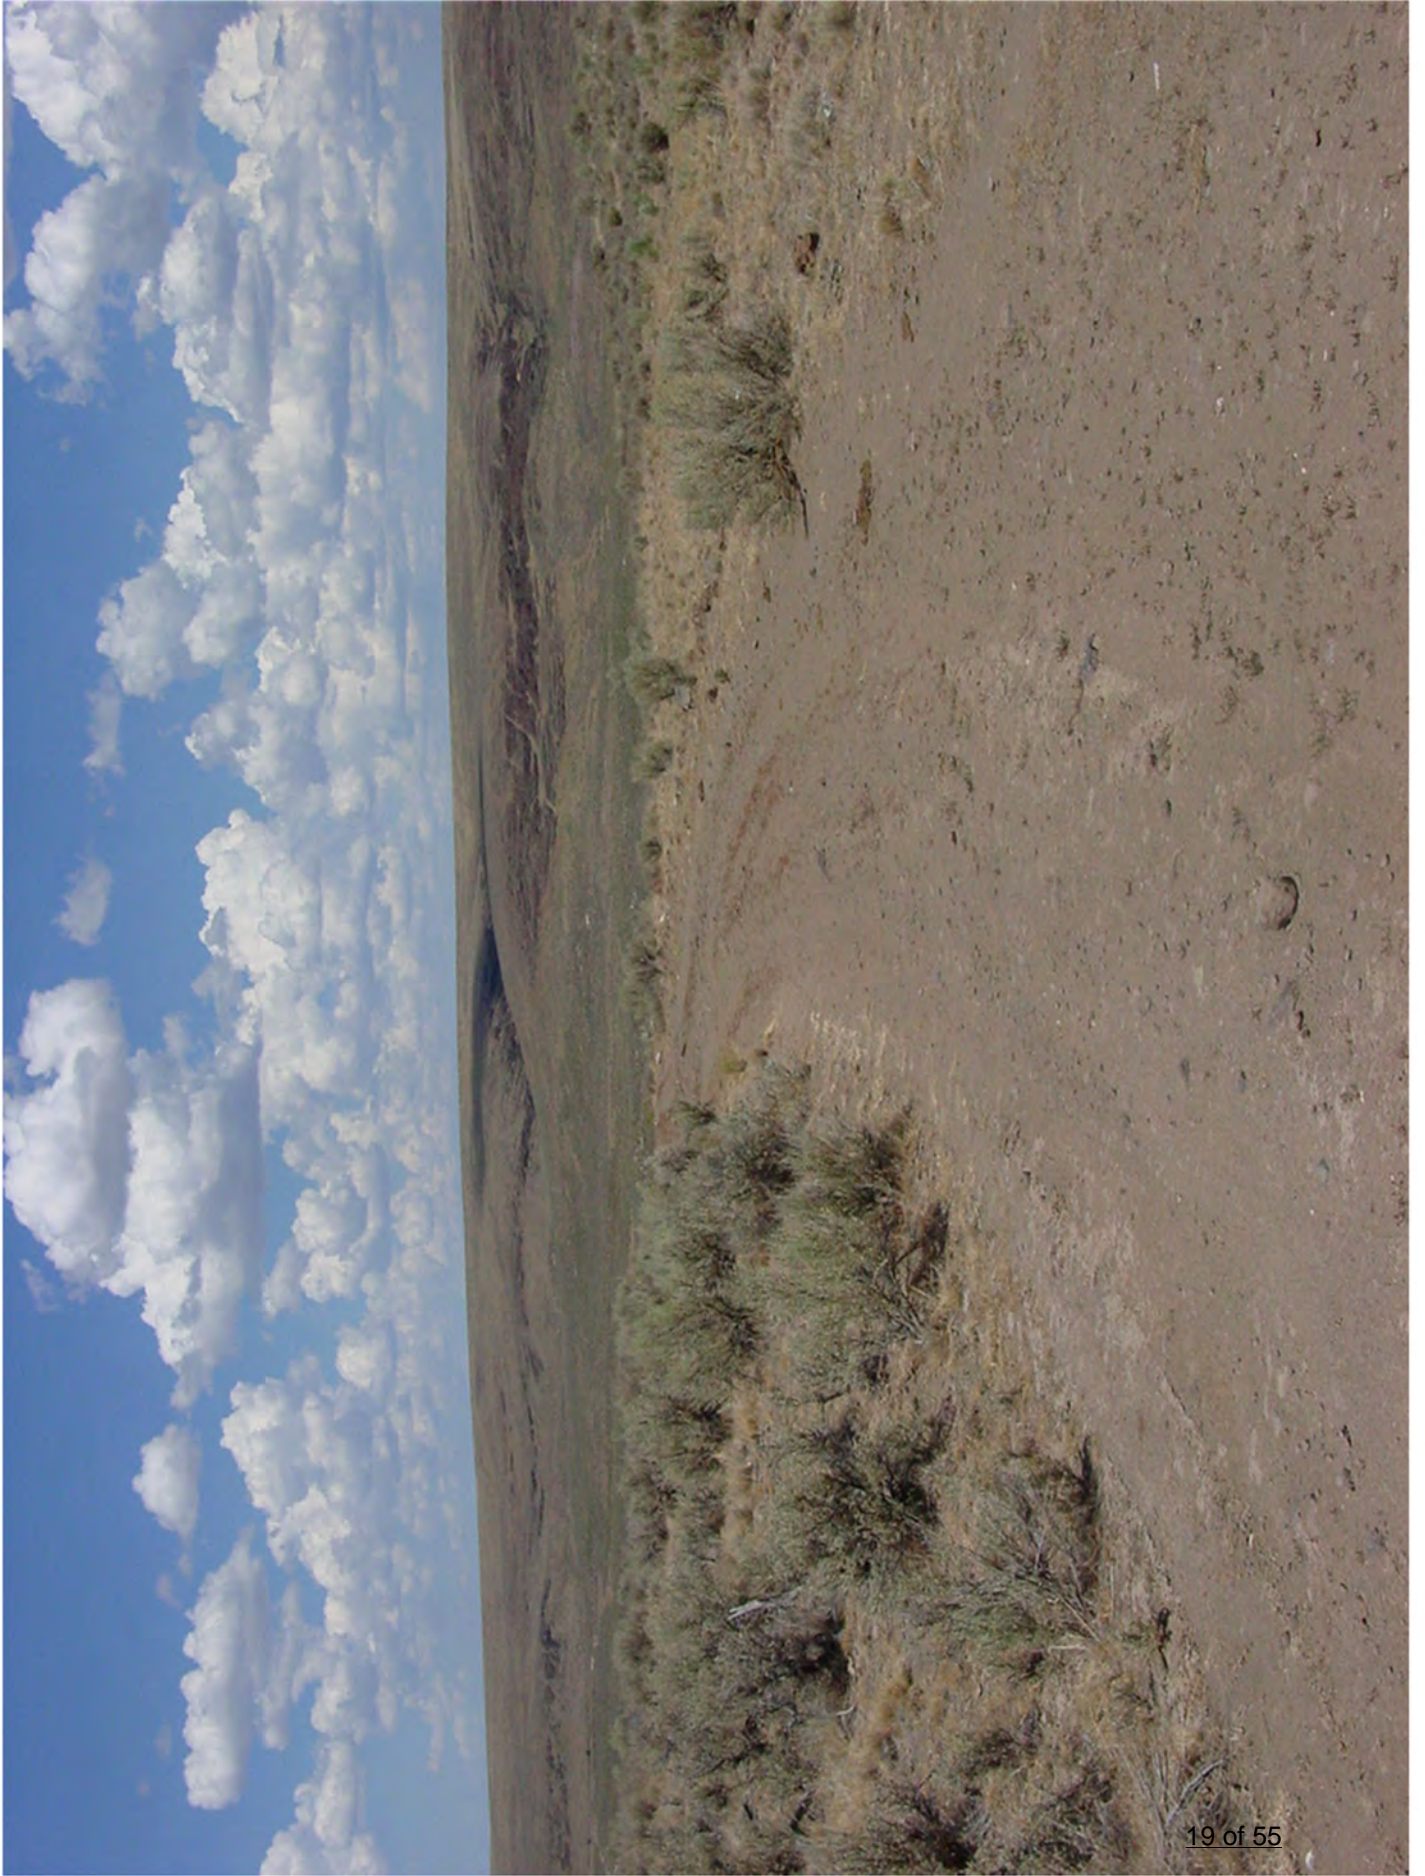
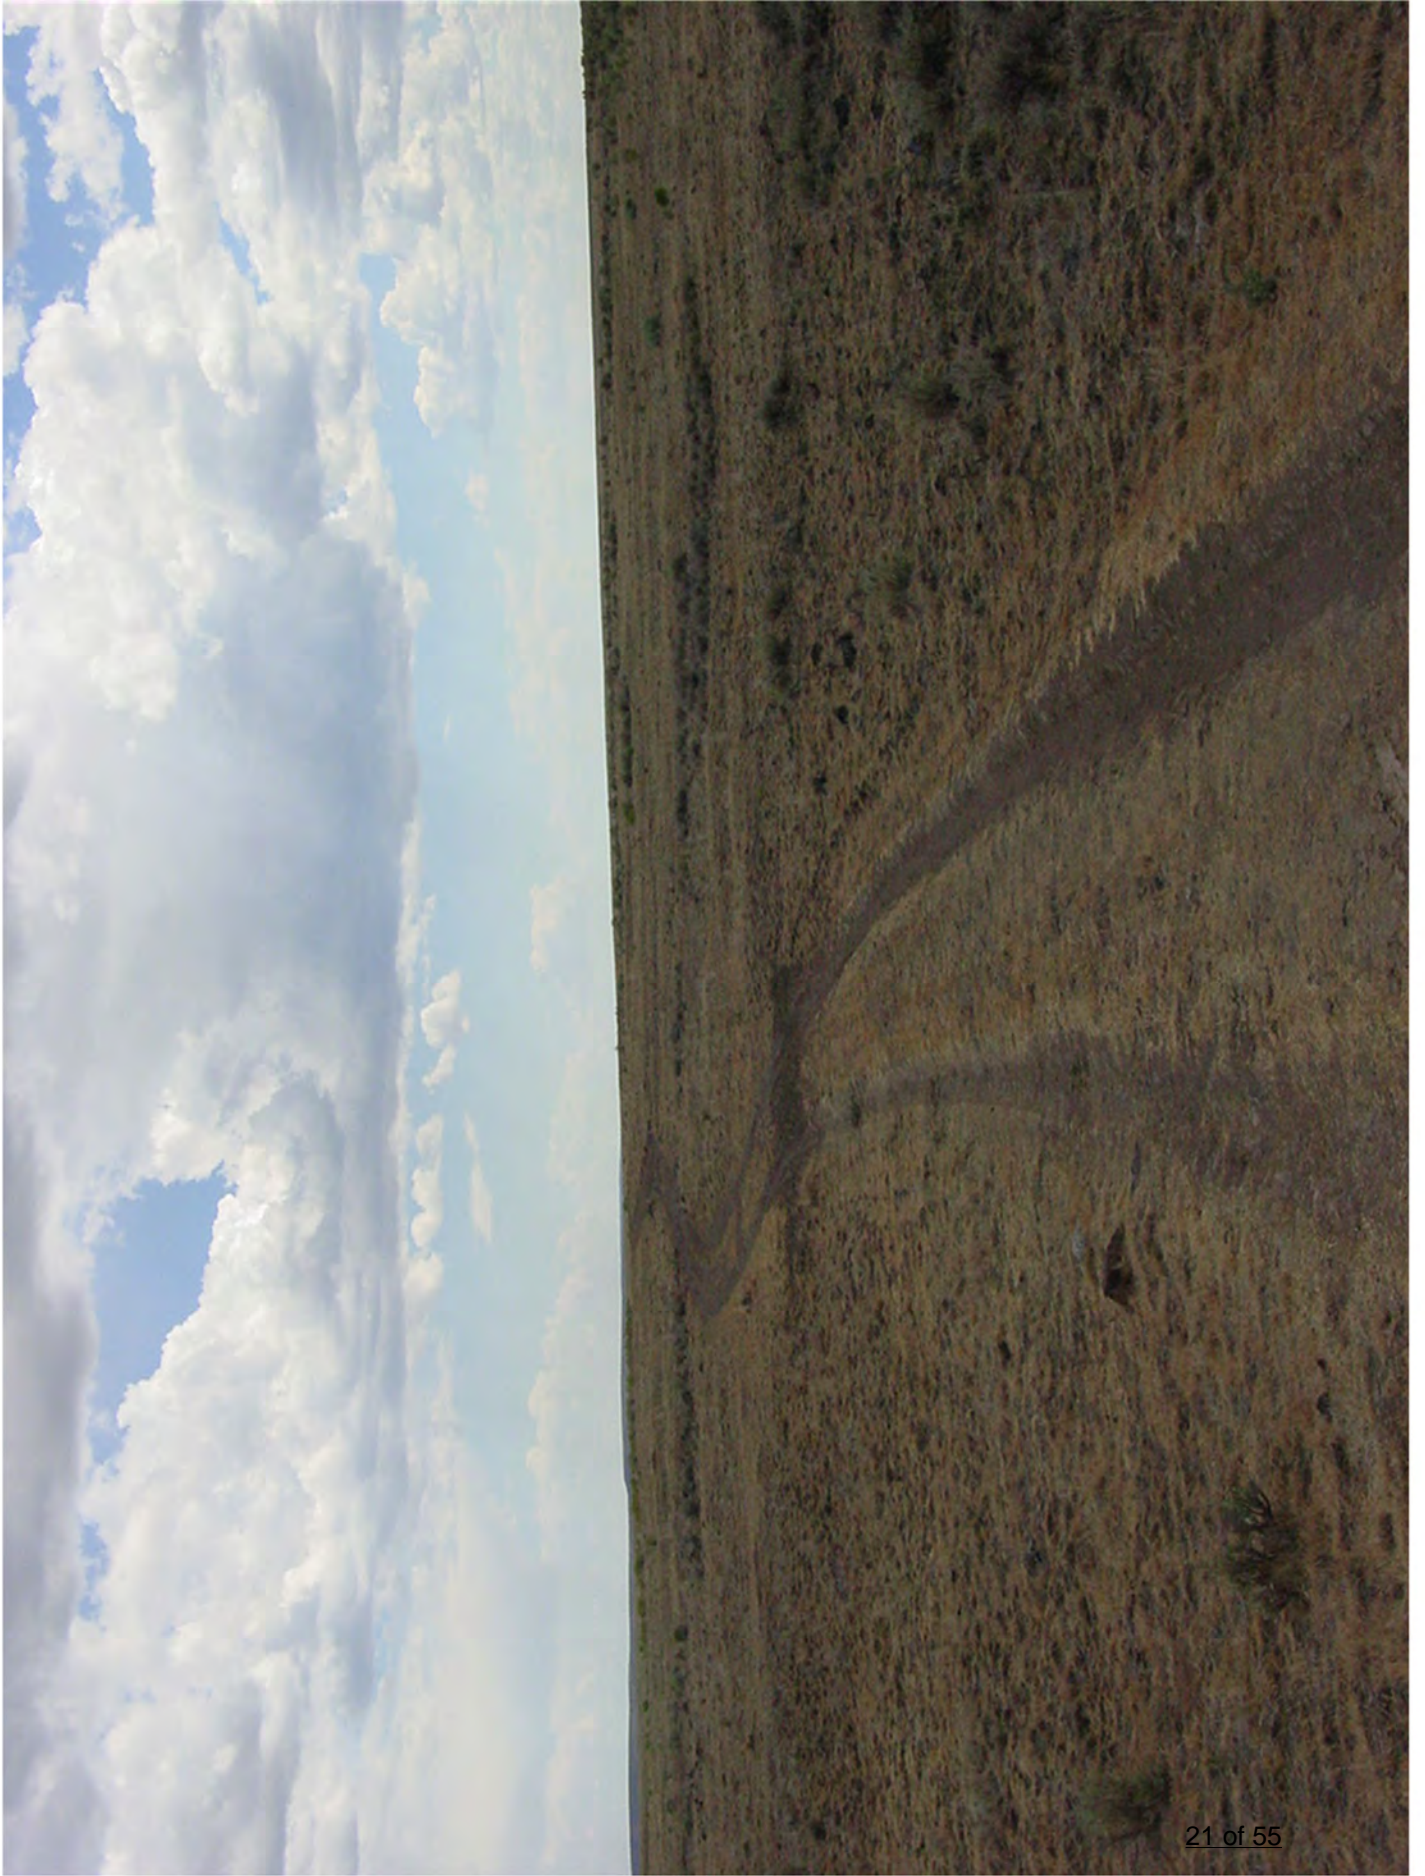
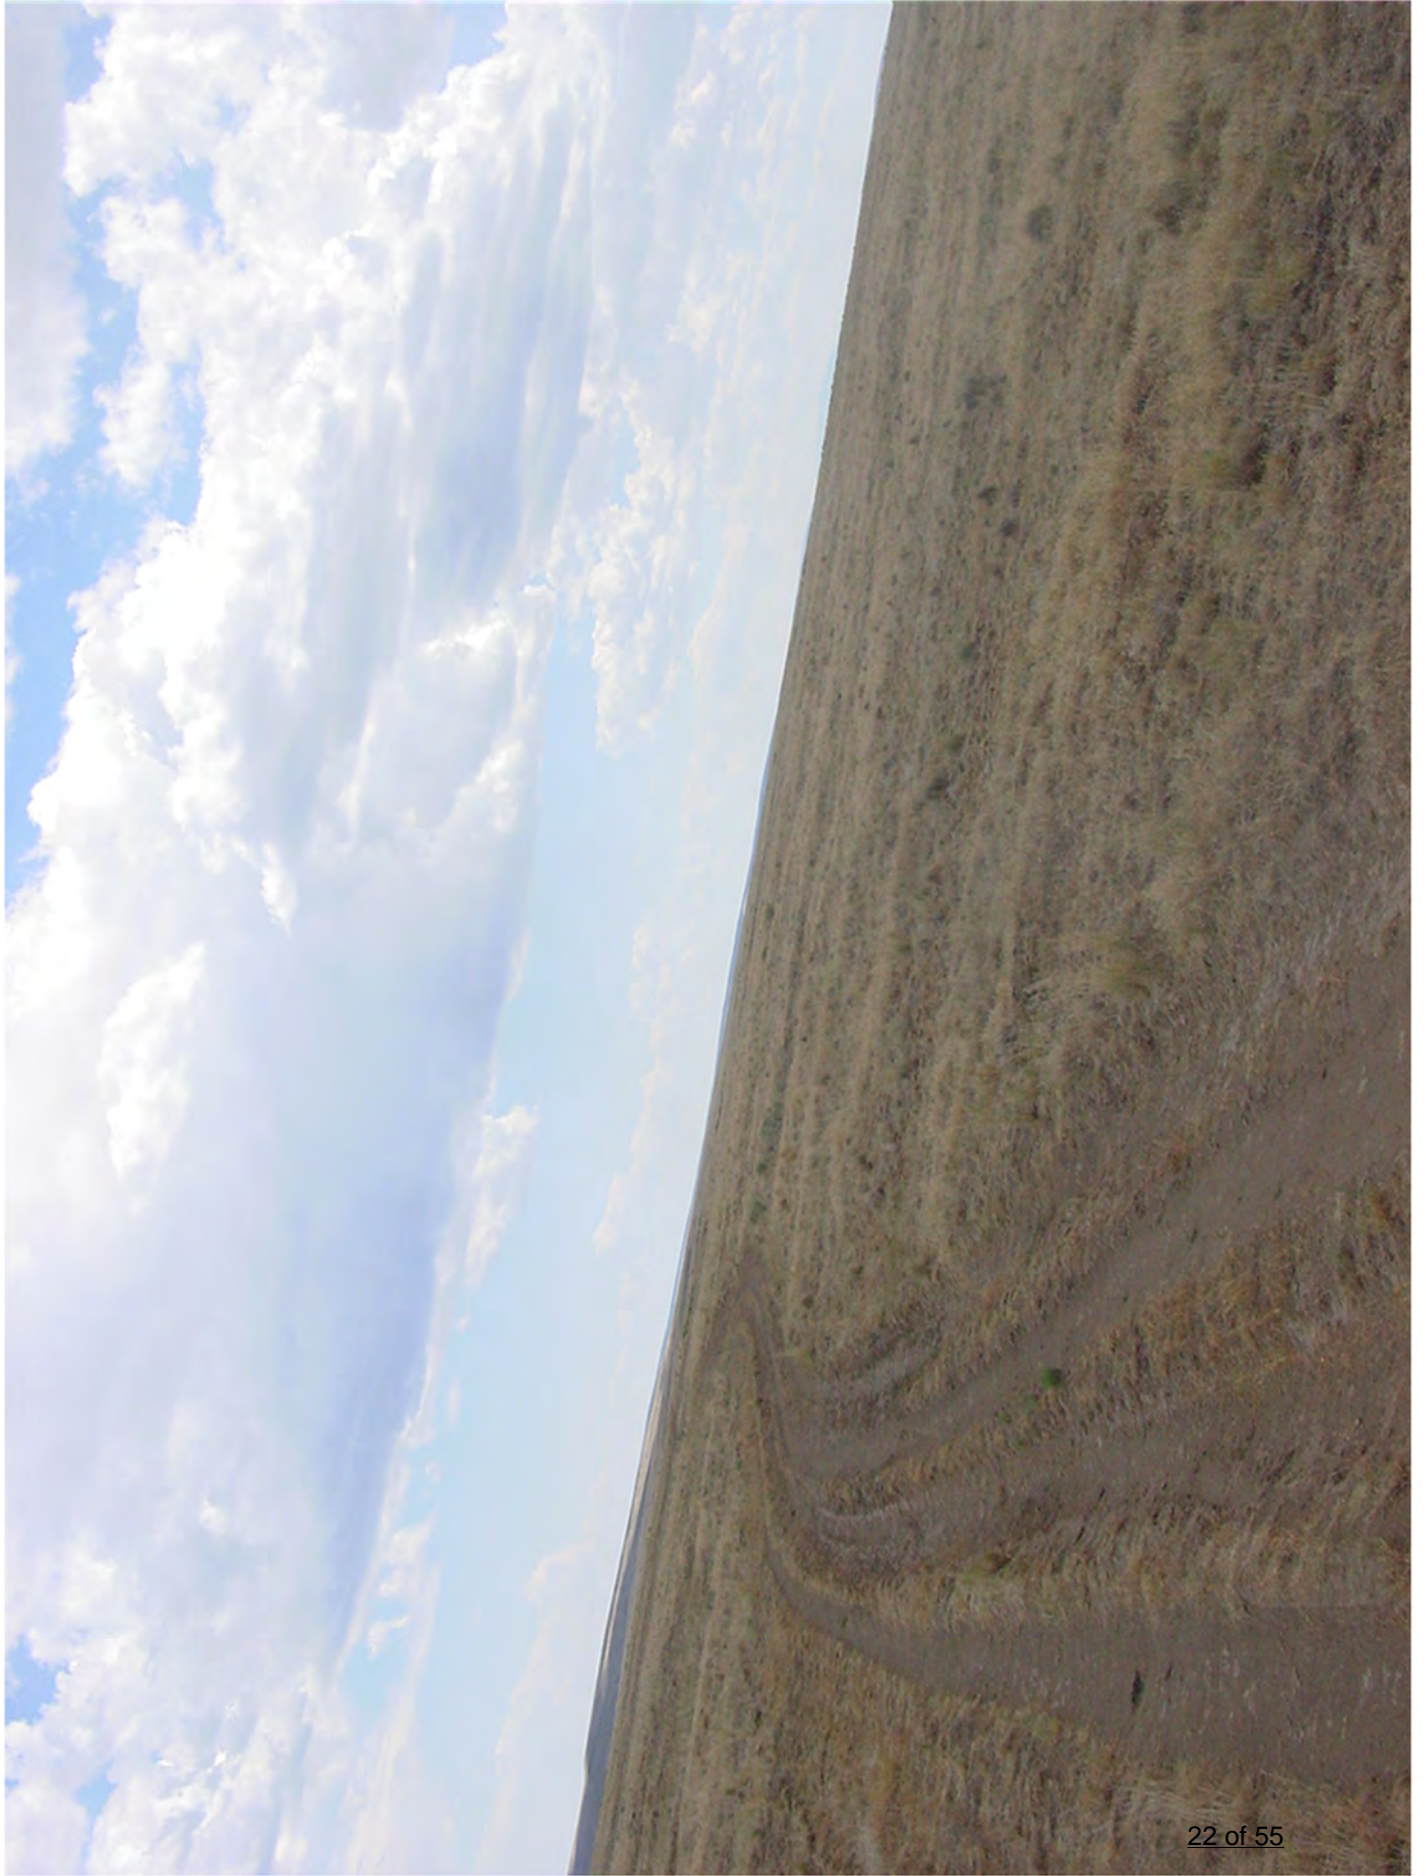
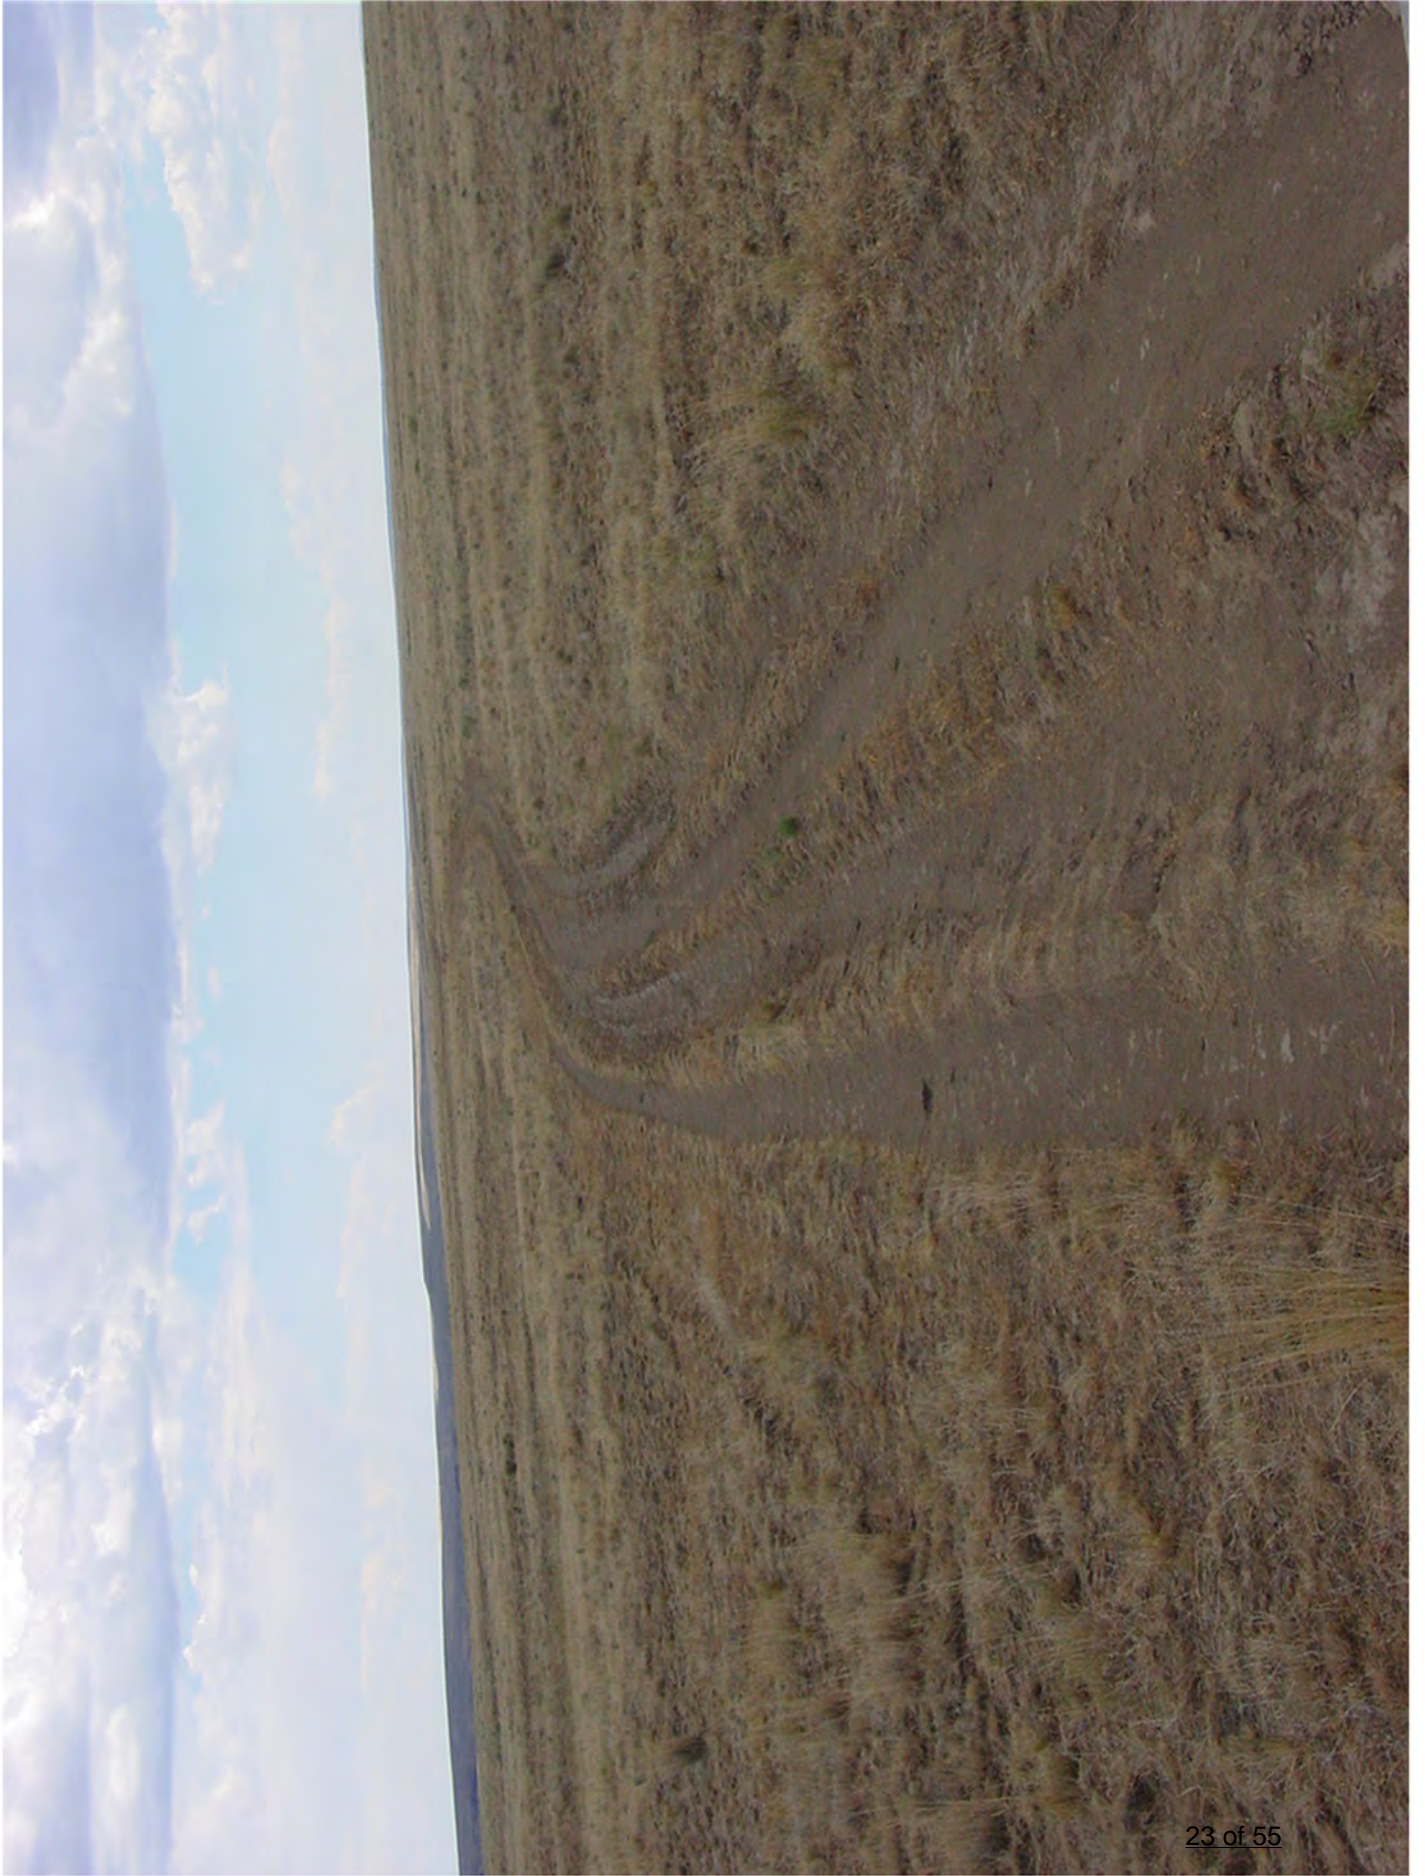
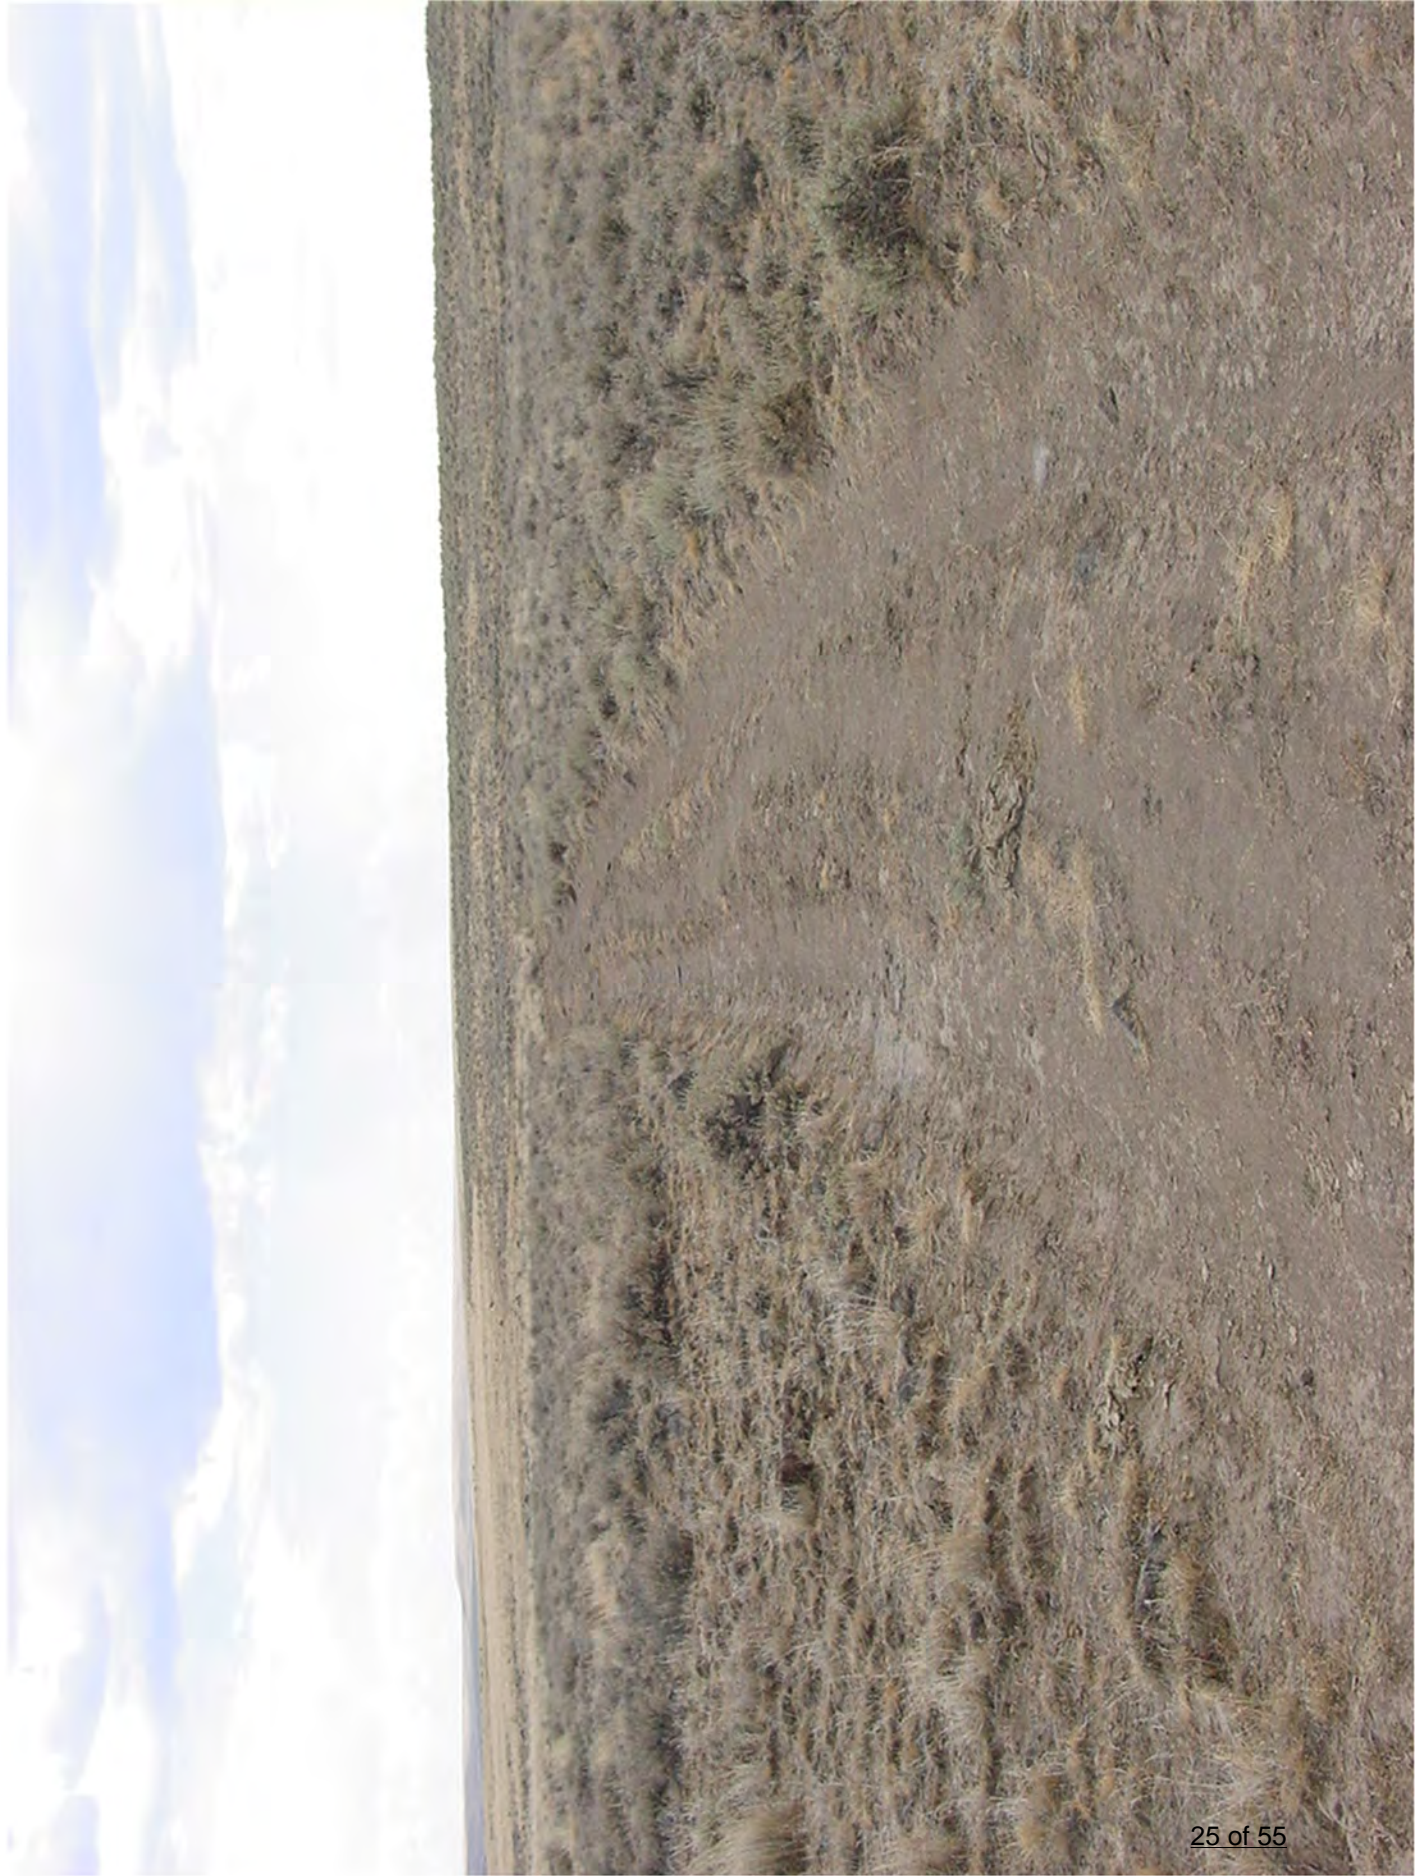
Hanson Canyon OR-036-016 Deadman Pass 6372-0-00

BLM road 6372-0-00 has annual use as evidenced by the lack of brush in the road and by well-used bare ground where vehicle tires track (photo DSC02461). This route is used mainly for maintenance of a fenceline and access to two livestock grazing allotments. This route does not receive continual use because it is only an isolated loop road and other routes are available as main travel routes.

DATE	Frame #	Camera Direction	Description	GPS/UTM Location	Township	Range	Section
7/27/2007	DSC02447	N	To Loveland Horsecamp	478087 4715717	T34S	R44E	Sec 13
7/27/2007	DSC02456	S	Visible road	479412 4714813	T34S	R44E	Sec13
7/27/2007	DSC02457	S	Visible Road	479684 4714203	T34S	R45E	Sec 19
7/27/2007	DSC02458	S	Visible road	480001 4713299	T34S	R45E	Sec 19
7/27/2007	DSC02459	S	Visible Road	480653 4712142	T34S	R45E	Sec 30
7/27/2007	DSC02460	S	Visible Road	480926 4711301	T34S	R45E	Sec 30
7/27/2007	DSC02461	SW	Spur road	481157 4709998	T34S	R45E	Sec 31
4/27/2007	DSC02462	S	Road continues	481157 4709998	T34S	R45e	Sec 32
4/27/2007	DSC02463	S	Gate to Ambrose Mahar	482524 4708694	T35S	R45E	Sec 05
