Louse Canyon Wilderness Inventory Unit Index of Documents
Hanson Canyon OR-036-016, 55 total pages

**H-6300-1-WILDERNESS INVENTORY MAINTENANCE
IN BLM OREGON/WASHINGTON**

Wilderness Inventory Area Name and Number (Unit ID): Hanson Canyon OR-036-016

Route Name and/or Identifier: BLM, Deadman Pass/6372-0-00; Mouse Trap Butte proposed
WSA Addition TF17 d

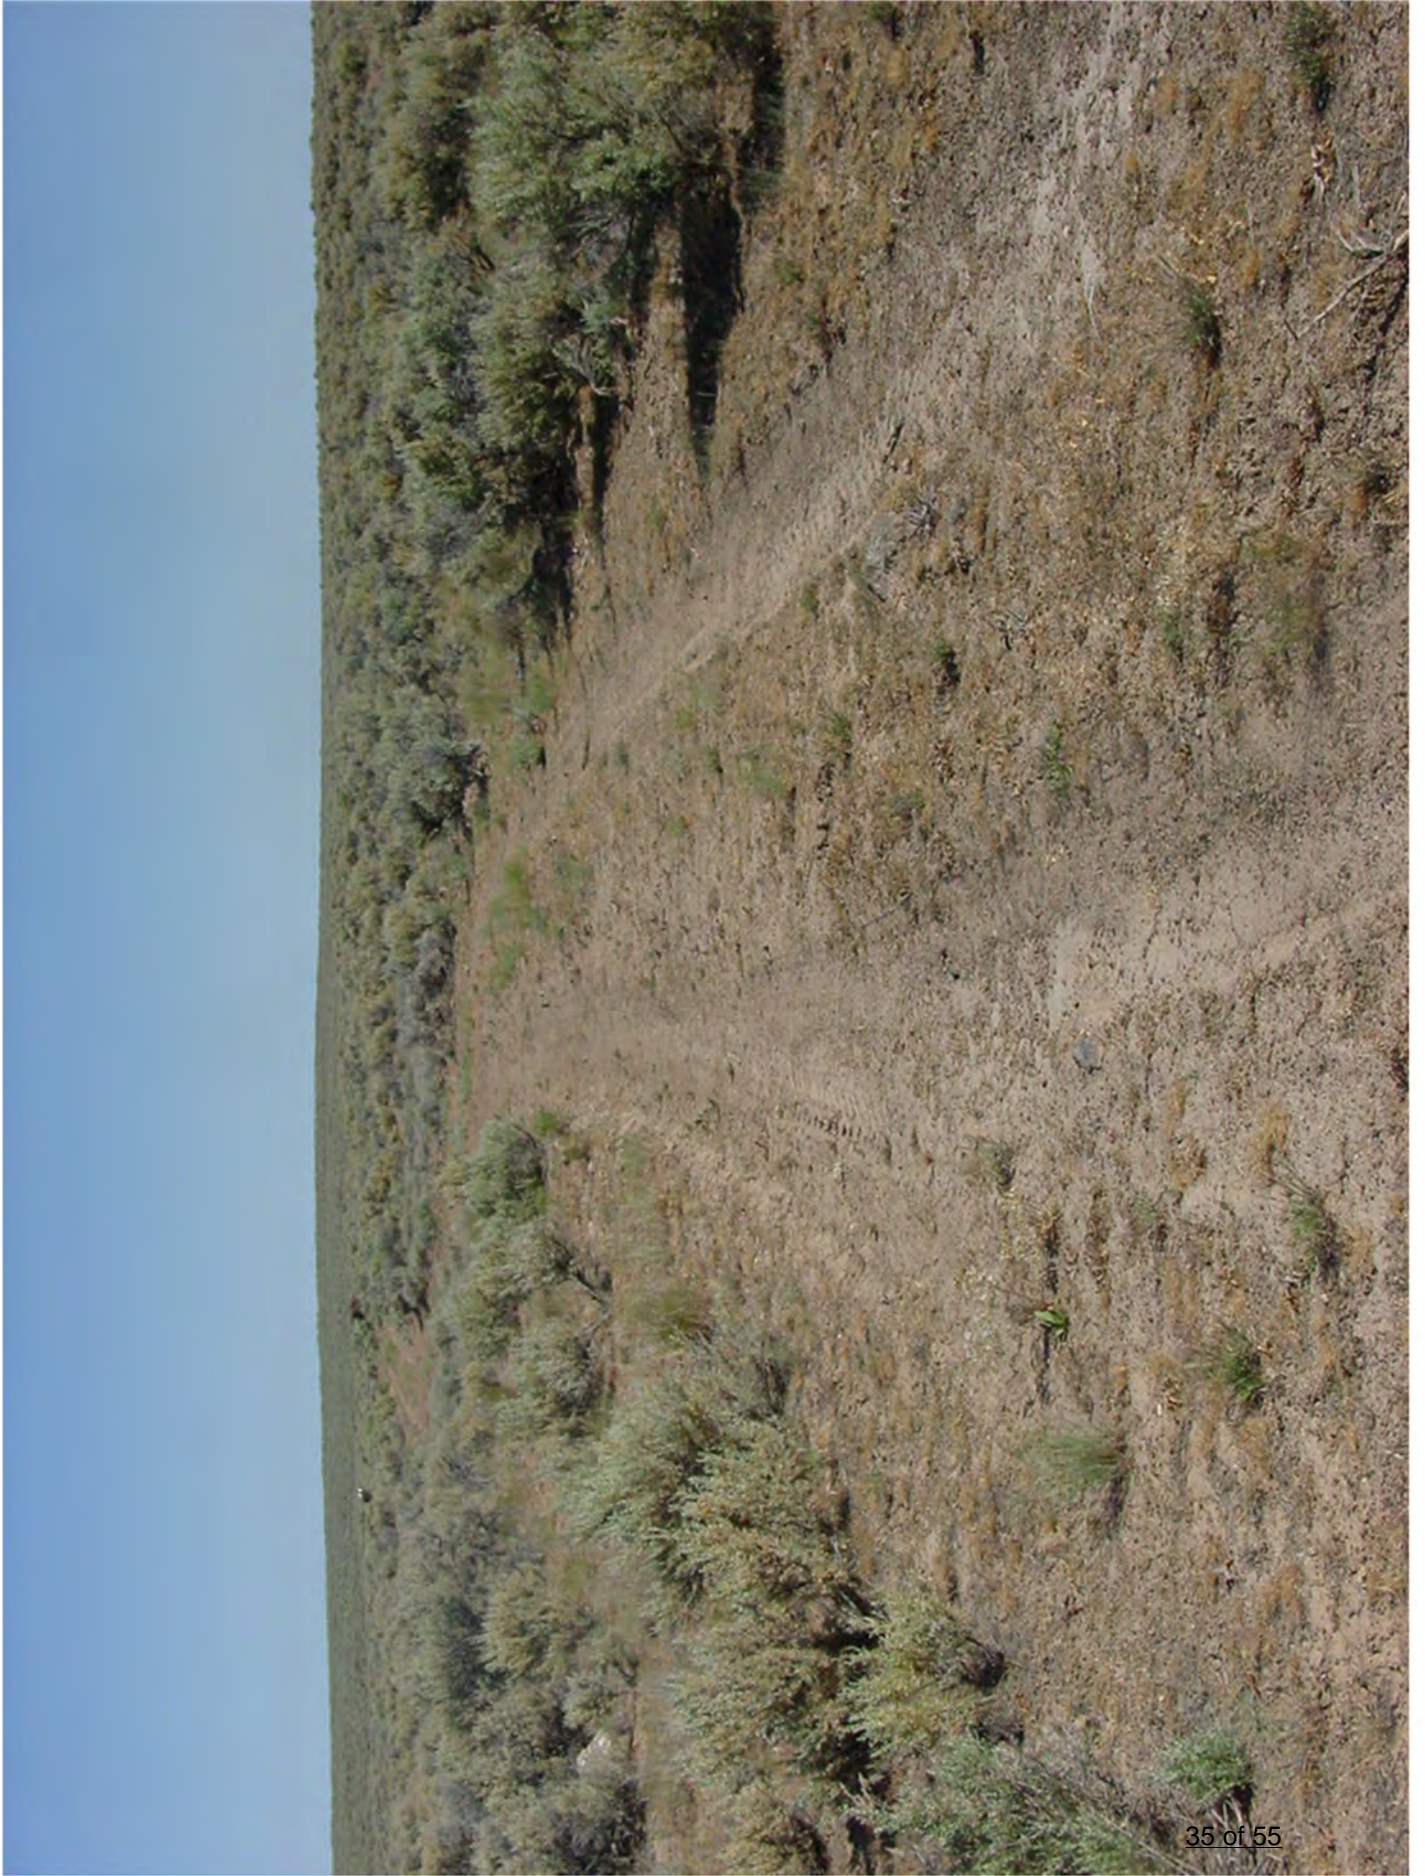
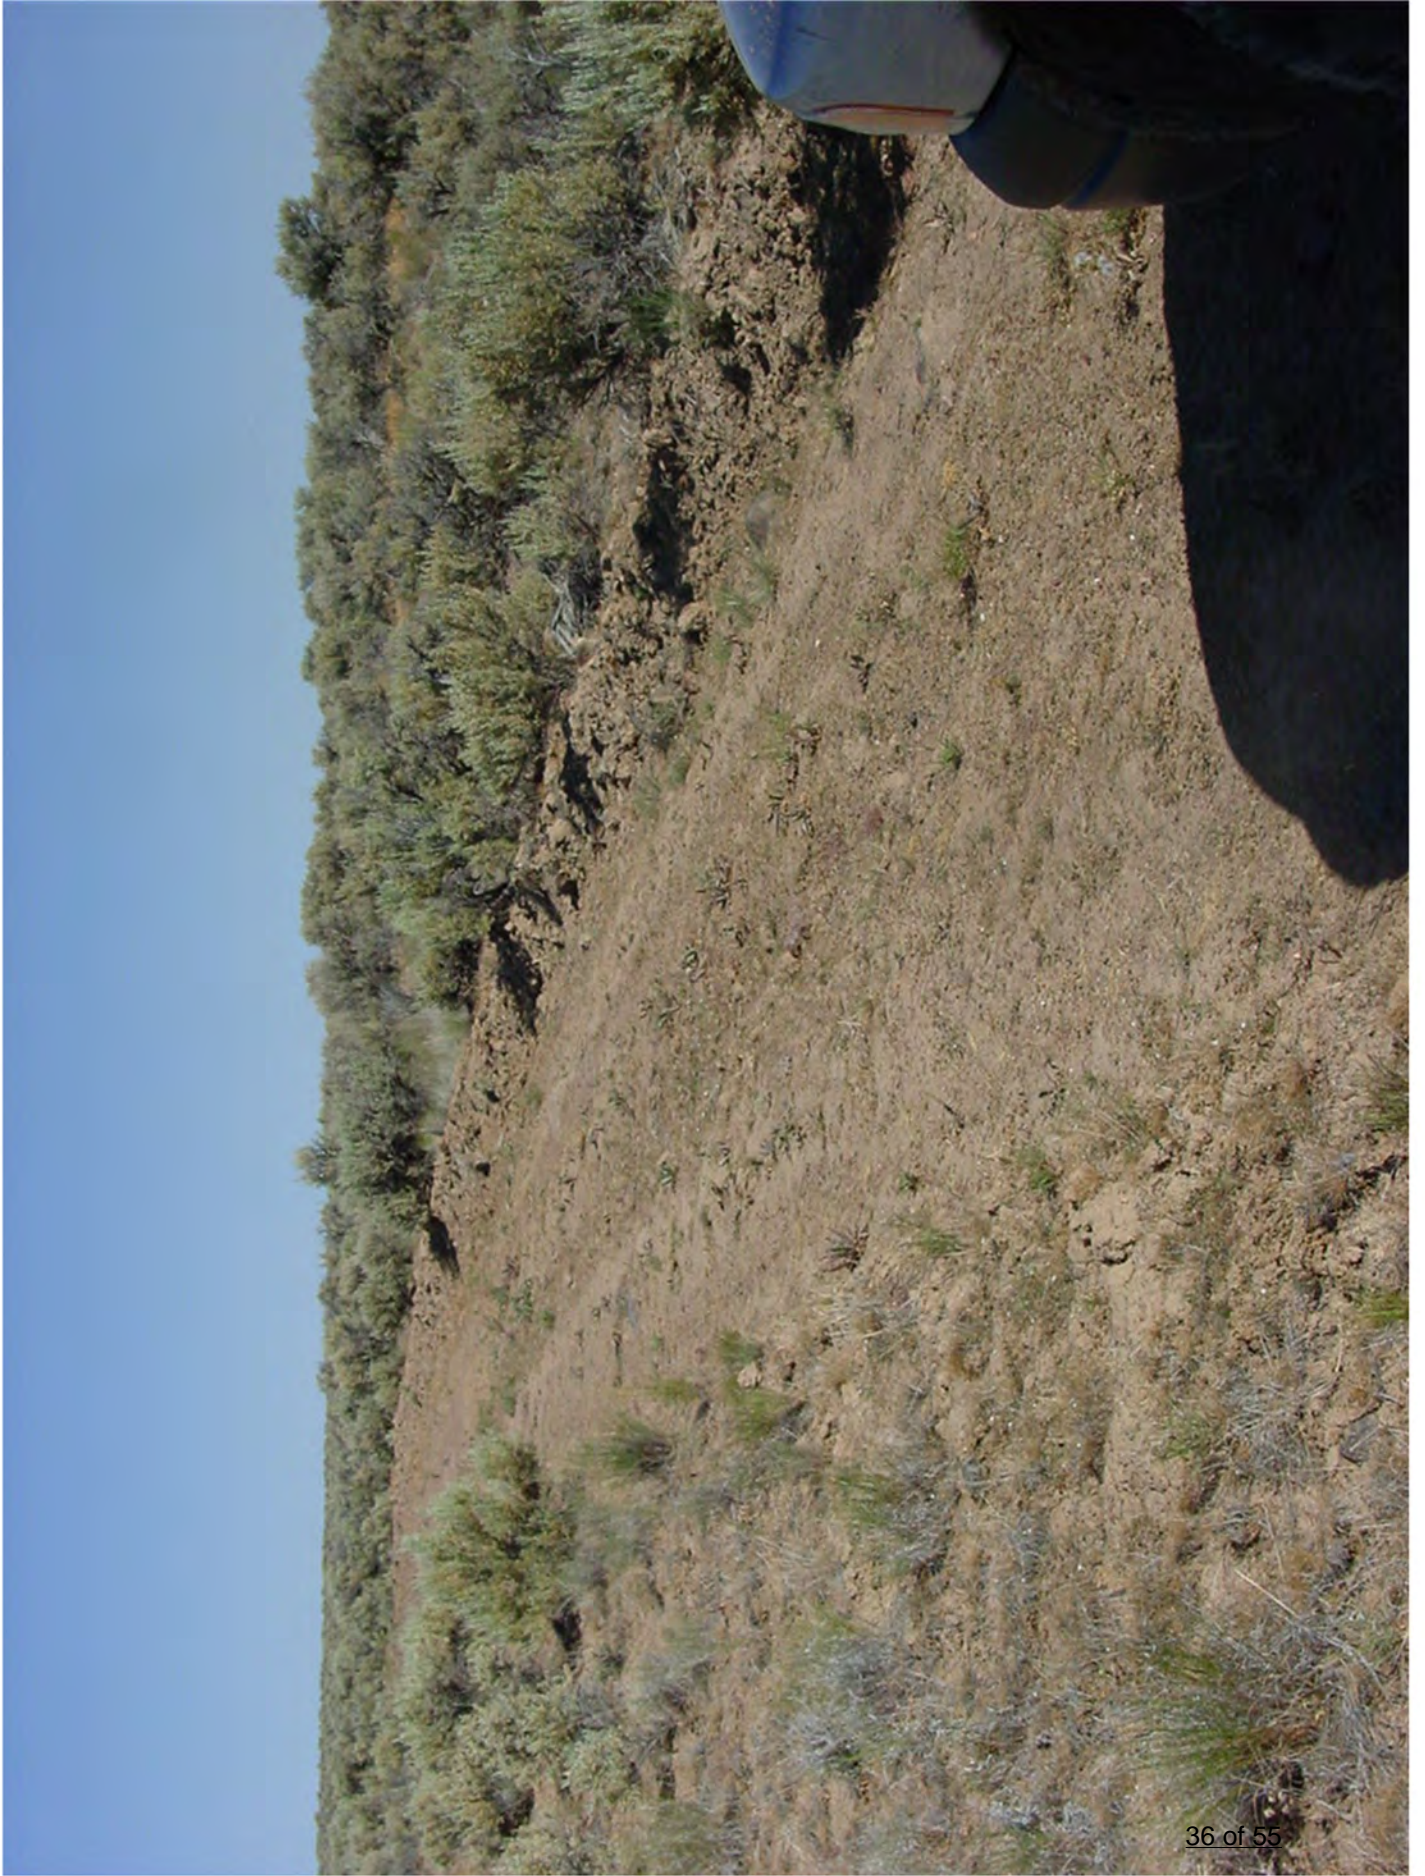
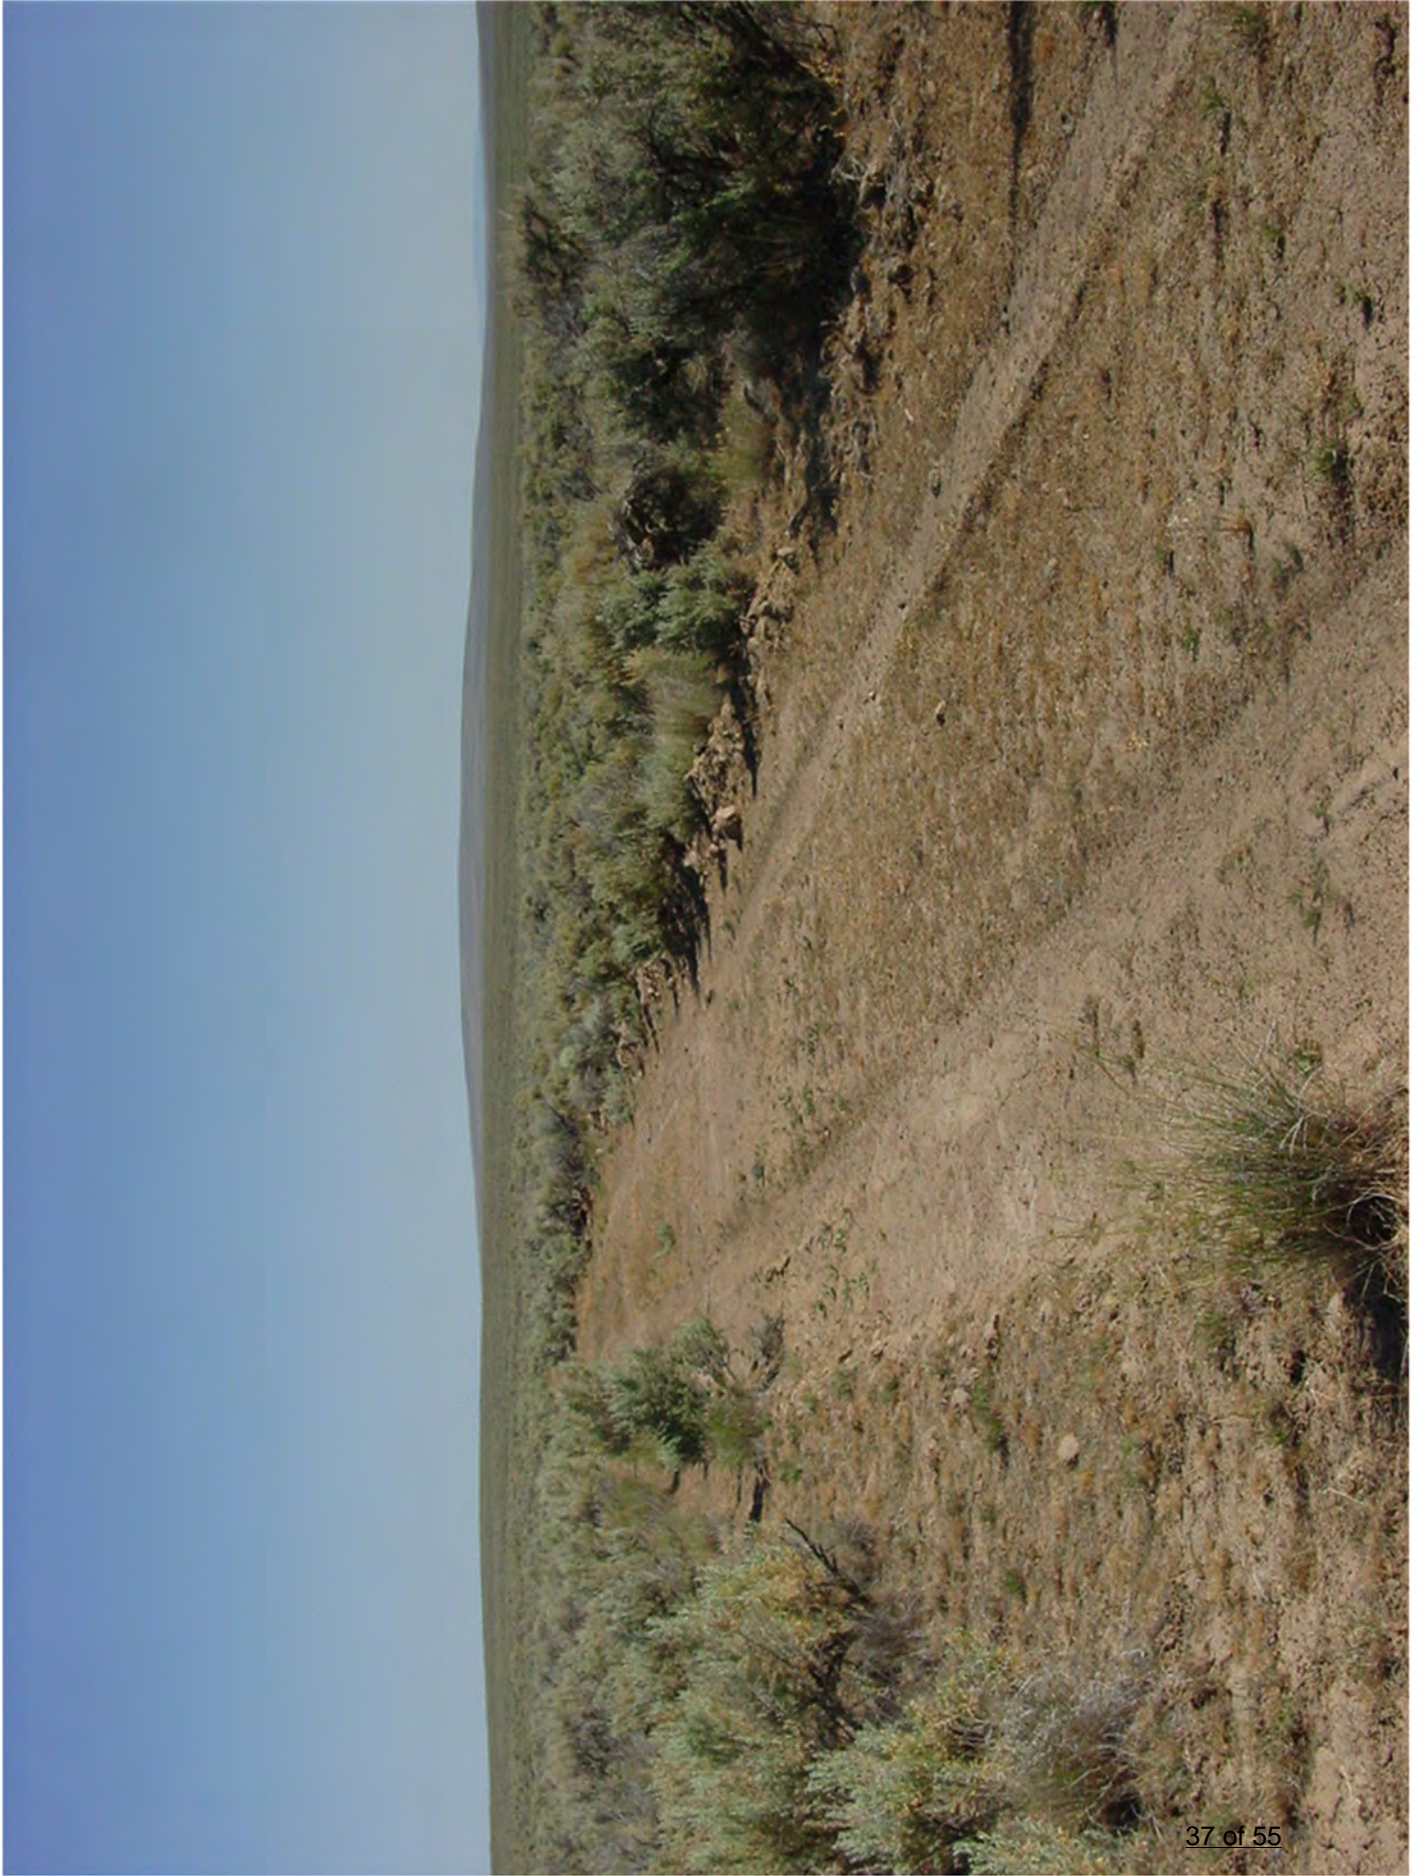
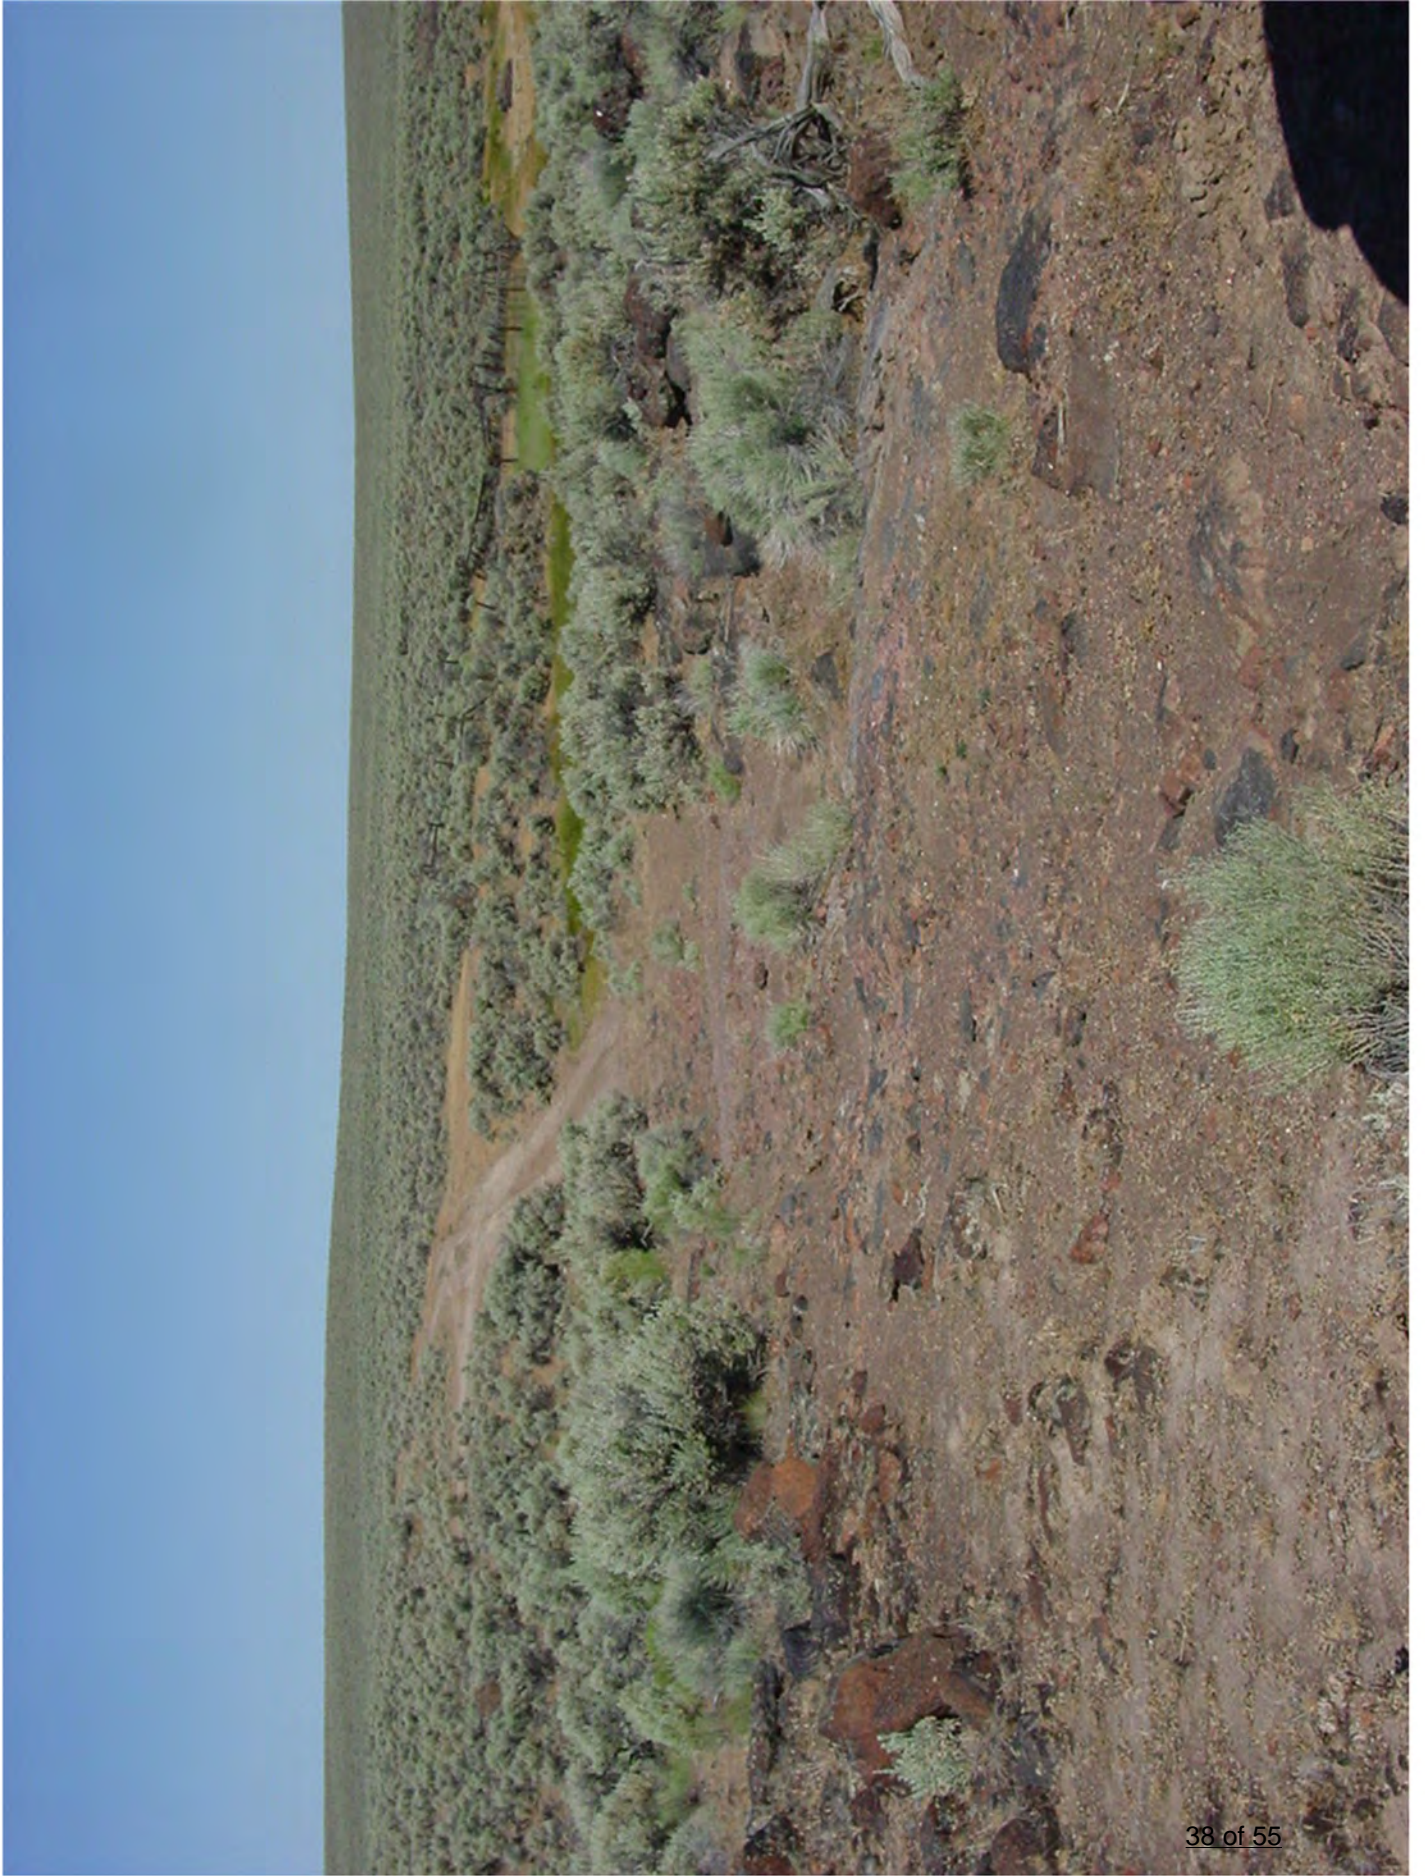
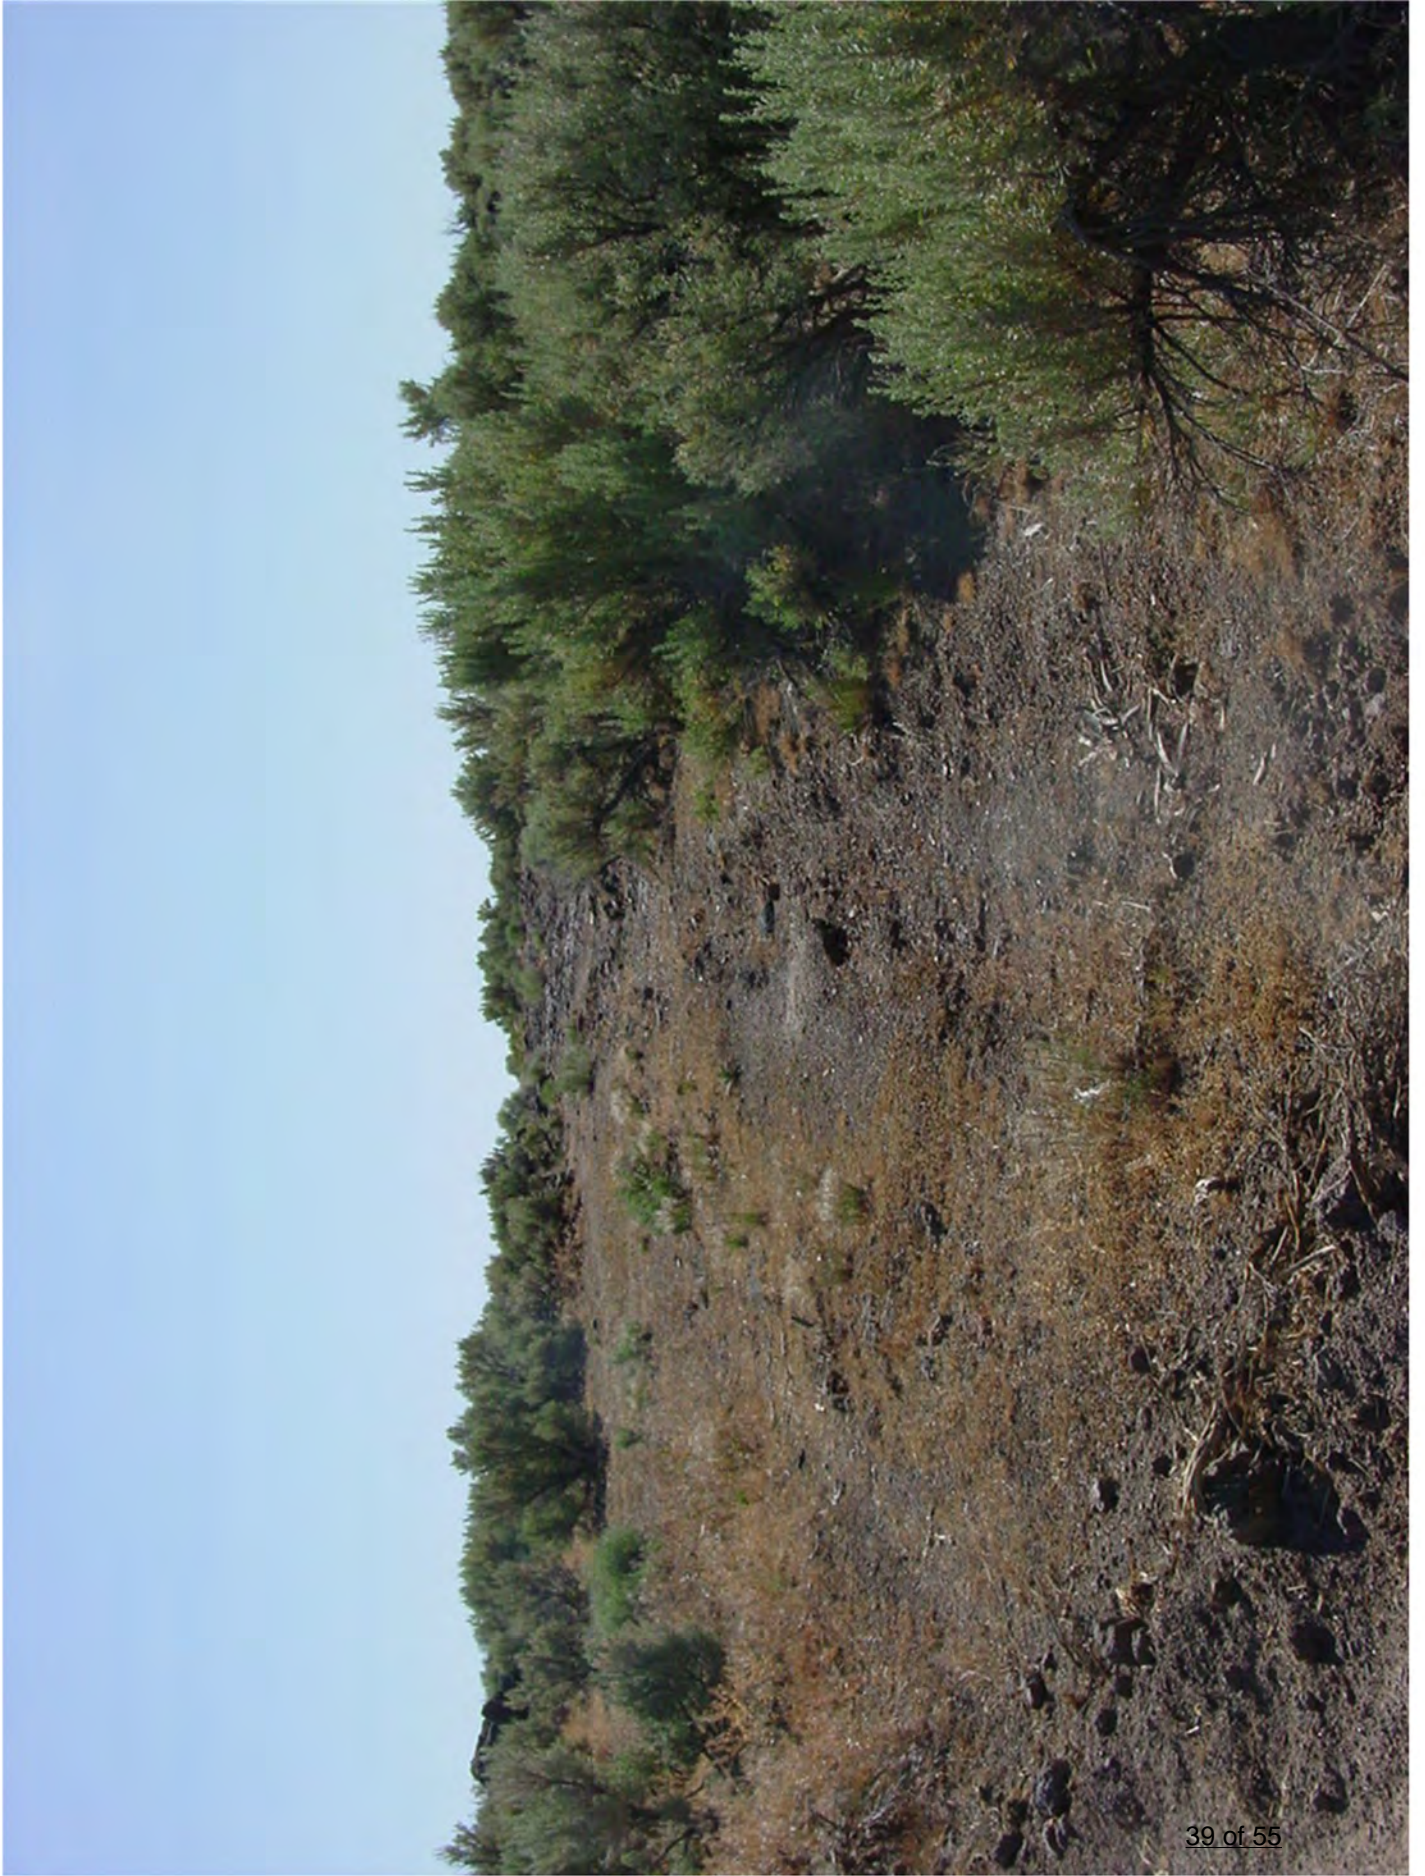
Hanson Canyon OR-036-016 Twin Springs Road 6357-0-C0

On August 21, 2006 a lightning-caused wildfire burned approximately 905 acres near the Twin Springs area within the unit. In an effort to suppress this wildfire BLM road 6357-0-C0 was bladed with a road-grader. The road was bladed to create a mineral-soil fire break to help reduce chance of the fire spreading across BLM road 6357-0-C0 into the Owyhee Canyon WSA and the Hanson Canyon unit. Because the wildfire suppression made necessary the use of BLM road 6357-0-C0 as a fire containment boundary, maintenance was applied to the road, creating roadside soil berms and a bladed roadbed along most of its length where it is the boundary between the Coyote Wells unit and the Hanson Canyon unit (BLM photos DSC02435 and 436).

DATE	Frame #	Camera Direction	Description	GPS/UTM Location	Township	Range	Section
6/21/2007	DSC02434	NW	Signs of recent use	475902 4705438	T35S	R44E	Sec 15
6/21/2007	DSC02435	NW	Bladed road	474884 4707384	T35S	R44E	Sec 10
6/21/2007	DSC02436	NW	Good road	473028 4707723	T35S	R44E	Sec 09
6/21/2007	DSC02437	NW	Junction	470636 4708633	T35S	R44E	Sec 06
6/21/2007	DSC02438	E	Back to Junction	470636 4708633	T35S	R44E	Sec 06
