Louse Canyon Wilderness Inventory Unit Index of Documents
Hanson Canyon OR-036-016, 55 total pages

**H-6300-1-WILDERNESS INVENTORY MAINTENANCE
IN BLM OREGON/WASHINGTON**

Wilderness Inventory Area Name and Number (Unit ID): Hanson Canyon OR-036-016

Route Name and/or Identifier: BLM, Deadman Pass/6372-0-00; Mouse Trap Butte proposed
WSA Addition TF17 d

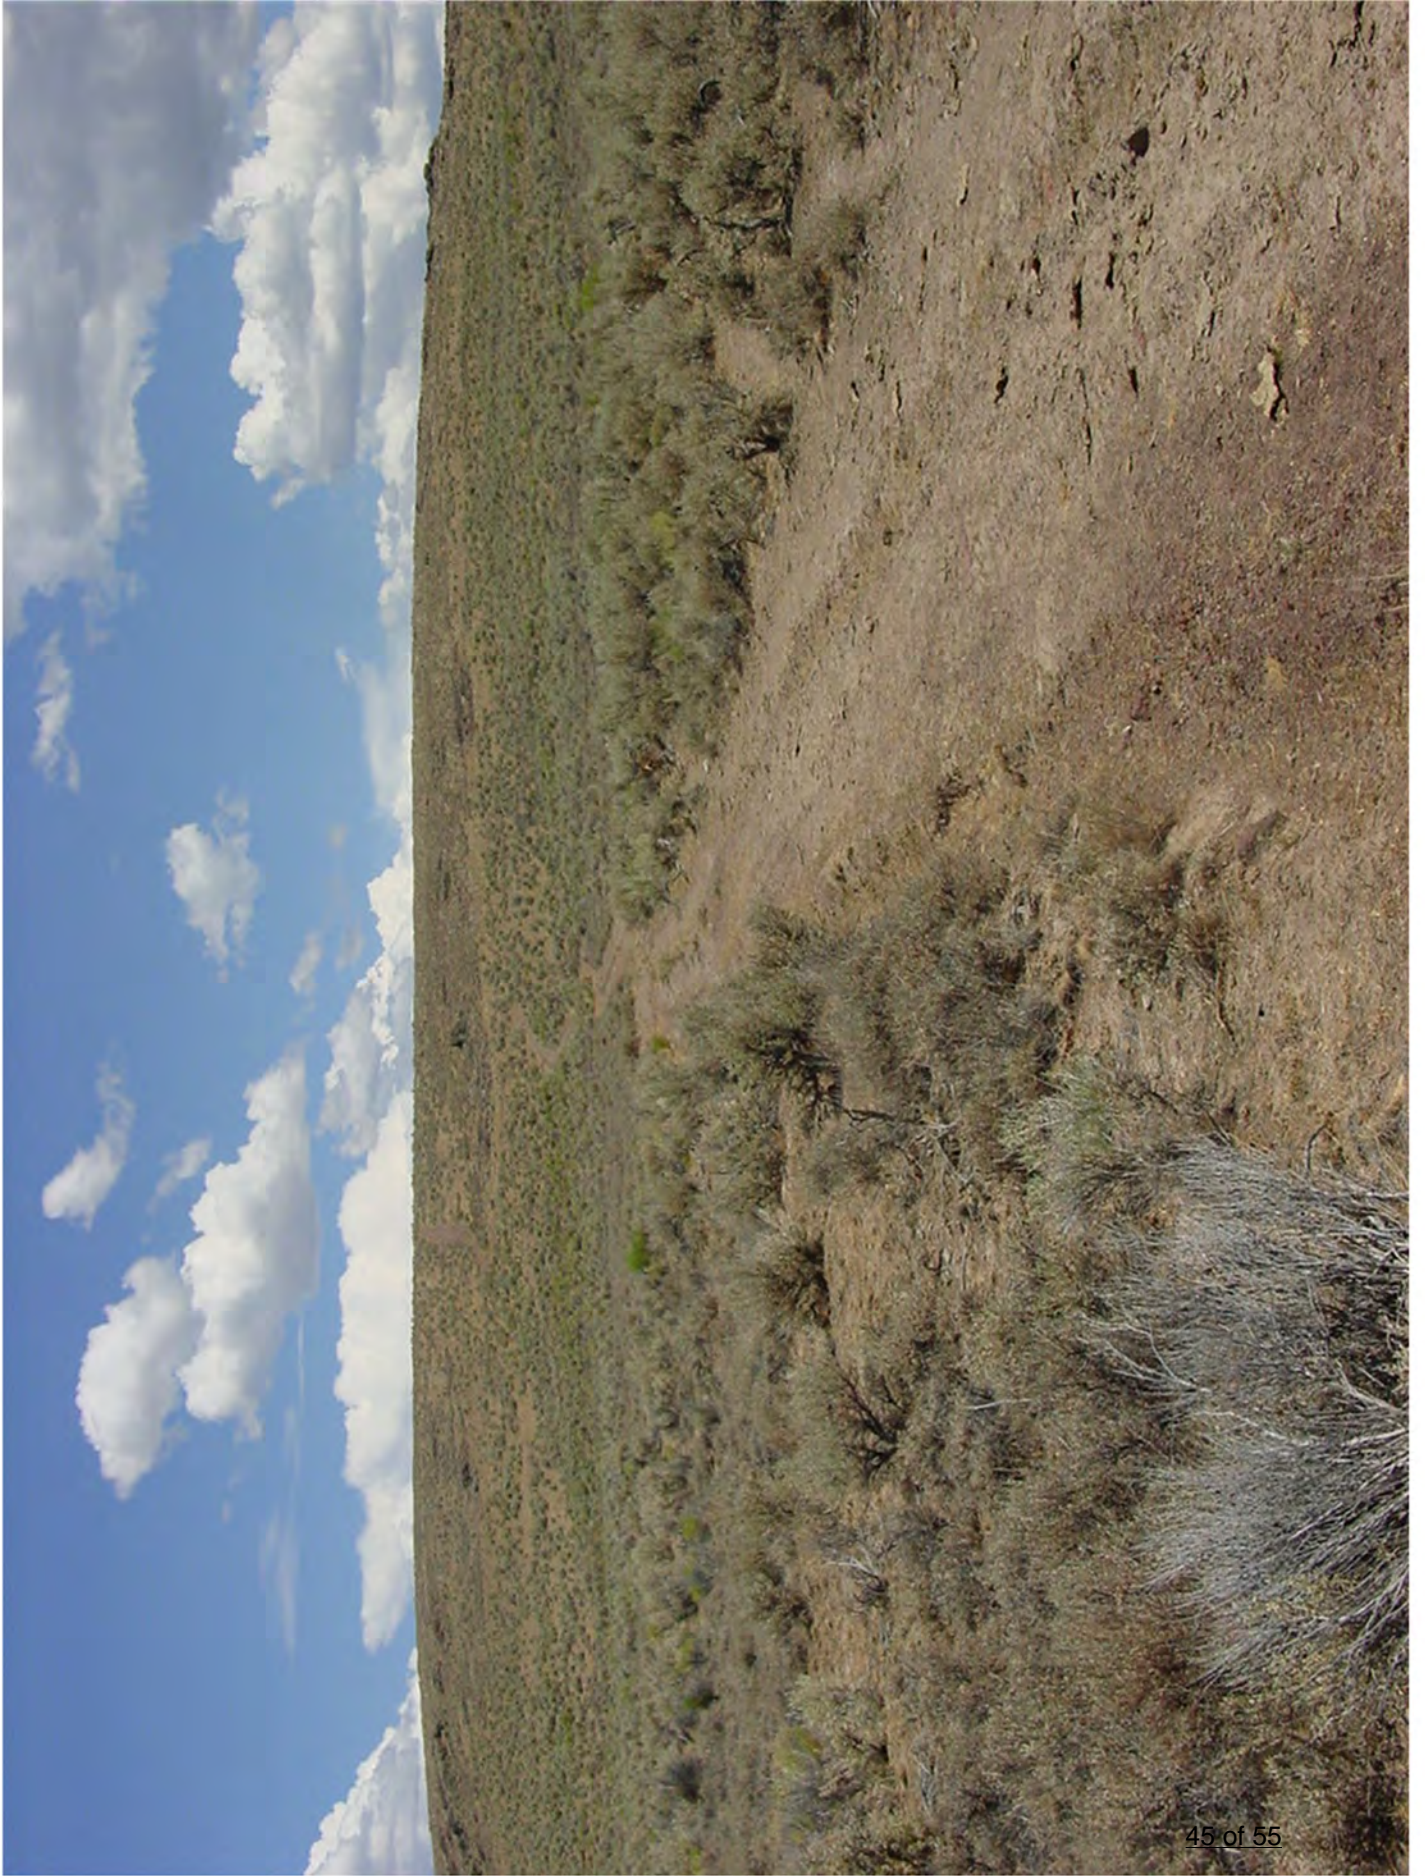
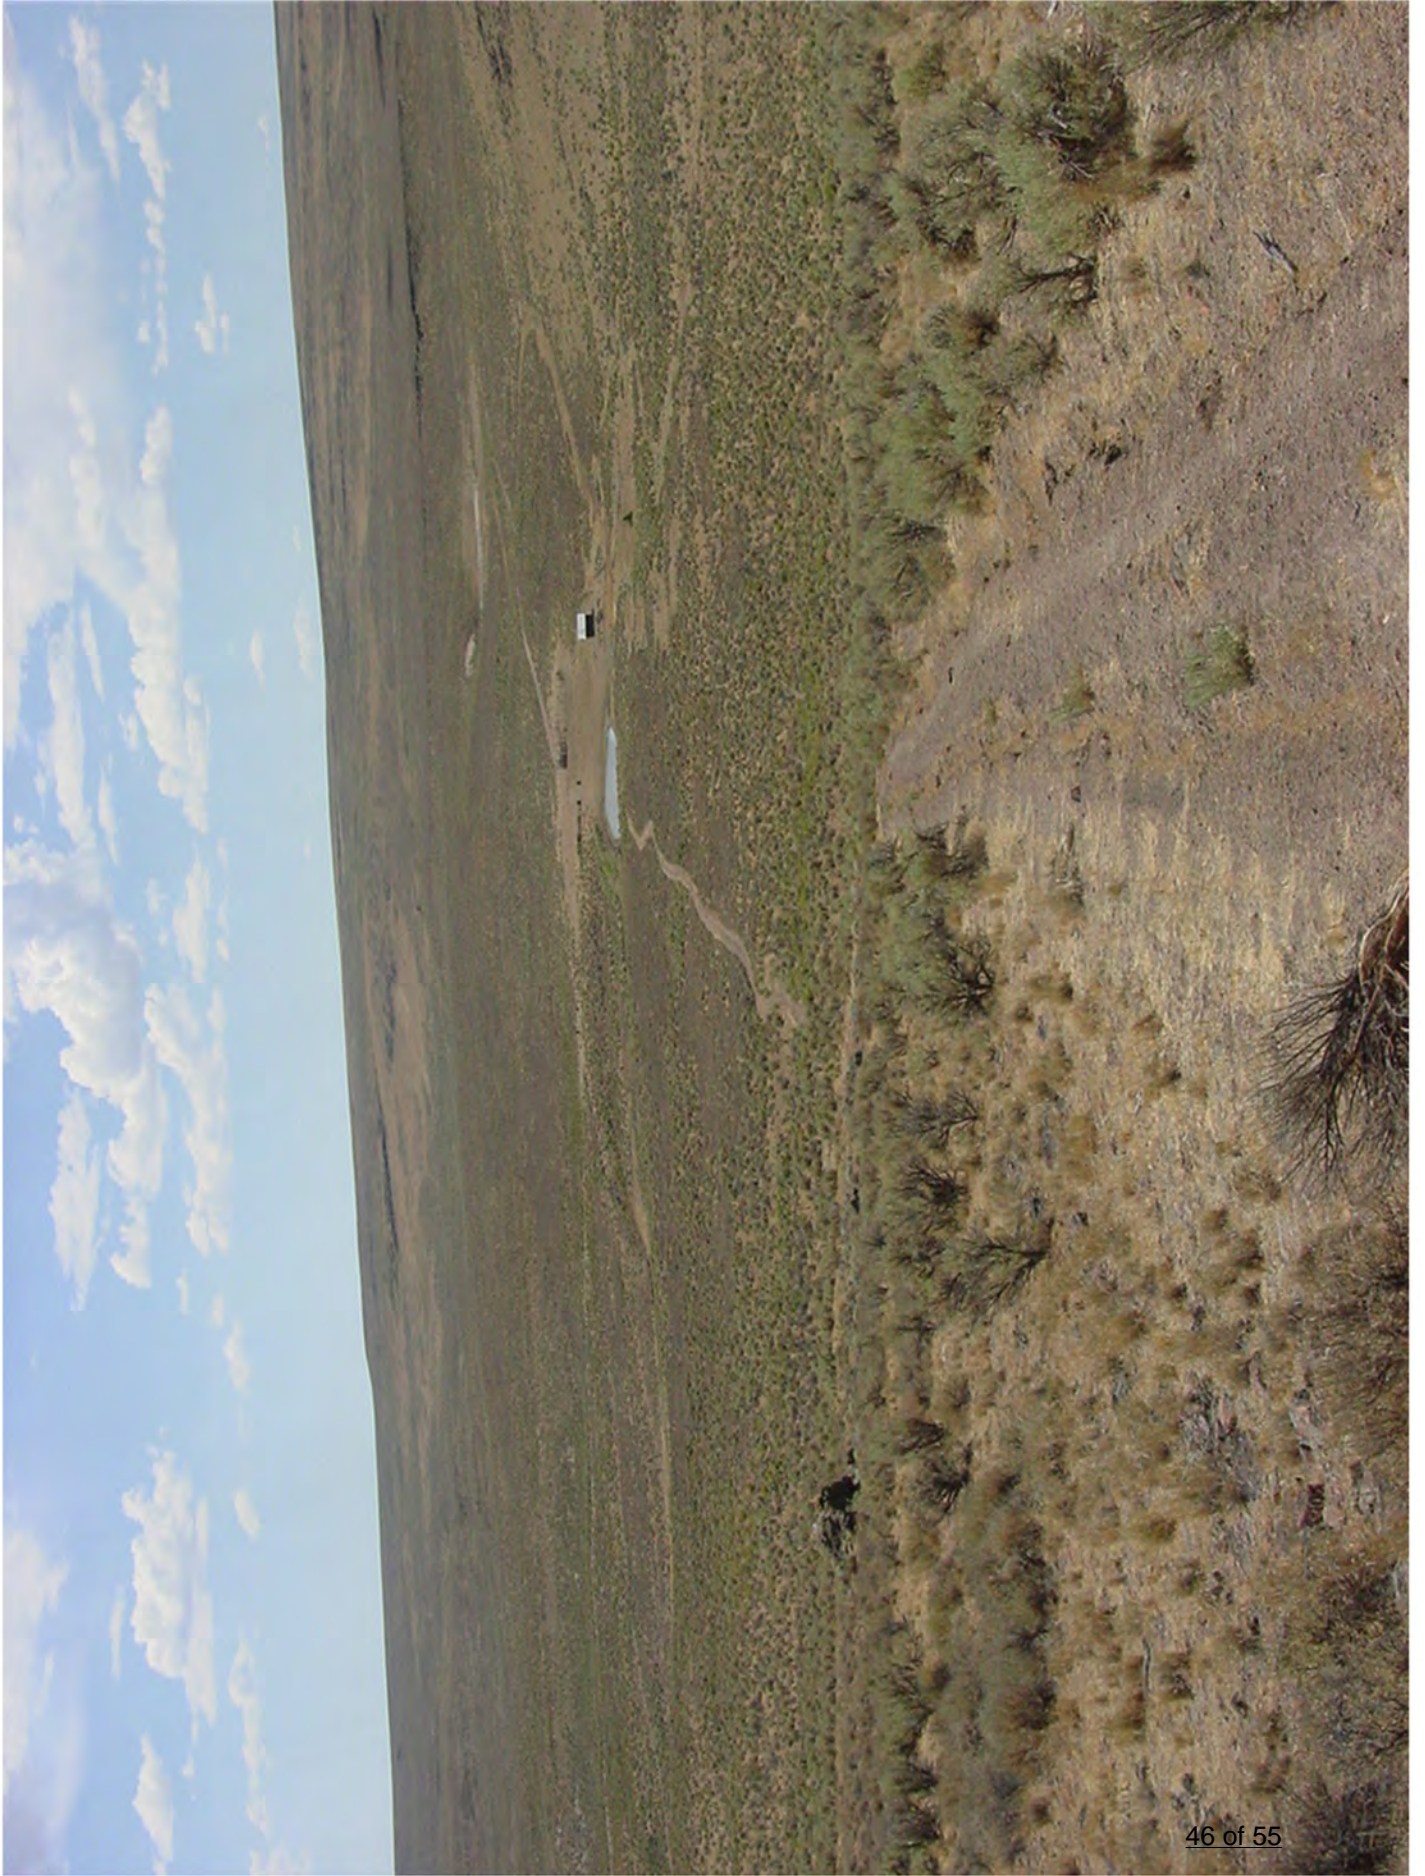
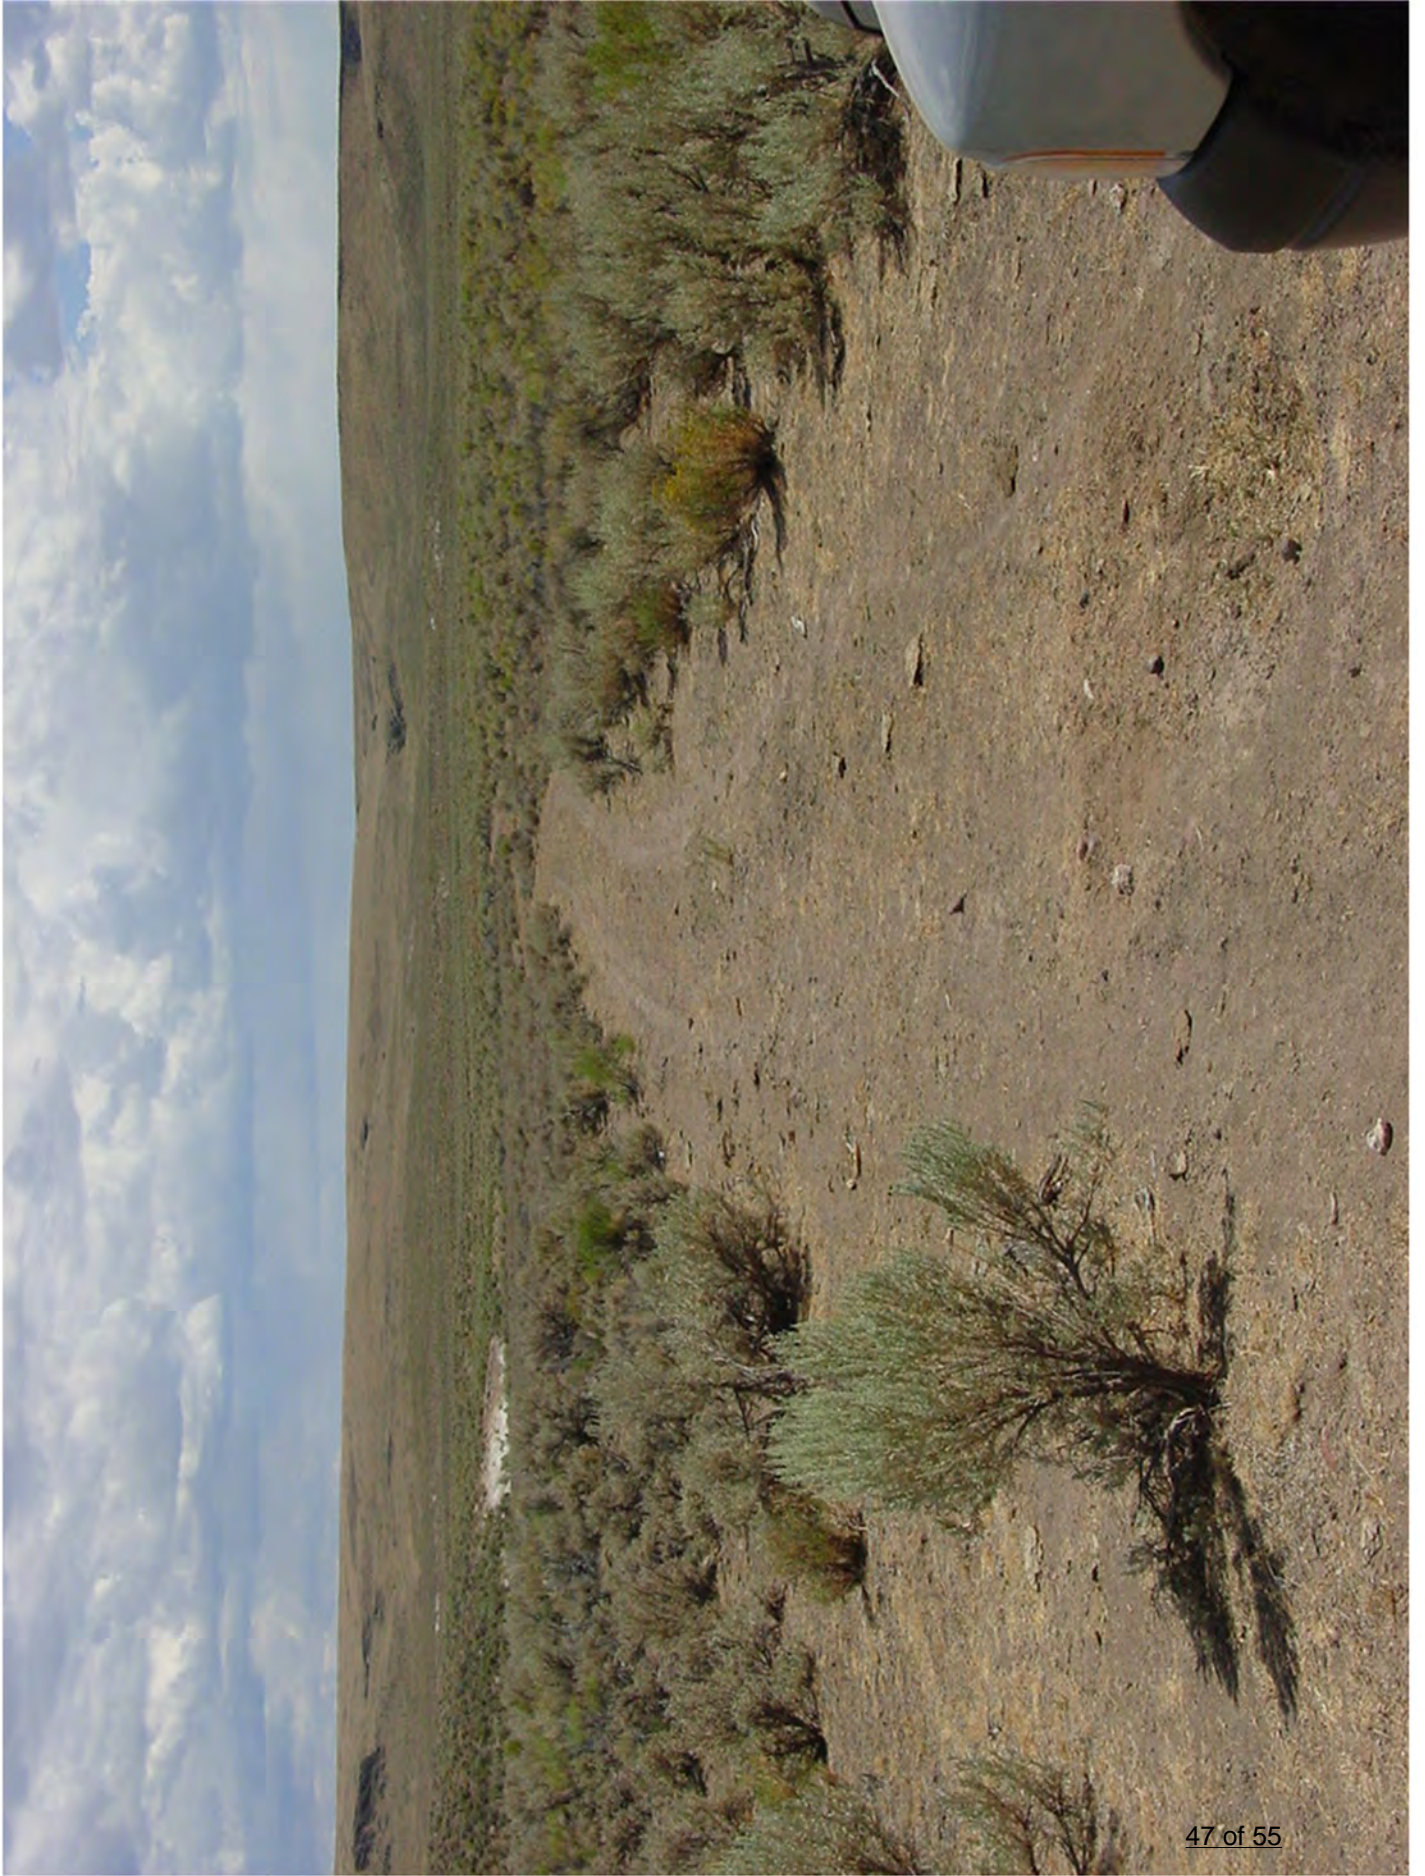
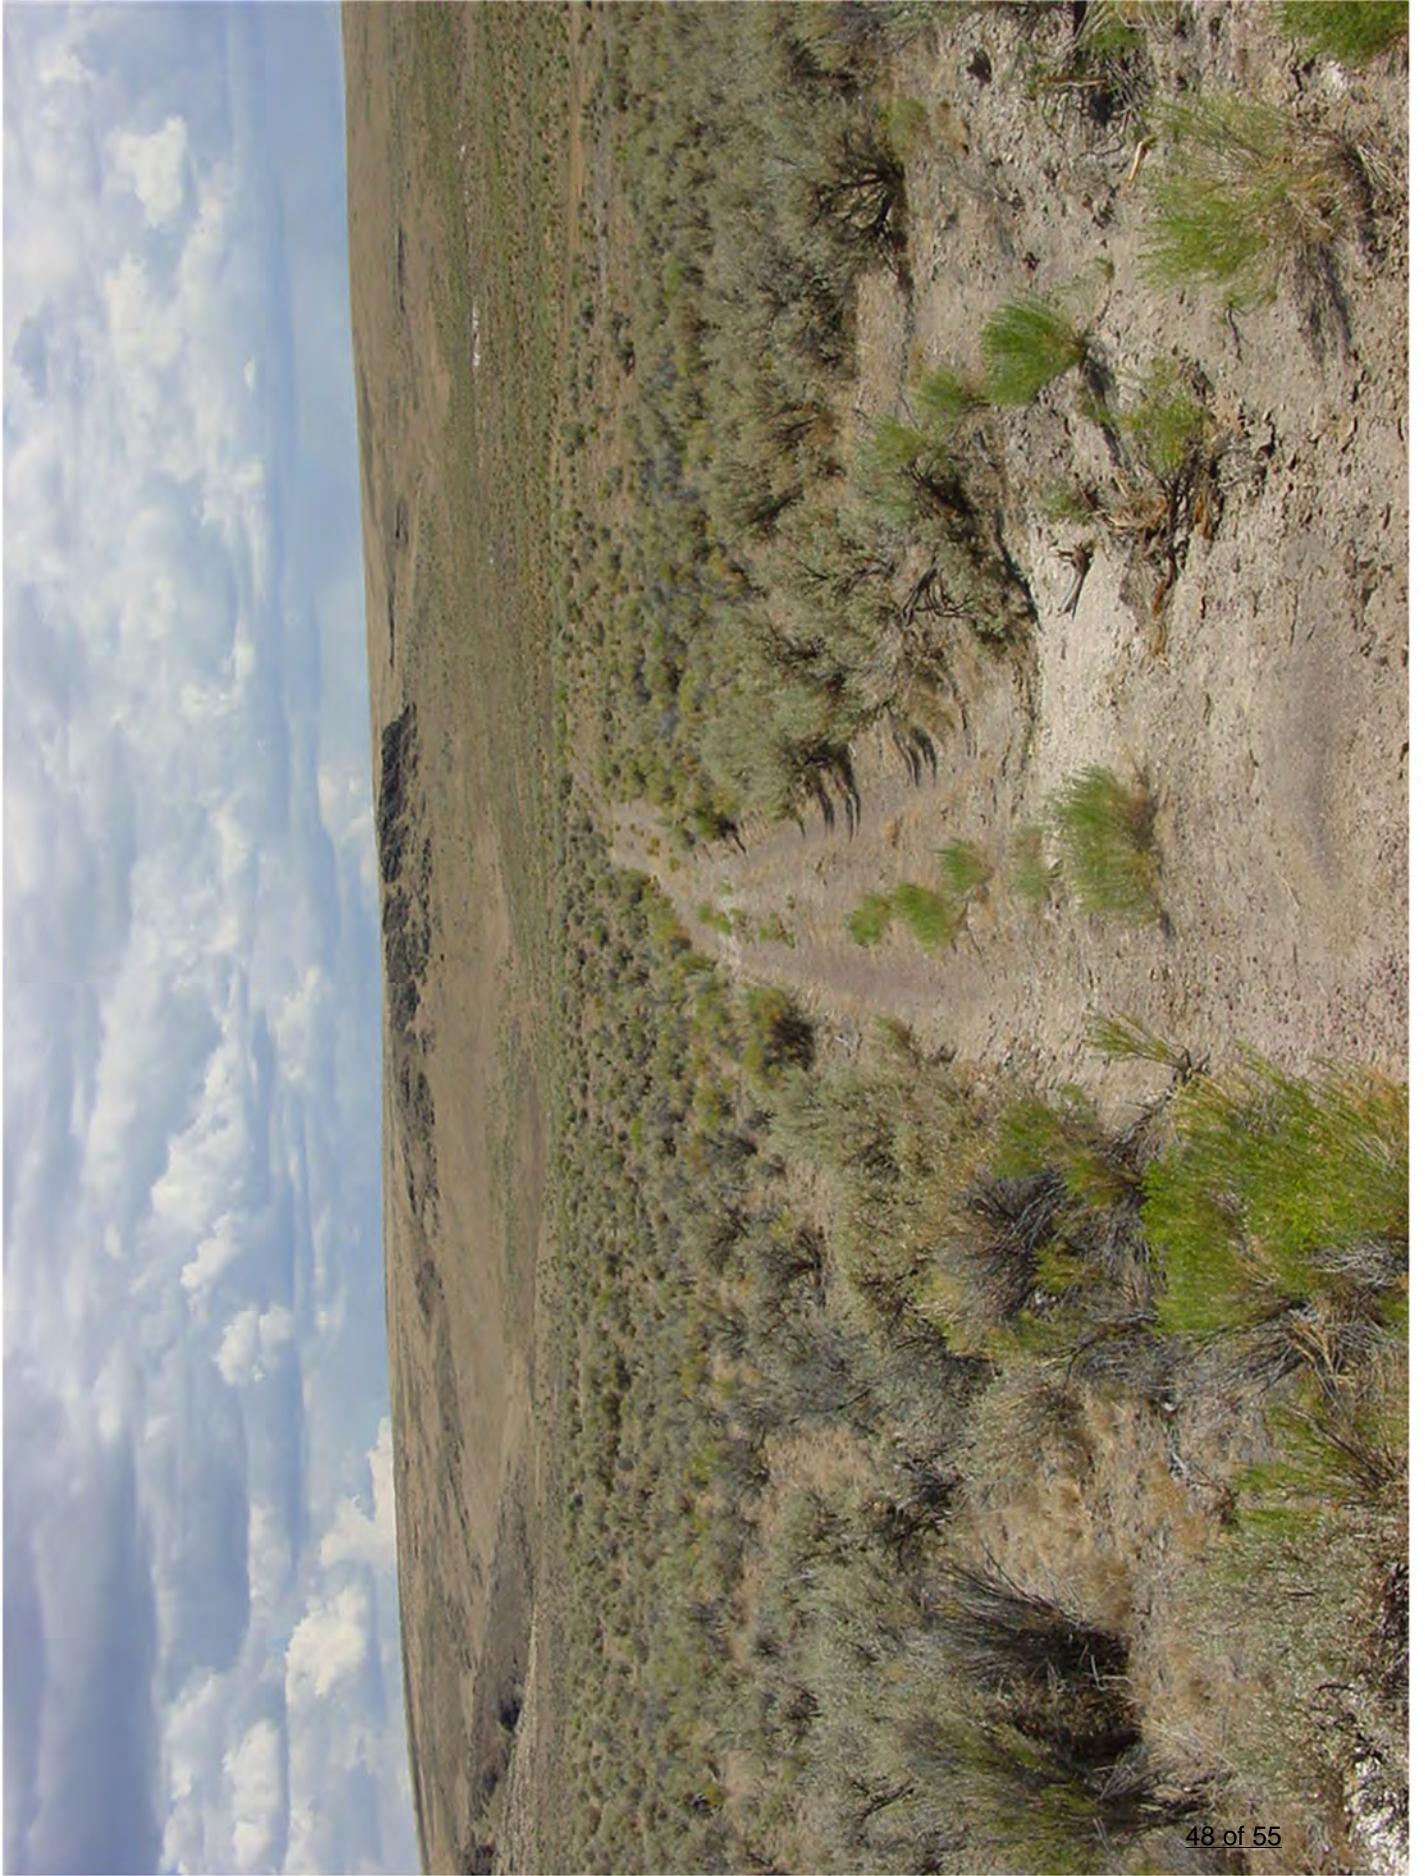
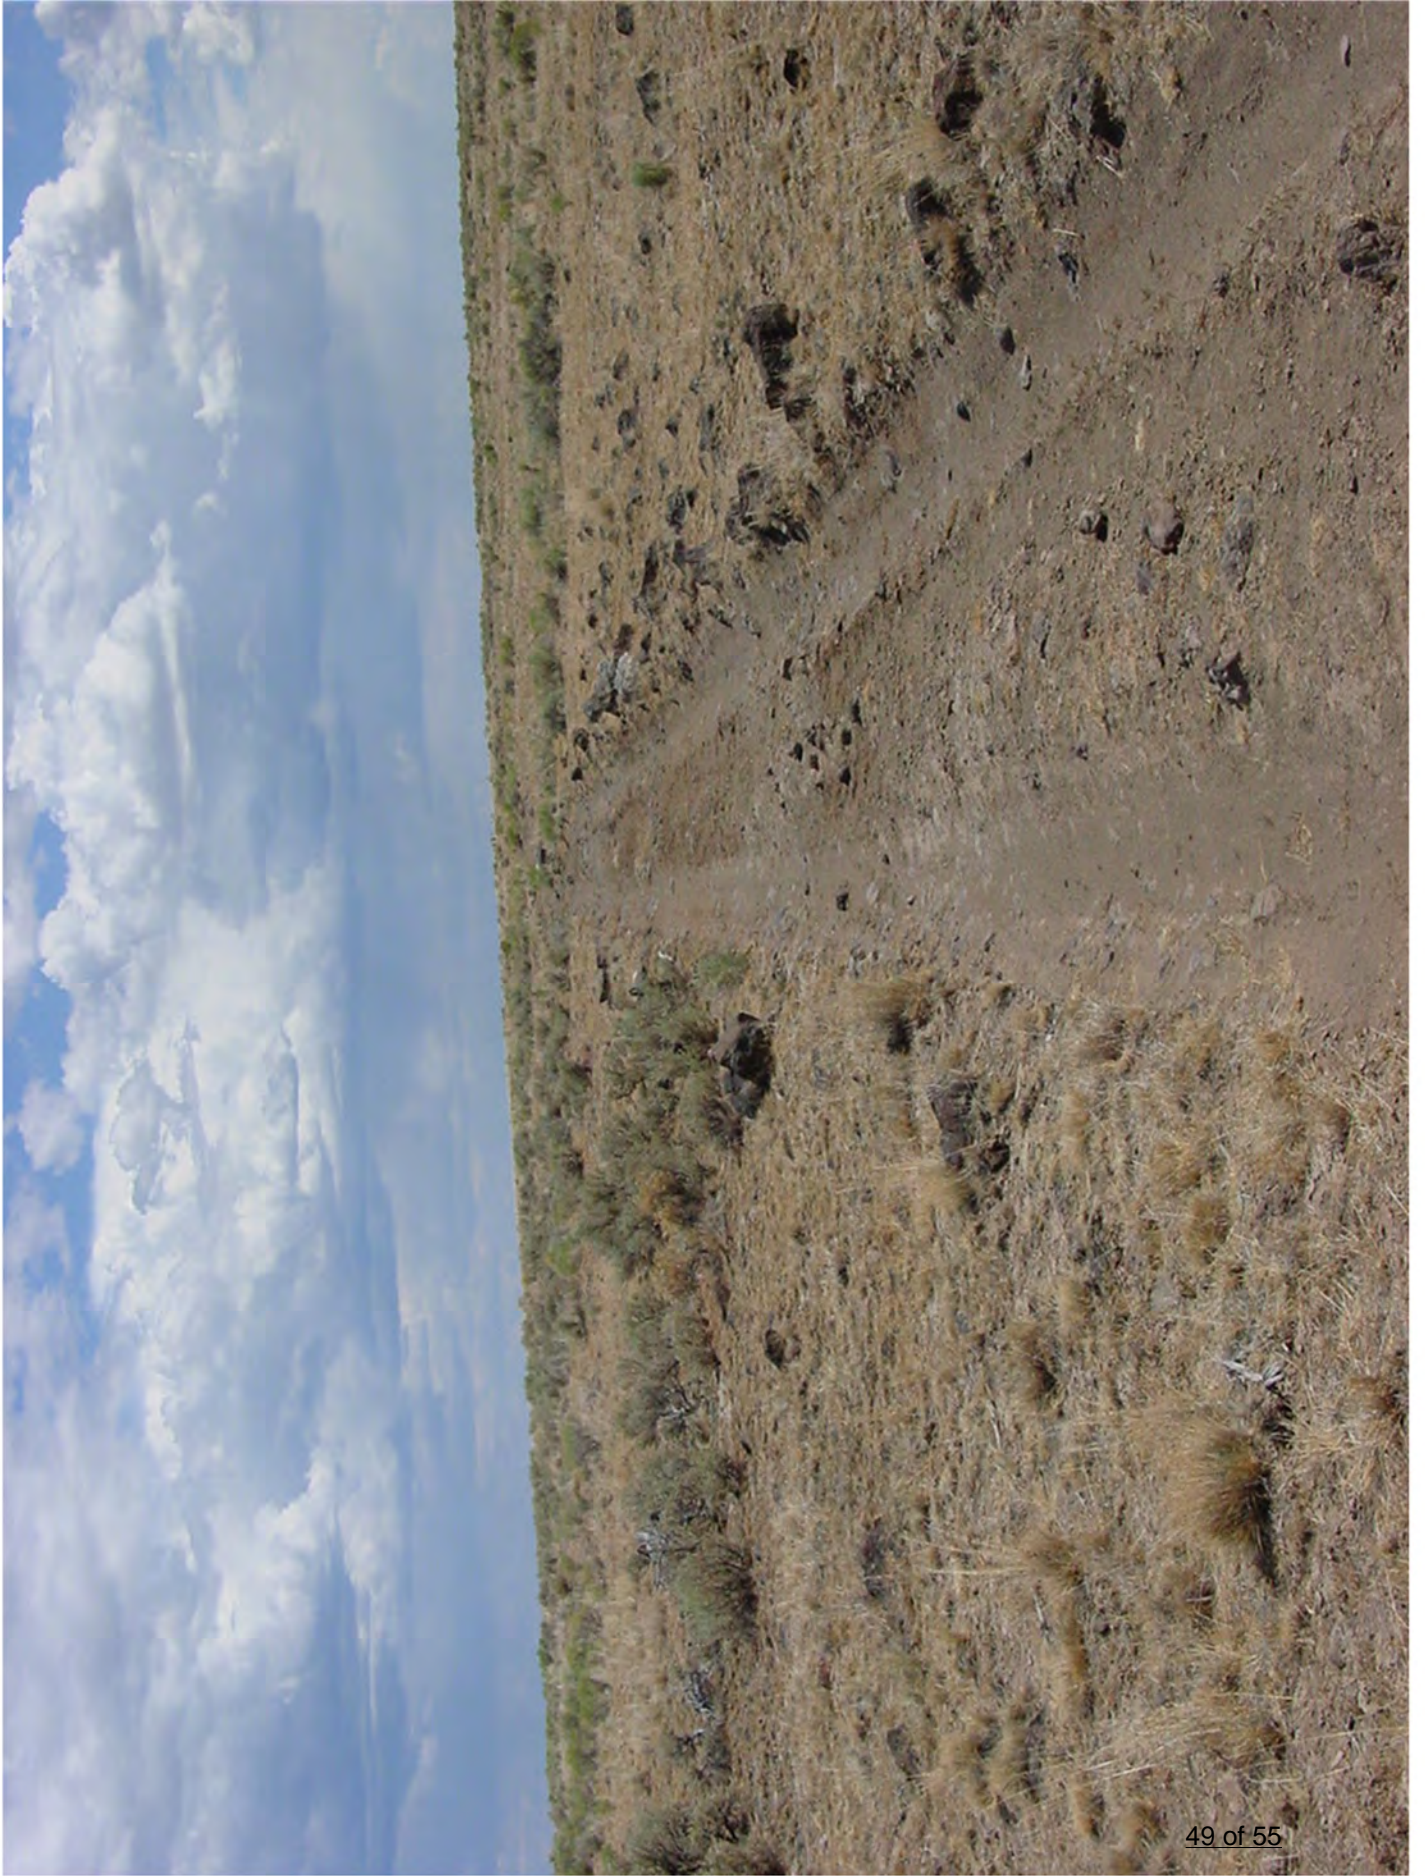
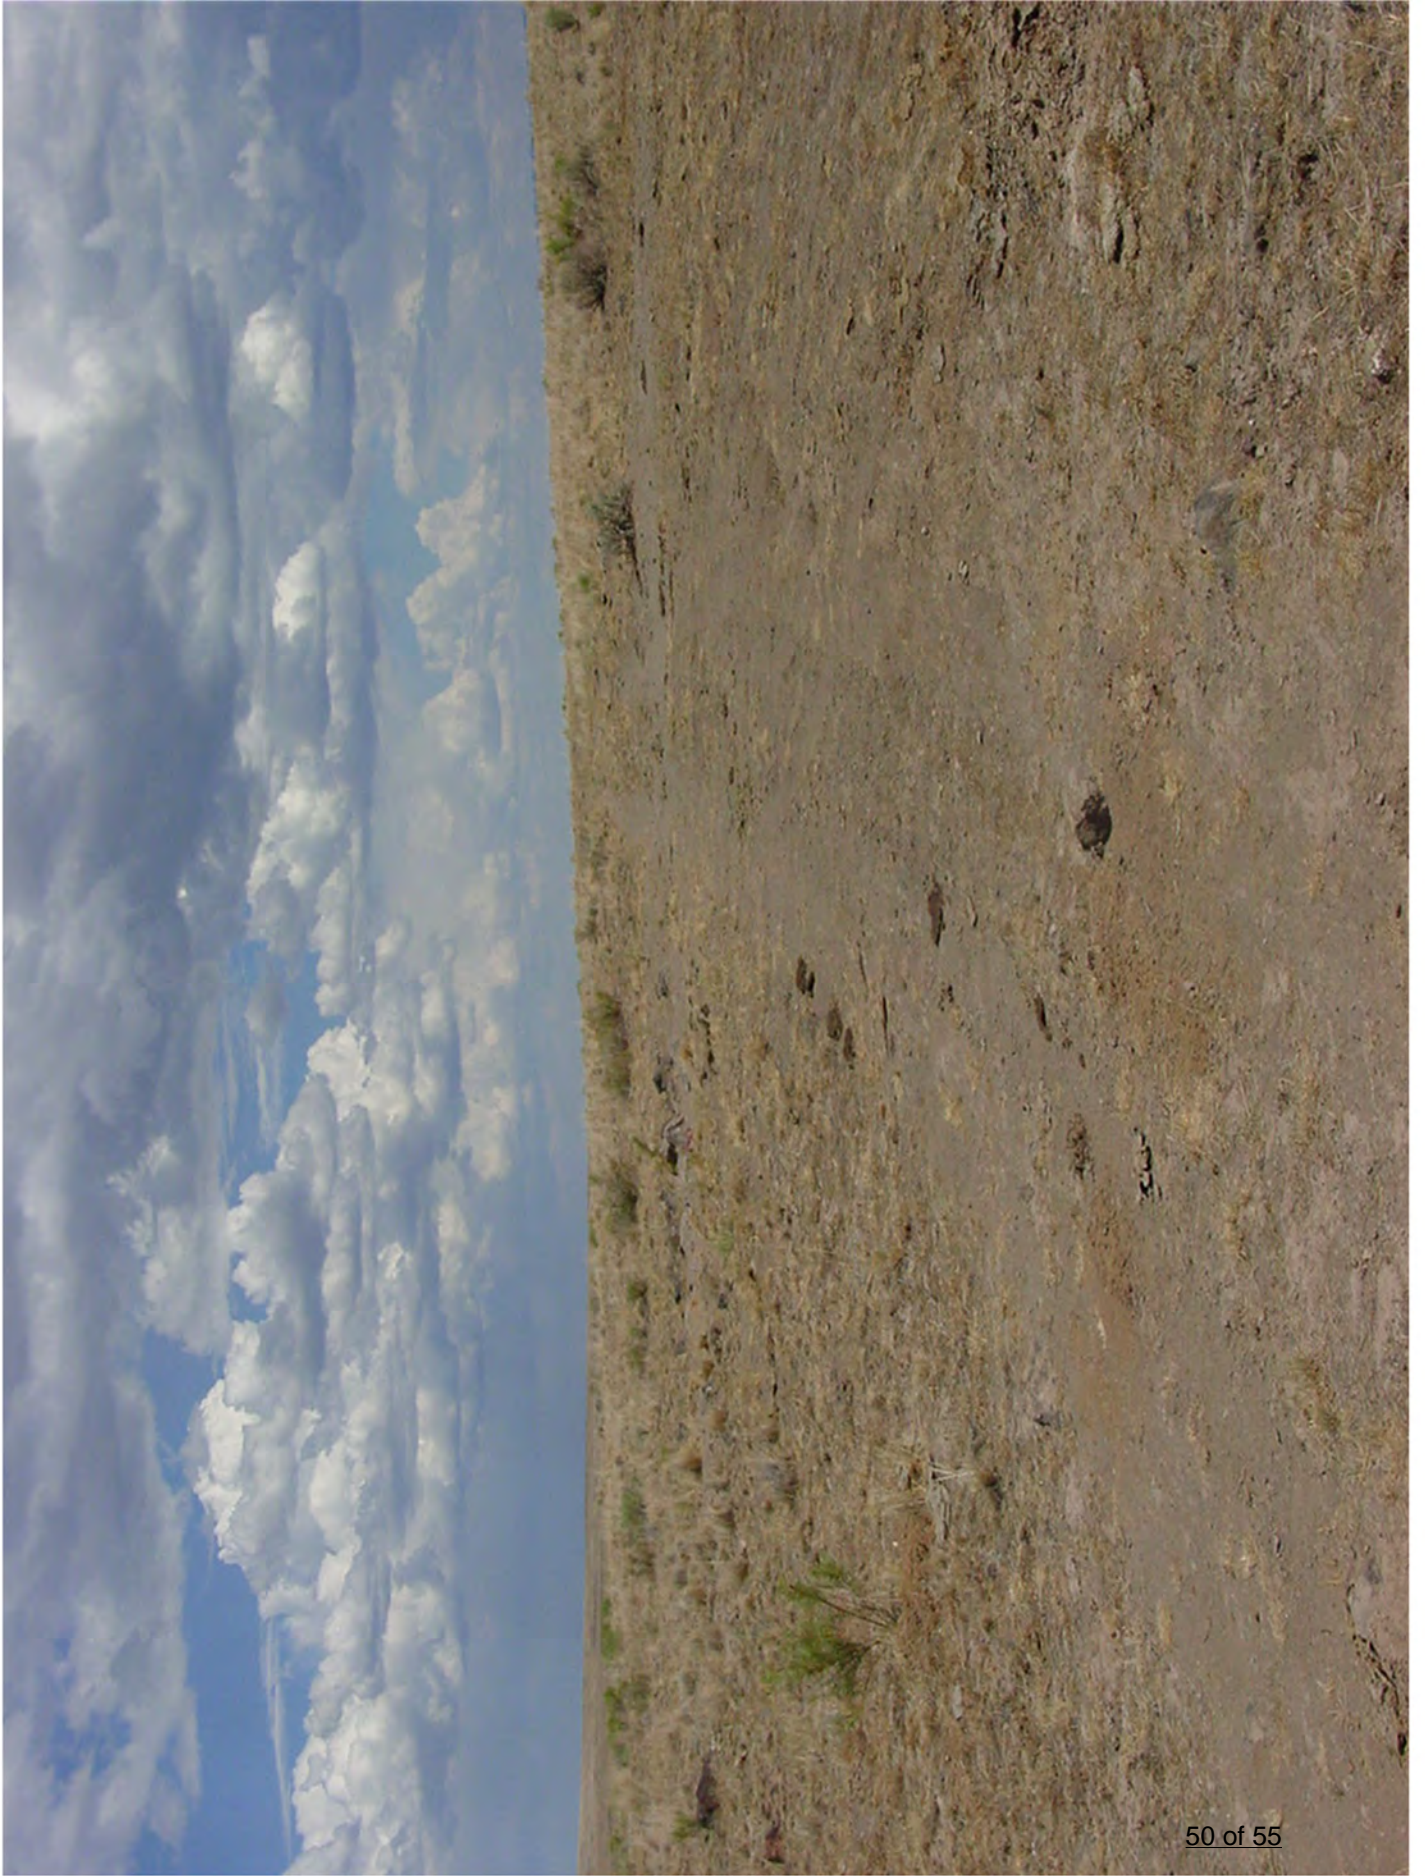
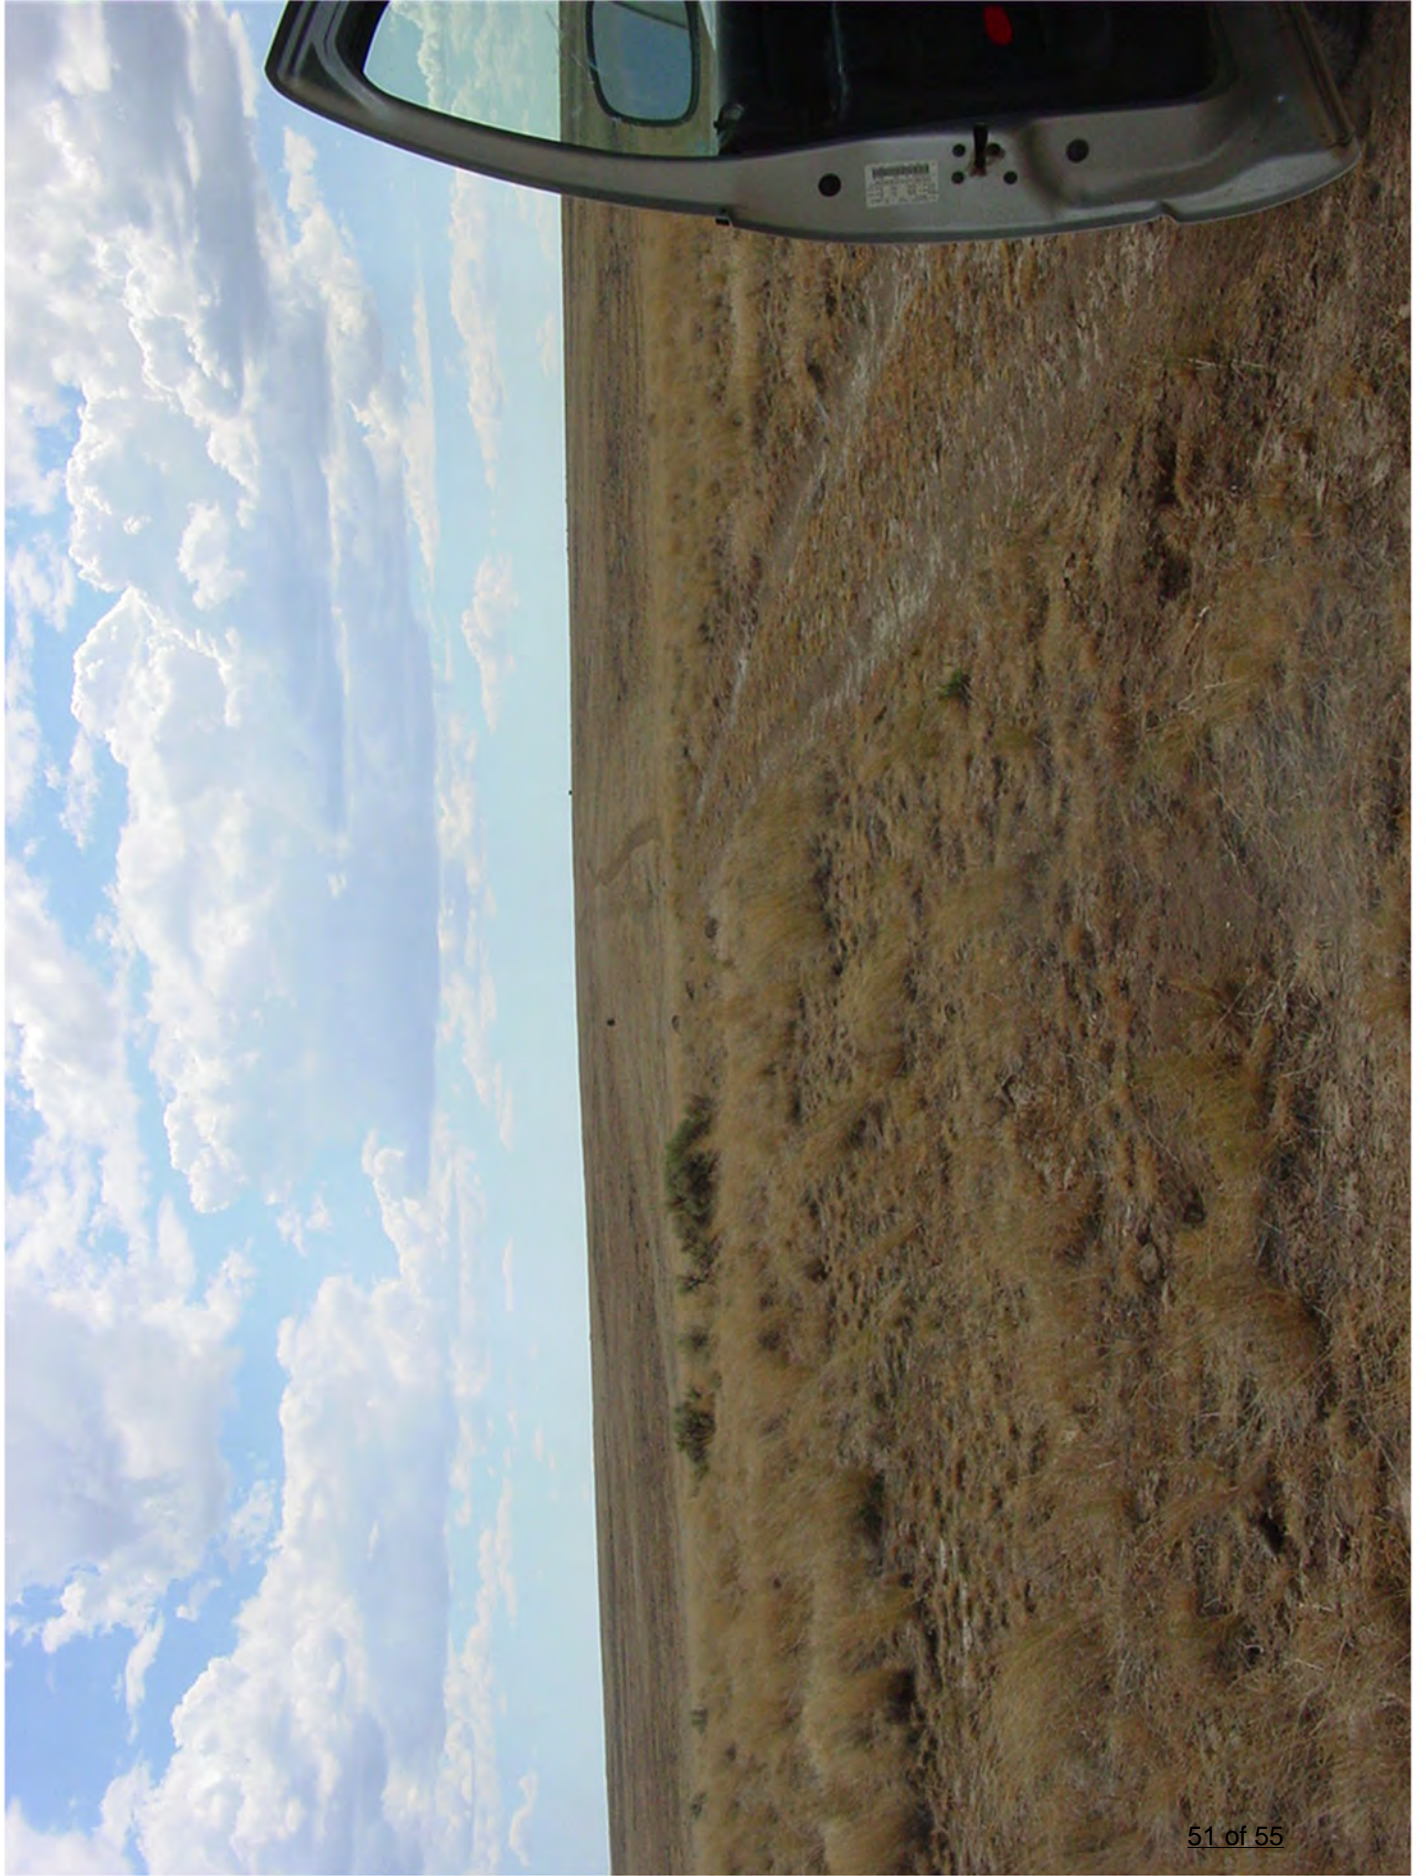
Hanson Canyon OR-036-016 Skull Creek Road County Road 522

DATE	Frame #	Camera Direction	Description	GPS/UTM Location	Township	Range	Section
7/26/2007	DSC02450	E	Uphill	478040 4717689	T34S	R44E	Sec 12
7/26/2007	DSC02451	W	Back to horsecamp	478352 4717689	T34S	R44E	Sec 12
7/26/2007	DSC02452	N	Visible road	478927 4717032	T34S	R45E	Sec 13
7/26/2007	DSC02453	N	Visible road	479420 4716761	T34S	R45E	Sec 13
7/26/2007	DSC02454	N	Grader berms	478943 4716458	T34S	R45E	Sec 13
7/26/2007	DSC02455	N	No need to grade	479170 4715440	T34S	R45E	Sec 13
7/26/2007	DSC02464	SW	Change directions	481833 4708084	T35S	R45E	Sec 05
7/26/2007	DSC02465	SW	Visible Road	482498 4708511	T35S	R45E	Sec 08
7/26/2007	DSC02466	SW	Visible road	481833 4708084	T35S	R45E	Sec 07
7/26/2007	DSC02467	SW	Road continues	478894 4706919	T35S	R44E	Sec 12
7/26/2007	DSC92468	SW	Gate to Twin Spring Pasture	476973 4705112	T35S	R44E	Sec 14
