Wilderness Inventory Unit Index of Documents  
**Black Butte OR-034-105, 19 total pages**

Year: 2010 Unit Number/Name: OR-034-105 — Black Butte

**Wilderness Inventory Unit Name/Number: OR-034-105 — Black Butte**

**BLM 034-RT57 (Vale District)**

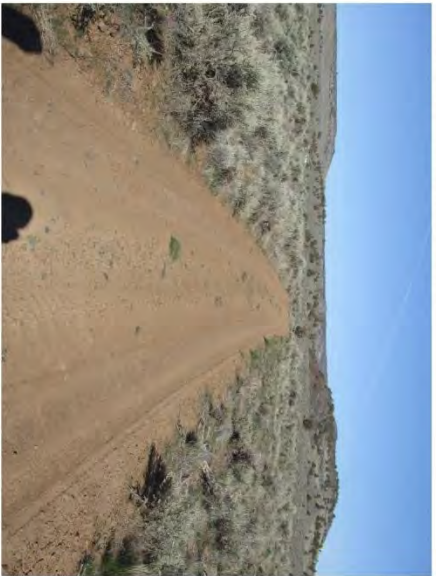
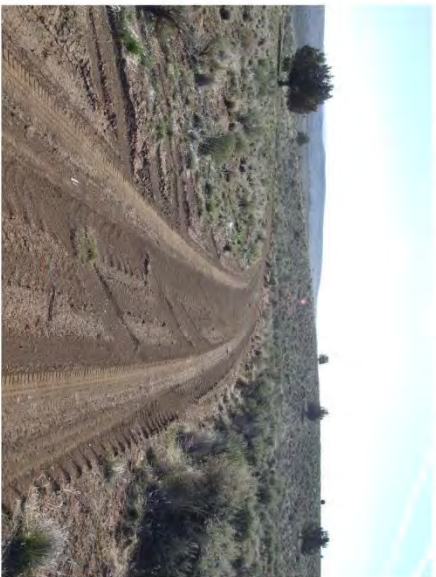
034-RT57-A-E.JPG

PHOTO LOCATION *	DIRECTION	PHOTO_TYPE	PHOTO DATE	COMMENTS
034-RT57-A	W	Route	20090407	Recent activity; berm, back.
034-RT57-B	E	Route	20090407	Recent activity; berm, front.
034-RT57-C	N	Route	20090407	Small berm, front.
034-RT57-D	S	Route	20090407	back
034-RT57-E	E	Route	20090407	back
034-RT57-F	E	Route	20090407	front
034-RT57-G	SE	Route	20090407	Berm, back
034-RT57-H	NW	Route	20090407	front
034-RT57-I	E	Route	20090407	back
034-RT57-J	W	Route	20090407	front
034-RT57-K	W	Route	20090407	front
034-RT57-L	E	Route	20090407	front
034-RT57-M	SE	Route	20090407	front

**Describe:** Date of original construction is not confirmed; date of right-of-way issuance for the communication facility site is Nov 9, 1988. The above actions have occurred, and rocks removed from the traveled surface of the route is evidenced.

**Explain:** Repeated blading has occurred (more than one berm on either side of the route is evidenced), and repeated ditch maintenance has been performed to manage surface water runoff and diversion.

Visual evidence of numerous apparently recent vehicle passes observed. Also, visual evidence of recent tracks remain of heavy equipment (likely a grader) likely due mechanical maintenance performed on the route.
