Wilderness Inventory Unit Index of Documents  
**Board Corral Spring OR-034-015, 20 total pages**

Year: 2009 Unit Number/Name: OR-034-015 – Board Corral Spring

**Unit Number/Name -- OR-034-015 – Board Corral Spring**

**Wilderness Inventory Unit Name/:** OR-34-015 – Board Corral Spring

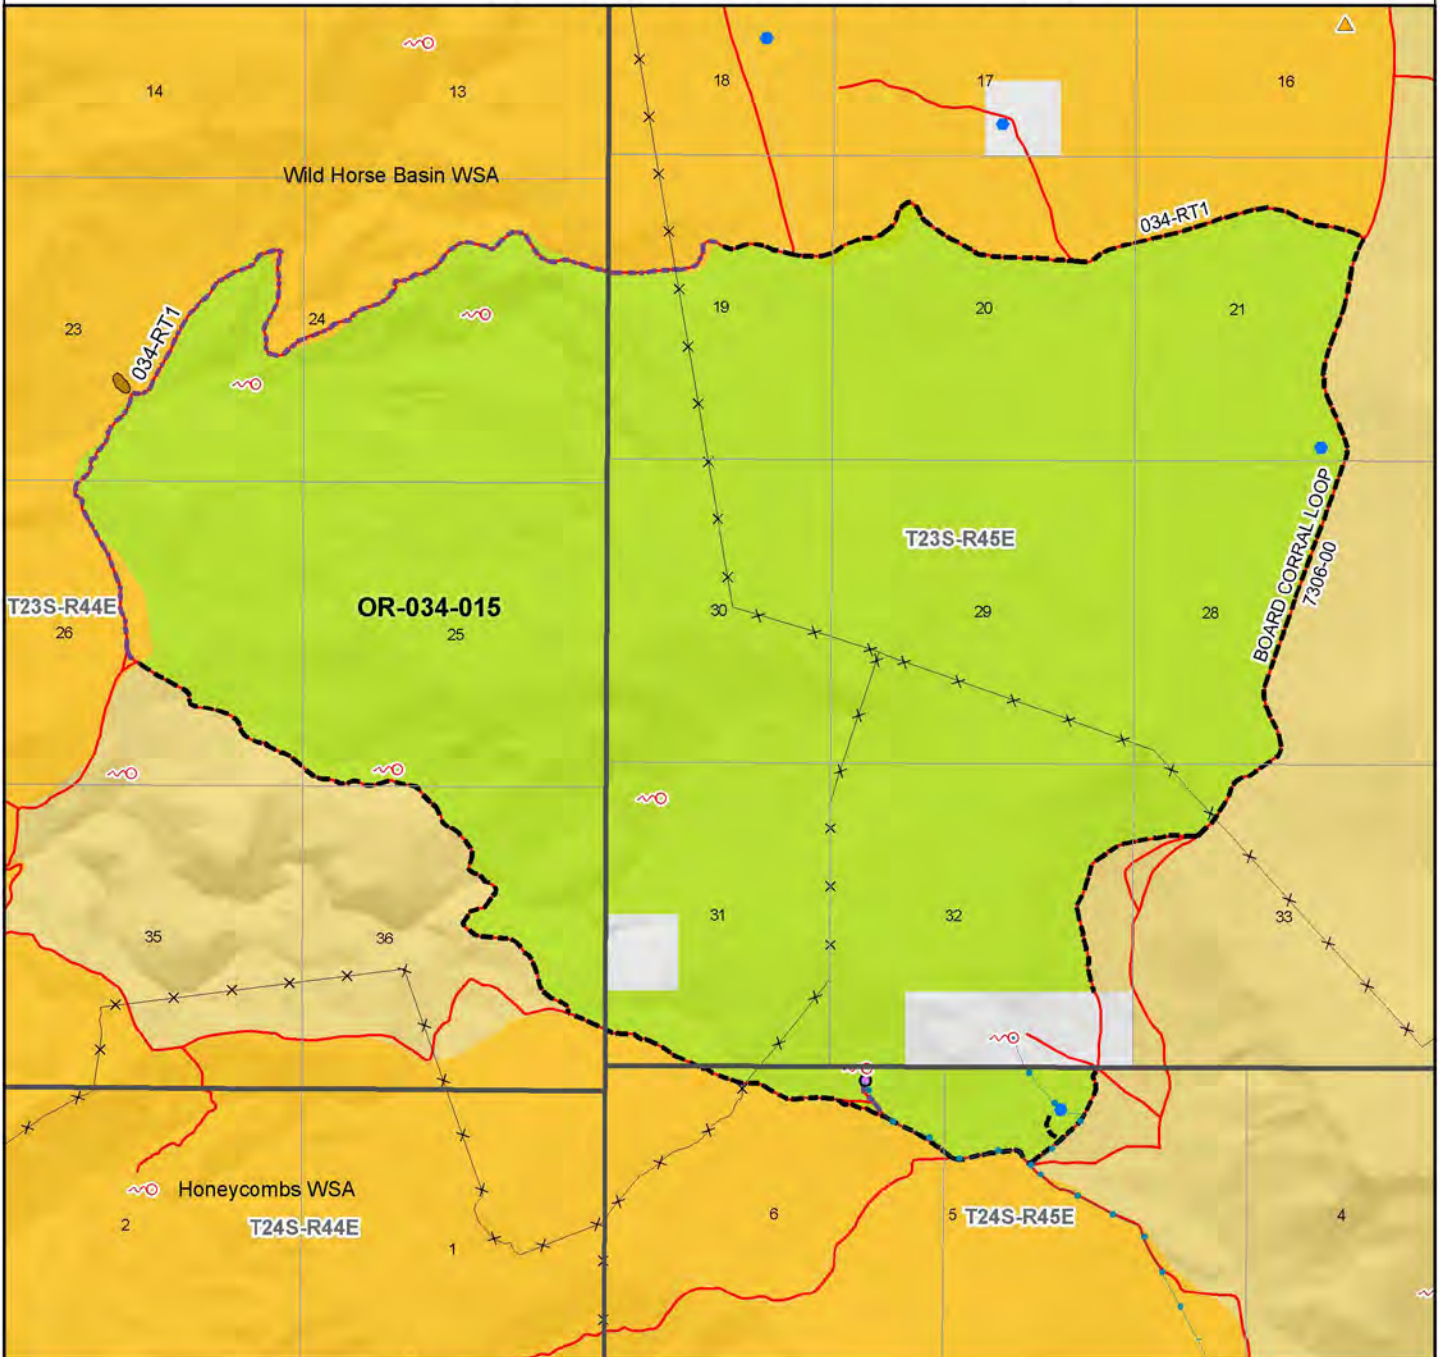
## Board Corral Spring - OR-034-015 - Map 1 of 2

**Description:** Refer to this unit’s associated Map 1 for its location. The boundaries are nearly the same as those identified in BLM’s original wilderness characteristics inventory of the late 1970’s. The difference is the present clarification of the unit’s road boundary location in its southeast corner. The 5,416 acre unit is bounded partially by roads and a 160 acre private parcel in the unit’s southeast sector. While bounded the same as that of ONDA’s proposal, the acreage variance between ONDA and BLM is due to GIS application methods for acreage determination. The unit’s east boundary is BLM road 7307-0-00; the unit’s south boundary is the road which partially abuts Honeycombs WSA, OR-3-77A; a 40 acre private parcel inholding and one very short cherry stem road to a National Interagency Fire Center weather station are also features of the unit’s boundary. The unit’s boundary roads receive mechanical maintenance as needed to keep them passable on a relatively regular and seasonally continuous basis.

Refer to this unit's associated Map 1 and Map 2 for human developments within the unit. They include 4.5 miles of fence, two earthen reservoirs, a fence enclosure associated with another water source (not on maps), 0.4 miles of buried water pipeline, and 5 developed springs. A 0.1 mile long motorized primitive trail (MPT) enters the unit to Rookie Spring. In 1966, approximately a third of the unit was affected by a chemical treatment brush control project (see this unit's associated Map 2). Approximately 150 acres in the unit's southeast corner were affected by the 1970 Sheepheads crested wheatgrass drill seeding. During the late 1970's wilderness characteristics inventory, the plow and drill seeding project was determined to be substantially noticeable to the average visitor. At the time, the seeding adversely affected the area's natural condition and appearance. Presently, due to the nature of the soils in the area of the drilled seeding, the visual evidence of the seeding and the earlier brush control project is no longer substantially noticeable as a human imprint to the average visitor of the unit. Overall, the inventory unit appears to be affected primarily by the forces of nature with the imprint of humans being substantially unnoticeable to the average visitor.

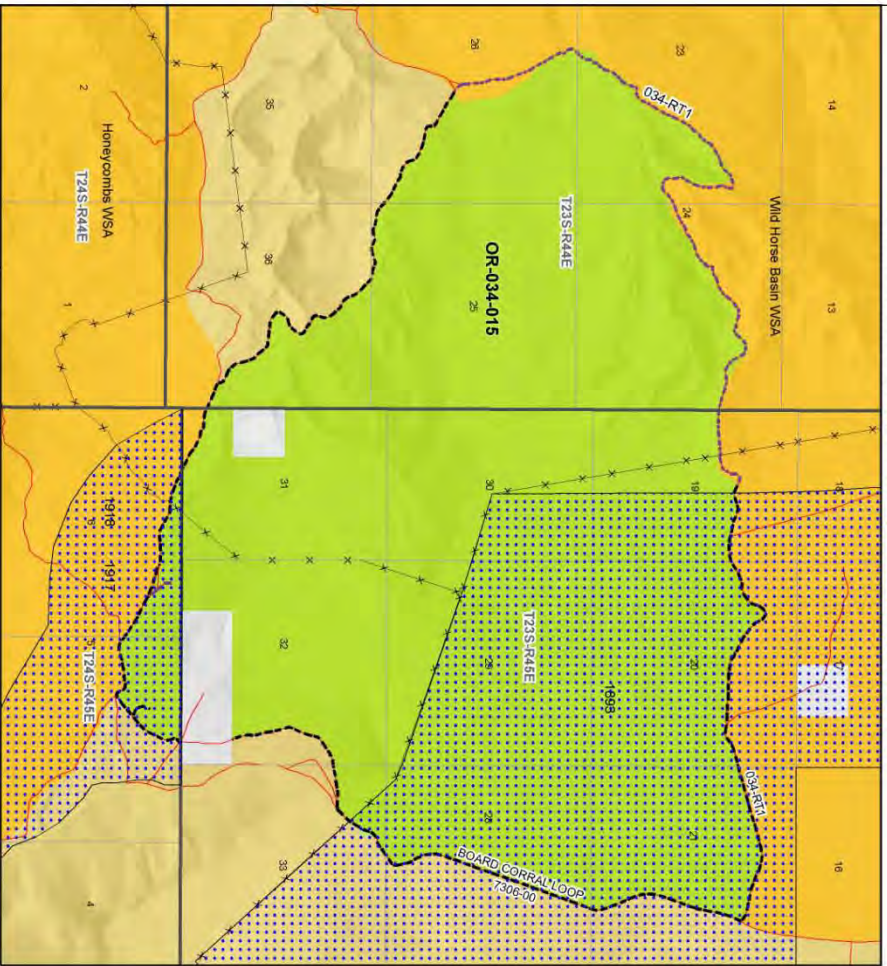
**Wilderness Characteristics - Land Treatments**  
**Board Corral Spring - OR-034-015 - Map 2 of 2**

OBJECTID*	NAME	TREATMENT TYPE	SEED GROUP	DATE
1893	BOARD CORRAL'S BRUSH CONTROL	Chemical Treatment	Not Applicable	1968
1917	SHEEPHEADS SEEDING	Plow/Disc	Not Applicable	1970
1918	SHEEPHEADS SEEDING	Drill Seeding	Unknown	1970

Note: The Land Treatments represented by navy blue dots on the map to the left are labeled with the treatments' ObjectIDs listed in the first field of the Land Treatments table shown above. Multiple types of treatments may have been applied to the same area. For example, one treatment area may have been plowed and drill seeded - a record is shown in the table for each type of treatment.

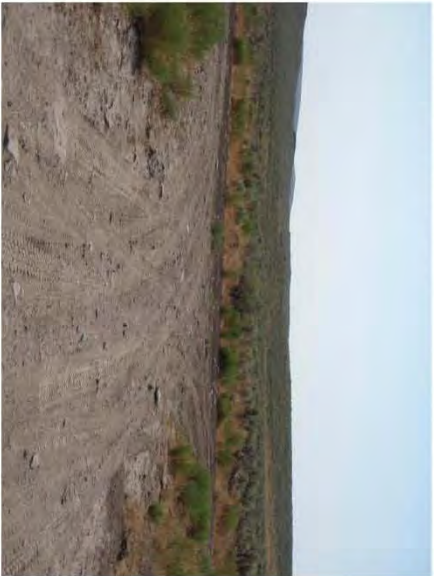
034-RT1-A-E.JPG

**Explain:** From BLM photo point (PP) 034-RT1-A Point west to the ridge crest in section 19, maintenance with a bulldozer has been conducted as recently as 2006 to support wild horse management or wild fire suppression activities (Cherry Creek Fire).

**Explanation:** As described and explained above, the portion of this route from its confluence with 7306-0-00 (PP 034-RT1-A) west to the cross fence in section 19 was a road in 1980 and remains a road presently. From the cross fence west

**Comments:** 1. Yes -- BLM would maintain the road for wild horse management and access to private land from PP 034-RT1-A and to the cross fence in section 19. 2. No -- BLM would not maintain the route from the cross fence to PP 034-RT1-G. Should this segment of the route become unusable, access for outdoor recreation users would decline and the alternative south boundary road of this BLM WC inventory would receive increased use.

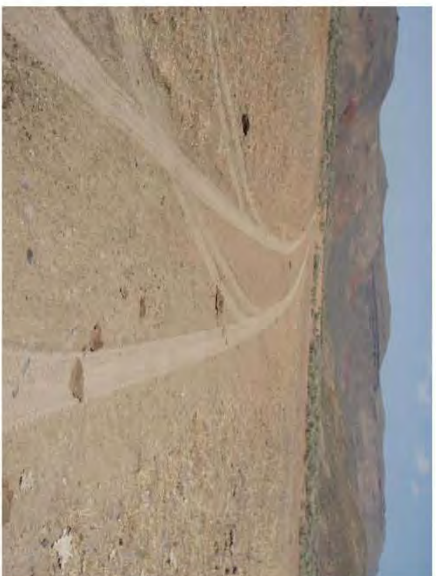
034-RT1-G-N.JPG

and south to PP 034-RT1-G (i.e, this BLM WC inventory unit’s south boundary road), this route segment no longer meets minimum road criteria. It presently is a motorized primitive trail ((MPT). This route segment of MPT status results in BLM WC inventory unit OR-034-015 being contiguous with Wild Horse Basin WSA, and with the vehicle route from PP 034-RT1-A west to the cross fence being a cherry stem road.
