Wilderness Inventory Unit Index of Documents
Cairn C OR-036-003, 22 total pages

Unit Name/Number: Cairn C OR-036-003

Wilderness Inventory Area Name and Number (Unit ID): Boundary road between BLM Cairn-C OR-036-003 and Deer Flat OR-036-005

Route Name and/or Identifier: BLM Road 8300-6-01; Oregon Butte proposed WSA Addition WO15a

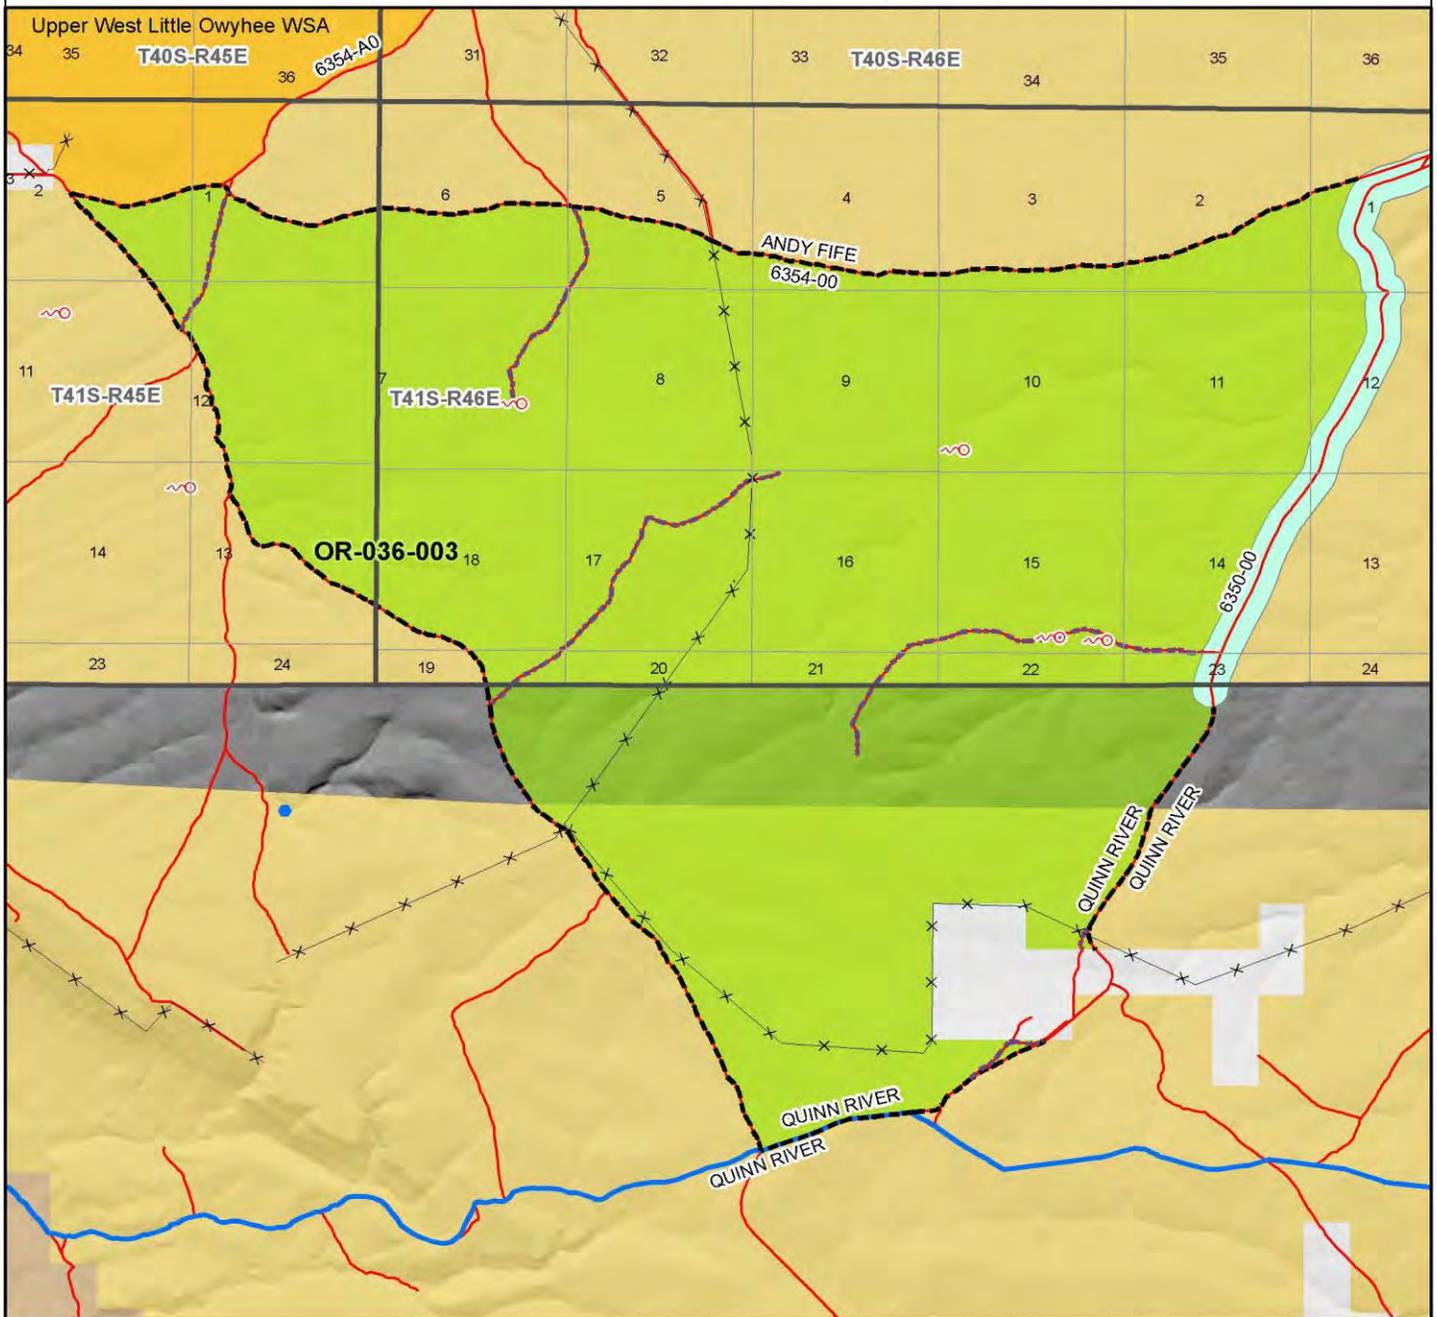
Cairn C - OR-036-003 - Map 1 of 1

Description: The boundaries of unit OR-036-003 are identified as BLM road 6350-0-00 on the east, BLM road 6354-0-00 on the north, BLM road 8300-6-01 on the west, and the Quinn River Road in Nevada on the south. BLM road 6350-0-00 continues south to meet the Quinn River Road. The unit is surrounded by 14.65 miles of boundary roads. Periodic maintenance of these boundary roads has occurred in the past (no confirmed dates available) and they are used regularly by ranchers (as observed by current BLM staff) and BLM employees for livestock management. Refer to map 2007_Cairn_C_OR_036_003.pdf for the unit boundary.

The unit exhibits a near natural condition throughout because fenceline generally blend in with the waist-high big sagebrush, the motorized primitive trails are few and widely scattered, and two of the three spring developments are substantially unnoticeable due to their small size. Cairn spring and meadow complex can be observed from the Tent Creek Road (BLM Road 6350-0-00). Overall the area appears to be primarily affected by the forces of nature with the imprint of human activity substantially unnoticeable. Refer to map 2007_Cairn_C_OR_036_003A.pdf for human imprints.
