Wilderness Inventory Unit Index of Documents  
**Clarks Butte Contiguous OR-036-057, 46 total pages**

Year: 2011 Unit Number/Name: OR-036-057 – Clarks Butte Contiguous

## **FORM 2 -- DOCUMENTATION OF CURRENT WILDERNESS INVENTORY CONDITIONS**

**Unit Number/Name** – **OR-036-057—Clarks Butte Contiguous**

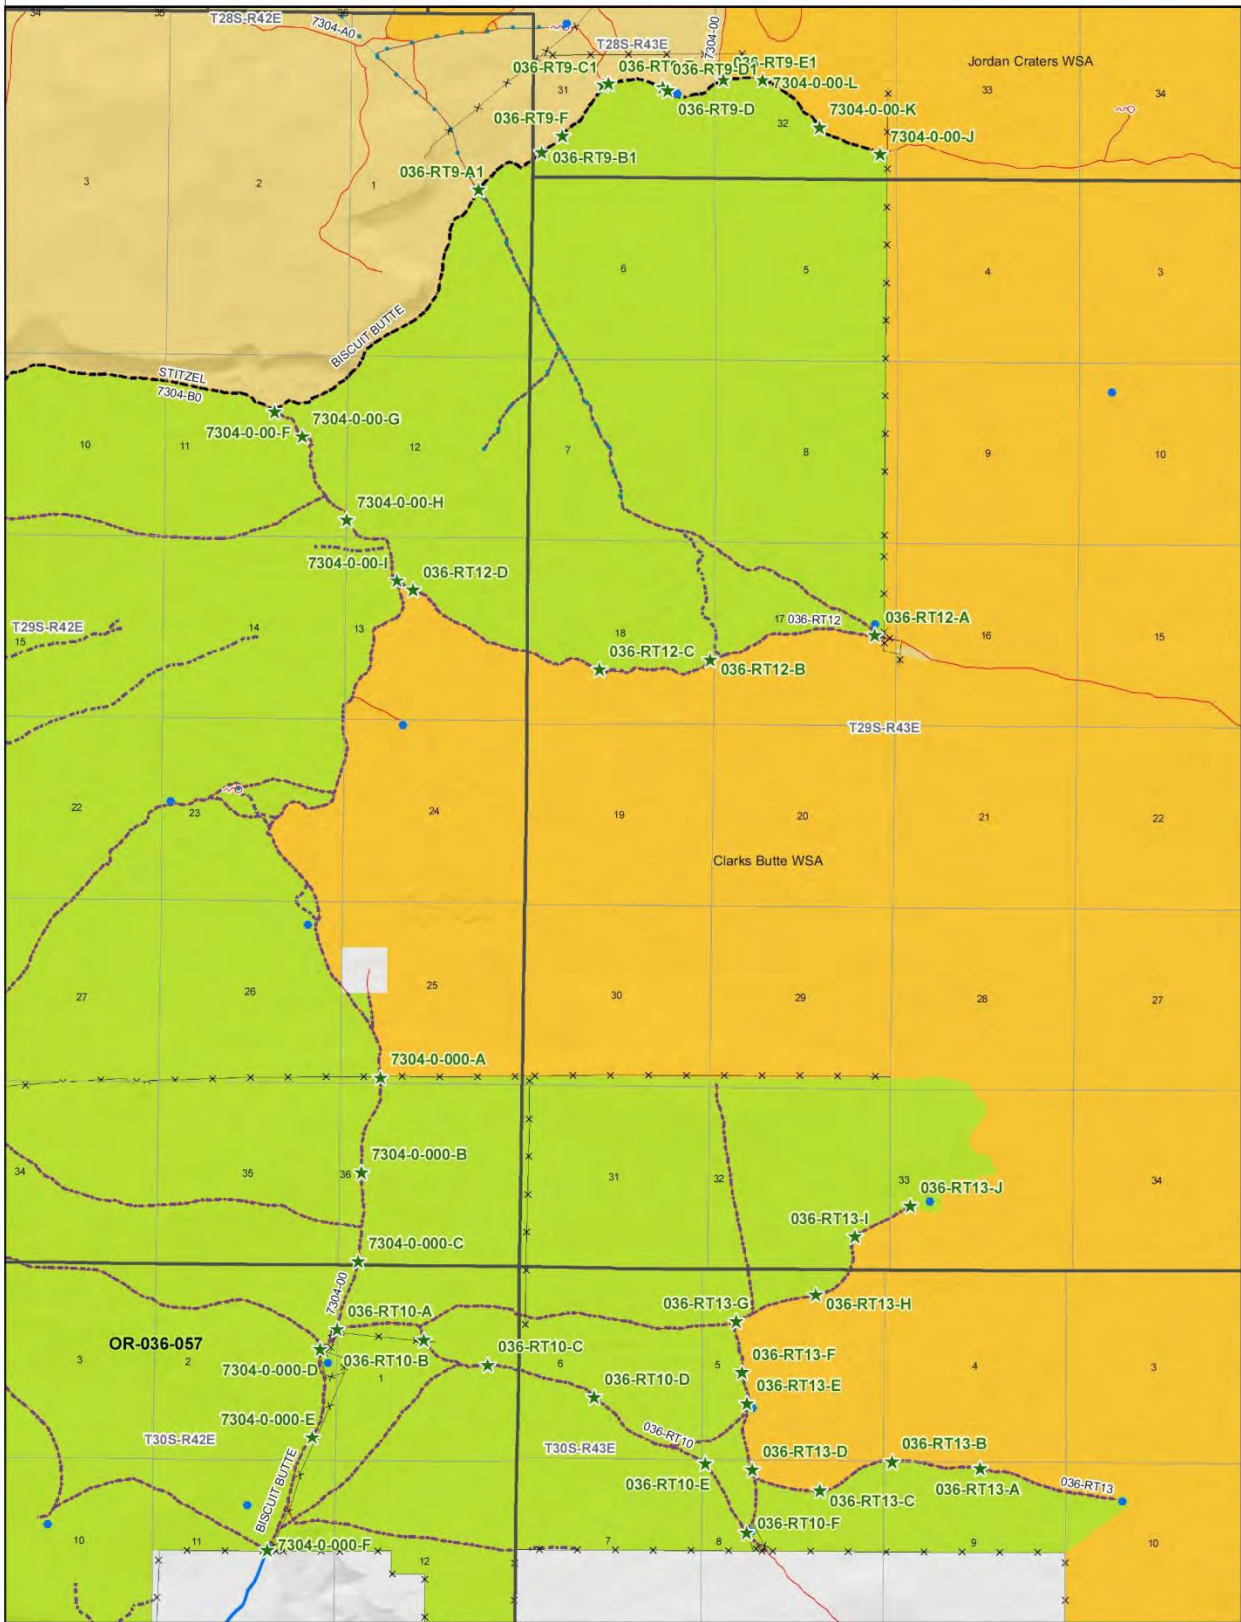
# Wilderness Characteristics - BLM Photo Points Clarks Butte Contiguous - OR-036-057

Note: The BLM Wild Char PhotoPoints displayed on the map are labeled with their Photo Locations.

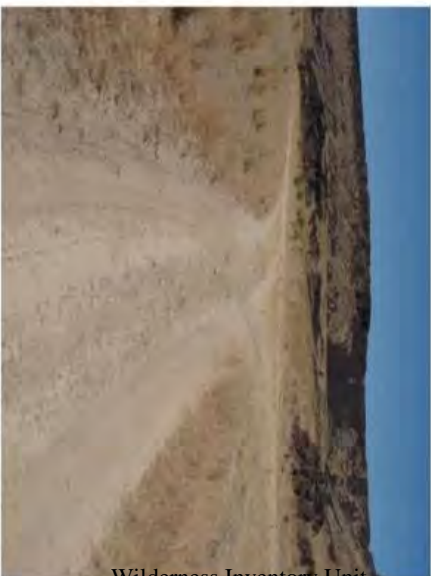
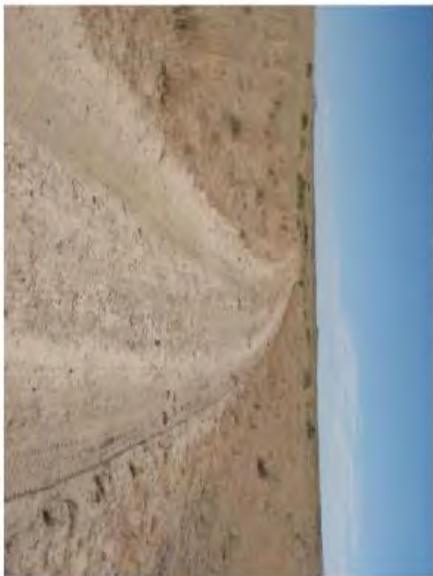
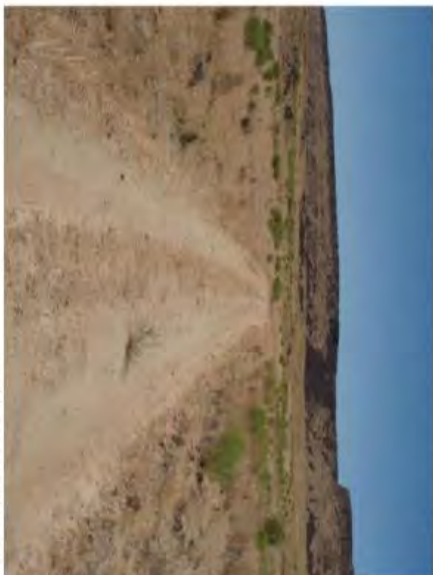
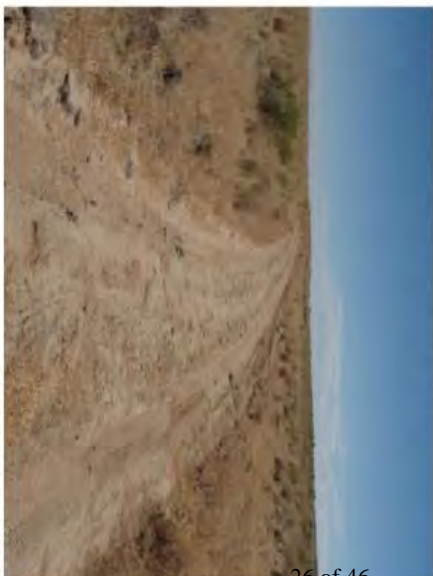
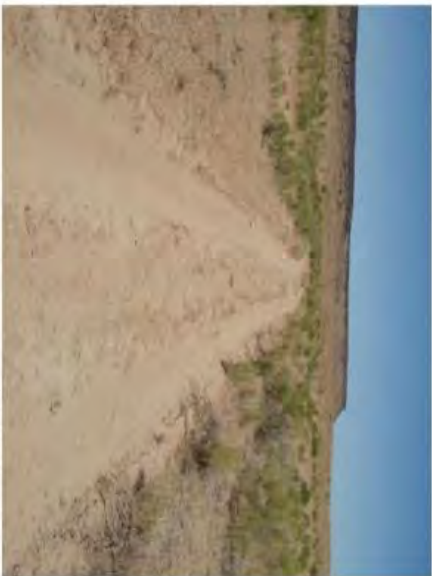
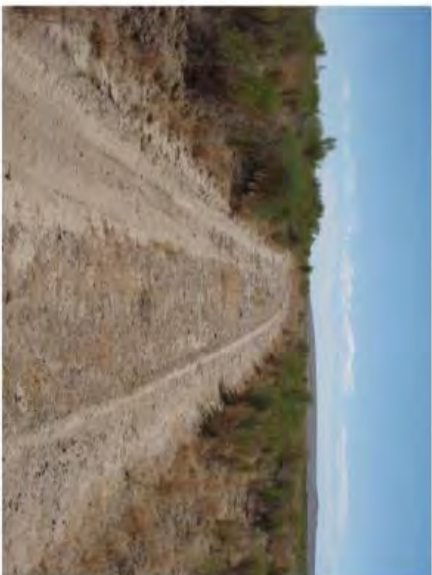
BLM Road 7304-0-00 section E-F receives a low level of regular use by ranchers and BLM staff for administration of grazing allotments as evident from a wide roadway from tire disturbance indicating use (BLM photos 7304-0-00-F through I and 7304-0-000-D-NE and F-N). BLM Road 7304-0-00 has annual seasonal use as evidence by the lack of perennial vegetation along all road segments in the north half of the road as evident by well-used bare ground where vehicle tire tracks can be observed. The southern half of BLM Road 7304-0-00 Section E-F is not as well-traveled and is clearly not as well defined on the landscape. BLM Road 7304-0-00 is also used on a seasonal basis by hunters and recreation enthusiasts to access spur routes that serve their purposes. BLM Road 7304-0-00 will continue to be annually used but receives a lower quantity of travel along its length and does not connect with any well-travel road to the south.
