Wilderness Inventory Unit Index of Documents  
**DeArmond Mountain OR-034-012, 35 total pages**

## **H-6300-1-WILDERNESS INVENTORY MAINTENANCE IN BLM OREGON/WASHINGTON**

Year: 2010 Unit Number/Name: OR-034-012 — DeArmond Mountain

**Unit Number/Name: OR-034-012 — DeArmond Mountain**

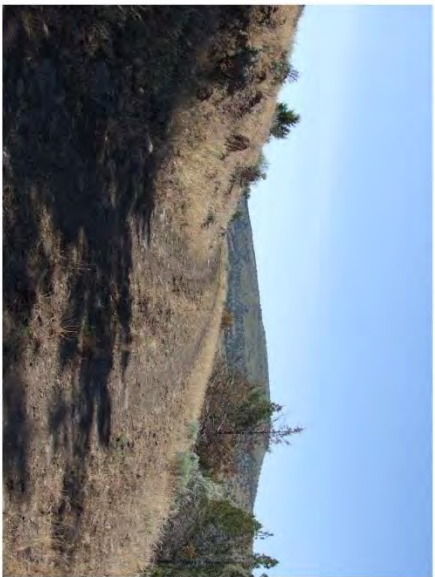
7354-00-I-N.JPG

PHOTO_LOCATION*	DIRECTION	PHOTO_TYPE	PHOTO_DATE	COMMENTS
7354-00-A	NE	Route	20090623	Ditch. Double berm.
7354-00-A	SW	Route	20090623	Ditch. Double berm.
7354-00-B	NE	Route	20090623	Ditch, rock berm on South side of route.
7354-00-B	SW	Route	20090623	Ditch, rocky berm on South side of route.
7354-00-C	E	Route	20090623	Small ditch, rocky berm. Road cut.
7354-00-C	W	Route	20090623	Ditch, culvert.
7354-00-D	E	Route	20090623	Ditch, rocky berm.
7354-00-D	W	Route	20090623	Ditch, rocky berm.
7354-00-E	E	Route	20090623	Ditch, rocky berm.
7354-00-E	W	Route	20090623	Ditch, rocky berm.
7354-00-F	E	Route	20090623	Culvert.
7354-00-F	W	Route	20090623	Large ditch.
7354-00-G	E	Route	20090623	Small ditch, large rocks moved off route.
7354-00-G	W	Route	20090623	Drainage.
7354-00-H	NE	Route	20090623	Drain. Rocky berm.
7354-00-H	SW	Route	20090623	Small ditch.
7354-00-I	S	Route	20090623	Side cut.
7354-00-I	N	Route	20090623	Side cut with culvert hidden in weeds.

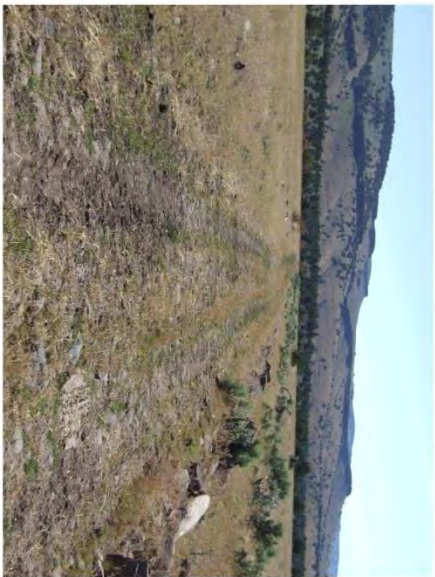
7354-00-J-W.JPG

7354-00-J	E	Route	20090623	Large rocky berm. Ditch.
7354-00-J	W	Route	20090623	Large rocky berm. Ditch.
7354-00-K	E	Route	20090623	Two large rocky berms, ditch.
7354-00-K	W	Route	20090623	Two large rocky berms. Ditch.
7354-00-L	N	Route	20090623	Side cut.
7354-00-L	S	Route	20090623	Side cut.
7354-00-M	E	Route	20090623	Side cut.
7354-00-M	W	Route	20090623	Ditch.
7354-00-N	N	Route	20090623	Side cut.
7354-00-N	S	Route	20090623	Side cut.
7354-00-O	NE	Route	20090623	Side cut. Small ditch.
7354-00-O	SW	Route	20090623	Side cut. Small ditch.
7354-00-P	N	Route	20090623	Small rocky berm on West side of route.
7354-00-P	S	Route	20090623	Small side cut.
7354-00-Q	N	Route	20090623	Side cut.
7354-00-Q	S	Route	20090623	Side cut.
7354-00-R	E	Route	20090623	Side cut, small berm on the North side of route.
7354-00-R	W	Route	20090623	Side cut, small berm on the North side of route.
7354-00-S	NW	Route	20090623	Side cut. Ditch.
