Wilderness Inventory Unit Index of Documents
Hunter Spring OR-034-039, 29 total pages

Year: 2009 **Unit Number/Name:** OR-034-039 -- Hunter Spring

FORM 2 -- DOCUMENTATION OF CURRENT WILDERNESS INVENTORY CONDITIONS

Unit Number/Name: **OR-034-039 – Hunter Spring**

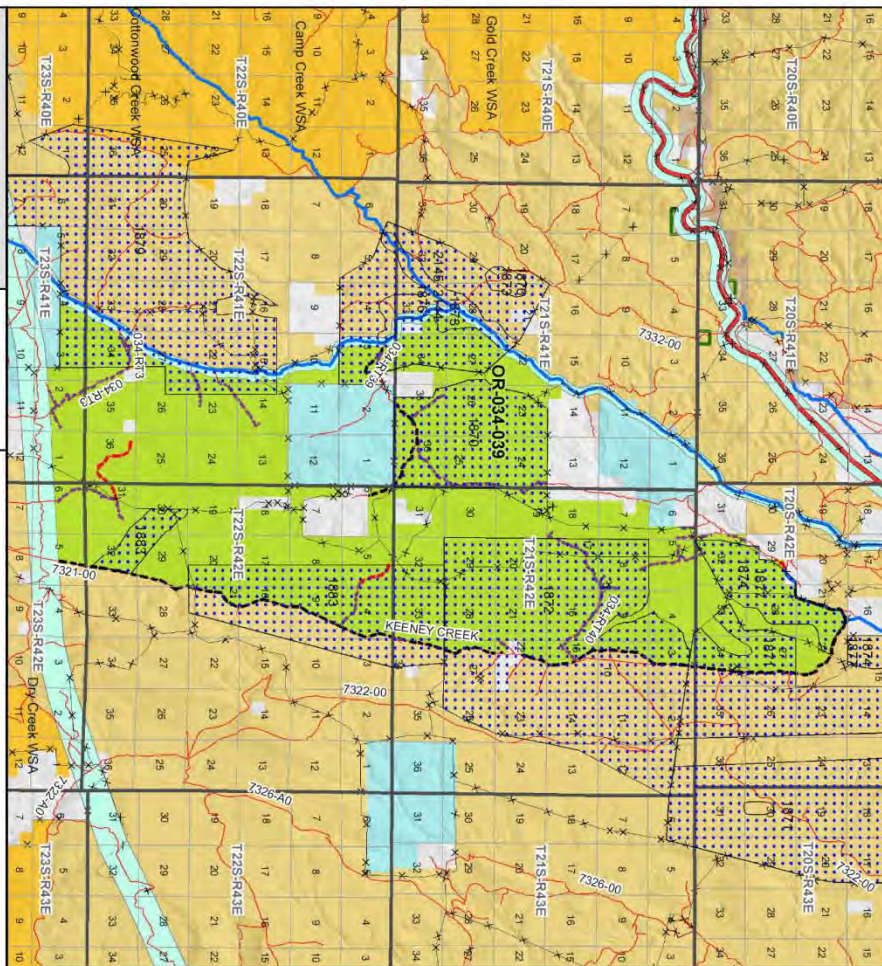
Wilderness Characteristics - Land Treatments
Hunter Spring - OR-034-039 - Map 2 of 2

Note: The Land Treatments represented by navy blue dots on the map to the left are labeled with the treatments' ObjectIDs listed in the first field of the Land Treatments table shown above. Multiple types of treatments may have been applied to the same area. For example, one treatment area may have been plowed and drill seeded - a record is shown in the table for each type of treatment.

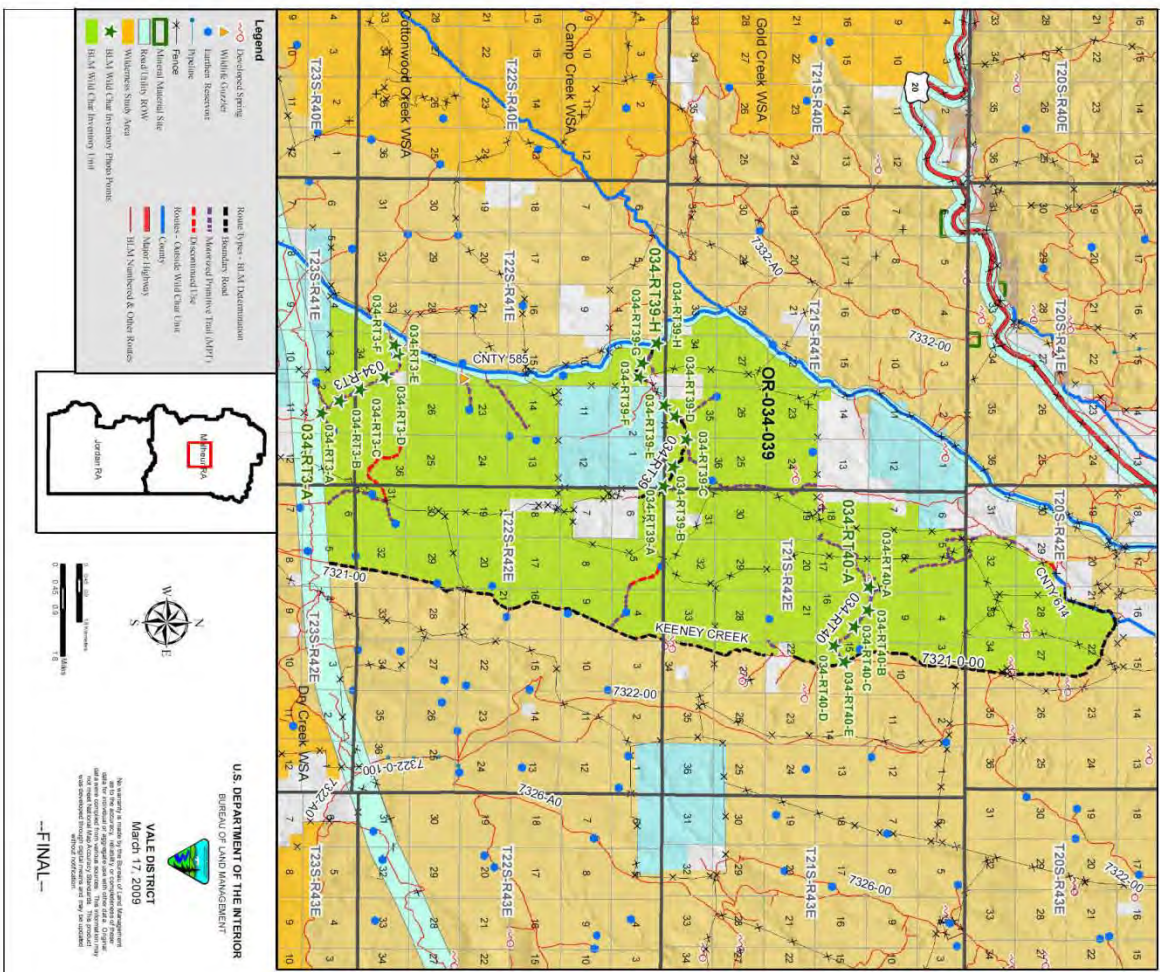
Wilderness Characteristics - BLM Photo Points
Hunter Spring - OR-034-039

Note: The BLM Wild Char PhotoPoints displayed on the map are labeled with their Photo Locations. The BLM Photo Log table shown above lists the photos taken at their respective Photo Locations. Multiple photos may be taken at each Photo Location. Scenery and Project Photo Type pictures have their photo names provided in the Comments field.
