## Wilderness Inventory Unit Index of Documents **Indian Camp OR-036-075, 20 total pages**

**Year:** 2011      **Unit Number/Name:** OR-036-075—Indian Camp

## **FORM 2 -- DOCUMENTATION OF CURRENT WILDERNESS INVENTORY CONDITIONS**

**APPENDIX C – ROAD\* ANALYSIS**

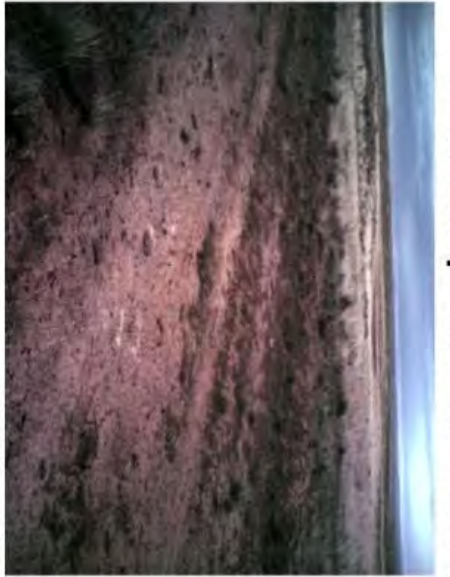
036-RT20-A-SE.jpg

BLM has conducted maintenance to BLM Road 036-RT20 over time as needed to keep this route passable. Earthen berms on the edge of the road in photographs 036-RT20-A-SE and D-S show maintenance work that has been performed on

BLM Road 036-RT20 receives annual use, as evidence by the lack of brush in the roadway and by well-used bare ground where vehicles travel. It should be noted that small amounts of brush occur sporadically throughout the length of the road along berms. Vale District has reduced road maintenance needs on roads to only the roadbed and does not blade originally constructed berms unless vegetation encroachment on berms tend to restrict vehicular travel or blade ditches unless drainage from roadways is impeded (as evident in photos 036-RT20-A-SE and D-S).

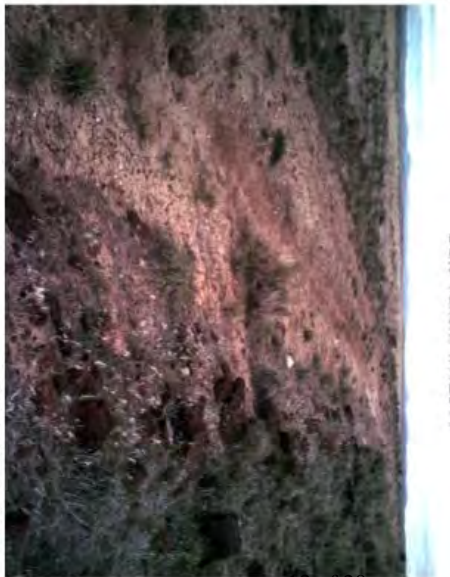
036-RT20-B-NW.jpg

Existing roadside berms are not particularly pronounced in some segments of BLM Road 036-RT20, especially in areas where the roadway travels over relatively flat topography (BLM photos 036-RT20-C-S, D-N, and E-N) since these areas require little maintenance to remain passable by vehicles. In other areas along BLM Road 036-RT20 some of the berms are covered with brush as well as sediment (BLM photos 036-RT20-B-NW, and F-W).
